# ARCHAEOLOGICAL ASSESSMENT OF SELECTED BASEMENT ROOMS, MARTIN MELCK HOUSE, STRAND STREET, CAPE TOWN.

**Gabriël Fagan Architects**

May 1994

**Archaeology Contracts Office**

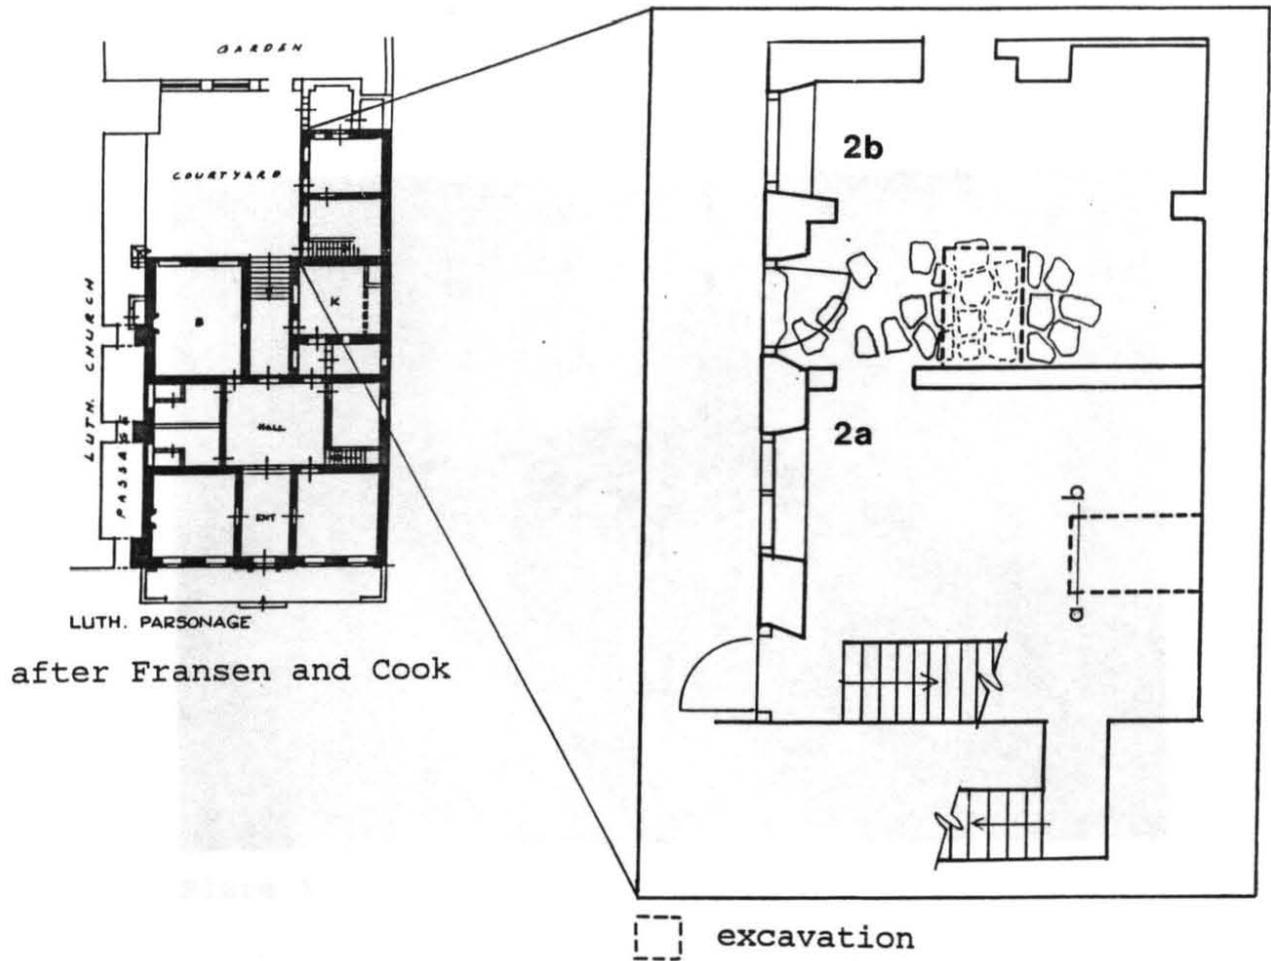
A plan of the house showing the location of the rooms to be investigated is presented in Figure 1. Also shown are the location of test excavations and a section drawing characterising the stratigraphic sequence of the deposits. Room numbers in the detail correspond to the room numbers on the architects working diagram. Subdivision into areas 2A and 2B are for purposes of discussion.

Excavations show the deposit in both 2A and 2B to be virtually identical. A description of the various units can be found in Figure 1 on the section drawing. The lime plaster layer marks a transition from 18th to 19th century or at least from the Dutch to British periods. Below the plaster layer, ceramics are exclusively of oriental manufacture whereas only refined earthenwares characteristic of the British period are recovered above. Artefact samples are very small and are in most cases in secondary context.

- timber floor
- brick
- light brown/grey soil
- ferruginous gravel
- lime plaster surface
- brown soil with shale rubble
- decomposing Malmsbury shale (sterile)

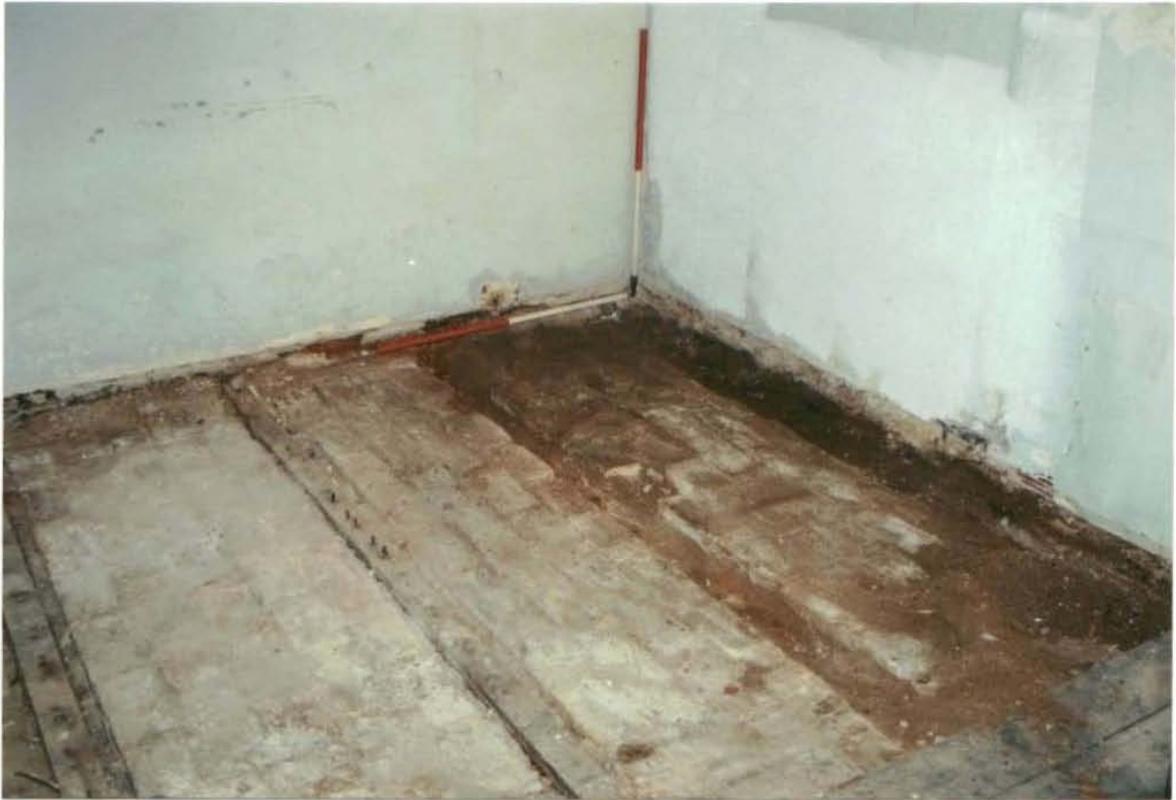
Plate 1

Removal of timber floors has revealed varying surfaces. In Room 2A, brick had been laid between the joists probably in an attempt to reduce damp (Plate 1). Floors and brick are probably late Victorian. In Room 2B, the situation is slightly different in that some stone paving has been preserved below timber floors in a small area (see Figure 1 and Plate 2). Other parts had been lowered to provide an aeration cavity. Several fragments of refined earthenware were recovered from the aeration gap and date to the later part of the 18th or early 19th century. These have probably worked their way into the deposit through gaps and cracks in the timber floor. The presence of this material to the exclusion of earlier styles would seem to confirm the date of the addition of timber floors.
