A REPORT ON THE DEMOLITION OF "THE KNOLL" (KNOWN HISTORICALLY AS BOTANY HOUSE), KLOOF ROAD, BANTRY BAY

Tim Hart

Archaeology Contracts Office

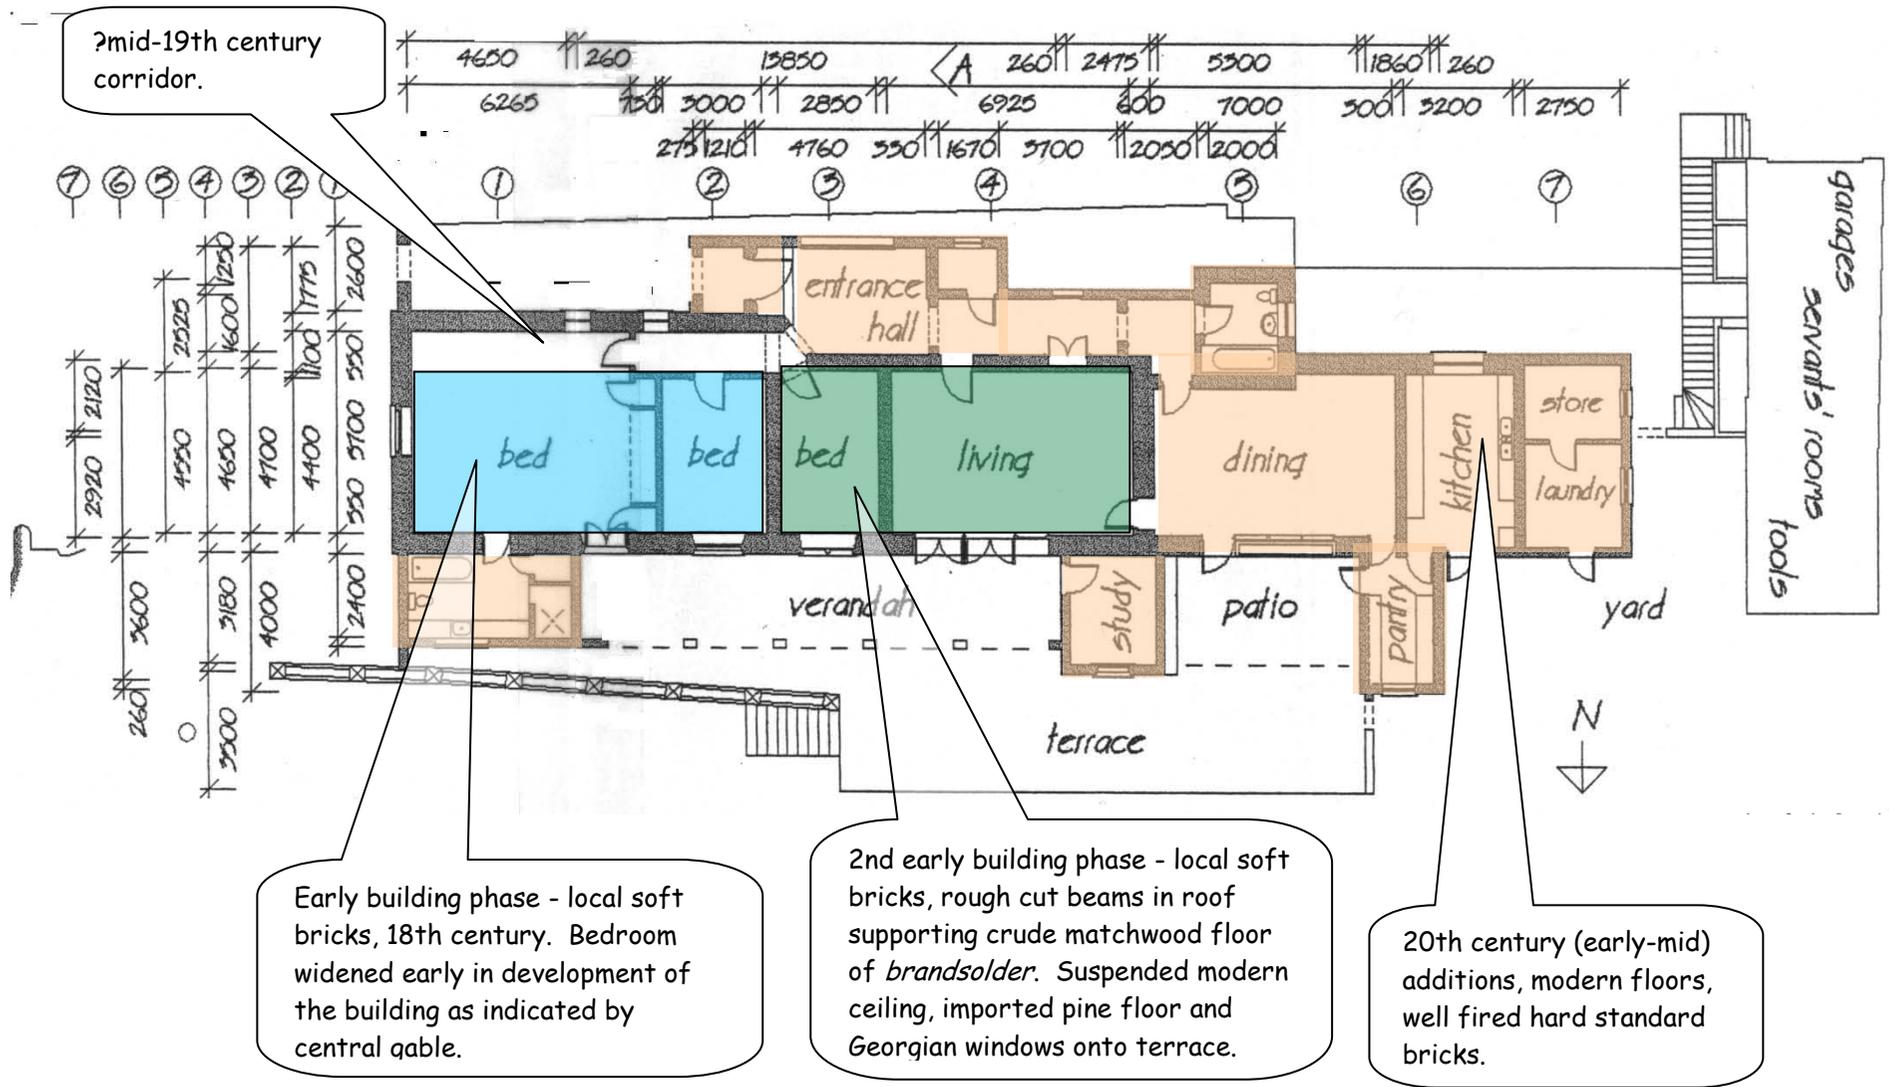
Figure 1 The building sequence

The brickwork in the eastern half of the structure was consistent with that found in 18th - early 19th century buildings in Cape Town indicating that the historic core of the building may date to the 18th century. Indications are that the original structure on the property consisted of a small single or double room dwelling with a simple straight gable at each end, and an attic space (*solder*), which was accessible via an external stair or ladder. In the late 18th or early 19th century the dwelling was extended (possibly when Liesching took over the property) with the addition of a further room to the west. This was attached to the end gable and finished with a third straight gable and attic door. At this point the building took the form of a typical extended vernacular style "*langhuis*" with a pitched thatched roof, 3-4 rooms with a central straight gable and gables at either end.

The next phase of changes to the structure took place sometime in the 19th century. This involved broadening the structure to include a corridor along the side of the southeast bedrooms. All three gables were heightened and broadened in a southerly direction to accommodate the changes in the building's profile, with the result that the attic doors lost their central position, however the plasterwork of the original gables remained visible within the roof space.

The final changes to the building took place in the 1930's with the addition of the dining room, kitchen, store and laundry together with the construction of the 4th gable built in the "Cape Dutch" revivalist style typical of the time. At the same time the three older gables were adjusted to replicate the new end gable.

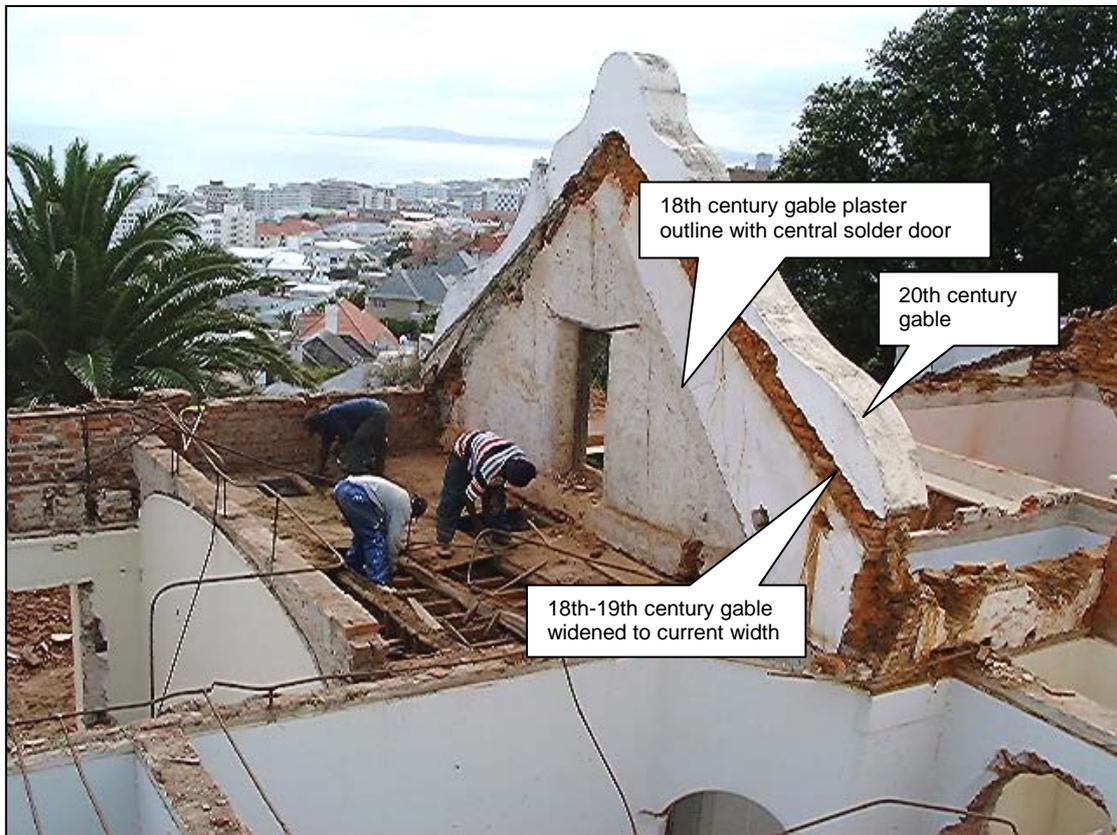
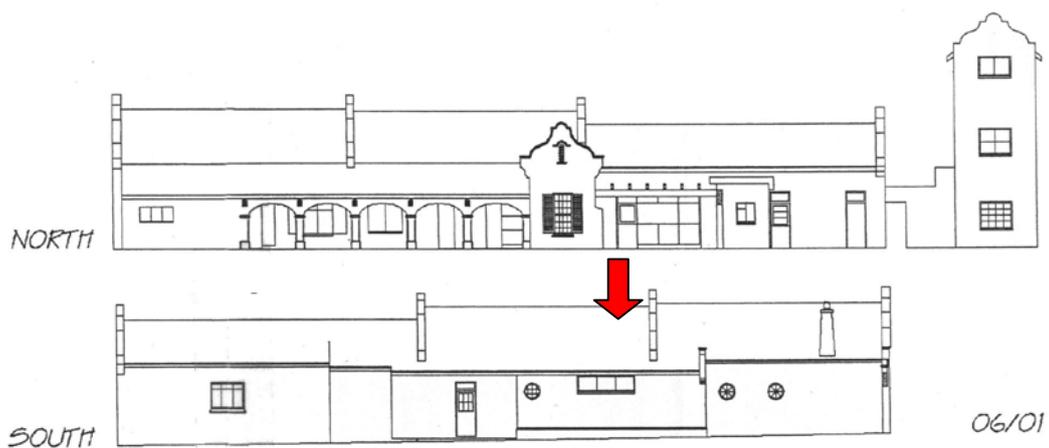
Figure 2 Detail of gable showing three building events that indicate that the original structure took the form of a narrow straight gabled building with an attic space. The western end of the building was subsequently broadened and the gable adjusted in width and height. The final form of the gable dates to the early-mid 20th century.

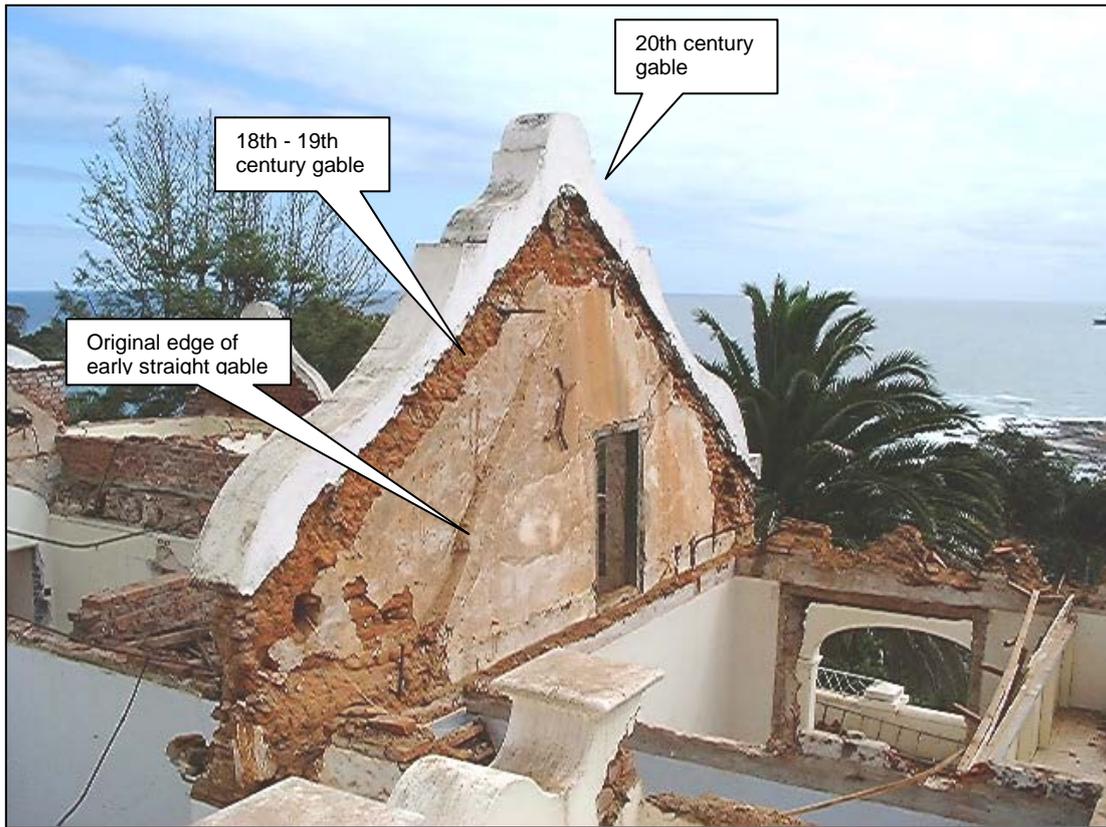
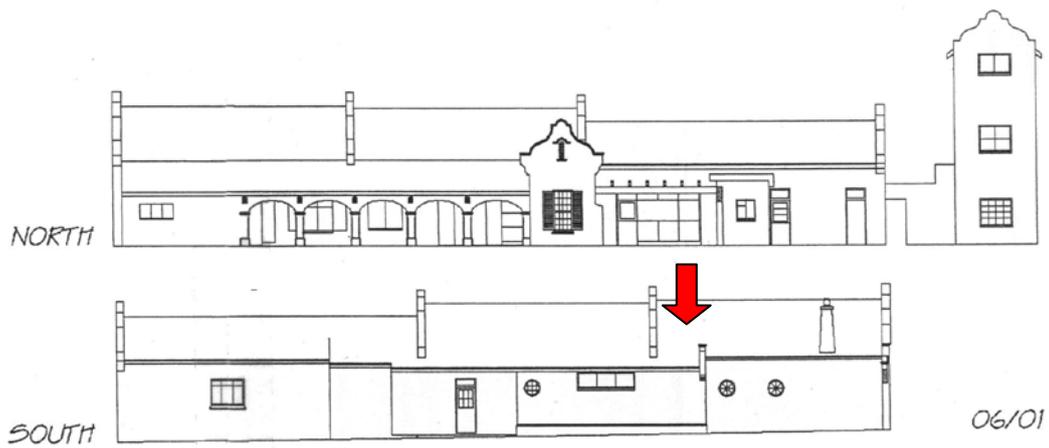
Figure 3 Detail of gable (opposite side) showing three building events that indicate that the original structure took the form of a narrow straight gabled building with an attic space. The western end of the building was subsequently broadened and the gable adjusted in width and height. The final form of the gable dates to the early-mid 20th century.

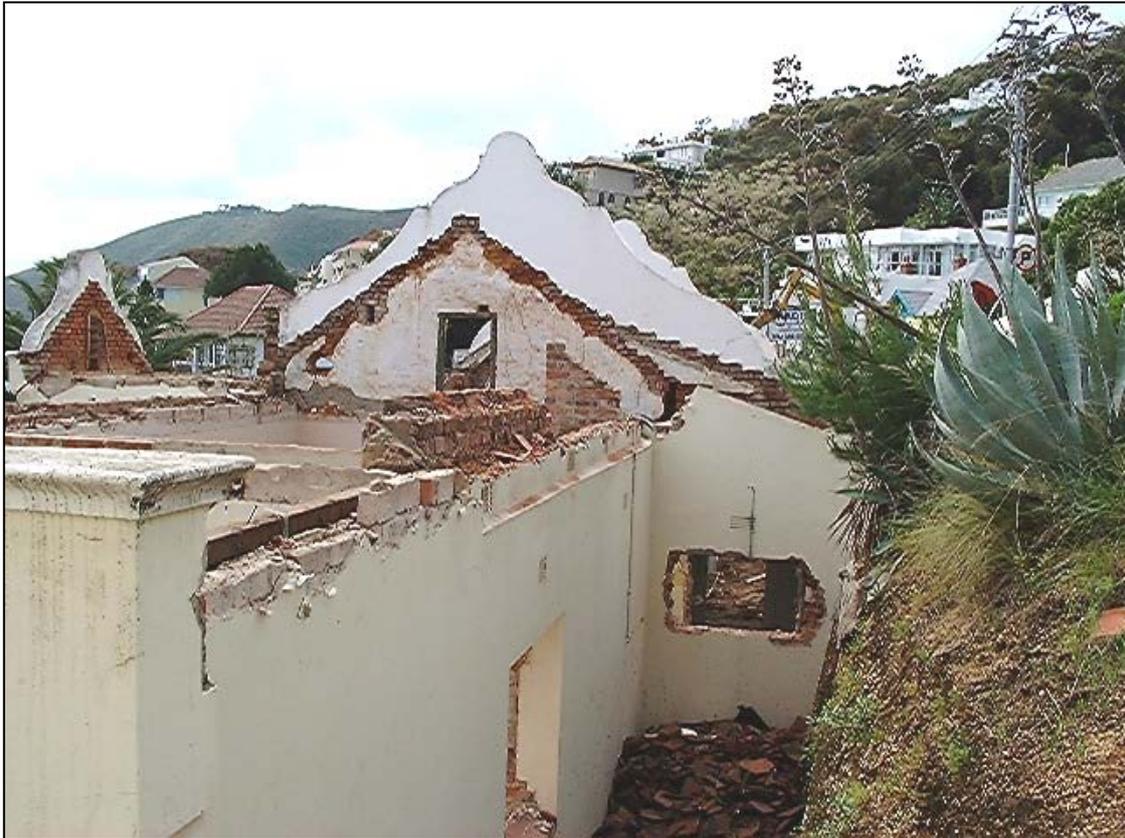
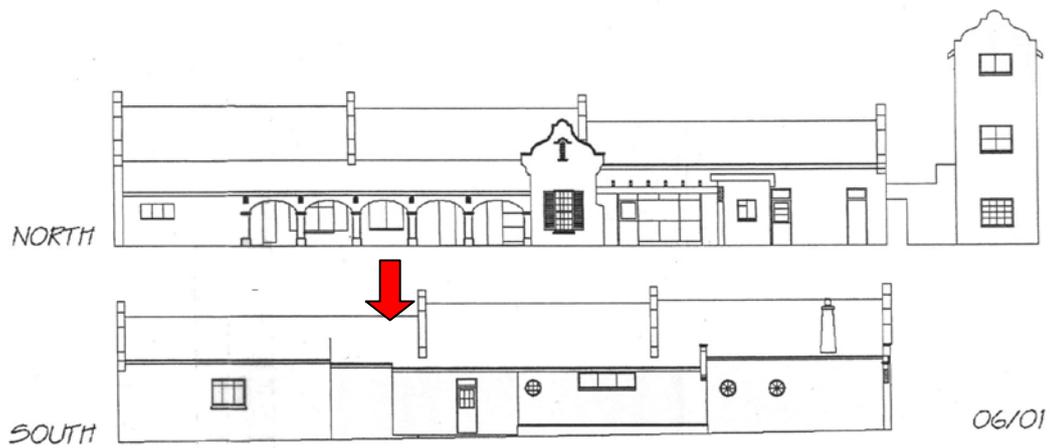
Figure 4 View of gable with attic door from westerly (20th century) end of the structure. Gable demonstrates how it has been asymmetrically modified to accommodate broadening of the structure.

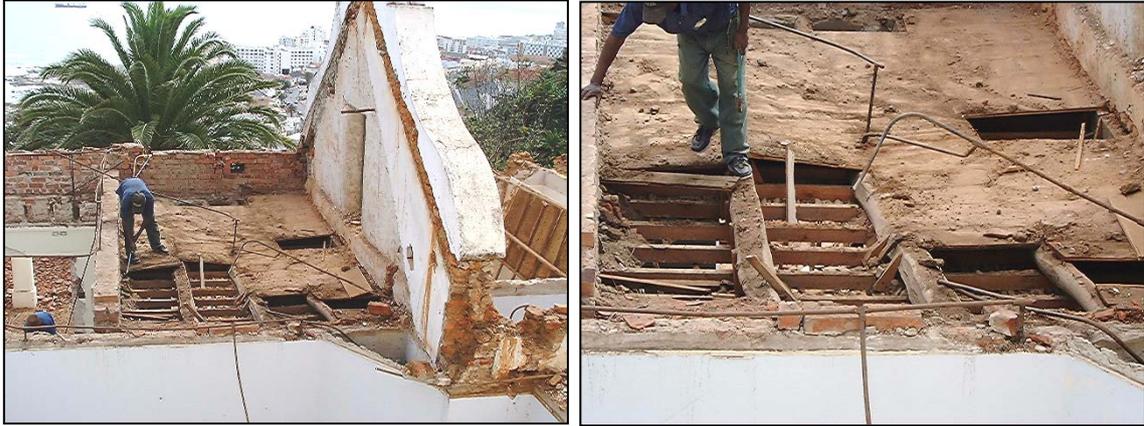
Figure 5 A portion of the Solder floor consisting of matchwood boards affixed to rough-cut beams. A modern ceiling had been hung from the beams obscuring this original early fabric under 20th century additions.

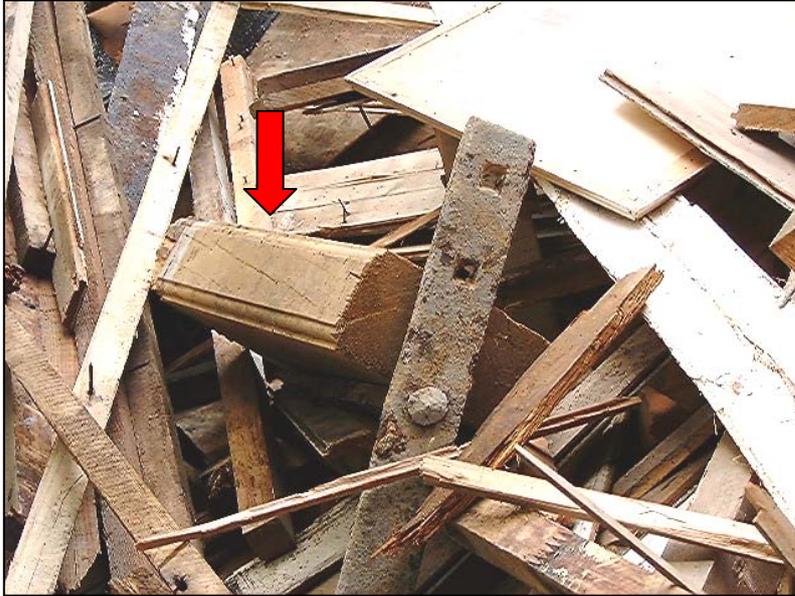
Figure 6 Portion of yellow wood beam among collapsed demolition rubble. Fabric such as this was hidden under 20th century additions.

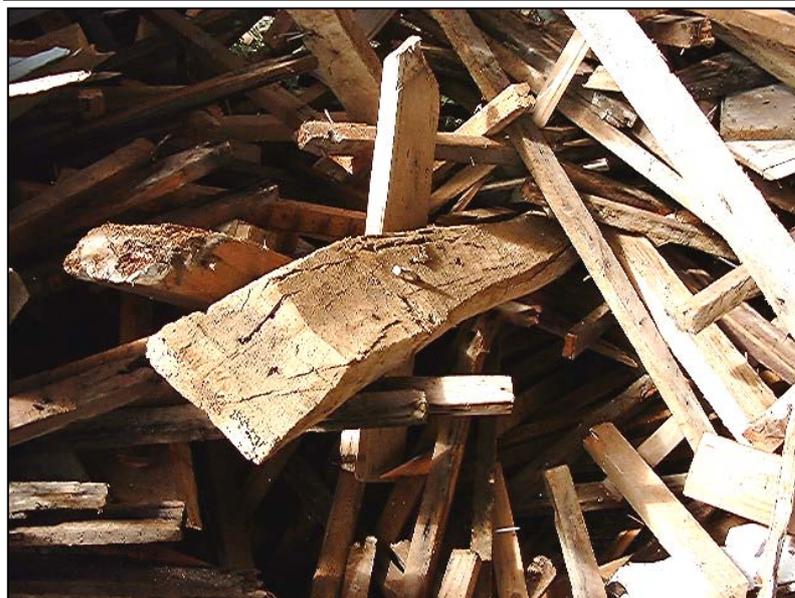
Figure 7 Length of rough-cut beam in demolition rubble.

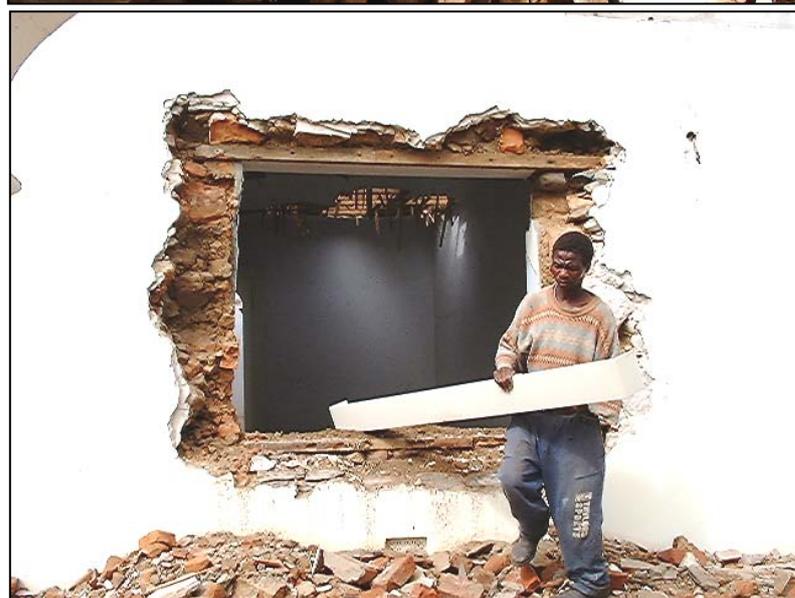
Figure 8 Architrave for casement window. Note original wooden lintel and use of soft local bricks.
