**A PHASE 1 ARCHAEOLOGICAL IMPACT ASSESSMENT OF  
THREE BORROW PITS ALONGSIDE MR 539 AND DR1487  
CLANWILLIAM  
WESTERN CAPE**

**Client: Provincial Government Western Cape:  
Department of Transport & Public Works**

**Agency for Cultural Resource Management**

**JULY  
2006**

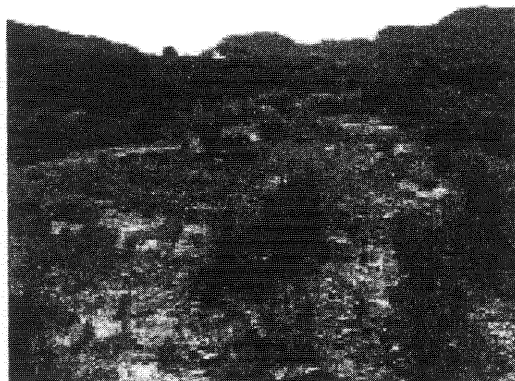
The proposed borrow pit is situated alongside DR1487 (Figures 4 & 5). The proposed site is fairly severely degraded, having been partially scraped and stripped of vegetation. Some deep pits for road material have already been excavated. No significant landscape features occur. The surrounding land comprises natural veld.

**Findings:** No archaeological heritage remains were located during the study.

Figure 4. Cederberg Borrow Pit  
View of the site facing south west

Figure 5. Cederberg Borrow Pit.  
View of the site facing north east.  
Arrow indicates DR1487

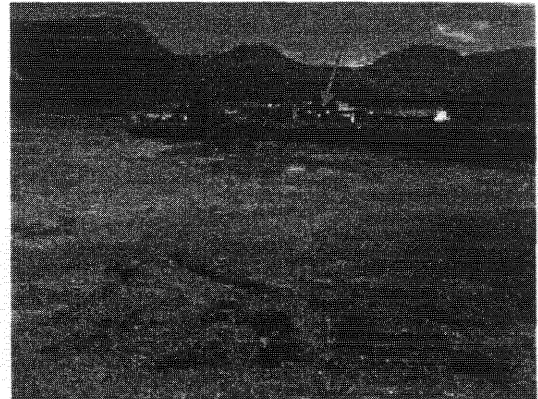
The proposed borrow pit is located on the Farm Dwarsrivier, alongside DR1487. The proposed site comprises a large farm dam. The proposed site is already severely degraded. The surrounding land use comprise mainly vineyards and grazing land, with some natural veld occurring.

**Findings:** No archaeological heritage remains were located during the study.

**Figure 6. View of the site facing north west. Arrow indicates DR1487**

**Figure 7. View of the site facing south west. Arrow indicates the Dwarsrivier homestead**
