Archaeological Site Inspection –

**BORROW PIT 76.0 QUARRY IMPACT ON
ARCHAEOLOGICAL 'MICHAUSDAL' DEPOSITS,
CRADOCK DISTRICT, EASTERN CAPE, SOUTH AFRICA**

DATE: 2006-08-25

Our Ref : 3225BA 2006.001

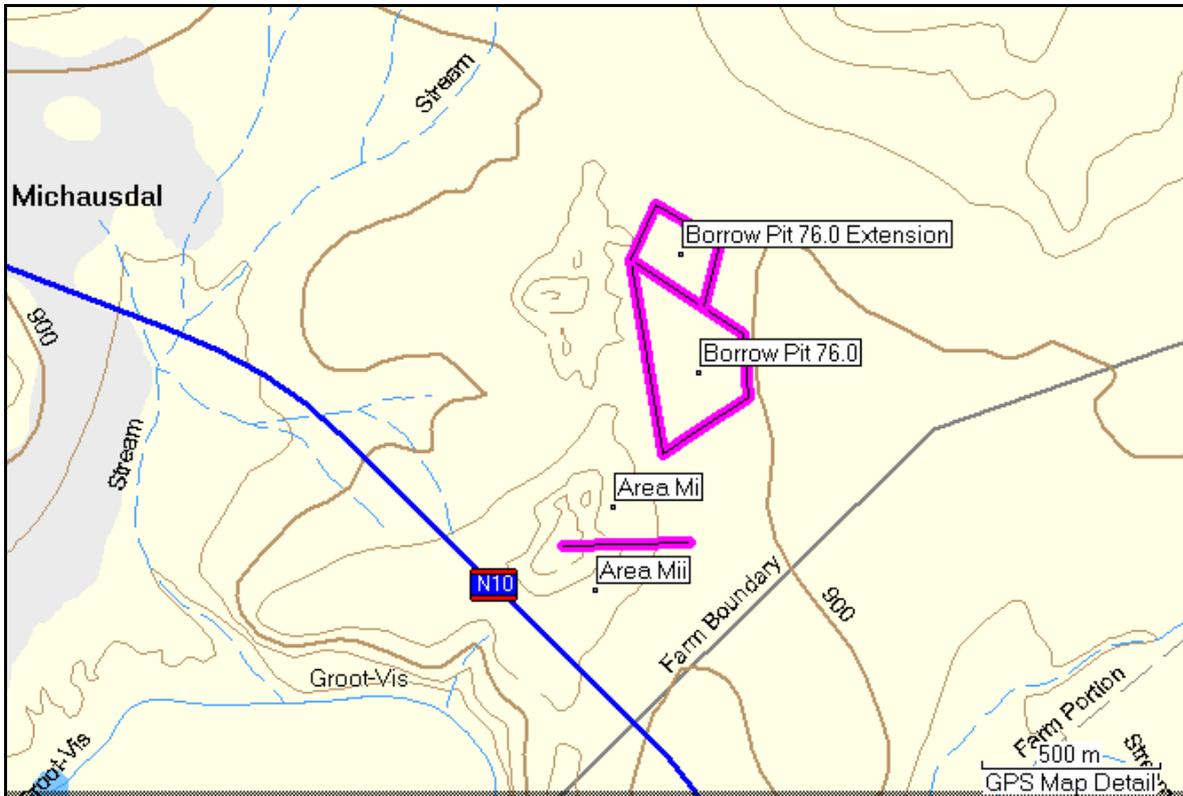
MAP 2: The 'Michausdal' / Borrow Pit 76.0 area. MSA deposits in Area Mi stretches from the horizontal line south of Borrow Pit 76.0 north, while deposits typical of Area Mii were restricted to the southern part of the hill

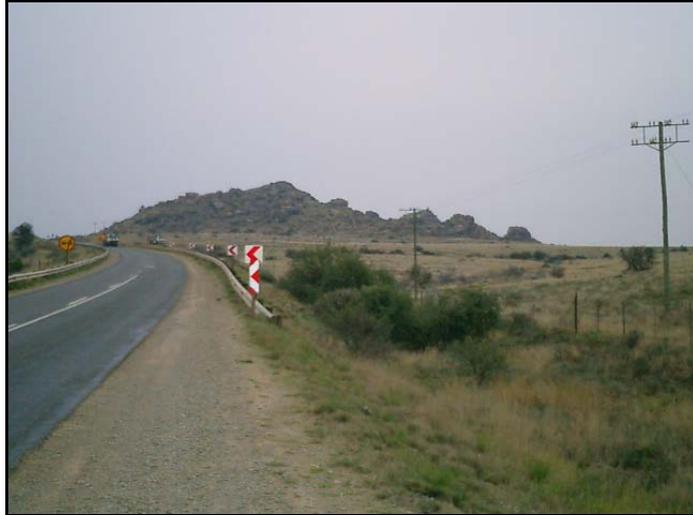
IMAGE 1: General view of the 'Michausdal' site and Borrow Pit 76.0

Borrow Pit 76.0 quarry activities impacted negatively on identified 'Michausdal' deposits. Deposits in the Borrow Pit area have been either totally destroyed, or impacted on, to such a degree that conservation of the remaining deposits will have little value in furthering our understanding of the past. The development however did not affect the total of the site. Remains were still identifiable in areas closer to the adjacent hills in the west. 'Michausdal' deposits are represented by identified ESA, MSA and LSA Stone Age components. A Historical presence is also evident on the site. ESA, LSA and Historical artefacts are extremely limited; remaining 'Michausdal' deposits can be described as a MSA site.

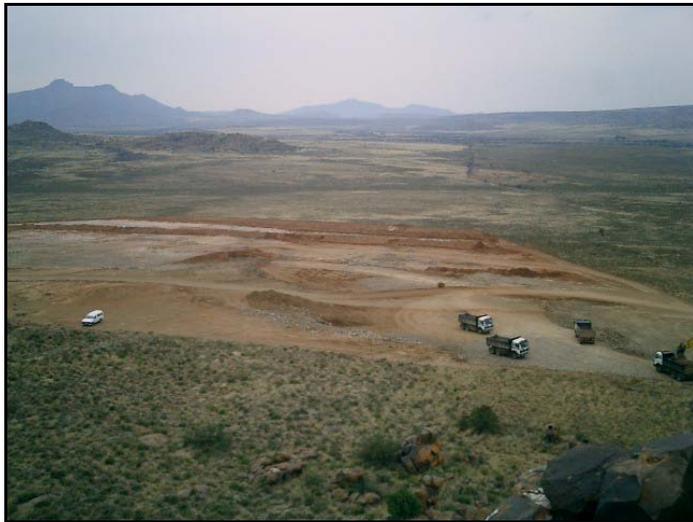
IMAGE 2: View onto the Borrow Pit 76.0 development

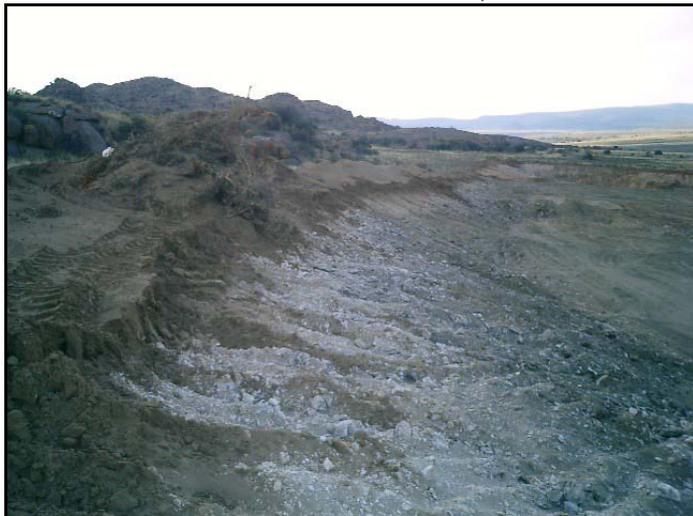
A number of MSA artefacts were encountered during assessment of Borrow Pit 76.0. Artefacts were restricted to quarry dumps or areas where the underlying calcrete layer was not yet reached, strengthening the interpretation that cultural deposits were restricted to the top layer. Thickness of the top layer decrease visibly towards the north and east. On average artefact quantities decrease from south to north. Virtually no artefacts were encountered in the northern exposures of the Borrow Pit, limiting the inferred impact of the development to the southern extremities thereof. In this area development impact was total and the few remaining artefacts does not validate conservation. No sign of the reported 'stone circles' (Pers. Comm: Holden) could be discerned.

IMAGE 3: Exposed north-western quarry section; note the shallow topsoil overlying calcrete layers

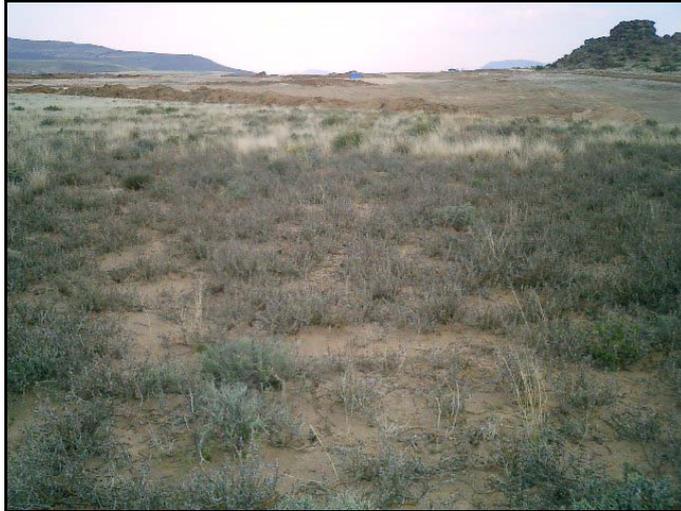
Assessment of Borrow Pit 76.0 Extension area indicated an extremely low presence of surface artefacts, serving as an indication of the 'Michausdal' site's boundary. Artefacts are typologically similar to material found at Mi, but with artefact ratios of <1:64.

IMAGE 4: View onto Borrow Pit 76.0 from proposed Borrow Pit 76.0 Extension site

Borrow Pit 76.0 Extension will not impact on any significant archaeological deposits; we would propose that development in this area proceed if applied for.

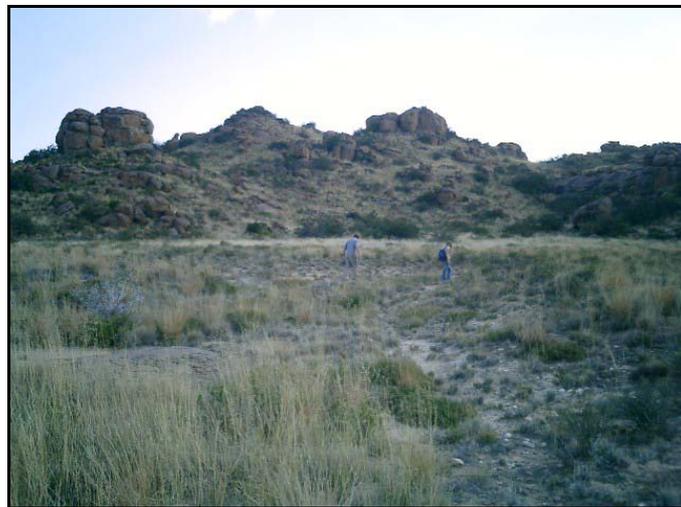
MSA artefacts encountered in Area Mi were predominantly produced from hornfels, a raw material not indigenous to the immediate area. Artefact types included a rich array of blades, flake-blades and irregular flakes with lesser quantities of convergent flakes. Little to no associated cores and waste material were encountered, giving the impression that primary knapping was done elsewhere. Some secondary knapping was evidently done on site. The general area may thus be indicative of an 'activity / specialist area' with a focus on demarcated Area Mi. Artefact quantities decreased towards the north with little to no artefacts encountered in the vicinity of the Borrow Pit 76.0 Extension site. Artefact ratios (artefacts:m²) thus vary considerably, ranging from >10:1 to 0:1. At Area Mi artefacts were concentrated around a palaeo-spring, situated within the U-shaped formation of the hill. Artefacts were more exposed in the immediate vicinity of the spring and in game footpaths, a result of erosion, giving the impression that the deposit may well have stratigraphic depth of up to 1.5m (inference based on an animal burrow). Faunal material was encountered. No direct association between faunal remains and the archaeological deposit could be established.

IMAGE 5: General view: The 'Michausdal' site, Area Mi

- 1) 'Michausdal' Area Mi: One $\geq 49\text{m}^2$ excavation down to approximately 1.5m (archaeological sterile level) and approximately three $\geq 1\text{m}^2$ testpits situated at various intervals north of Area Mi to monitor inferred decrease in artefact quantities.
- 2) 'Michausdal' Area Mii: Excavation / systematic surface collection of one knapping area.

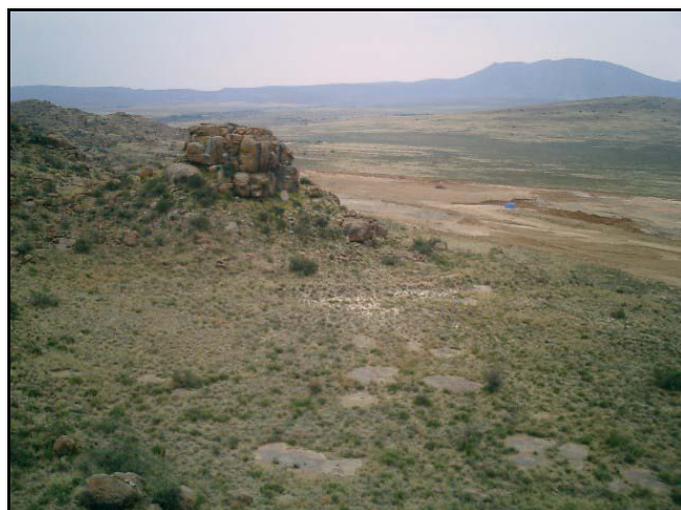
IMAGE 6: The 'Michausdal' site, Area Mi. Note the spring located off centre in the middleground of the photograph (white sandy patch)

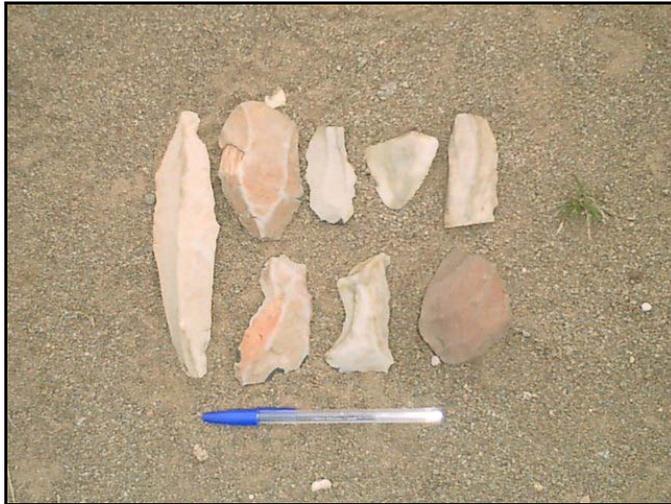
IMAGE 7: Blade and flake hornfels artefacts from Area Mi

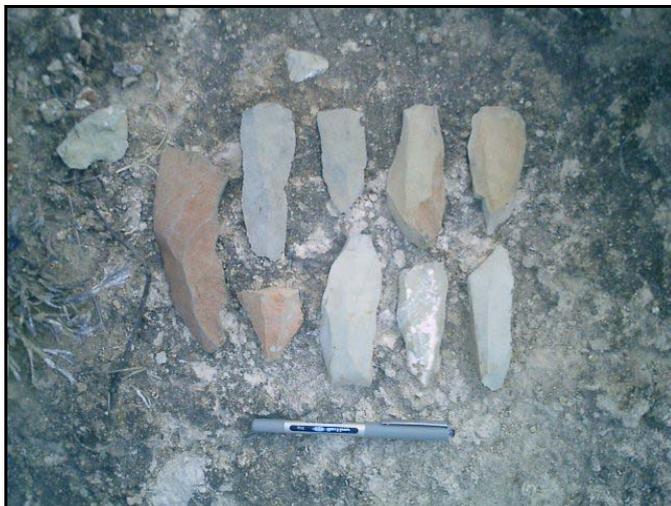
IMAGE 8: Blade and flake artefacts from Area Mi (the artefact on the left is produced from fine grained dolorite)

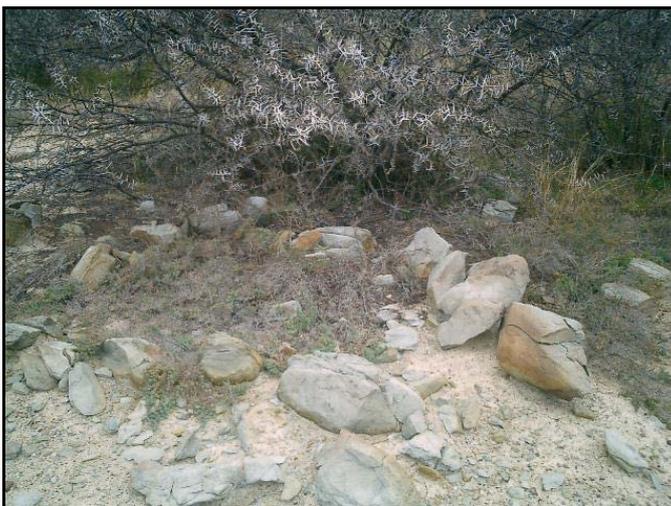
A single ephemeral stone circle was located next to the spring. Two similar 'structures' were present in the Borrow Pit 76.0 area (Pers. Comm: Holden). Stone circles may well have pointed to a Later Stone Age (LSA) occupation phase at the site with a probable focus on lower altitudes.

IMAGE 9: A 'stone circle' situated next to the spring. Similar 'stone circles', in association with younger lithics were recorded from the area destroyed by the Borrow Pit 76.0 development (Pers. Comm: Holden)

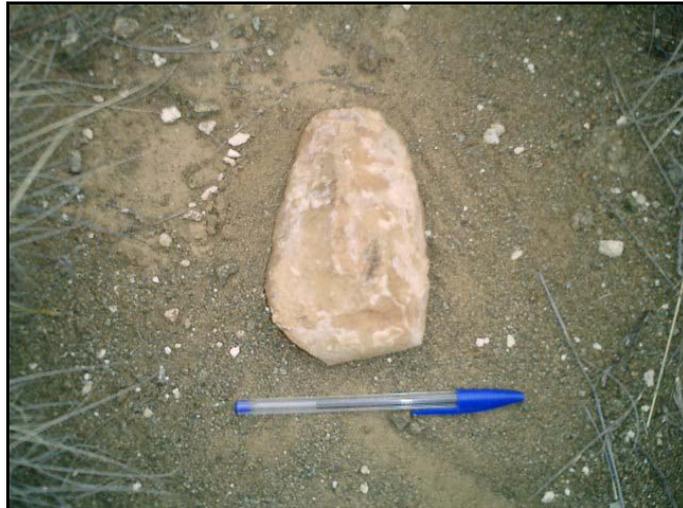
A single cleaver is indicative of an Earlier Stone Age (ESA) component in the area.

IMAGE 10: A single cleaver from Area Mii, indicative of an ESA presence at the 'Michausdal' deposits

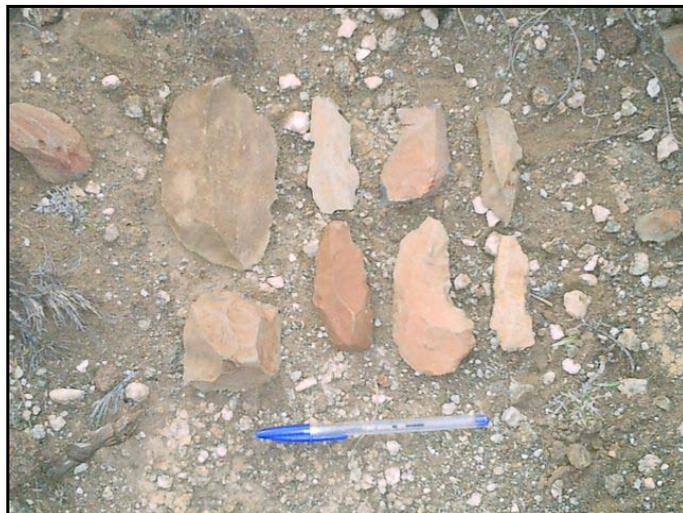
IMAGE 11: A collection of mixed raw material artefacts from Area Mii

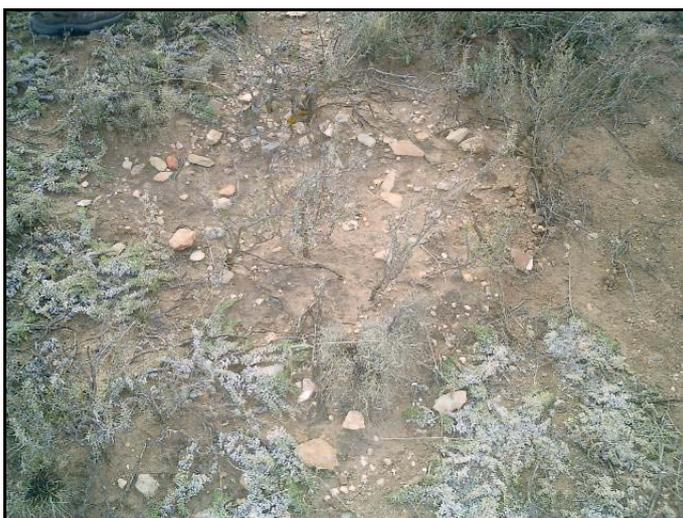
At Area Mii MSA associated artefacts were encountered in characteristic small exposed scatters. Scatters seem to be the direct result of on site knapping activities. A wider variety of raw materials were used. The difference in raw material may well be the reason for the change in typology, also impacting on technology. Artefact types at Mii were dominated by tools produced from shorter flakes and blades, with higher quantities of irregular shaped tools in direct association with large

numbers of cores and waste material. Artefact ratios vary considerably from dense artefact scatters to almost 'sterile' areas. Any attempt to ascribe a general artefact ratio to the area would present a biased view their distribution pattern. Stratigraphic depth is inferred to be relatively limited.

IMAGE 12: Typical surface concentrations in which artefacts in Area Mii were found

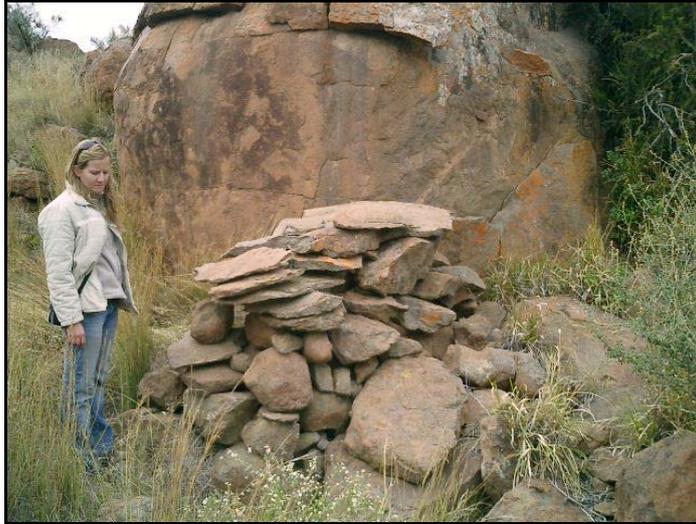
In Area Mii a number of metal objects and a small stone structure represented the Historic Period.

IMAGE 13: A historic stone shelter in Area Mii

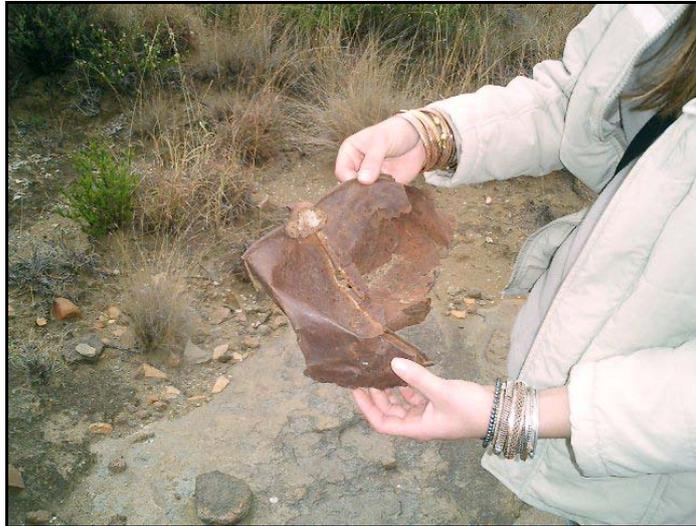
IMAGE 14: Historic metal remains from the 'Michausdal' site

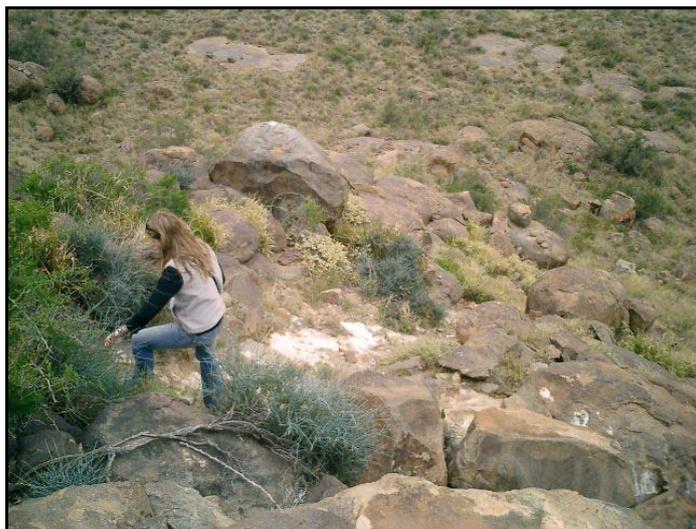
Identified flowstone is suggestive of a wetter palaeo-environment and complements the identified spring in Area Mi. The total of the site thus seem to have a strong focus on water availability as an important draw card to the site.

IMAGE 15: Exposed flowstone in Area Mii is indicative of a much wetter climate in the past

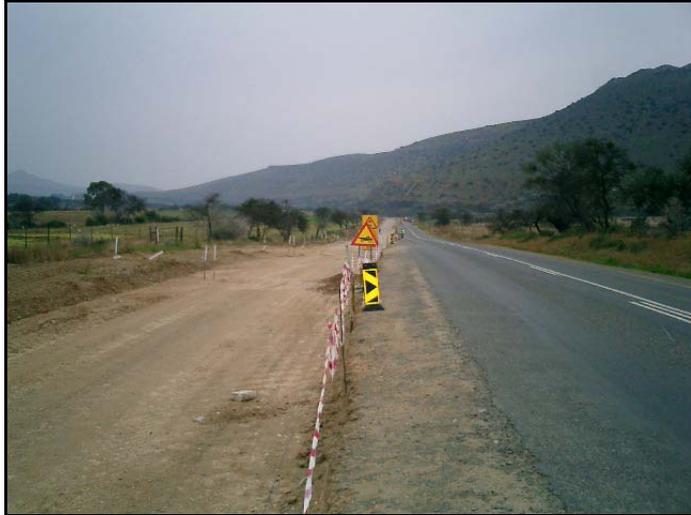
IMAGE 16: Upgrading of the N10 within the 5 km between Tarka Bridge and Cradock

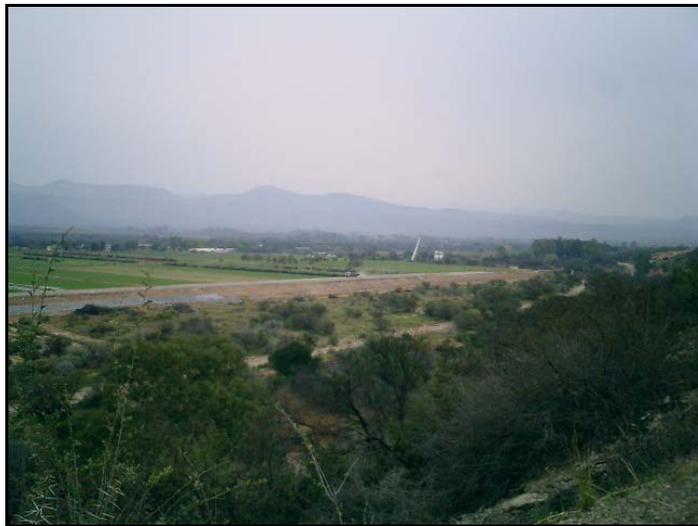
IMAGE 17: A part of the 5km reroute development project

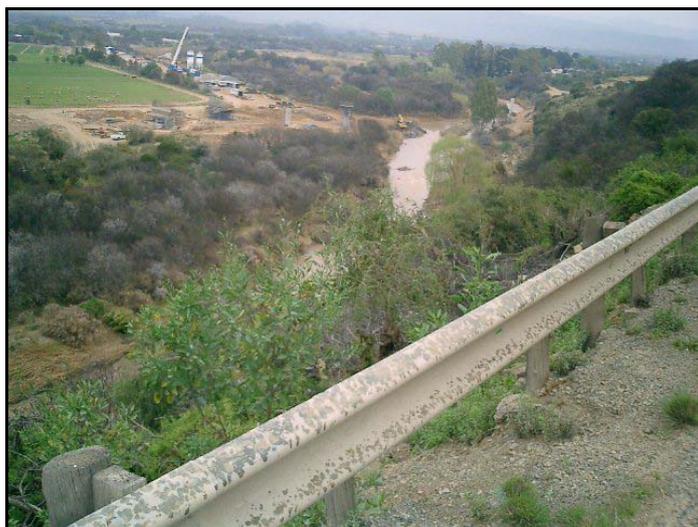
IMAGE 18: One of the bridges (under construction) included in the reroute development with a view onto the production area

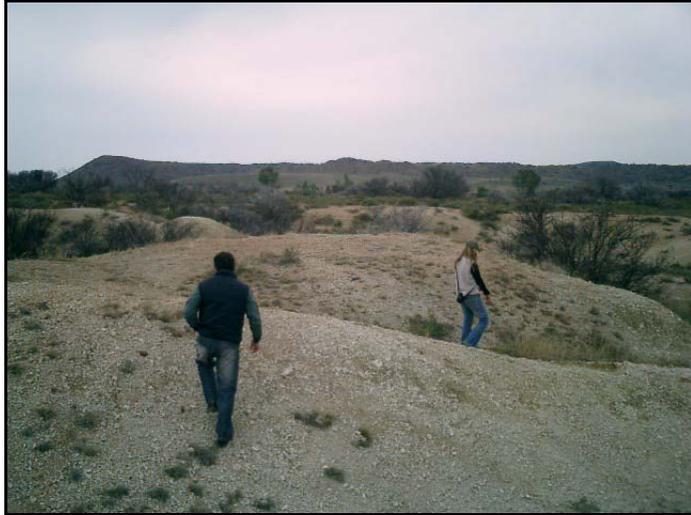
Cain's site stretches over a couple of hectares, generally characterised by calcrete rich erosion gullies. MSA stone tools were produced from a variety of raw material sources present in the area. Formal tool types include blades, flake-blades, convergent points and a variety of scrapers. Waste material such as cores and production *debris* is also present on site. General tool size is relatively small, a probable result of the use of river cobbles as raw material.

IMAGE 19: General view of 'Cain's site'

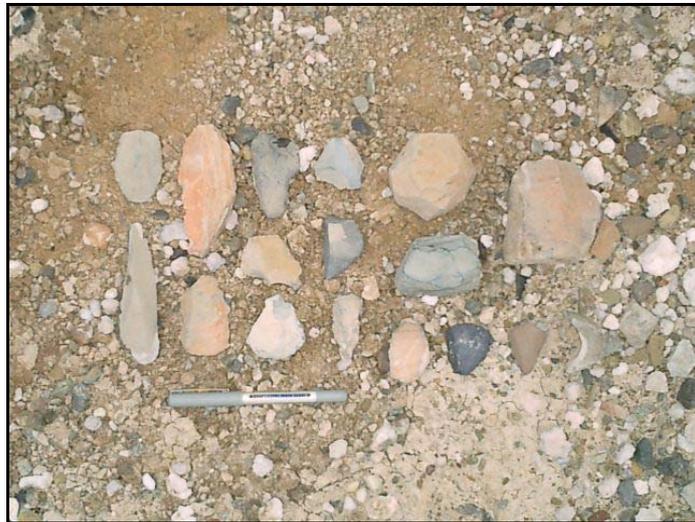
IMAGE 20: A collection of artefacts from 'Cain's site'

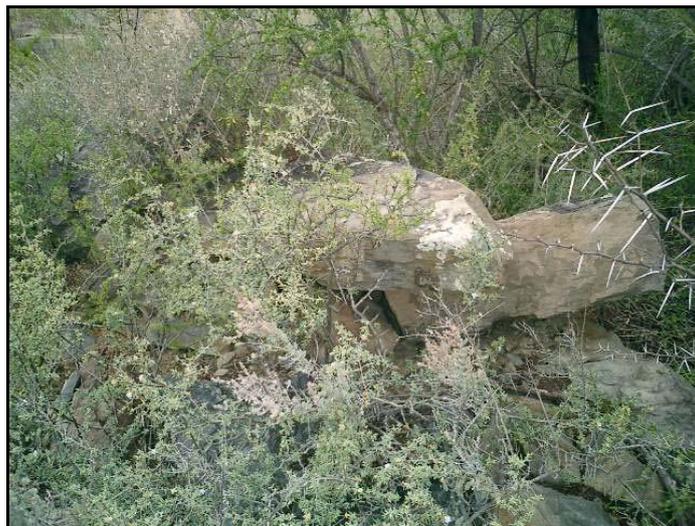
Some stone walling was identified in a densely vegetated part of the Stone Age site. Walling is not associated with the MSA lithic deposit.

IMAGE 21: Stone walling in dense vegetation, 'Cain's site'

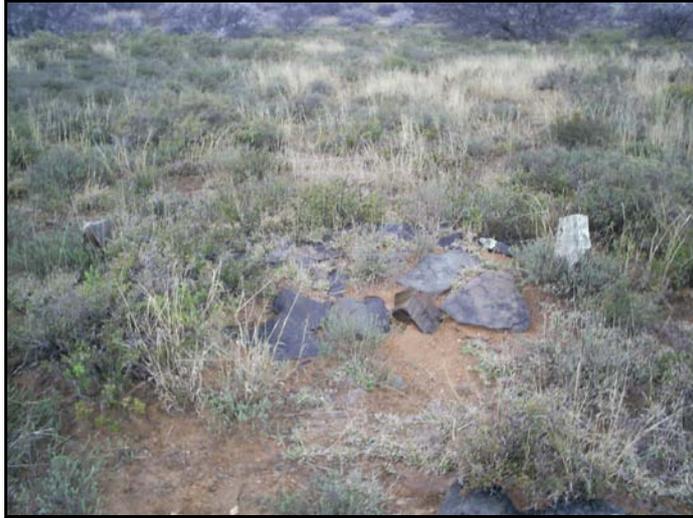
Close to Cain's site and situated at approximately S32°07'46.3"; E25°37'21.5" is an informal Historical grave site. Graves are marked with stacked stones. Some graves have head and footstones. The graves were preliminary, based on grave size, identified as follows: two adult graves (one with a head and footstone), three children's graves (two of which were marked with head and footstones) and one infant grave (marked with a head and footstone).

IMAGE 22: A historic grave from the grave site in the vicinity of 'Cain's site'

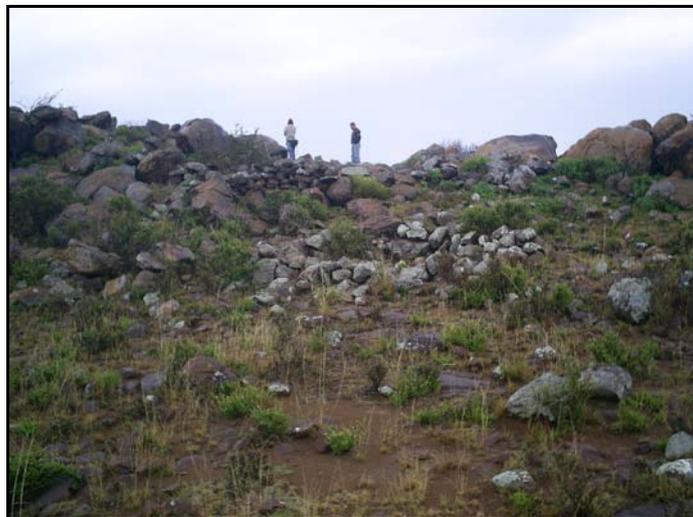
Artefact concentrations are focussed on the hill where ratios of approximately 6:1 were recorded. Though still present, artefact ratios decreased significantly with distance from the hill. Stone tools were produced from a mixture of raw material. Relatively small scrapers and flakes constitute the primary types. Knapping *debris*, including cores and waste flakes are present. A member of the public apparently collected the majority of the artefacts, approximately 2 years ago (Pers. Comm: Holden). If so, any interpretation of the site will be relatively biased. However, the remaining artefacts indicates a possible later MSA / macrolithic LSA occurrence in a factory context.

IMAGE 23: General view; the top of 'Hunter's site'

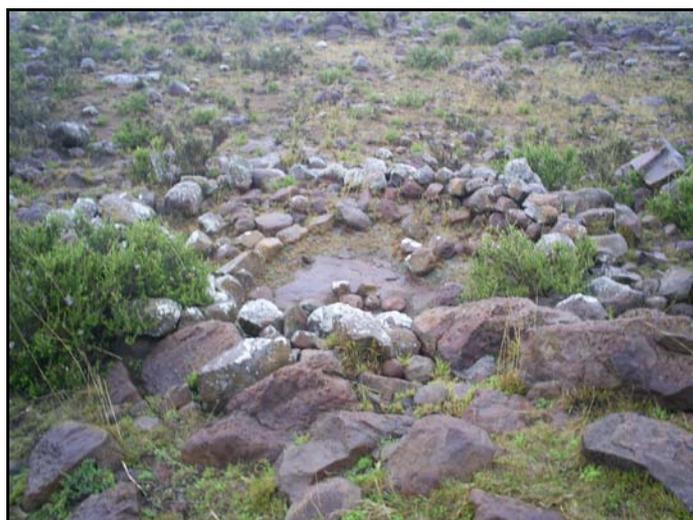
Two stone circles with approximate diameters of 2-4m are situated on the hill. Stone tools were found within the confines of the circles. The stone circles are not associated with the Stone Age deposit and interpreted as a later reoccupation of the area.

IMAGE 23: One of the stone circular enclosures at the 'Hunter's site'

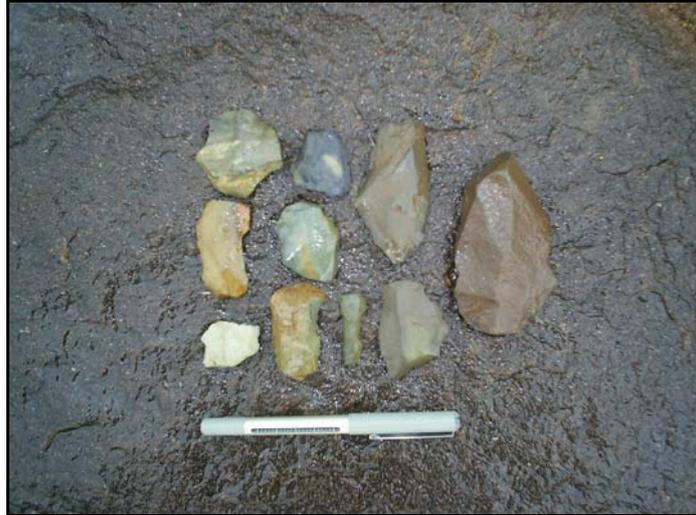
IMAGE 24: A collection of stone artefacts from 'Hunter's site'
