EARLS COURT - *LIFESTYLE ESTATE*

Portion of Erf 464, George, Western Cape

PROPOSED RESIDENTIAL - "LIFESTYLE" - DEVELOPMENT

HERITAGE IMPACT ASSESSMENT

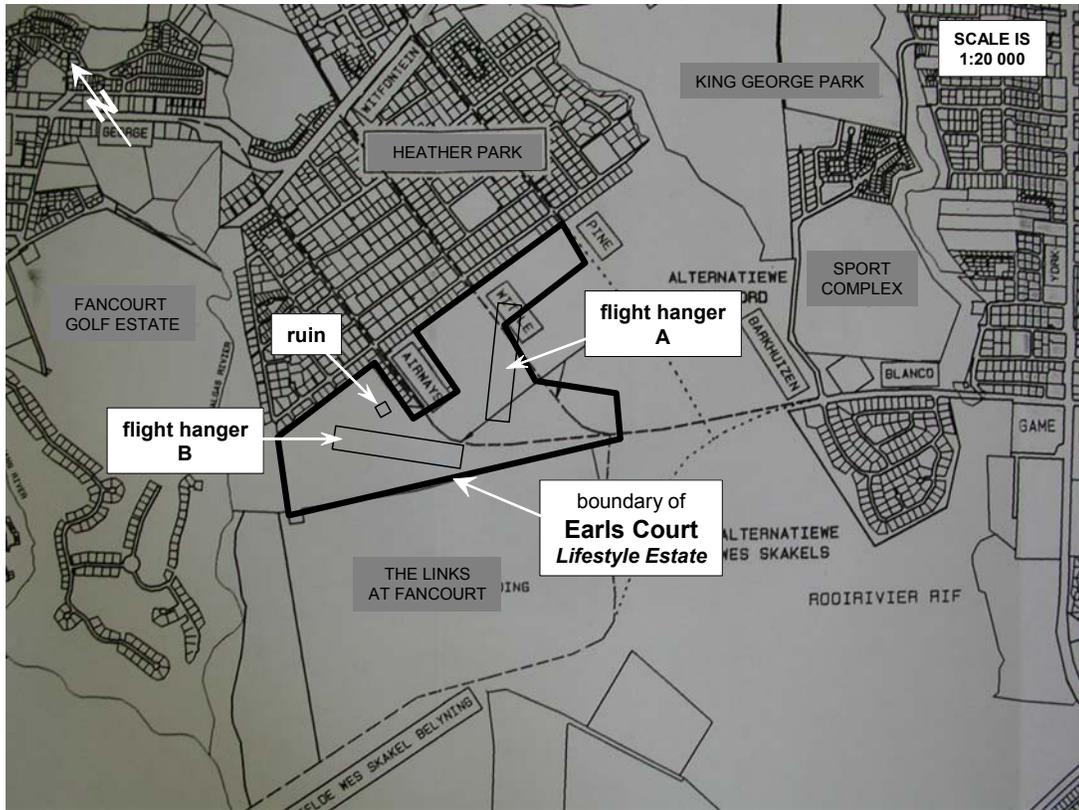
Figure 2. Location of proposed development – Earls Court Lifestyle Estate – on 1:20 000 map indicating rough positions of airfield features.

detailed version of Figure 1 and the rough outline of the area studied during the fieldwork for this HIA as well as the rough positions of features associated with the old aerodrome. To the best of our knowledge, no previous archaeological research was conducted on Erf 464, George.

On 24 November 2003 a survey of the study area revealed the presence of two large areas of continuous concrete slabs (flight hanger floors), the ruins of a structure that was likely associated with the airfield, and an old tar road leading to the ruined structure (see Figure 2). After an archival search, Ms Schulz provided the following information. Plate 3 is an aerial photograph taken in 1936 prior to the construction of the aerodrome at George. The aerodrome (George Airport) was built in 1936 and registered as an A3d aerodrome (A1a being top of the scale of ratings for aerodromes). With the outbreak of war in 1939, the South African Defense Force commandeered the George Airport. In 1940 it became an air school (number 61AS) for advanced navigational training for which it was upgraded. Plate 4 is an aerial photograph of the area taken in 1968 that shows features of the aerodrome referred to as part of the upgrade of the airport. Ten large hangars were built to house various types of airplanes (Plate 5). Staff living quarters, training classrooms, engineering shops, stores and many other buildings needed in times of war were built. In 1942 a WAAF camp was completed.

Due to limitations described earlier, the entire study area and ground surface could not be inspected comprehensively. The GPS coordinates for some aerodrome features are given below (map datum WGS 84) and their rough positions are shown in Figure 2 (also see Plate 5). Table 1 summarizes the age, significance and required mitigation for heritage resources discovered during fieldwork and the archival search as well as Early Stone Age implements

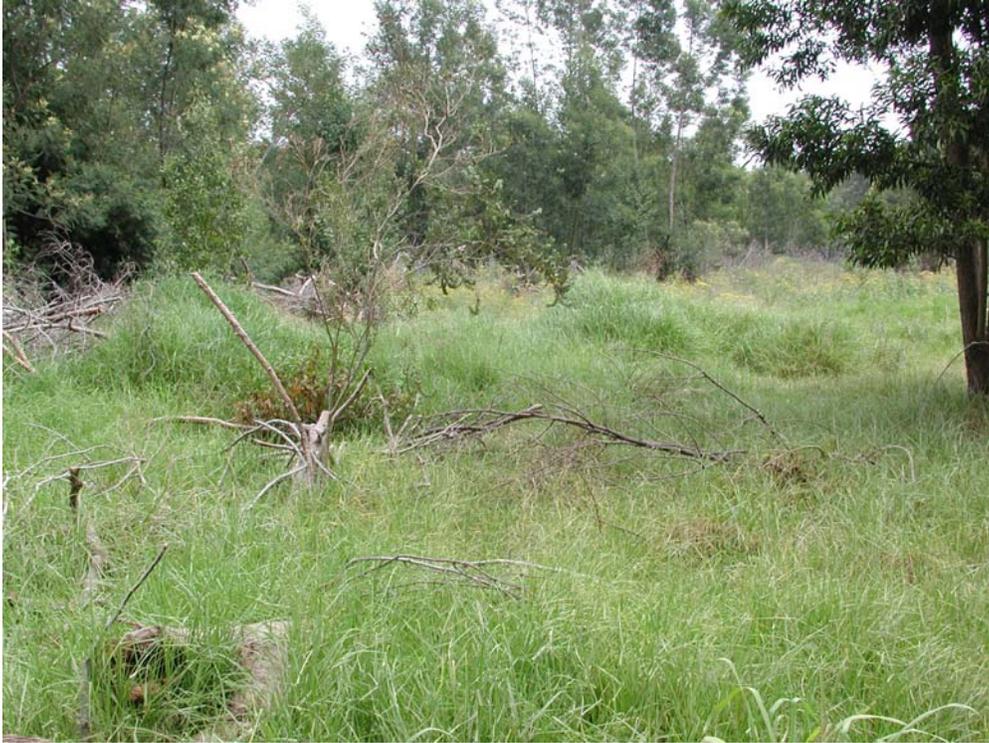
Plate 1. Vegetation cover.

Almost the entire study area is very densely vegetated by grass, bush and a wide variety of indigenous and exotic trees, rendering the ground surface invisible (Plates 1 & 2). Less than 5% of the ground surface is exposed for visual inspection and this was the major limiting factor to conducting a detailed and comprehensive study of the area. Large areas with very dense vegetation were impenetrable and could not be investigated. It is possible that archaeological sites or materials are currently covered by vegetation and sand/sediment and are therefore not currently visible.

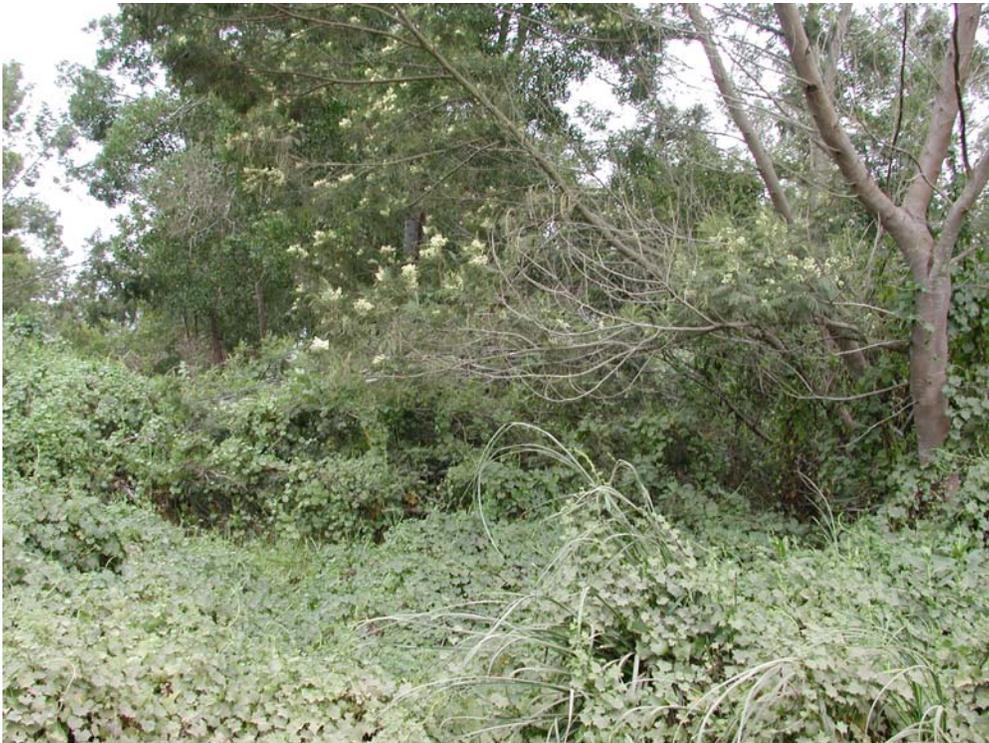
Plate 2. Vegetation cover.

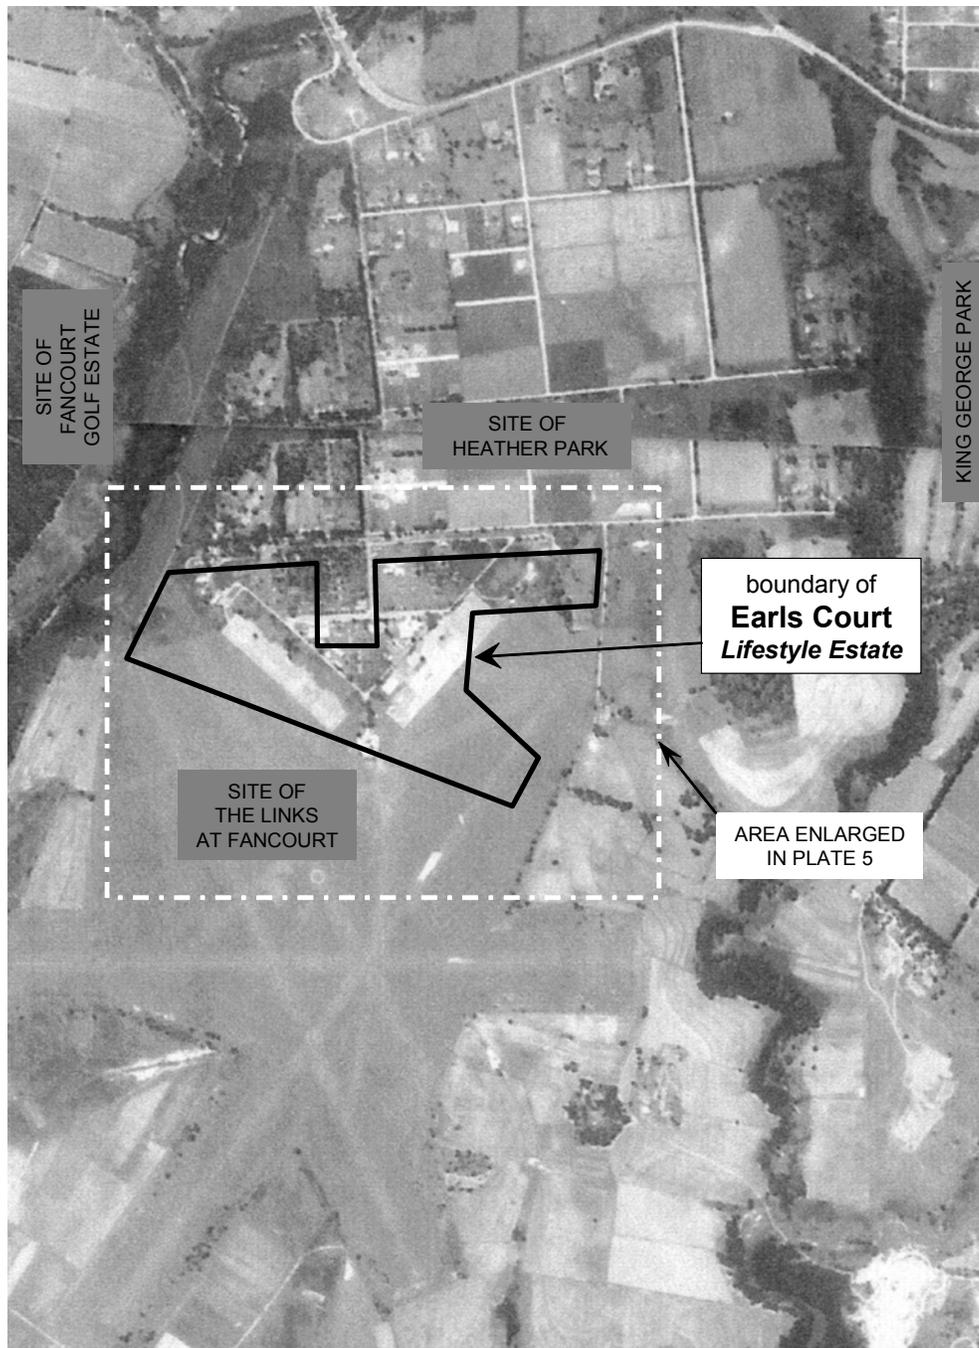
Plate 4. An aerial photo of George taken in 1968 showing the old aerodrome (see Plate 5), built in 1936, relative to the future sites of the Fancourt Golf Estate, the Links at Fancourt and the suburb of Heather Park. King George Park was already established.

Due to dense vegetation cover, *in situ* parts of this hanger floor were not visible and therefore, GPS readings were not taken. Nevertheless, the position and extent of this floor is clear on aerial photographs (Plates 4, 5 and 6 and also see Figure 2). Large parts of this concrete floor were lifted mechanically and bulldozed into piles of rubble (Plate 10).

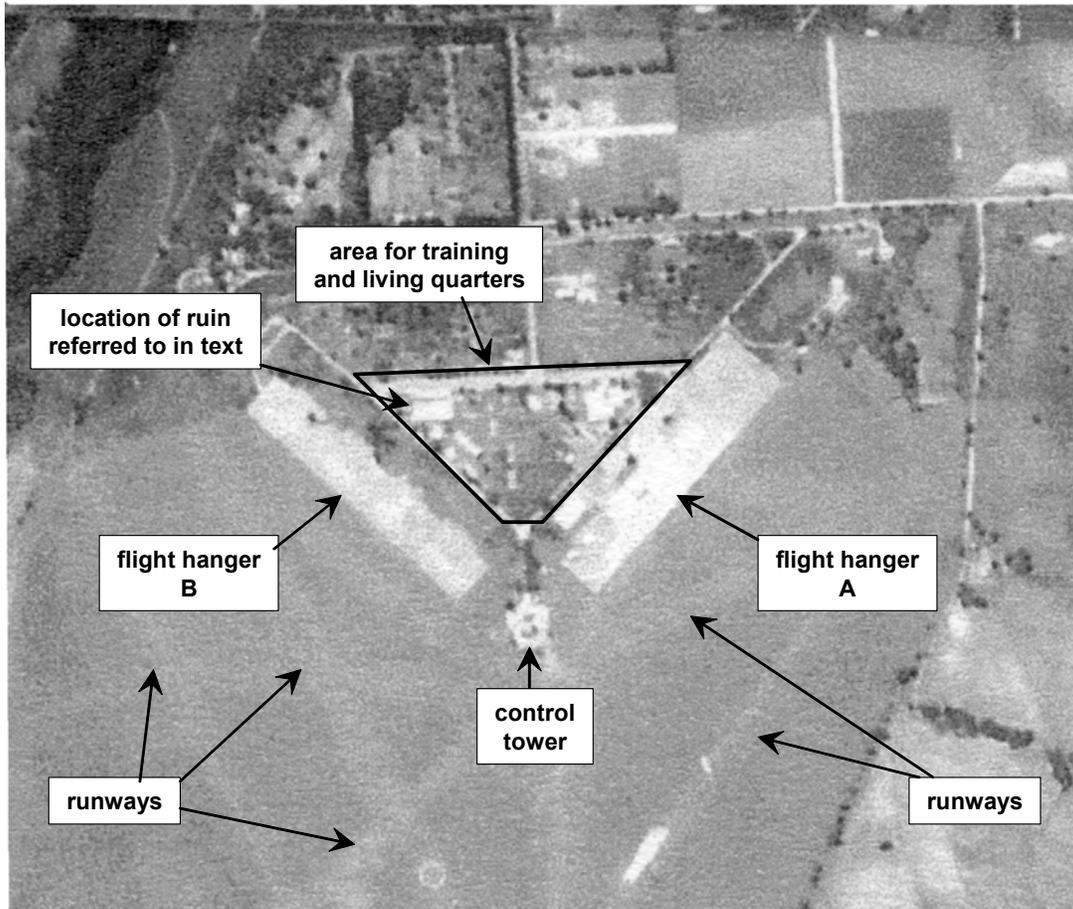
Plate 5. This enlarged portion of Plate 4 shows more detail of various features associated with the old aerodrome.

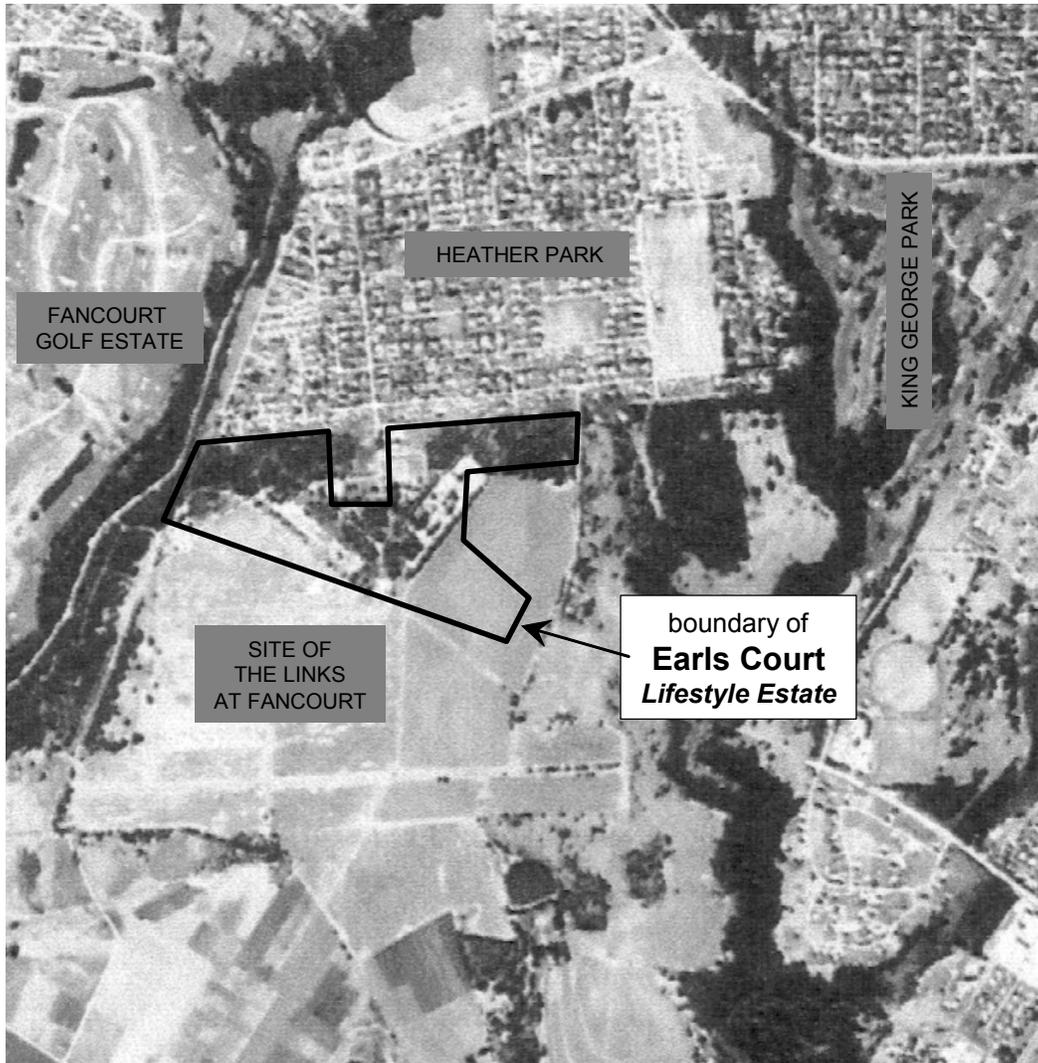
Plate 6. This aerial photo, taken in 1998, shows several structures still standing at the site of the old George Airport and World War II Air Strip (number 61). The Fancourt Golf Estate and the suburb of Heather Park are in place.

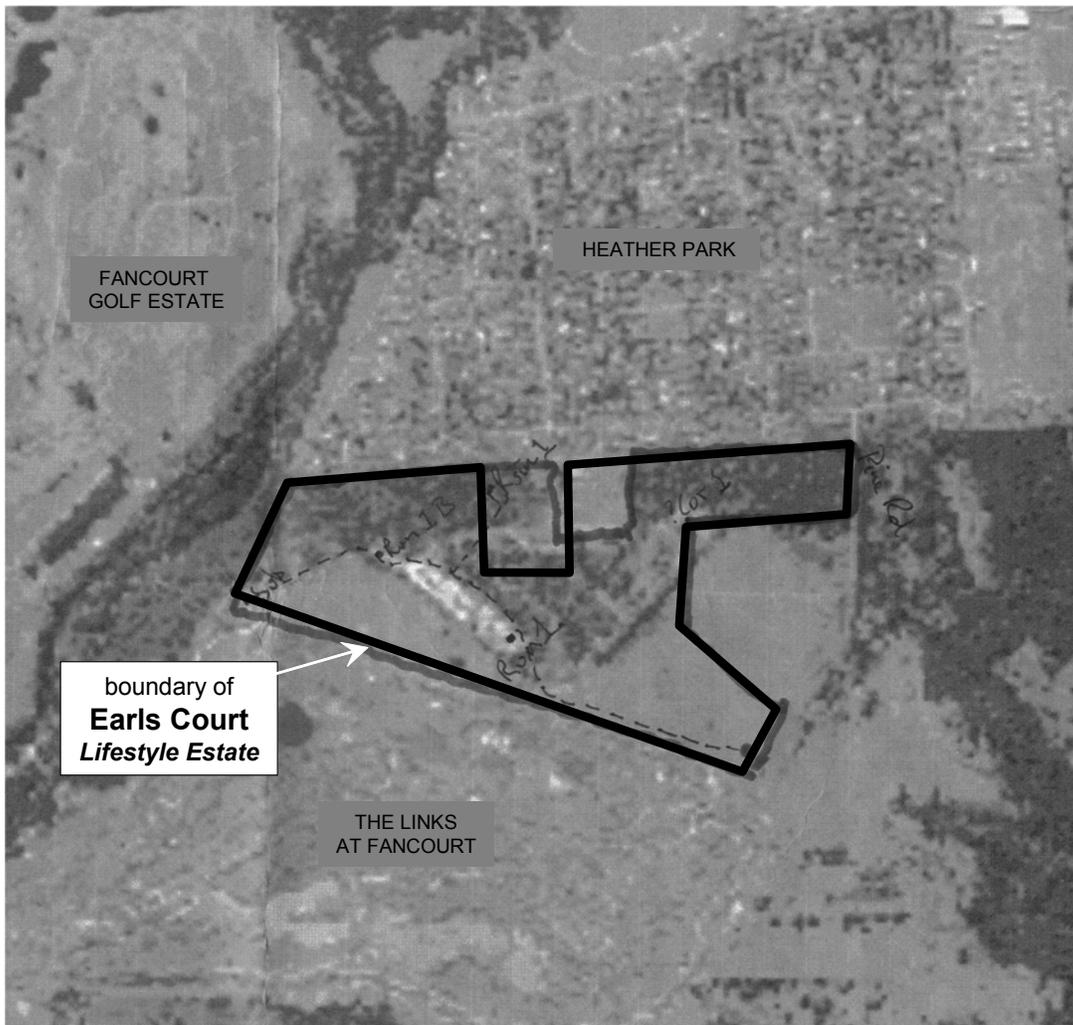
Plate 7. This aerial photo taken in 1999 or 2000 shows very little trace of the former aerodrome, and the area is much more densely vegetated today (2003). Within the boundary of the proposed development one can still see the V-shape of the former flight hanger floors. The Links at Fancourt is already in place.

The Air School closed its doors on 8 April 1945 and resumed operations as a domestic aerodrome. Construction on the current George Airport started in 1971, was completed in 1977 and opened on 27 May 1977. Aerial photographs of the area taken in 1998 show that most of the runways are no longer visible and that substantial trees had grown since 1968 (Plate 6). Also visible are some structures appearing in a fairly good state of repair (Plate 6). By 1999 or 2000, the only evidence for the former aerodrome is the V-shape of the two flight hanger floors (Plate 7).

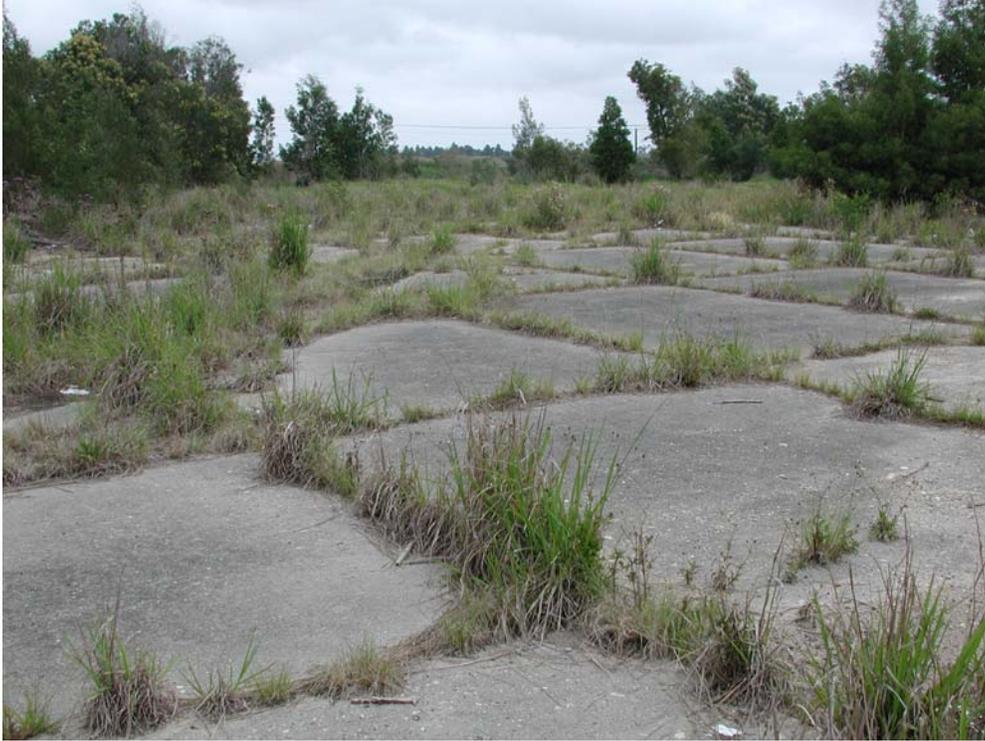
The south-eastern extent of the floor of flight hanger B is at S 33.96255° and E 022.42377° and the north-western extent is at S 33.96092° and E 022.42075°. While a large part of this hanger floor is *in situ*, large areas are warped and/or undulating while others were lifted mechanically and bulldozed into piles of concrete rubble (Plates 8 & 9).

Plate 8. A portion of the floor of flight hanger B.

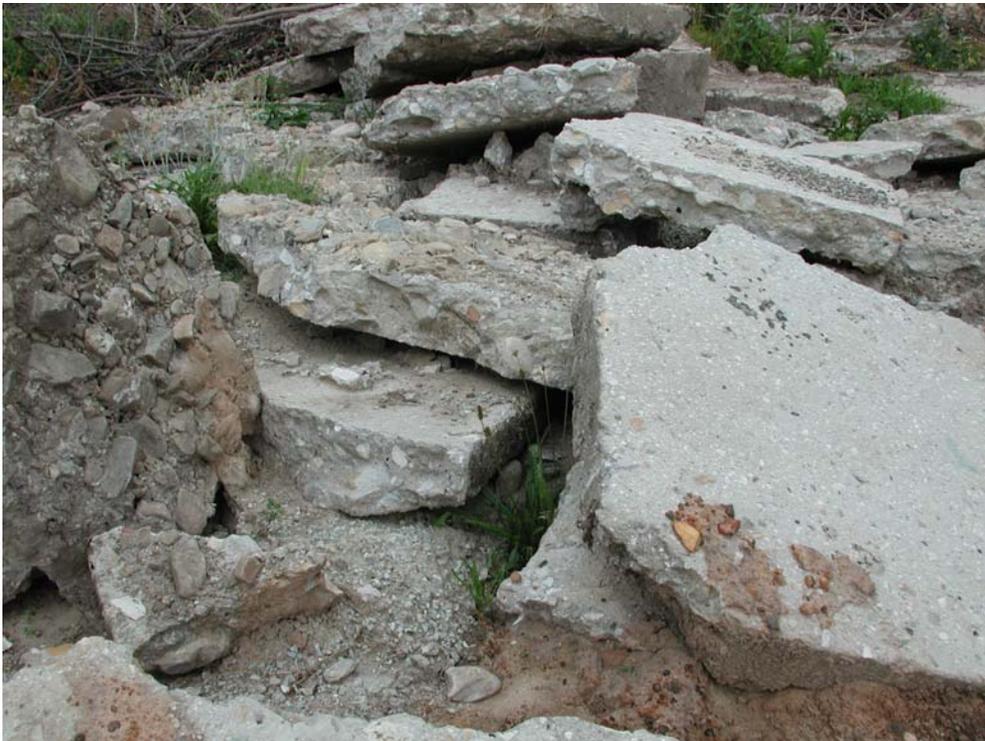
Plate 9. Concrete rubble at the north-westerly extent of flight hanger B.

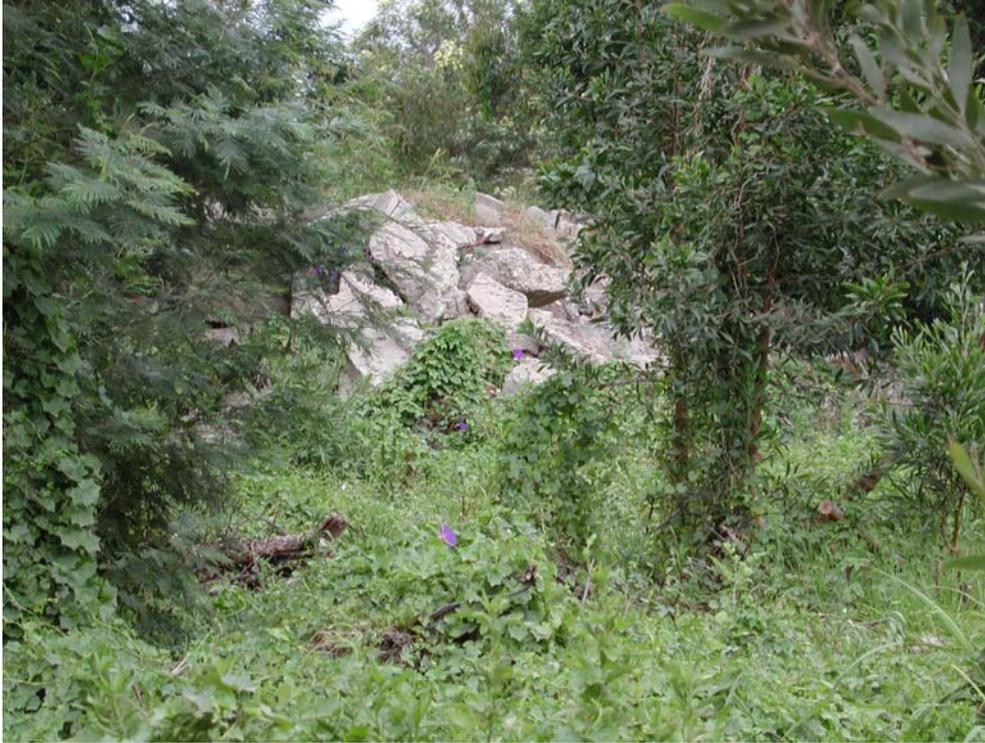
Plate 10. Pile of concrete rubble from flight hanger A.

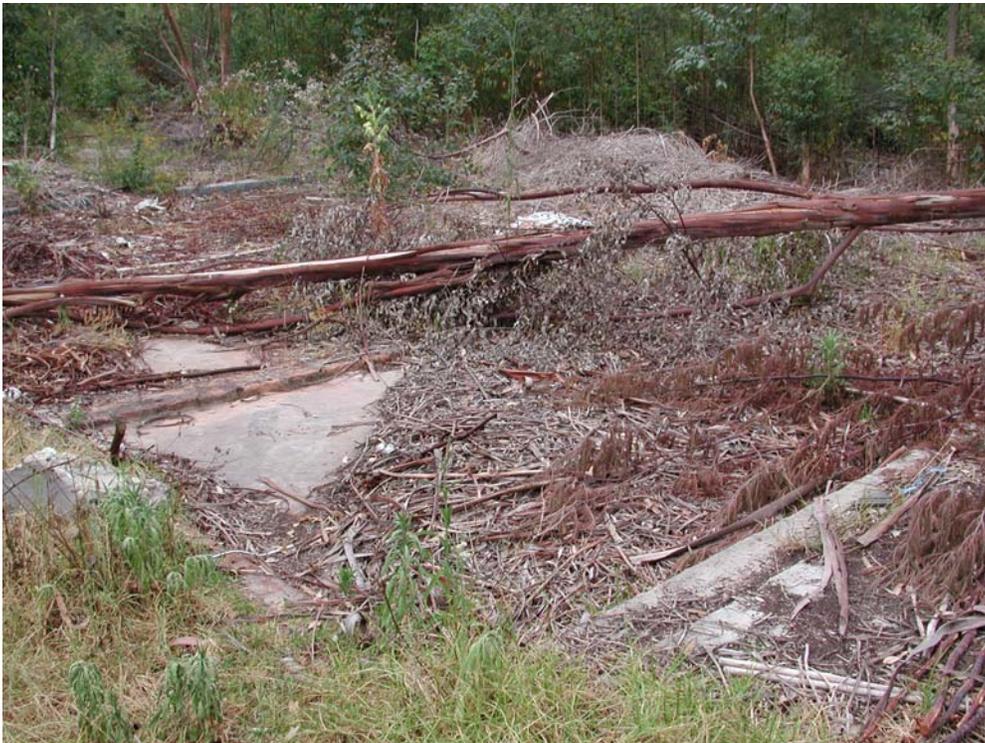
The structure in ruins is situated at S 33.96022° and E 022.42071°. Only the floor and foundations of this building survive and no artefacts indicative of the World War II era were noted in the immediate vicinity of the ruin. It is unlikely, therefore, that this particular structure was associated with human habitation, but was likely a maintenance or service facility for the old aerodrome (see Plates 11, 12 & 13). The “airing or breathing” pipe visible on Plate 9 suggests the presence of a subterranean fuel tank associated with the ruin. A tar road of questionable age leads to this area (Plate 14).

Plate 11. Floors and wall footings of ruin.

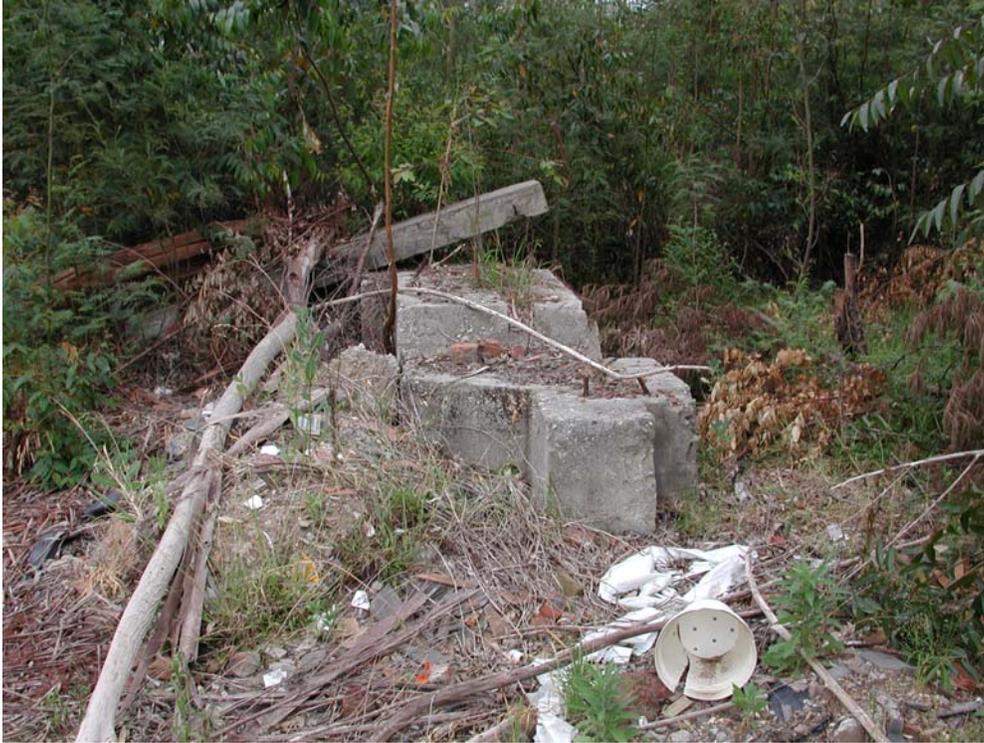
Plate 12. The bulk of this ruin feature suggests it to be a base/housing for heavy equipment or machinery.

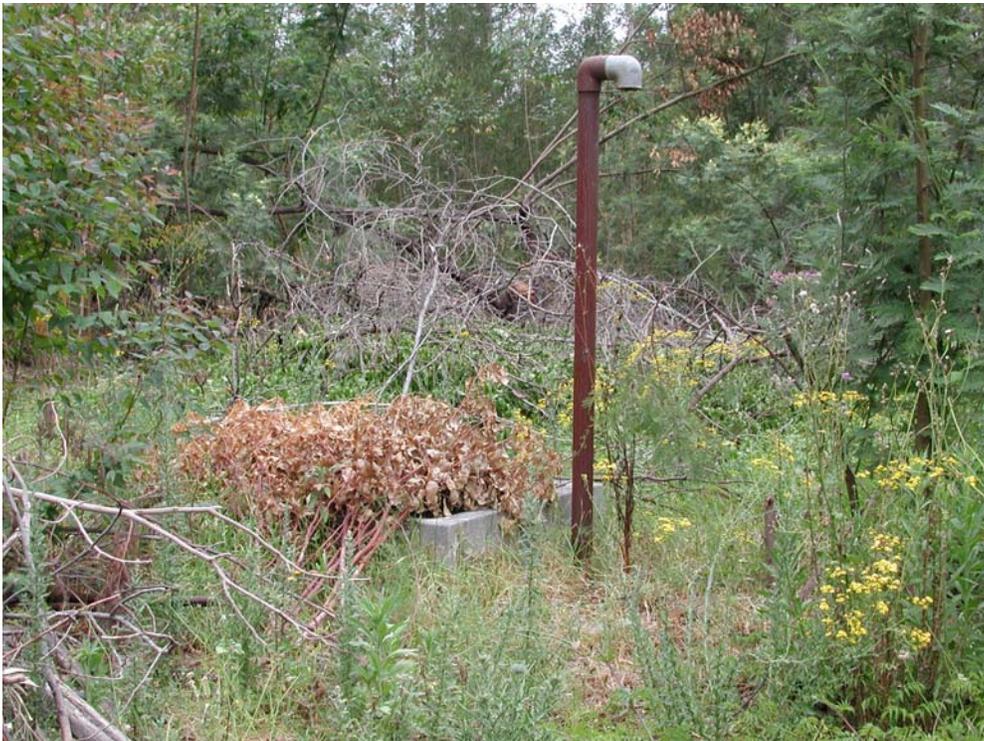
Plate 13. This is likely an “airing/breathing” pipe of a subterranean fuel tank.

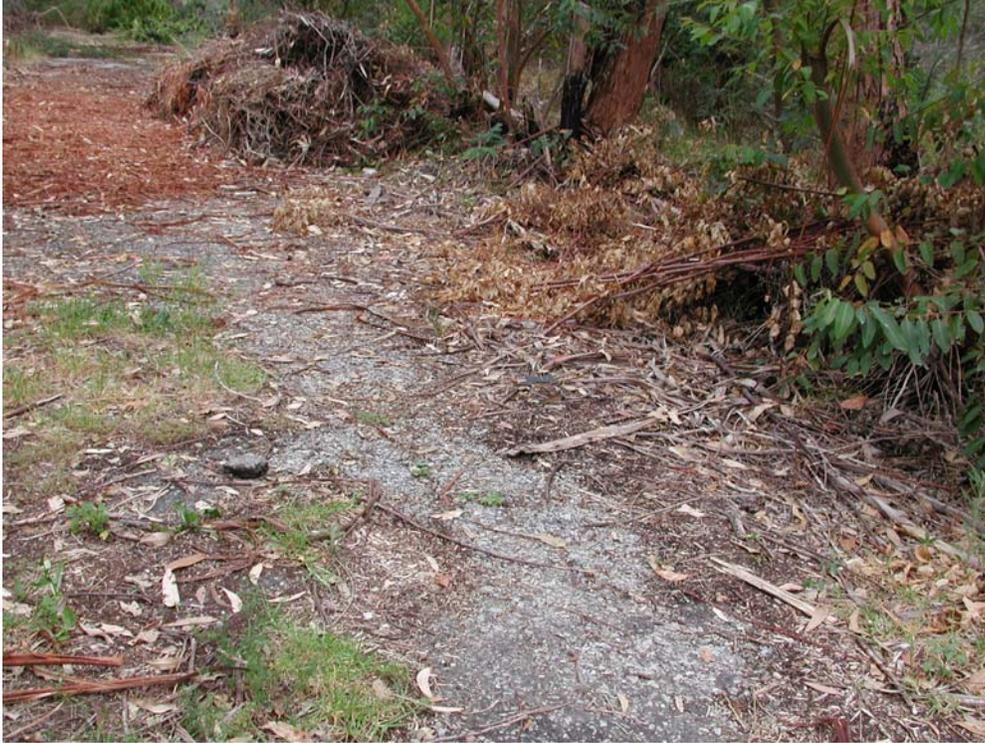
Plate 14. Tar road leading to area containing ruins.
