# ARCHAEOLOGICAL HERITAGE IMPACT ASSESSMENT

## Erf 7524, a Portion of Erf 1821, Tyolora: Proposed Thembalethu Plaza and Nursery School, Corner of Sandkraal- and Ngcakani Roads, Tyolora, Thembalethu, George, Western Cape Province

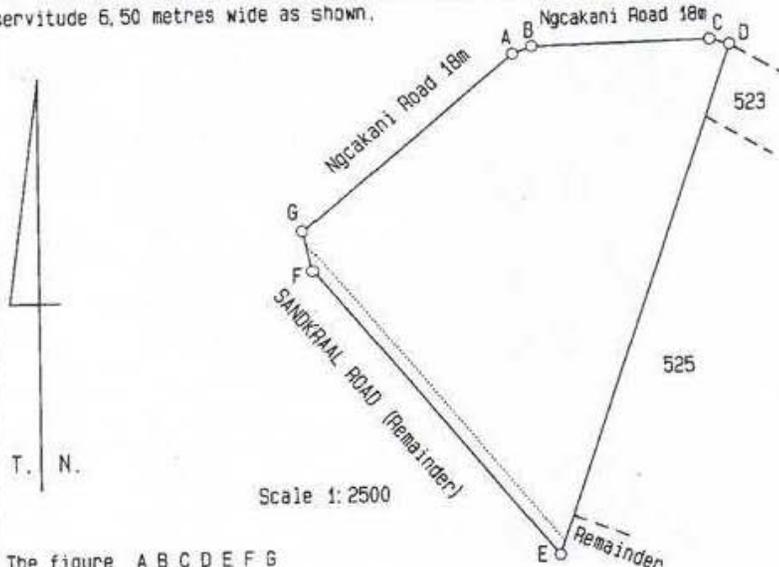
Figure 3. Surveyor's diagram with coordinates and survey data of the affected property as obtained from Dirisana Environmental and Ecological Consultants..

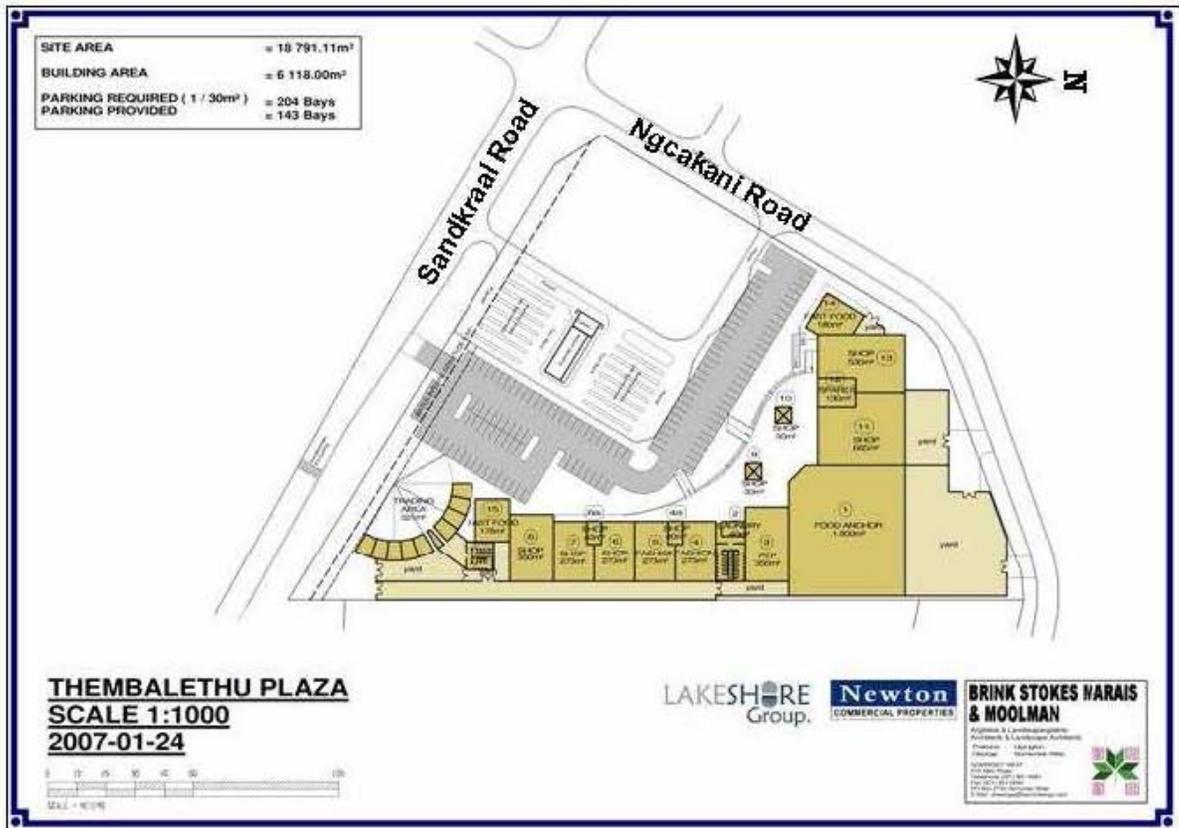
Figure 4. Layout plan of the proposed development as obtained from Dirisana Environmental and Ecological Consultants.

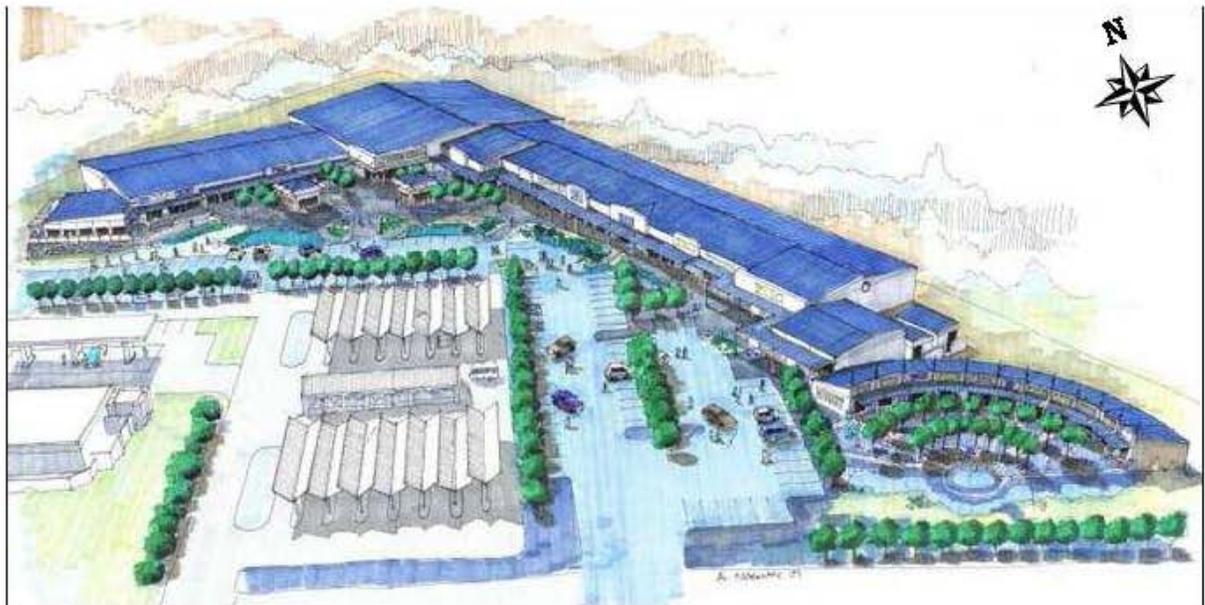
Figure 5. Schematic architect's sketch of the proposed development viewed from the south south west as obtained from Dirisana Environmental and Ecological Consultants.

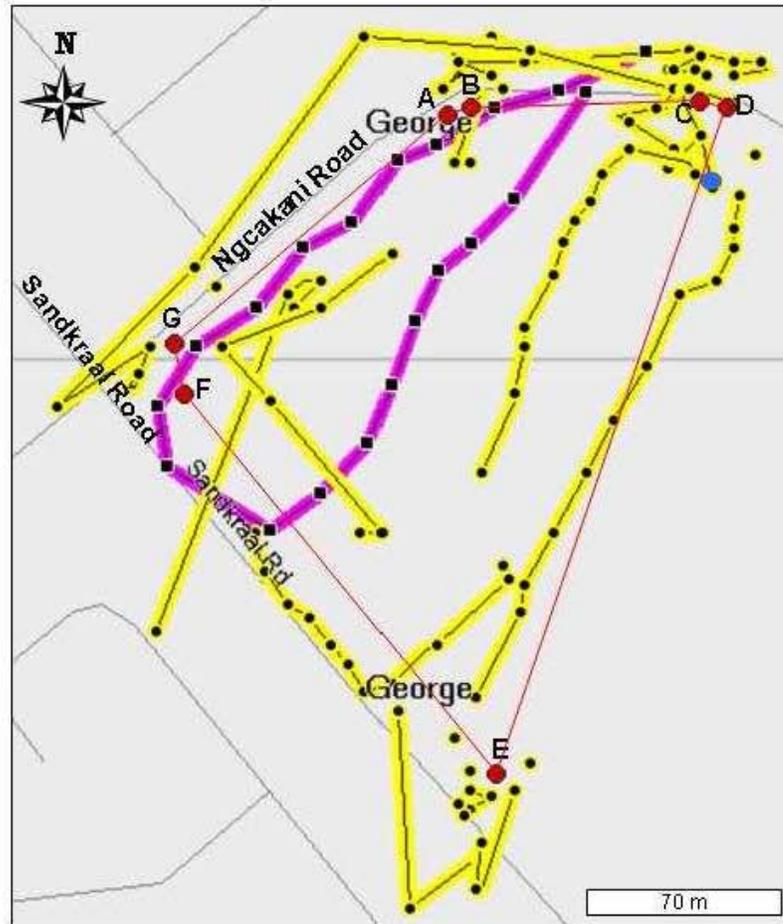
Figure 6. Area enlarged as indicated in Plate 2 showing walk tracks in yellow and purple (fixed with hand-held GPS), property boundary points with labelled red dots and red lines, as well as a borrow pit with exposed profiles indicated with a blue dot (see Plate 7; produced with Garmin - MapSource).

Figure 6 shows the AHIA walk tracks - in black dash-dot/square line in middle of yellow and purple lines - as fixed with a hand held GPS during the foot survey. In about 1.5 hours of survey a distance of 1.8 km was walked covering an area of around 1.8 hectares. Due to grass cover a somewhat smaller area was archaeologically visible. Archaeological visibility was moderate to good (Plate 6). Several areas with clear evidence for disturbance of sediments, and the activity associated with construction of road, buildings and their associated bulk services, resulted in substantial disturbance of surface and near surface sediments (Plate 5). If

Not a single archaeological heritage trace was seen. Exposed profiles of a “borrow pit” show that sediments consist of topsoil, clay and ferruginous deposits that include numerous ferruginous nodules (see blue dot in Figure 6 and Plate 7). In places the ferruginous deposits are exposed at the surface providing further evidence for disturbance (middle right image in Plate 6). Coordinate data for the “borrow pit” are as follows (Map Datum WGS 84):

Blue dot (Figure 6), S33.99936 E22.48051 (decimal degrees); 23 Y0047994 X3763712 (SA Natnl. Grid)

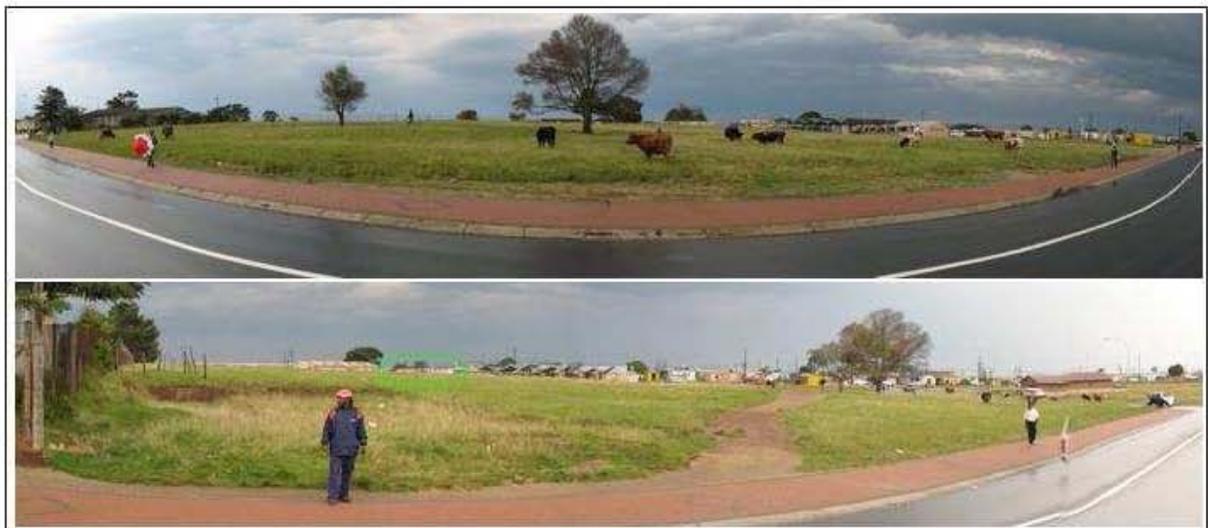
Plate 3. Panoramic views of study area as seen from boundary points A/B and C/D, top and bottom respectively (see Plate 2). Winston Manginda at left for scale (bottom image). The existing nursery school is indicated by the green oval (also see Plate 4).

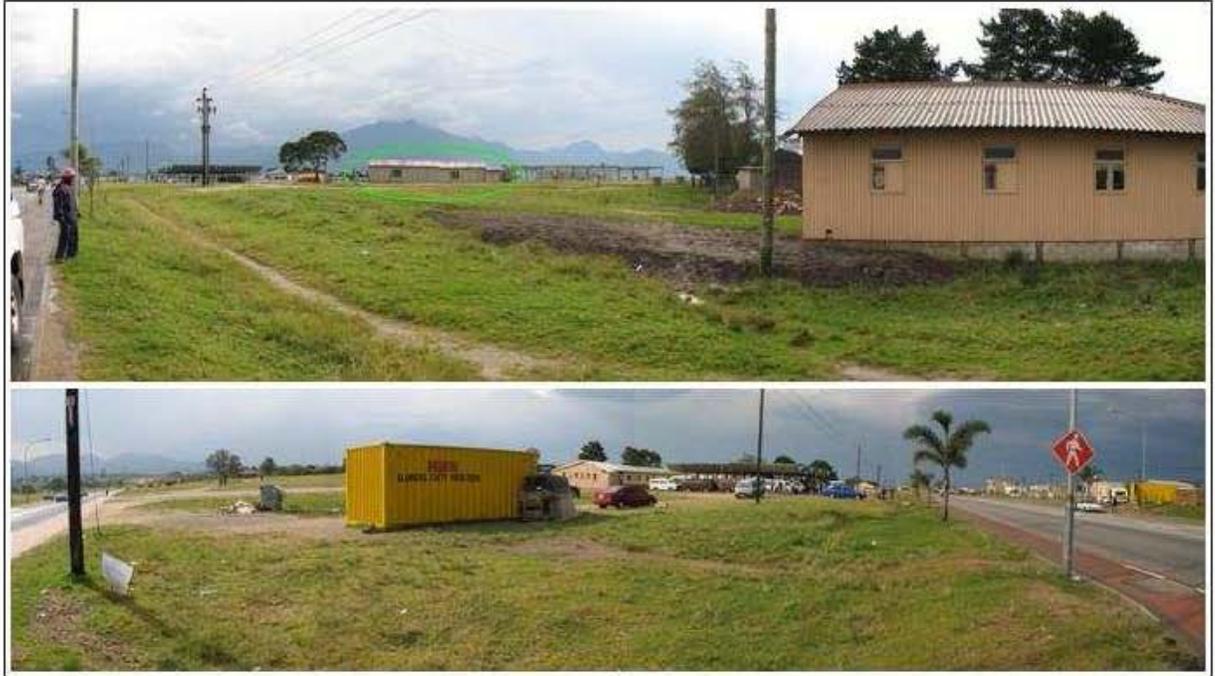
Plate 4. Panoramic views of study area as seen from boundary points E and F/G - top and bottom respectively (see Plate 2). Winston Manginda at left for scale (top image).

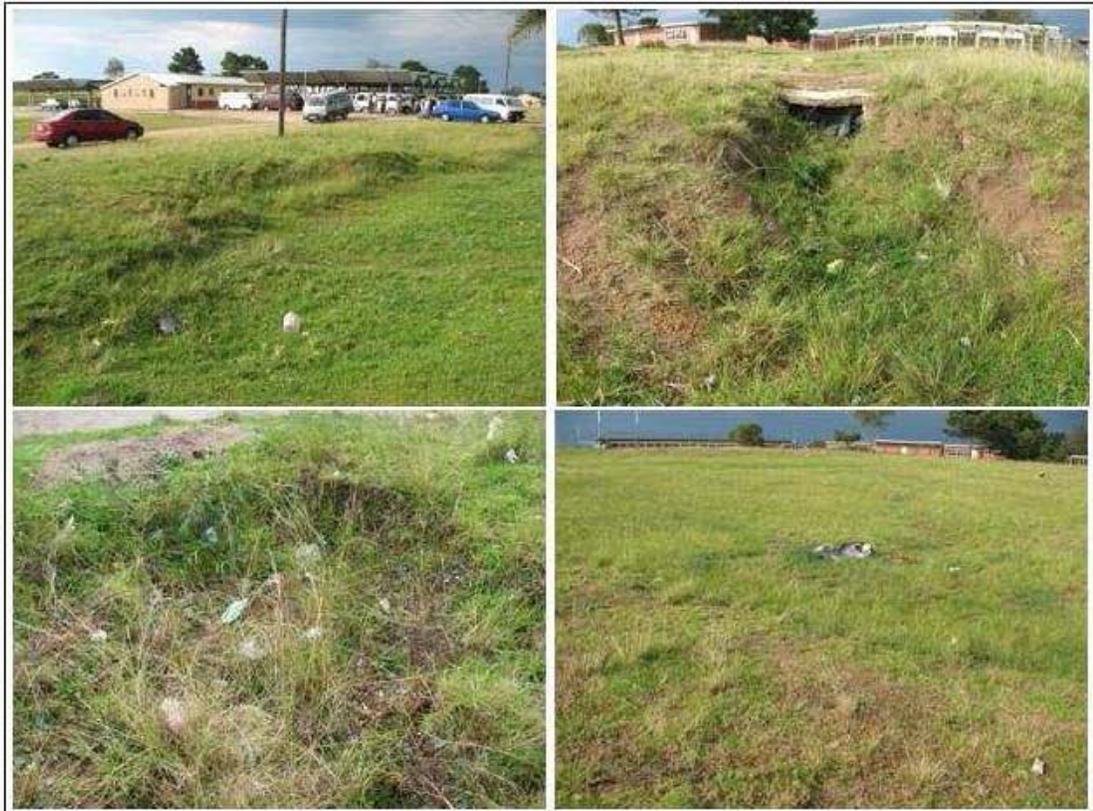
Plate 5. In addition to roads and the built environment, the above are examples of evidence for significant disturbance of sediments in the study area.

The topography comprises the high ground of gently sloping hills that descend towards the east north east and west south west several hundred meters from the study area. The highest areas are approximately 200 m above mean sea level (amsl) and the descending slopes are about 180 m amsl to the east north east at a distance of around 300 m from the property and about 180 m amsl to the west south west at a distance of some 700 m from the study area. Geologically, and what is visible in the profiles of a "borrow pit", the area contains topsoil, clay and ferruginous sediments (including large numbers of centimetre size ferruginous nodules) that are significantly disturbed as a result of construction related to roads, bulk services and buildings (Plate 5).

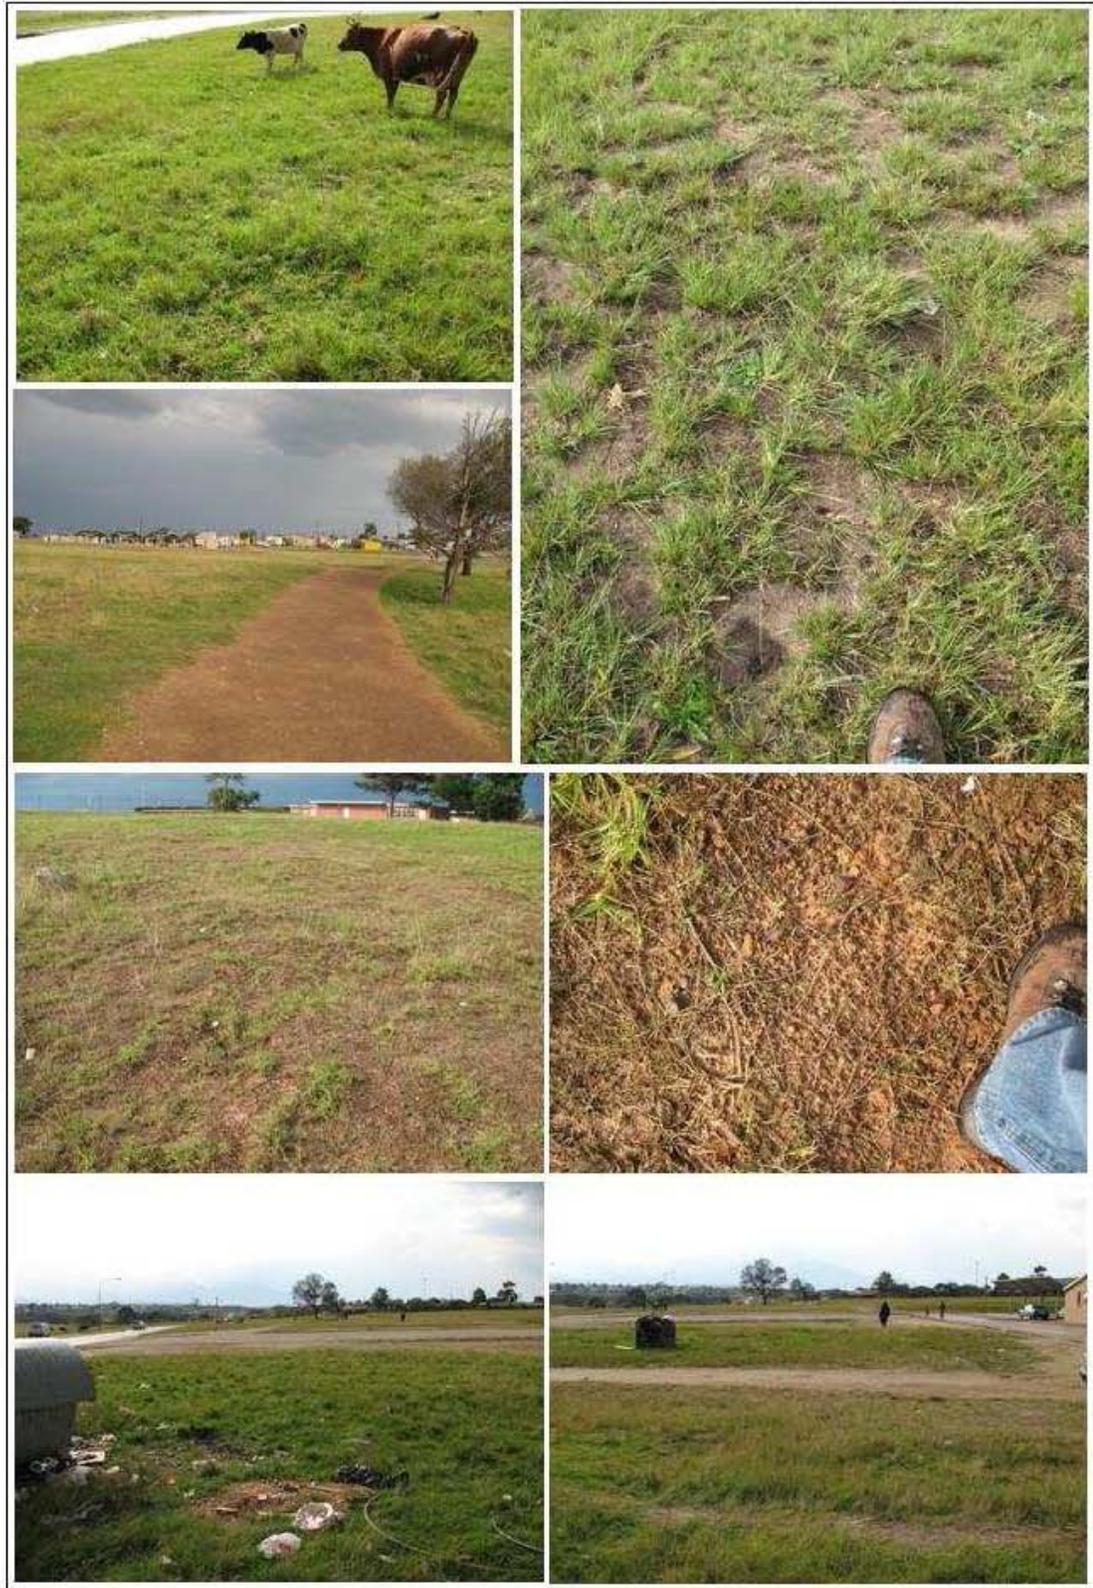
Plate 6. Dense grass cover shown in top left image, and other images show examples of exposures and clearings allowing good visibility of ground surfaces.

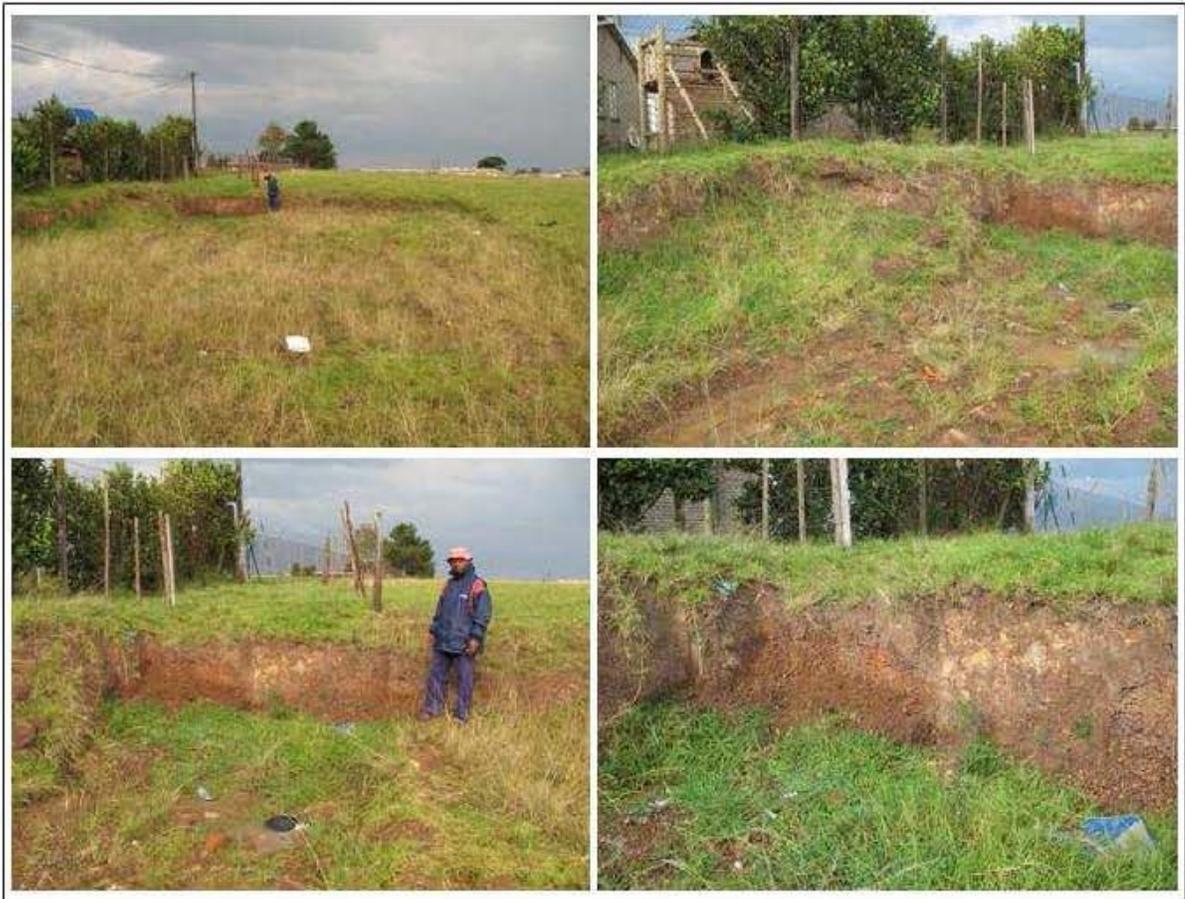
Plate 7. Borrow pit with exposed profiles showing layers of – lower to upper - ferruginous sediments (with centimetre sized ferruginous nodules), clay and topsoil (see Figure 6; also see ferruginous nodules at the surface in Plate 6 - middle right image).
