**AN ARCHAEOLOGICAL ASSESSMENT OF TWO BORROW PITS
ALONGSIDE DR3321 UAP
NORTHERN CAPE PROVINCE**

**Provincial Government Northern Cape:
Department of Transport: Roads & Public Works**

**AUGUST
2008**

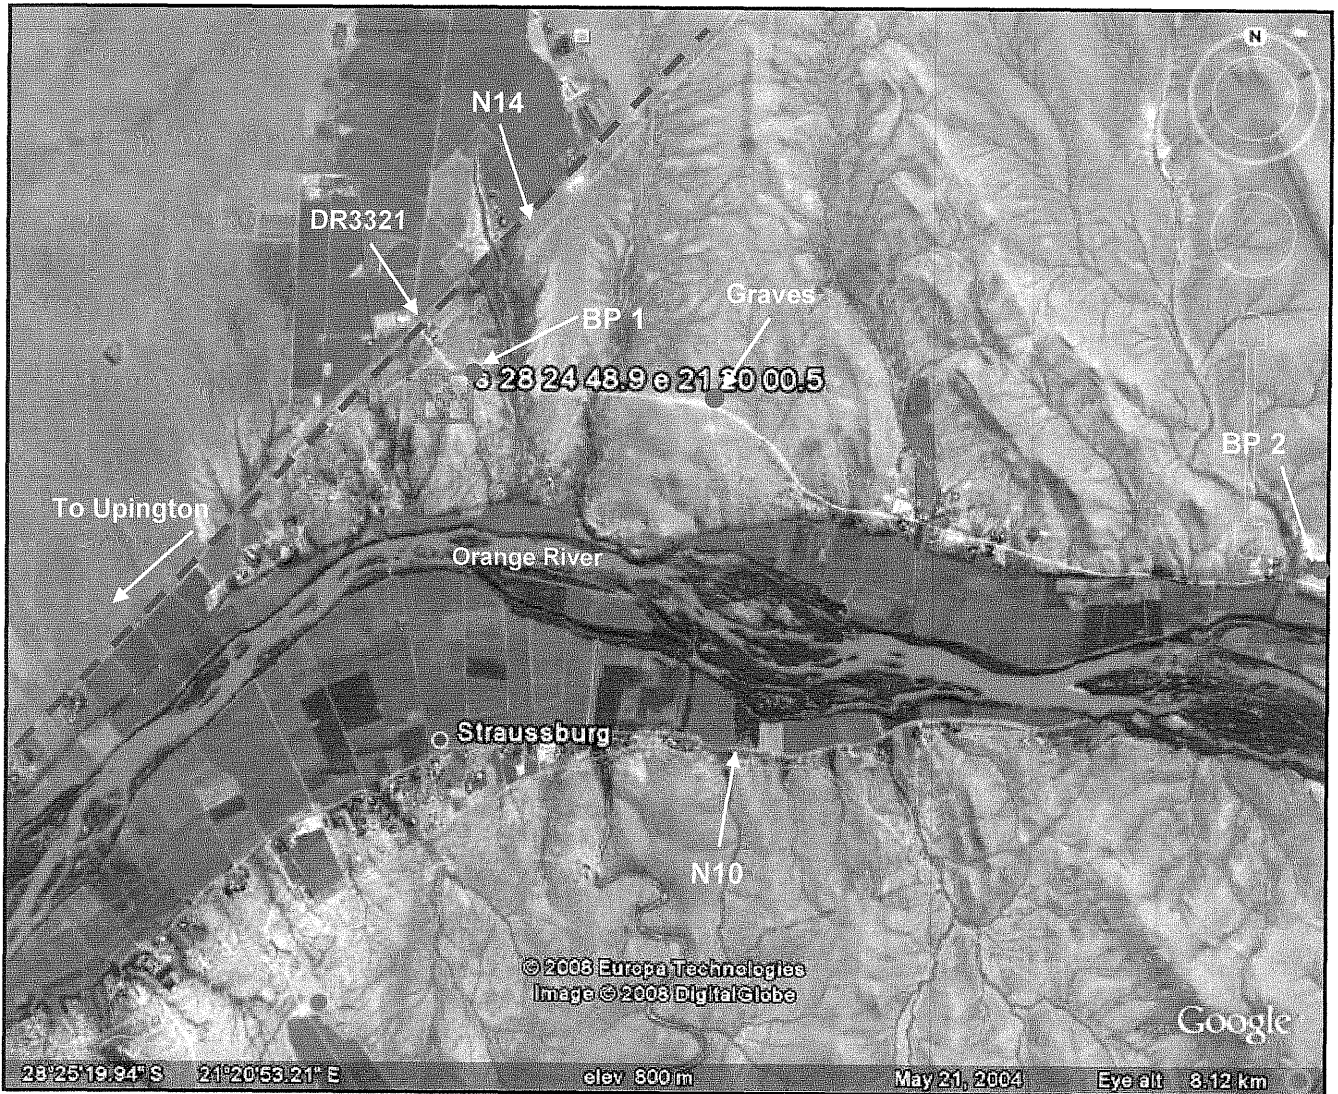
Figure 2. Aerial photograph of the proposed borrow pits

An aerial photograph of the study area indicating the proposed borrow pits is illustrated in Figure 2.

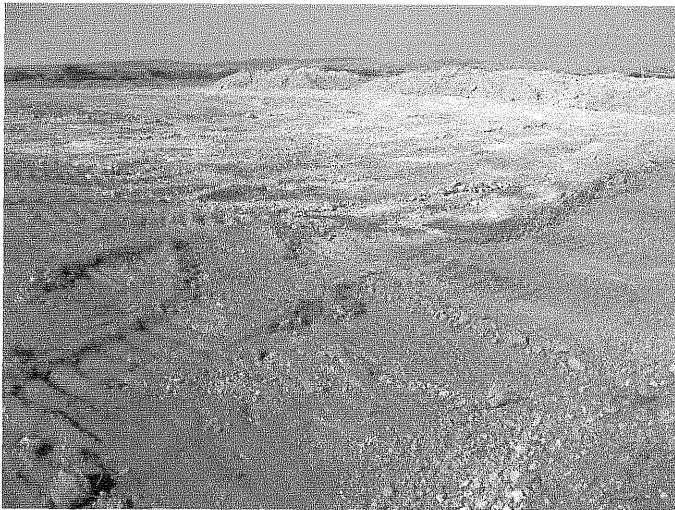
Figure 3. BP 1. View of the facing south east

The proposed borrow pit is situated about 100 m from DR 3321. Unfortunately, the site has already been excavated for source material and is therefore in a completely degraded state (Figures 3-5). The surrounding land use comprises mainly natural veld.

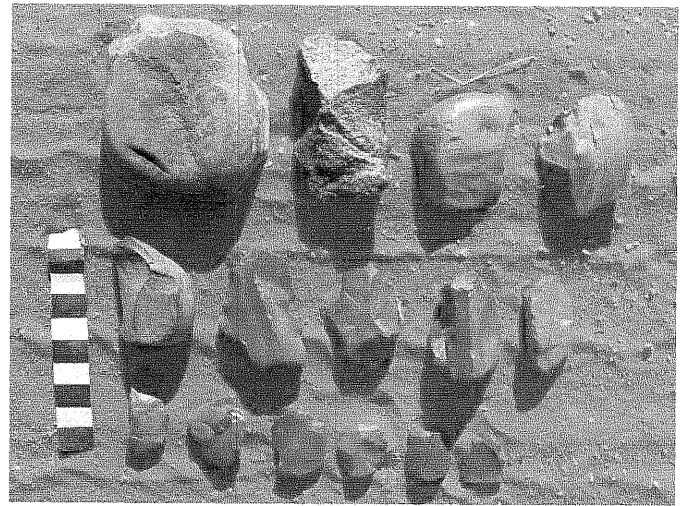
Findings: Relatively large numbers of Later Stone Age (LSA) tools were counted in a thin (± 2 m wide) strip of land between the fenced off site and the edge of the borrow pit. These included several end and convex scrapers, one adze, a number of miscellaneous retouched pieces, utilised and unmodified flakes and several round cores (Figure 6). Most of the tools are made on rolled, fine grained chalcedony, which very likely came from the nearby Orange River, while a few retouched flakes and utilised pieces are also made on locally available dolerite, including a large, chunky convex scraper. A few tools in quartz were also noted. In addition, several larger Middle Stone Age flakes in quartzite and indurated shale were also found.

Since the receiving environment has already been largely destroyed, the archaeological remains have been rated as having low local significance.

Figure 6. BP 1. Collection of Stone Age tools. Scale is in cm

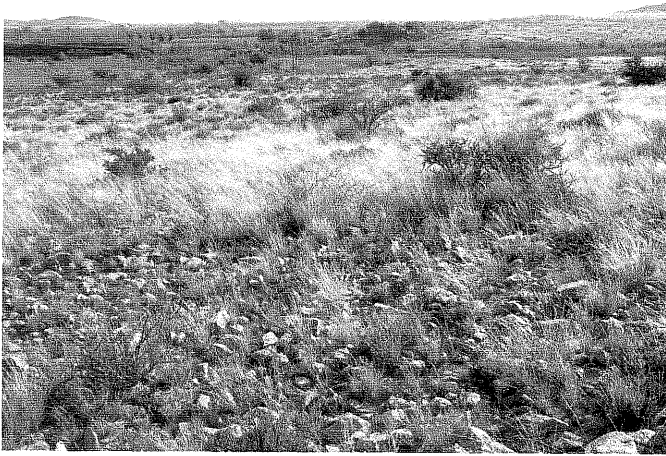
Figure 7. BP 2. View of the site facing north

The proposed borrow pit is situated fairly close to DR 3321, alongside an existing old borrow pit. It is very likely that this site will not even be used for road material, as most of the required volumes will come from BP 1 (Irme van Zyl pers. comm.). The proposed site slopes from south to north, abutting the old borrow pit (Figures 7-9). The slopes of the receiving environment are covered in surface stone such as quartz and quartzite with much low bush and thorny scrub and succulents occurring. No significant landscape features occur on the site. The surrounding land use comprises mainly natural veld and agricultural land.

Findings: A low density scatter of LSA utilised, retouched and unmodified chalcedony flakes were documented during the study. The tools are comparable to those that were found in BP 1. In addition, a reamer in indurated shale was also found, while a well crafted end scraper in chalcedony was found in the old borrow pit. A few pieces of green chert were also counted on the rocky and stony slopes.

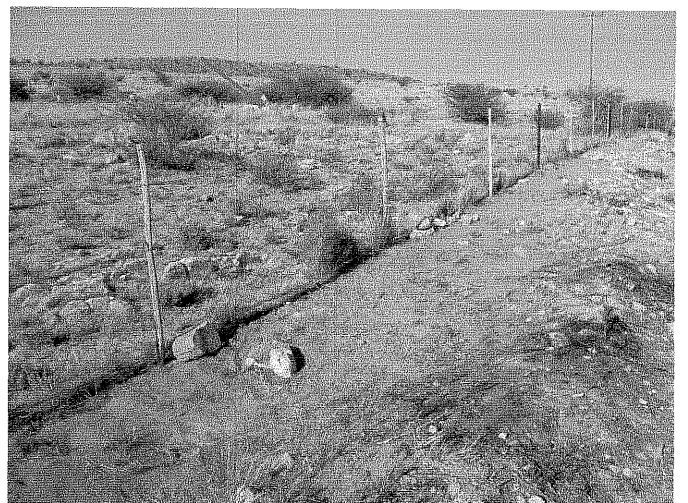
Two small informal cemeteries/graveyards occur alongside (i.e. north of) DR3321, close to a local school (Figure 10 and refer to Figure 2). The graveyards are behind the fence, aligned alongside the road reserve and will not be impacted by the proposed project (Irme van Zyl pers. comm.).

Figure 10. Arrow indicates graveyard

- Should any unmarked human remains be disturbed, exposed or uncovered during earthworks, these must immediately be reported to the South African Heritage Resources Agency (Mrs Mary Leslie or Dr A. Jerardino 021-462 4502).
