**PHASE 1 ARCHAEOLOGICAL IMPACT ASSESSMENT ON THE
CONSTRUCTION OF 50 KM OF LOOP ROADS ON THE FARMS ADDO
HEIGHTS [209], LISMORE [208], ZOUTE FONTEIN [210], NIEU JAARS
KOP [300] AND OLIPHANTS PLAAT [214] WITHIN THE SOUTHERN
SECTION OF THE ADDO ELEPHANT NATIONAL PARK, EASTERN CAPE**

Dr Lita Webley
Albany Museum
Somerset Street
Grahamstown
6139

16 November 2007

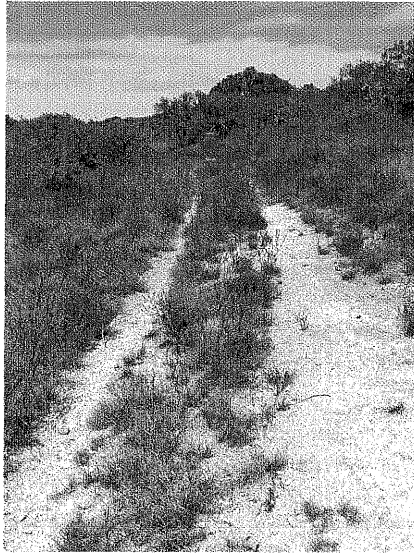
Fig. 3: Loop 4 road.

This loop extends in a westerly direction from the main north-south access road (Figure 2). It travels through extremely dense bush. The bush has not yet been cleared for the road, and we followed existing farm roads and cut lines in this general direction. There are quartzite cobbles and flakes cobbles to be found wherever the road crosses a calcrete surface. Since these "flakes" are found in the road, it is not always clear if they are the result of human action or due to vehicles moving over the quartzite cobbles. A number of GPS readings were taken along Loop 4. The readings presented below do not represent ALL the distributions of stone tools. However, they give an indication of the frequency of distributions found.

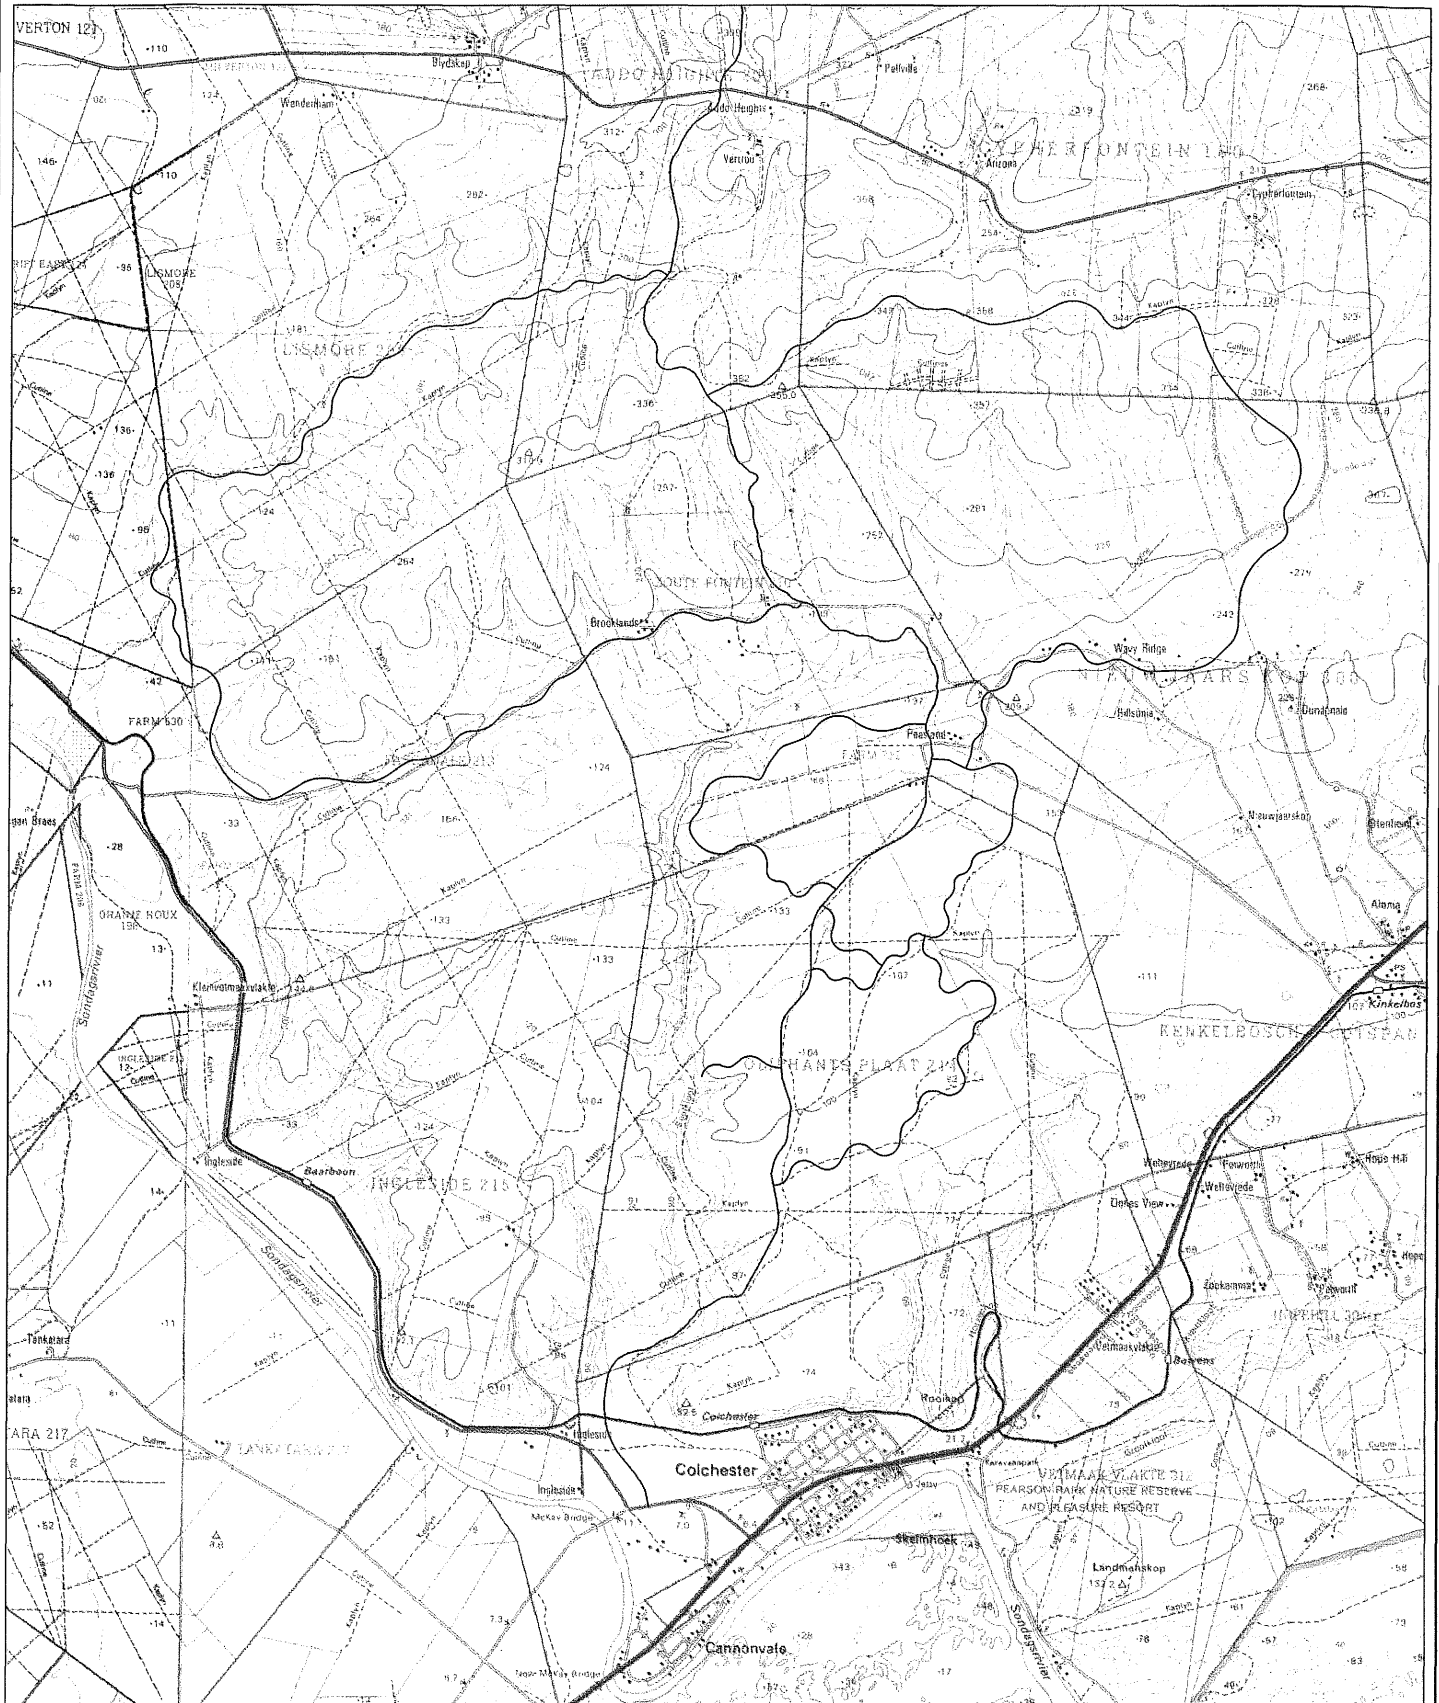
ADDO ELEPHANT NATIONAL PARK PROPOSED GAME VIEWING ROADS IN SOUTHERN PORTION

While this area has been incorporated into GAENP the fences have not yet been completed and therefore game has not been introduced. SAN Parks intends to construct 7 loop roads in this section, to join up with the main north-south road from Spekboom to Colchester. The total length of these loop roads will be 50 km. They also plan to develop a picnic site in an old gravel pit which was used during the first road development of the park.

Many of the loop roads indicated in Figure 2 have not yet been cut through the bush and it was not possible to follow their exact route. However, I am of the opinion that, while we were not always able to travel on the exact road, this is not likely to effect the results of the survey. The survey has indicated a general pattern to the distribution of the stone tools and this may be used to predict possible localities.
