HERITAGE IMPACT ASSESSMENT OF ERF 2074 MARINE WAY, PLETTENBERG BAY

31 May 2005

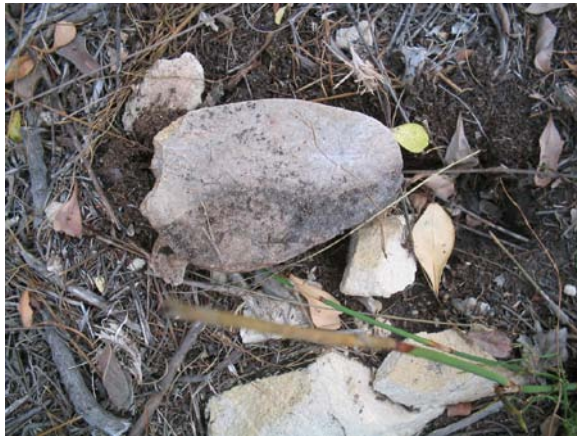
S 34°03'18,9"

Locality 1: is an odd shaped stone tool lying on the side of the road near the southern end of the property. It is possible that it was flaked by a vehicle? The flaked stone tools appear to be more concentrated on the escarpment overlooking the Piesang River than elsewhere on the property, but this could be related to greater visibility in the fynbos area.

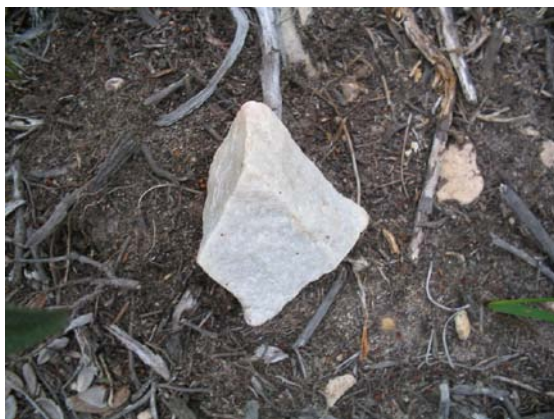
S 34°03'21,2"

Locality 2: are what appears to be badly weathered stone tools lying underneath the pine trees which are located in the centre of the property. It is more difficult to locate stone tools in this area because of the pine needle cover.

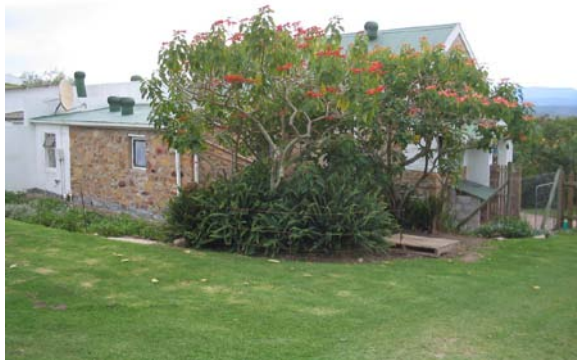
Renovated stone house

Locality 3 (Stone House): There is a well-established stone house located towards the front of the property. The consultants requested information on the status of the building and whether it could be demolished during development. It is not possible, from a mere visual inspection of the outside of the building, to establish its age. Further, the building has been extensively renovated in the recent past.

b) With regard the status of the stone building; the National Heritage Resources Act (No 25 of 1999) clearly protects all buildings older than 60 years. The Act states “No person may alter or demolish any structure or part of a structure which is older than 60 years without a permit issued by the relevant provincial heritage resources authority” (clause 34). It is not possible from a visual inspection of the building to be confident on its age. However, the title deeds will reflect the age of the dwelling and this is a relatively simple matter to resolve. If the structure is older than 60 years, permission to demolish will have to be obtained from Heritage Western Cape.
