# Archaeological Impact Assessment Report

**Project Title:** Darling Fresh Chicken Breeder Farm

**Project Location:** Bergrivier 'B' Municipality, West Coast District Municipality, Western Cape.

**Farm Number:** 137/7 Picketberg    **Size:** 52.12 ha

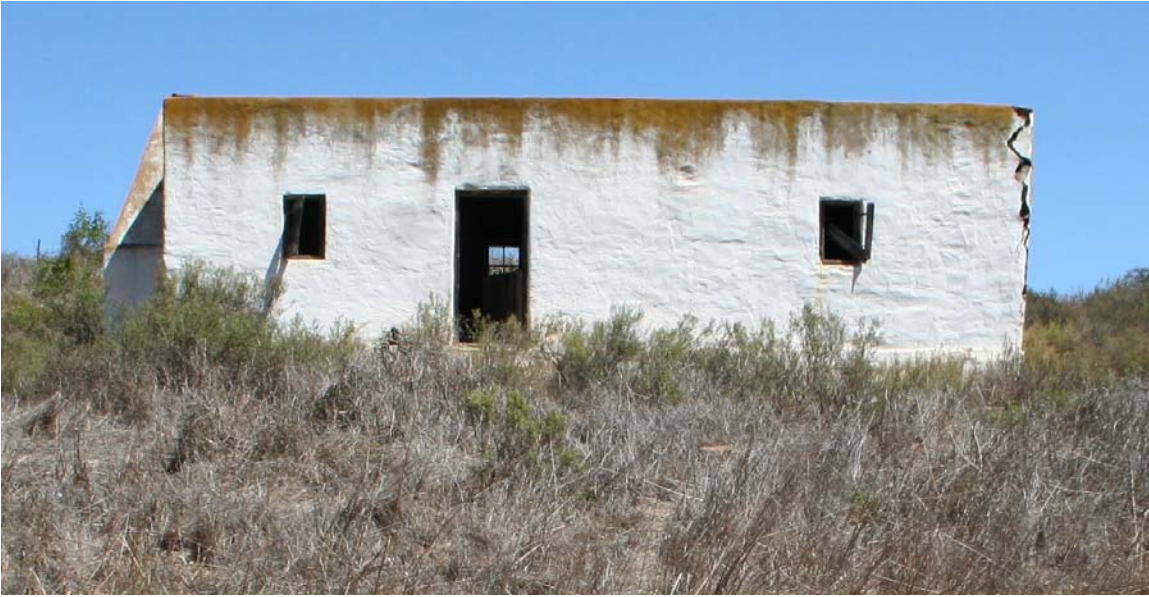
**Figure 3.** Worker's cottage on the property - note the crack in the end wall.

The 'House' marked in Figure 2 is a vacant flat roofed dwelling comprising two rooms, an external chimney and built in stone (shale) in traditional style (Figure 3). The end wall has developed a major structural crack needing attention. The external plaster is in reasonable but the internal plaster is in poor condition because of the inadequacies of the roofing. The style of this worker's cottage suggests an age older than 60 years and therefore any modification would require approval of Heritage Western Cape. The heritage value of the structure is in the fabric, the use of local shale packed slabs in the walling, and in the traditional design. The proposed developments on the property are some distance from the structure and should not directly impact on it.
