**PHASE 1 ARCHAEOLOGICAL IMPACT ASSESSMENT
PROPOSED DEVELOPMENT
OUTENIKUASBOSCH SAFARI PARK
FARMS OUTENIKUASBOSCH 149 AND
HARTENBOS 217
MOSSEL BAY**

**JUNE
2007**

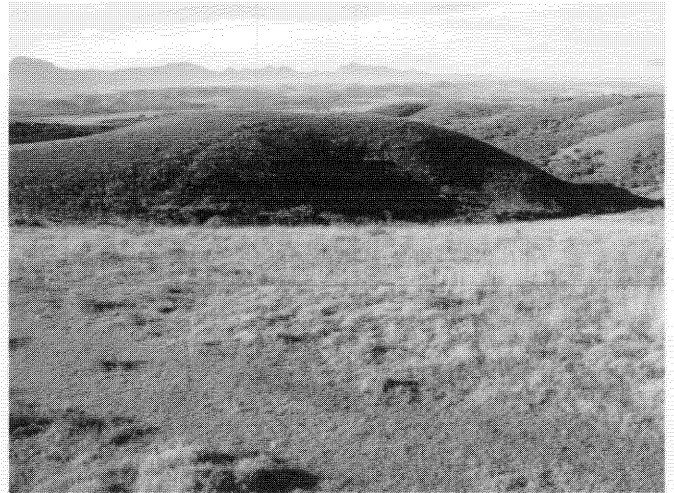
Figure 13. View of the site facing north

Four flaked and broken/split quartzite cobbles, and two MSA quartzite flakes were counted among large numbers of loose quartzite and quartz pebbles that occur on the spur of a large kopje comprising old grazing lands and natural veld, in the northern portion of the farm (refer to Figure 13).

The archaeological remains have been rated as having low local significance.

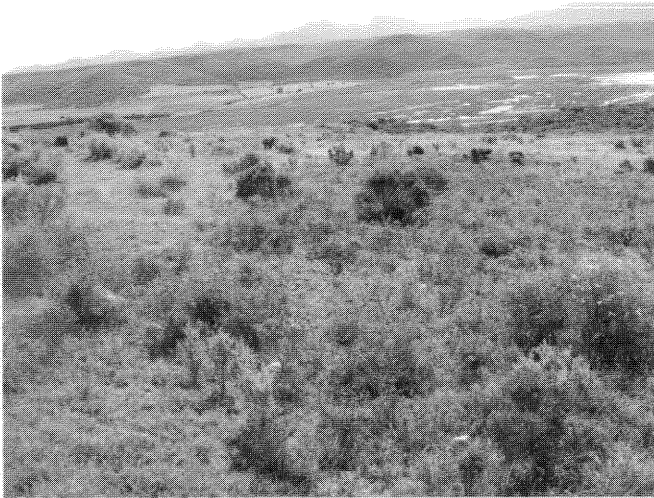
Figure 15. View of the site facing north west

Several large flaked and split/broken quartzite cobbles and one large ESA flake was found among a scatter of round (unworked) quartzite cobbles on a flat spur of grazing lands alongside the winding gravel road that leads down to the floodplain of the Klein Brak River (Figure 38). A few broken and flaked quartzite chunks/cobbles were also found among the thick grasslands overlooking the floodplain (refer to Figure 15).

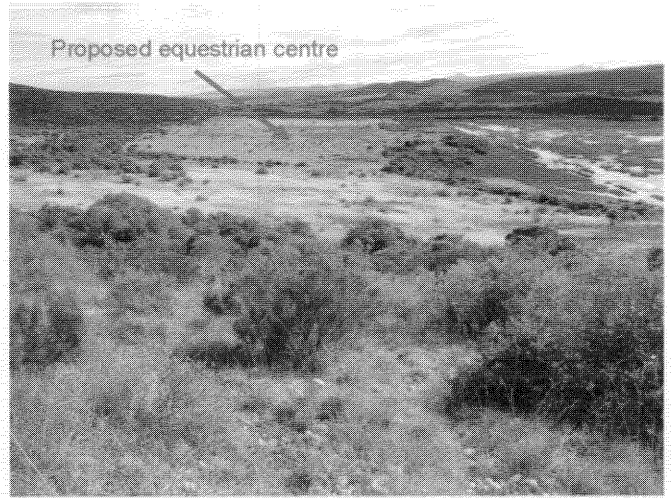
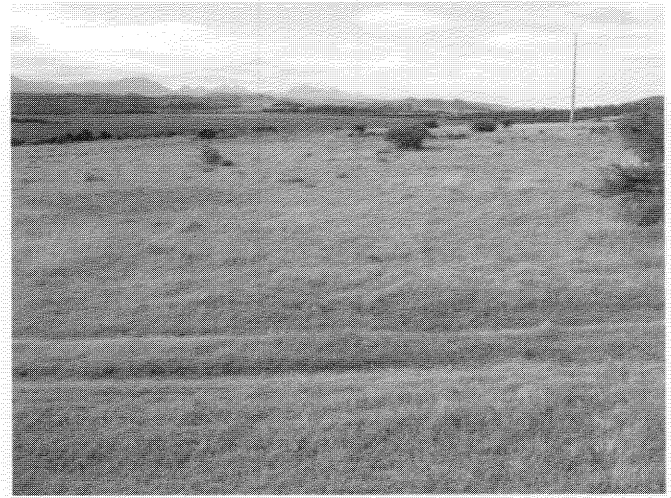
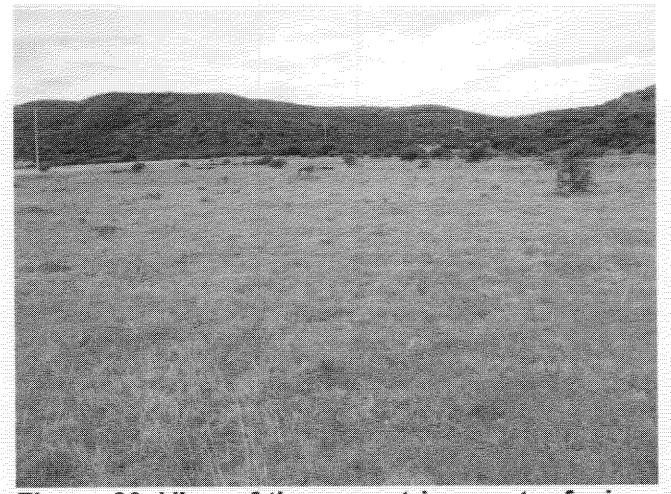
Figure 18. View of the site facing west

Figure 19. View of the equestrian centre facing east

Figure 20. View of the equestrian centre facing south

No stone artefacts were documented in the proposed equestrian centre alongside the floodplain of the Klein Brak River, which comprises heavily grazed grasslands. A few quartzite cobbles were found on the proposed site, none of which have been worked or modified as tools (refer to Figures 18-20).

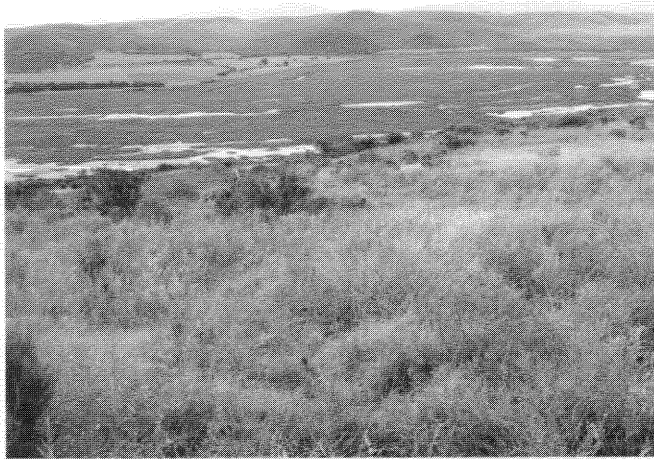
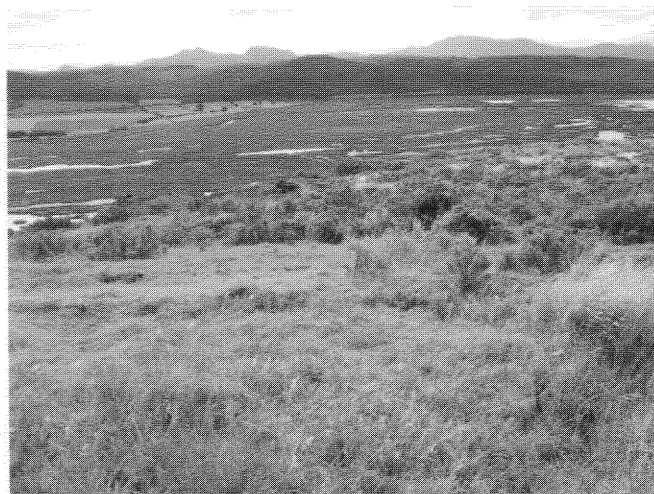
Figure 16. View of the hotel site facing north.

Figure 17. View of the hotel site facing north

One ESA quartzite flake and one MSA quartzite faceted flake was found in the gravel access road running alongside the northern boundary of the farm. The north facing slopes of the proposed hotel site are very well vegetated, but a thin scatter of large rounded quartzite cobbles were noted on the old terraced and contoured lands. Three flaked/split cobbles were documented on the

vegetated north facing slopes (refer to Figures 16 and 17).

The archaeological remains have been rated as having low local significance.

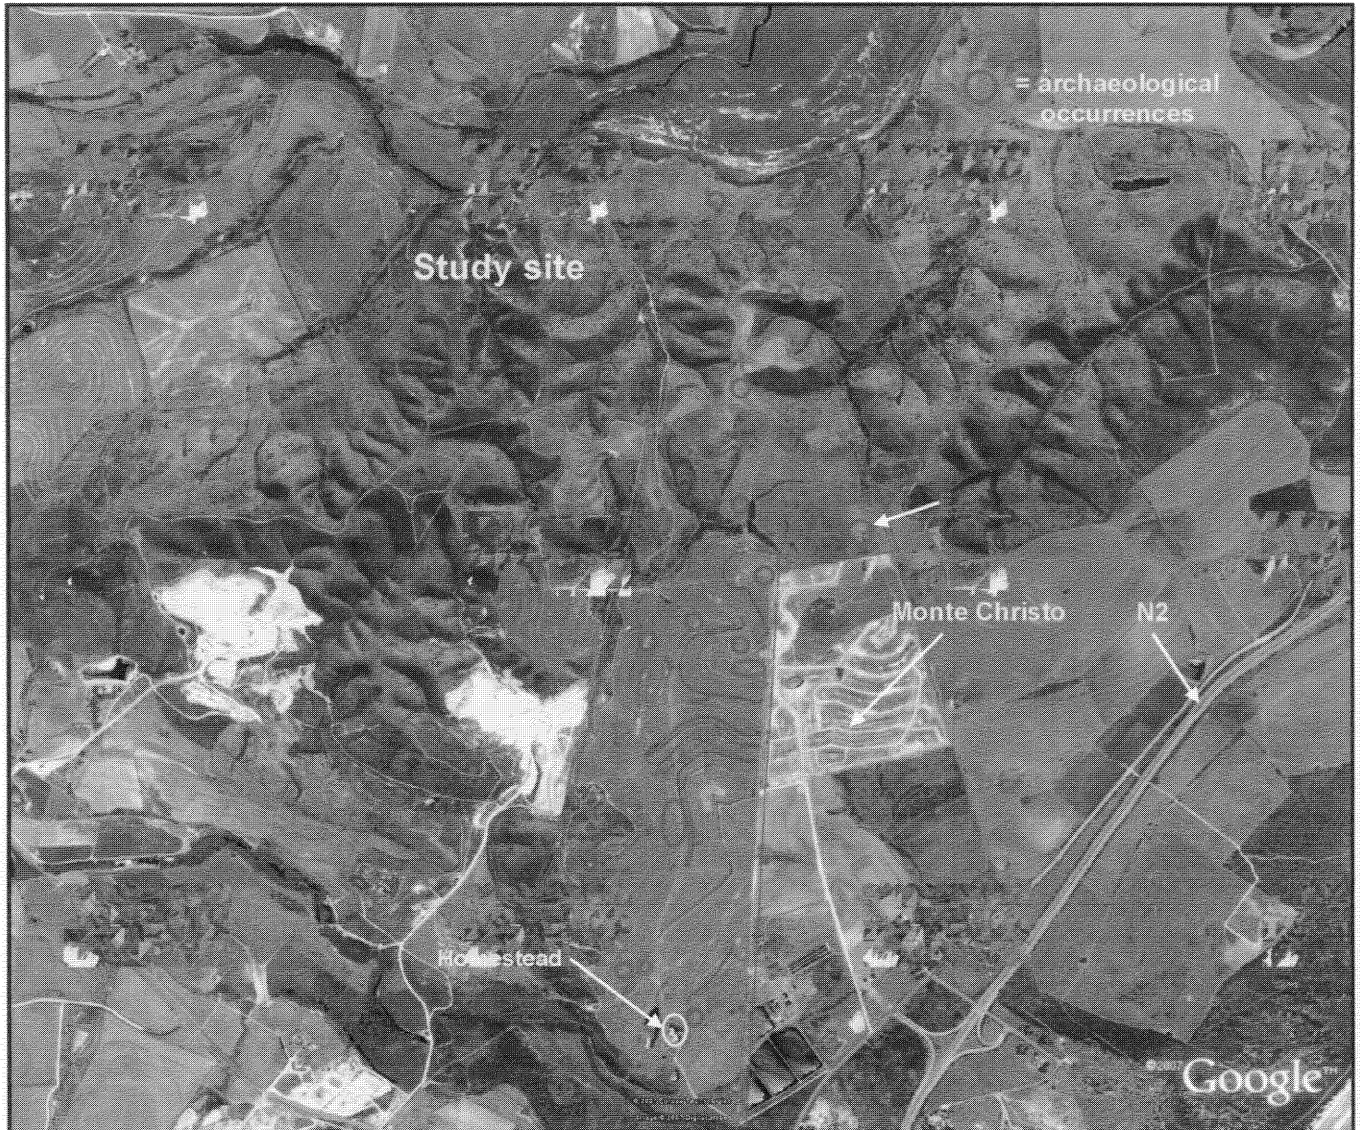
Figure 21. Aerial photograph of the Outeniquasbosch Safari Park illustrating archaeological occurrences documented during the study

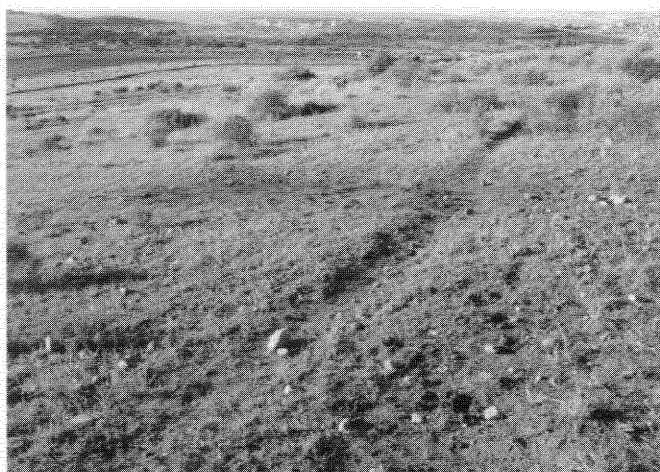
A low density scatter of ESA and MSA tools were located on compact brown sands on a gravel patch below a contoured slope alongside the road that runs through the central portion of the farm (Figure 22). Several ESA and MSA tools were also documented on the east facing slopes of the highly terraced and contoured lands west of the gravel road. The surrounding grazing lands are scattered with round quartzite river cobbles, some of which have been flaked and broken. A few tools were also noticed on exposed gravels where the farmlands have been heavily grazed and trampled. One or two tools were also noticed in some of the game trails that intersect the surrounding farmlands. The tools, all in locally available quartzite, include mainly side struck flakes, including a few edge retouched and utilised specimens, chunks, large flaked and split chunks, several pitted hammerstones and prepared cores and at least one blade tool. No handaxes or other formal tools were found. The tools all occur in a highly disturbed context. A collection of tools is illustrated in Figure 23.

Figure 22. Archaeological context of Site A.
View facing south east

The archaeological remains have been rated as having low local significance.

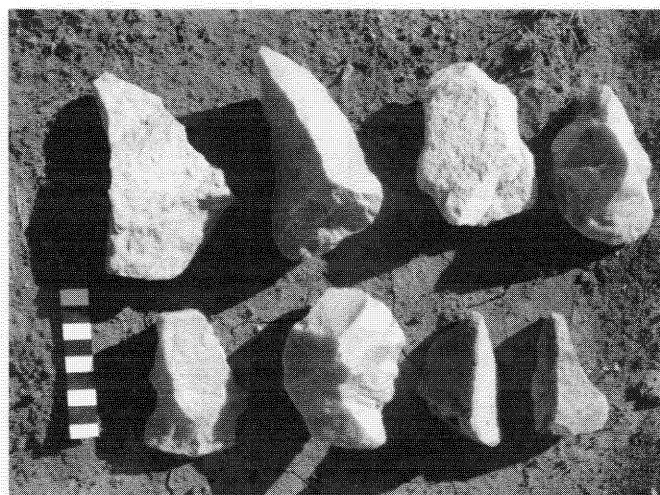
Figure 23. Collection of stone tools from Site A.
Scale is in cm

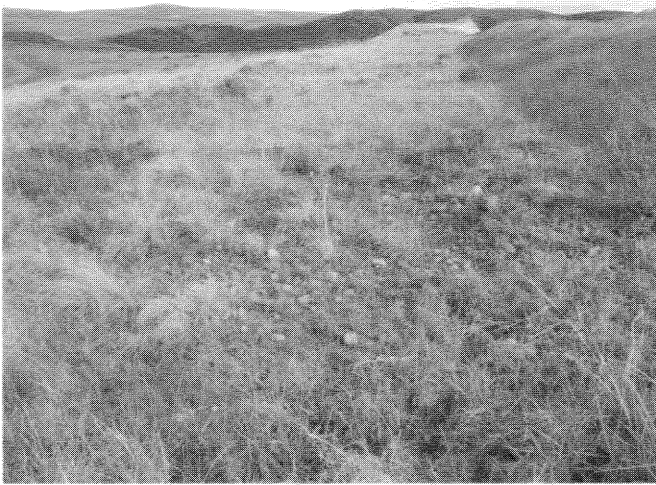
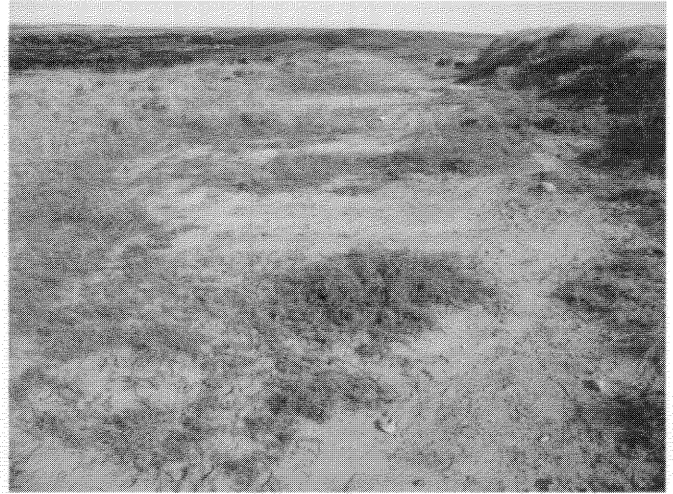
A low density scatter of MSA tools were found on compact brown sands, on an exposed gravel patch below a terraced bank alongside the road that runs along the eastern boundary of the farm (Figures 24 & 25). Several tools were also found on the contoured slopes and surrounding grazing lands, as well as in the gravel road. The tools, all in quartzite, comprise mainly flakes, chunks, and two round flattish, prepared cores. The tools occur in a highly disturbed context. A collection of artefacts is illustrated in Figure 26.

**Figure 24. Archaeological context of Site B.
View facing east**

**Figure 25. Archaeological context of Site B.
View facing east**

The archaeological remains have been rated as having low local significance.

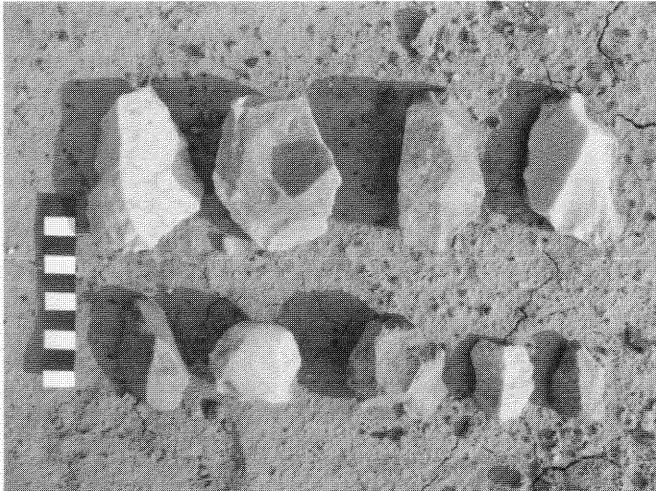
**Figure 26. Collection of stone tools from Site B.
Scale is in cm**

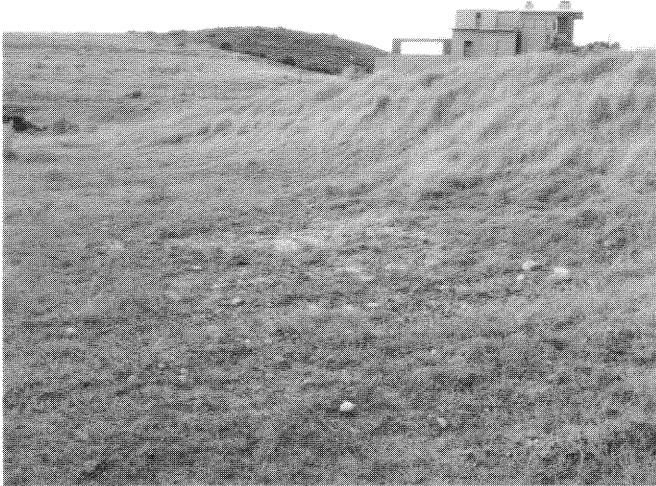
A low density scatter of ESA and MSA tools were found on a patch of trampled and exposed gravel about 20 m north of Site B, below a series of steeply terraced banks about 30 m from a new house at the Monte Christo housing development (Figure 27). The tools, all in quartzite, comprise about nine flakes, of which three have faceted platforms, several chunks and broken cobbles. No formal tools were found. The tools occur in a severely disturbed context. A collection of artefacts is illustrated in Figure 28.

Figure 27. Archaeological context of Site C. View facing north east

The archaeological remains have been rated as having low local significance.

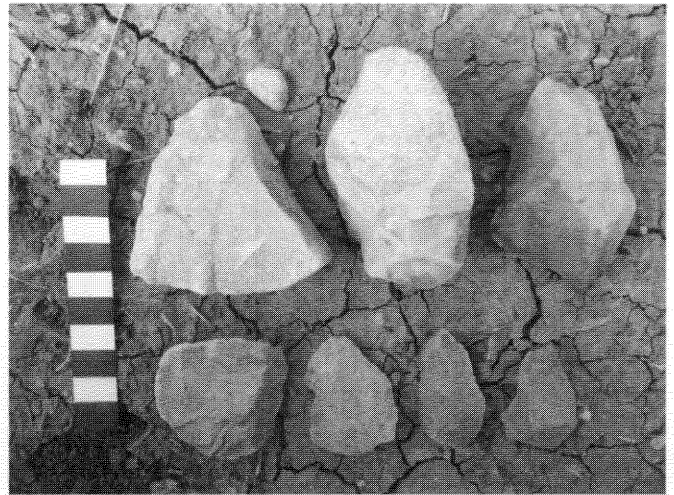
Figure 28. Collection of stone tools from Site C. Scale is in cm.

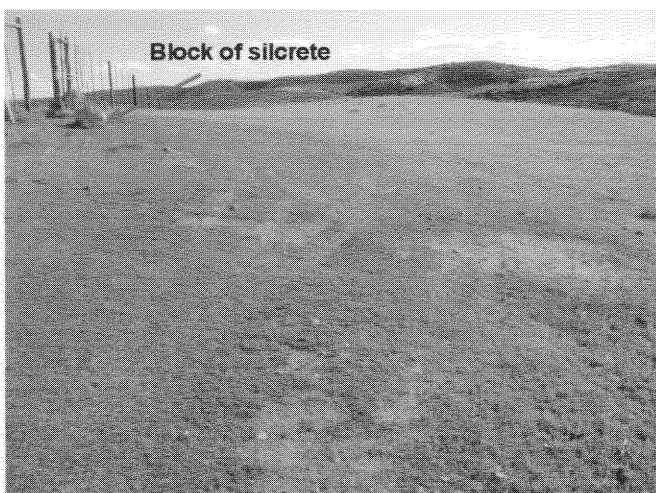
ESA and MSA tools were found on compacted brown sands on heavily grazed and trampled lands near a farm gate/fence, directly alongside the north eastern corner of the Monte Christo development (Figure 29). The tools, mostly in quartzite, but a few also in silcrete, comprise mainly flaked chunks, split/broken cobbles, two cortex flakes, a small round flattish prepared core and a partially retouched (possible) unifacial handaxe. A large block of silcrete was found right next to the farm gate, the source of which is unknown. A collection of tools is illustrated in Figure 30.

Figure 29. Archaeological context of Site D. View facing west

The archaeological remains have been rated as having low local significance.

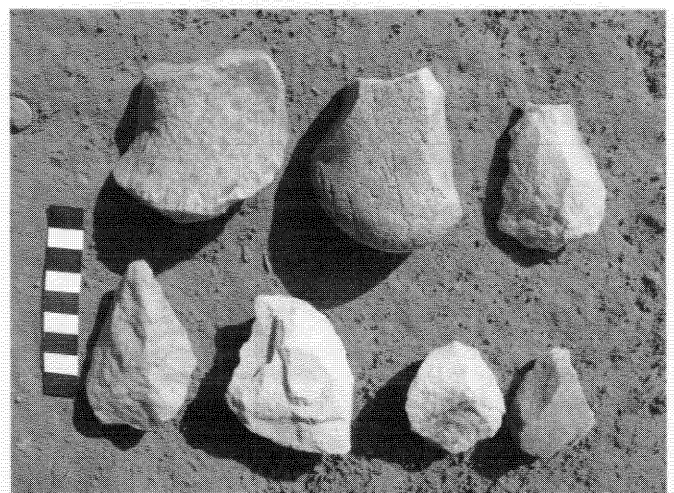
Figure 30. Collection of stone tools from Site D. Scale is in cm

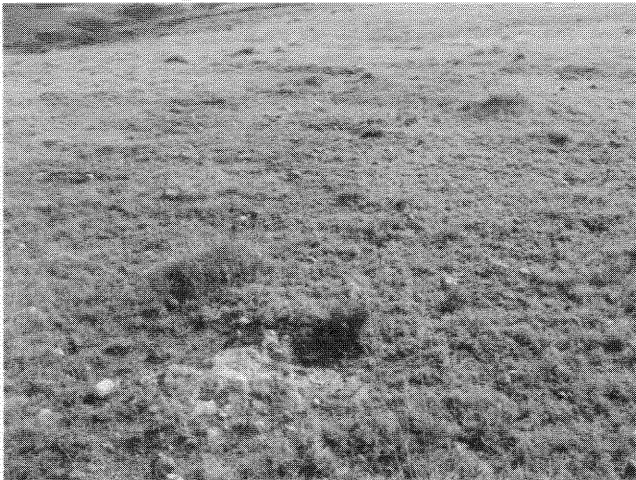
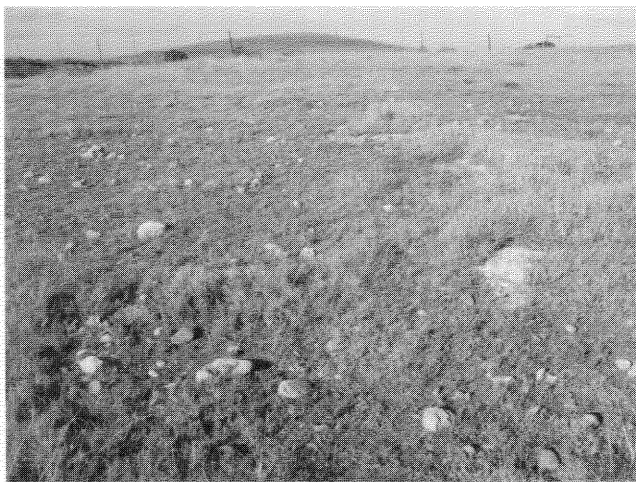
A low density scatter of ESA and MSA tools were located on a large patch of heavily grazed lands on a flat-topped hill in the south eastern corner of the proposed site (Figure 31 & refer to Figure 10). Relatively large numbers of rounded quartzite and (occasionally) flaked cobbles occur near the fence line (Figure 32). The tools comprise a selection of flaked and split chunks and cobbles, several modified and unmodified flakes, large and smaller cores, and several blade tools. No formal tools were found. The tools are mostly in quartzite, but several tools in silcrete were also found. The artefacts show little evidence of abrasion and polish, suggesting that they were not rolled or transported by natural agents. It therefore appears likely that most of the artefacts occur in primary or close to primary context. A few stone tools were also documented on the well vegetated, west facing slopes of the property, as well as among a pile of rocks cleared from the surrounding fields. A collection of tools is illustrated in Figures 33 and 34.

**Figure 31. Archaeological context of Site E.
View facing north**

**Figure 32. Archaeological context of Site E.
View facing east**

The archaeological remains have been rated as having low local significance.

At the same time, however, several thin and dispersed scatters of tools identified during the baseline study (notably Site E and Site G), appear to occur in primary, or close to primary context, and it is not inconceivable that earth moving operations might expose in-situ material over the less disturbed portions of the proposed site.

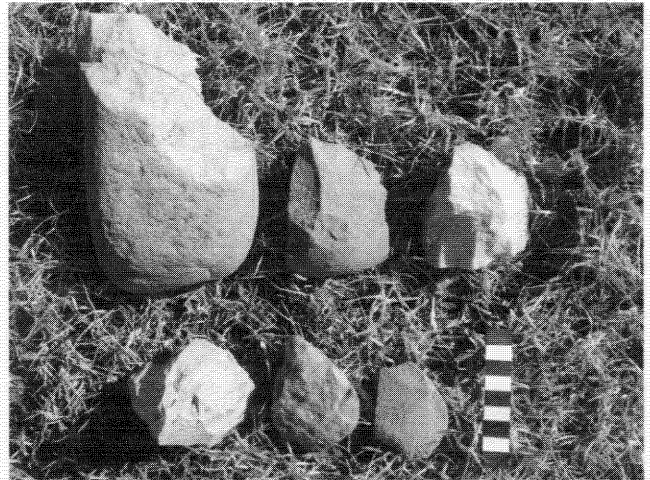
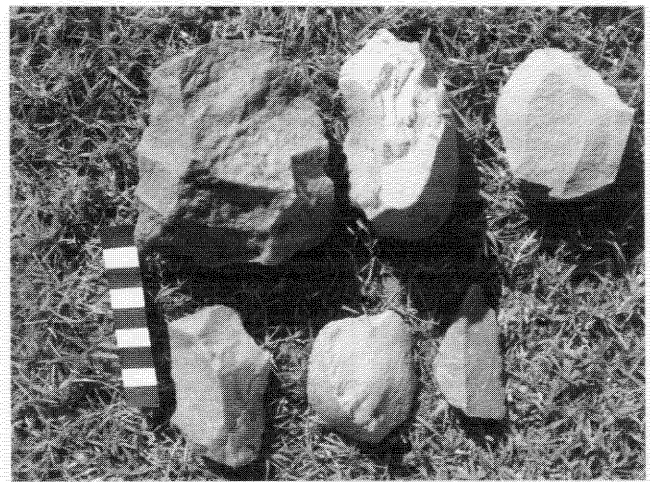
**Figure 33. Collection of stone tools from Site E.
Scale is in cm**

**Figure 34. Collection of stone tools from Site E.
Scale is in cm**

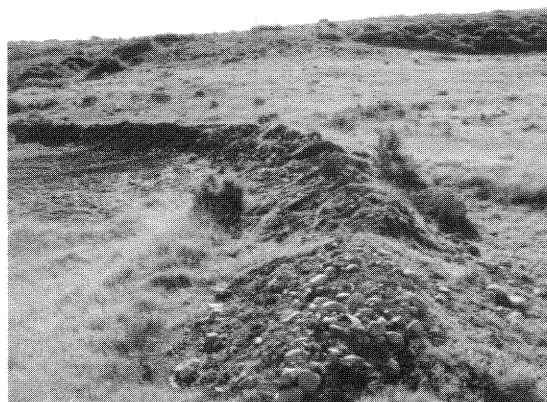
One ESA flake and several ESA flaked/broken chunks were found among a large pile of gravel and quartzite cobbles that have been excavated for a small drinking dam for animals and deposited alongside the dam (Figure 35).

Figure 35. Archaeological context of Site F.

The archaeological remains have been rated as having low local significance

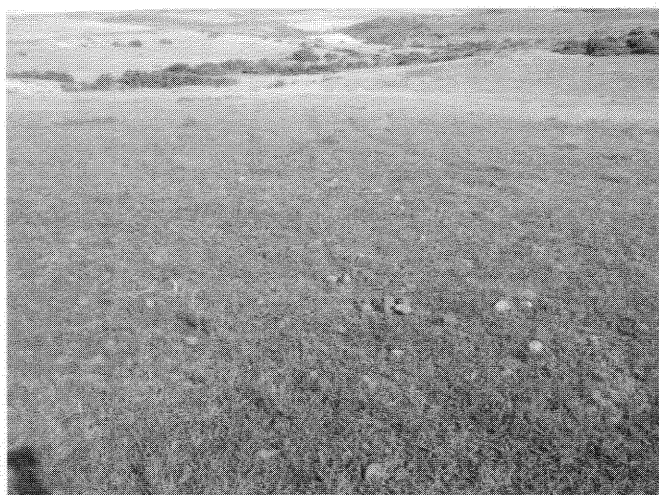
Relatively large numbers of round, unworked quartzite cobbles were documented on the south west facing slopes of grazing lands at the top of the valley (Figure 36). A thin scatter of ESA and a few MSA tools were documented on the slopes. These include mainly flaked and split cobbles and chunks, a few flake tools, one core and one partially retouched unifacial pointed flake. Several weathered and patinated tools were also counted, indicating considerable antiquity. The artefacts appear to occur in primary or close to primary context. A collection of tools is illustrated in Figure 37.

Figure 36. Archaeological context of Site G. View facing north west

The archaeological remains have been rated as having low local significance.

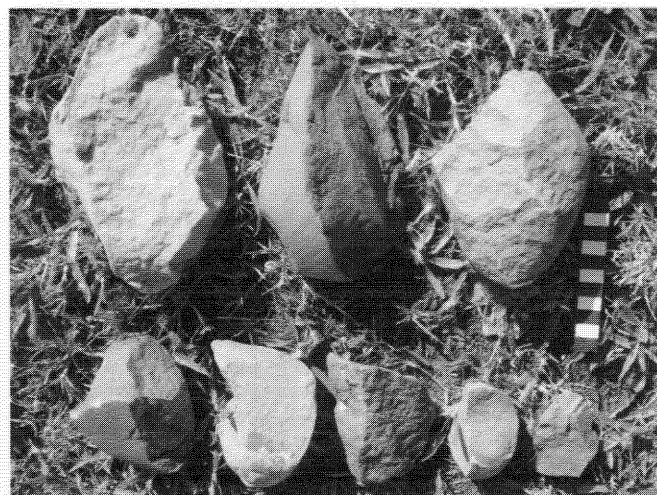
Figure 37. Collection of stone tools from Site G. Scale is in cm

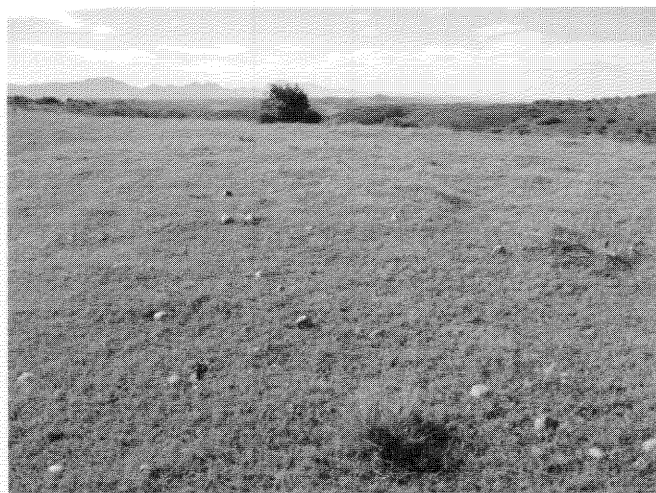
Figure 38. Archaeological context of Site J. View facing north

The archaeological remains have been rated as having low local significance

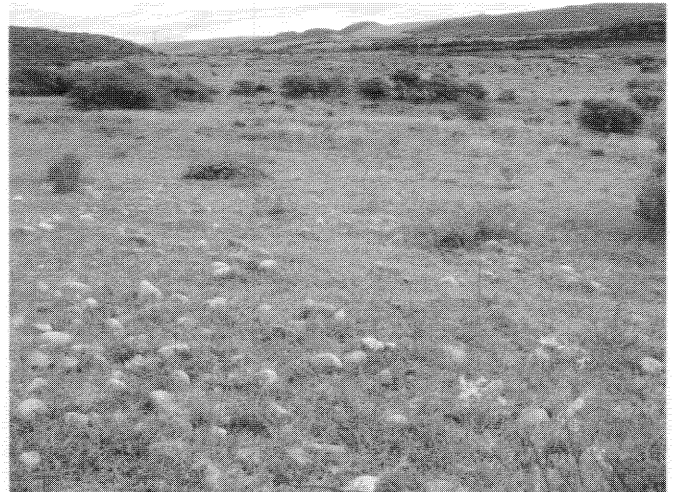
However, a few flaked and split/broken cobbles were documented among relatively large numbers of rounded quartzite cobbles near the access to the proposed Equestrian Centre (Figure 39).

**Figure 39. Archaeological context of Site L.
View facing west**

The archaeological remains have been rated as having low local significance.

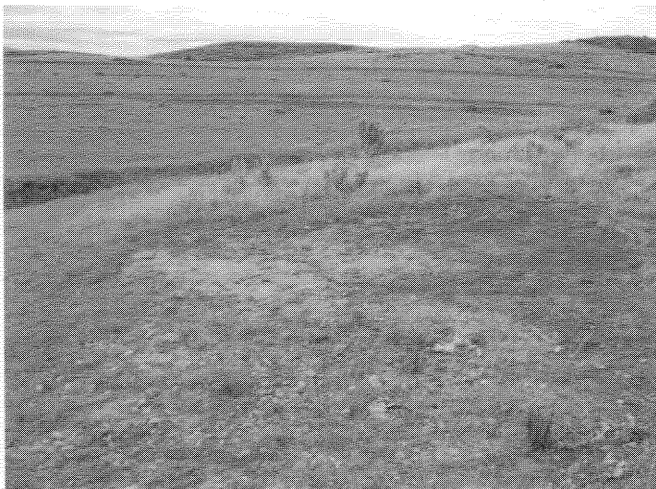
Thirteen MSA tools including flakes, chunks and several round cores in quartzite were counted on two patches of gravel alongside the main access that runs road through the farm, below a row of terraced ridges and contoured grazing lands (Figure 39). Several more flake tools were found in the gravel road. A collection of tools is illustrated in Figure 40. The remains occur in a very disturbed context.

**Figure 39. Archaeological context of Site M.
View facing north east**

The archaeological remains have been rated as having low local significance.

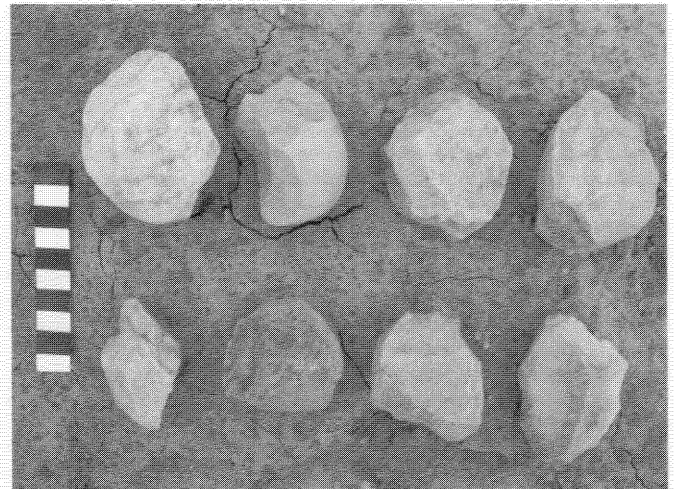
**Figure 40. Collection of stone tools from Site M.
Scale is in cm**

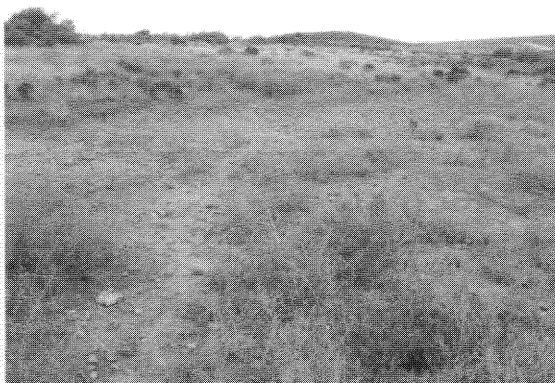
About 20 ESA and MSA tools were counted on a large patch of eroded gravel beside a small footpath about 150 m from the western boundary of the farm, alongside a long line of terraced and contoured grazing lands (Figure 41). Large numbers of rounded quartzite cobbles and smaller pebbles and stone have eroded from the terraced banks. The tools, all in quartzite, comprise several large pointed bifacial flakes (possibly incomplete handaxes), flaked and broken chunks, several round cores and faceted flakes including some that are retouched and utilised. A number of the flakes are also broken or snapped. A collection of tools is illustrated in Figure 42.

Figure 41. Archaeological context of Site M. View facing south

The archaeological remains have been rated as having low local significance.

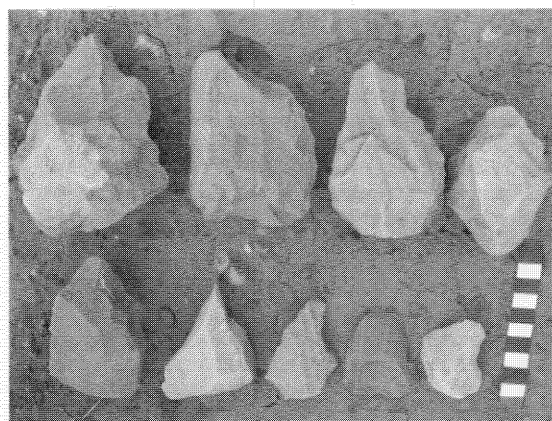
Figure 42. Collection of stone tools from Site N. Scale is in cm

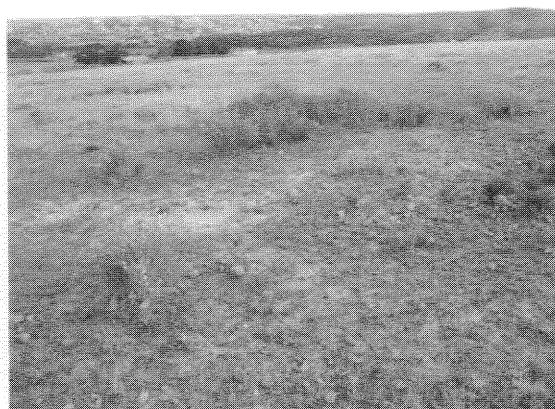
Five MSA quartzite flakes and chunks were found on a small patch of land in the southern portion of the property, about 450 m from the farmhouse. The tools occur in a disturbed context.

Figure 43. Archaeological context of Site O. View facing south

The archaeological remains have been rated as having low local significance.

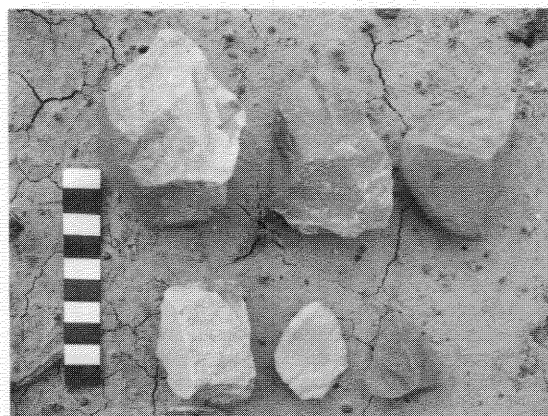
Figure 44. Collection of stone tools from Site O. Scale is in cm.

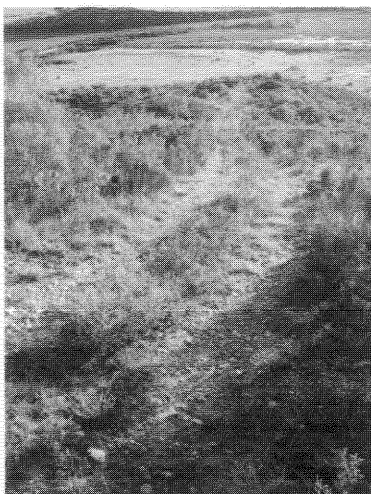
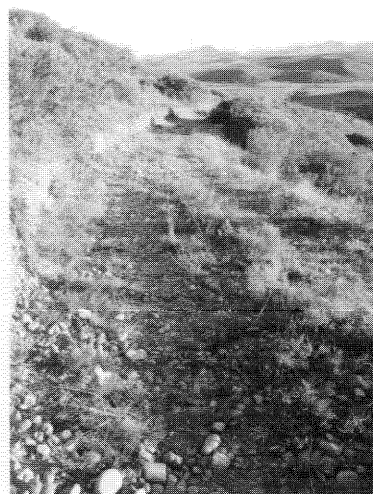
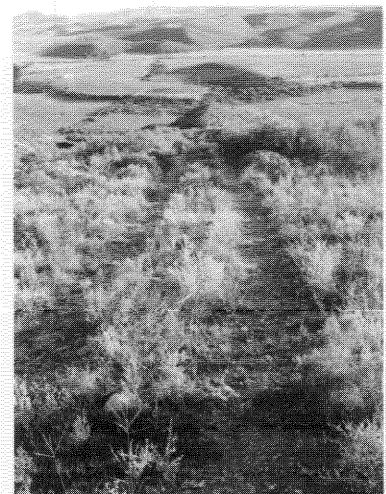
Findings: A few ESA tools were noted near a gravel and cobble cutting alongside the proposed MTB trail, while a few more tools were noted in the loose gravel road. The route is mainly very steep and narrow.

Figure 45. Possible MTB trail

Figure 46. Possible MTB trail

Figure 47. Possible MTB trail

The archaeological remains have been rated as having low local significance.
