NATIONAL MONUMENTS COUNCIL

FILE NOTE

RE: ROCK ART SITE ON FARM OUDE MURAGIE NEAR DE RUST, OUDTSHOORN DISTRICT

OUDE MURAGIE ROCK SHELTER, OUDTSHOORN DISTRICT

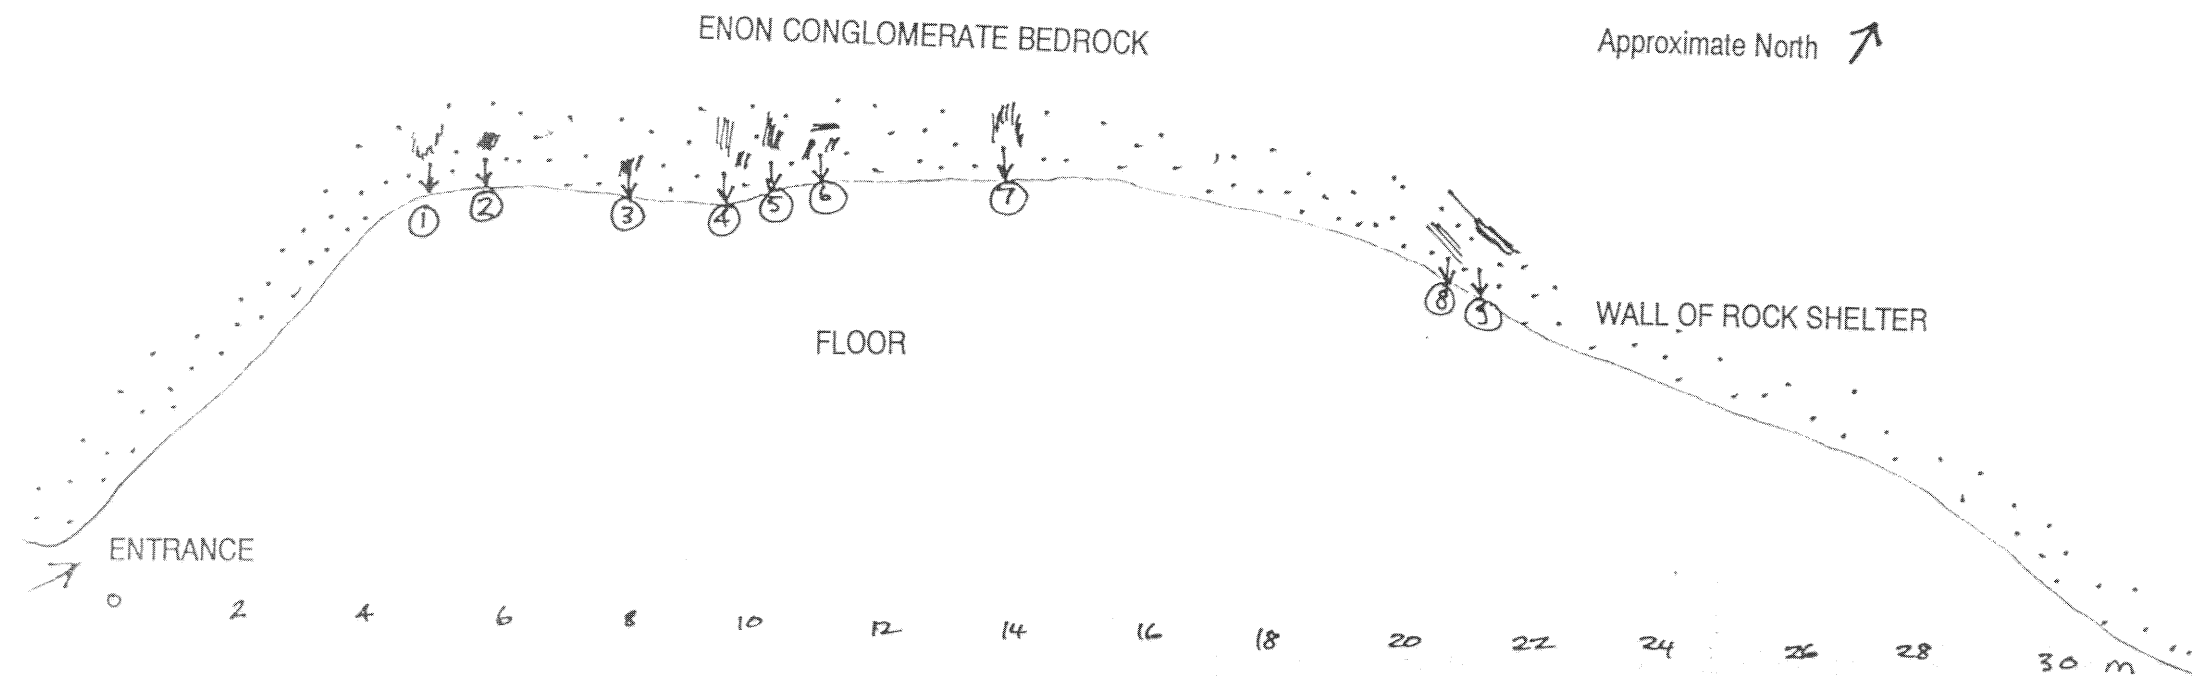
3. Blood had been smeared by hand onto the shelter wall in 9 patches (see attached site plan). It covered rock paintings in the patches numbered 8 and 9 on the eastern side of the shelter.

Plan of site showing position of patches of blood before removal

4. The blood was removed first from patches that were not associated with paintings. The method used was recommended by Dr Jannie Loubser of the National Museum in Bloemfontein who had consulted experts in Australia on our behalf. The blood was

covered first with a sheet of white paper towel, fixed in place with masking tape. This was covered in turn with cotton wool dampened with Golden Products Super 10, and then with a second layer of paper towel moistened with distilled water. This poultice was covered with plastic cling wrap and sealed with masking tape. The first poultice was left for two hours, but thereafter we removed them after 40-60 minutes.

5. After the poultice was taken off the rock, the remaining blood was dabbed with small poultices that were pressed against the rock by hand. The paper towel was replaced as soon as it became stained. This allowed greater control, particularly where rock paintings underlay the blood smears.

9. This process worked well on the majority of the blood patches, but problems were experienced with patches numbered 1 and 6. In the case of patch 1, when the last paper towel patch was removed, it was found that a whitish residue had formed on the surface of the rock. We tried removing it with distilled water and a stiff brush, but this made no noticeable difference. In the case of patch 6, a whitish deposit was left on the right-hand side of the rock and could not be removed. It is possible that there are salt accumulations in these two rocks in the conglomerate that have been brought to the surface by the distilled water.

10. Although we avoided using Super 10 on the rock paintings under patches 8 and 9, the surfaces were affected and the part of the rock on which Super 10 was applied is slightly paler than the surrounding area. However, as all the paintings were badly faded before we began, there is no noticeable effect on the paintings themselves.
