ARCHAEOLOGICAL SURVEY OF A DAM SITE IN THE FRANSCHHOEK AREA

Prepared for

Ninham Shand

May 1996

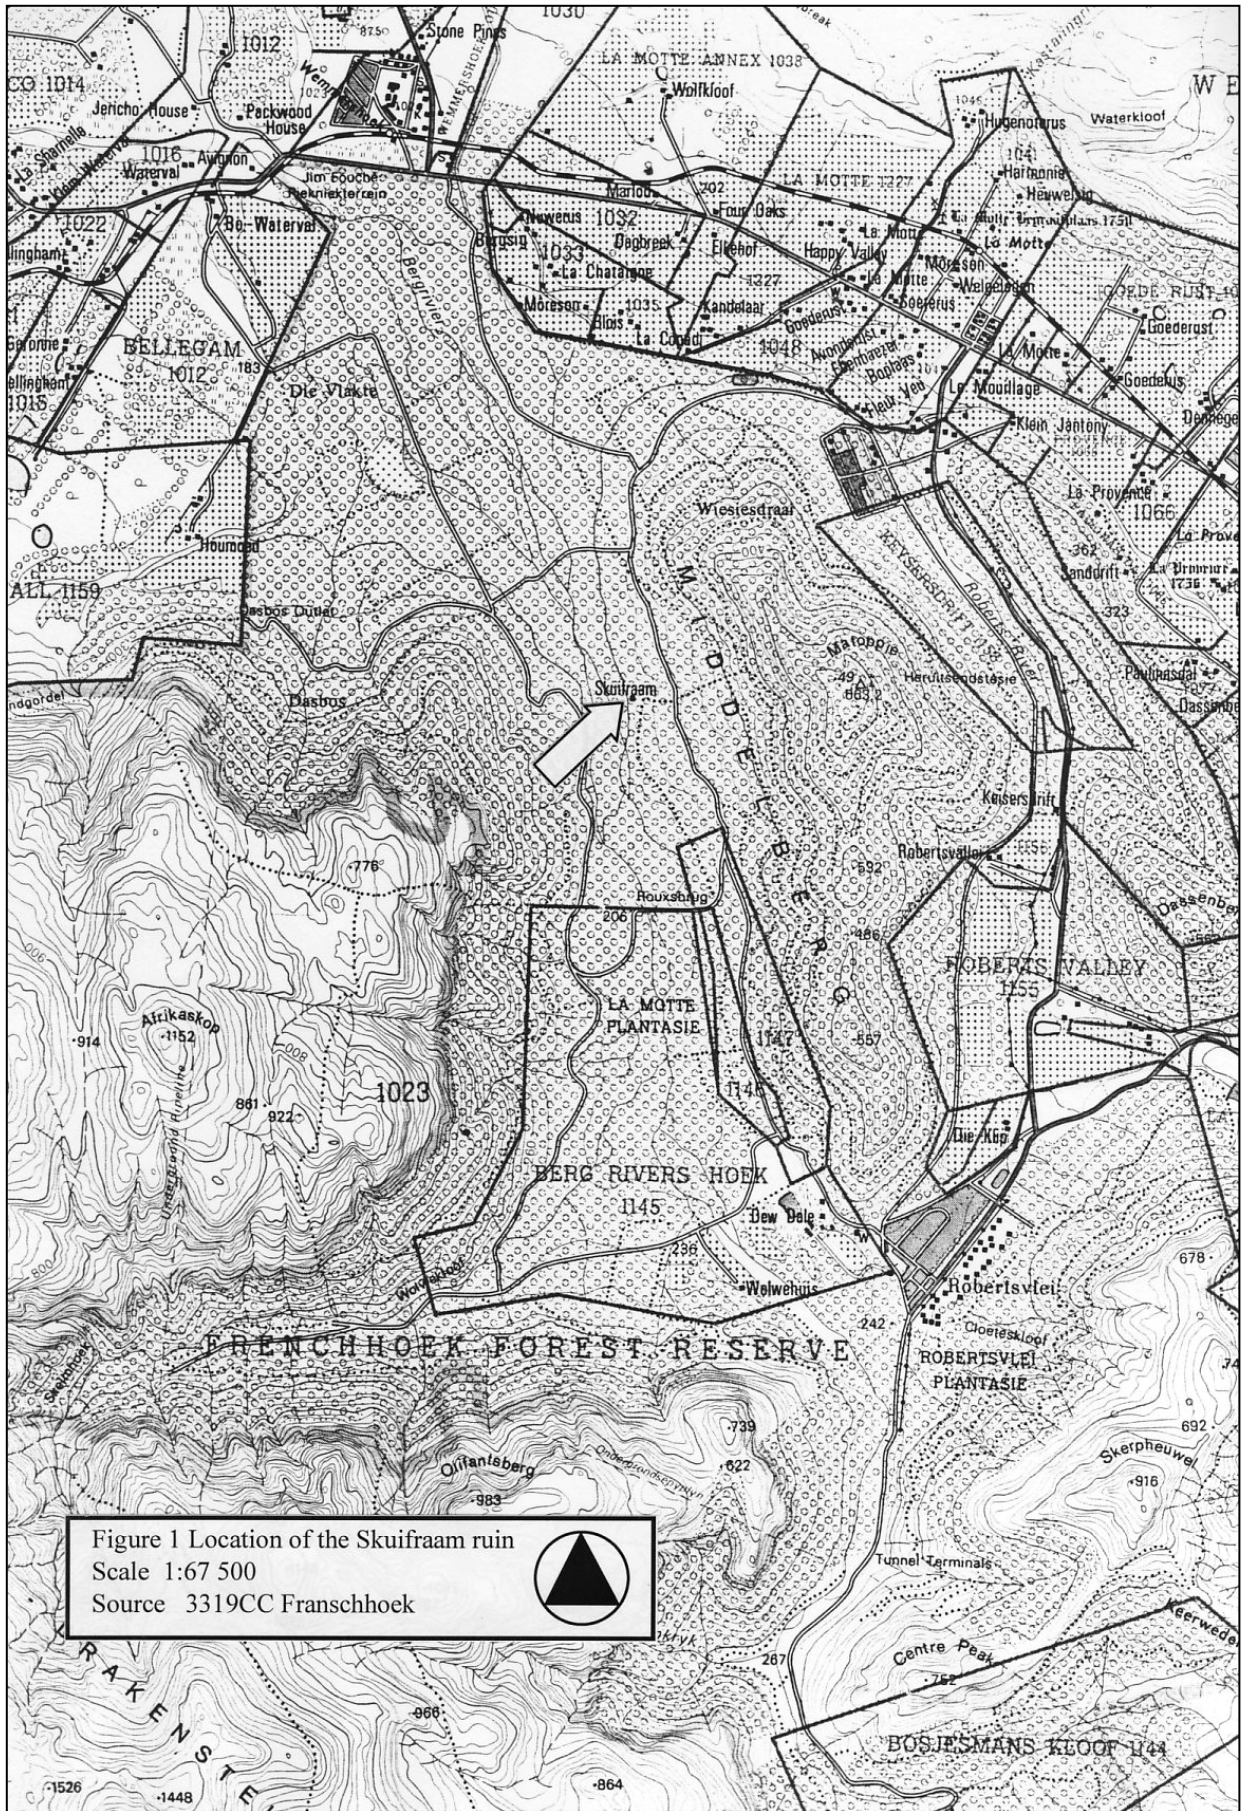
The proposed area of the dam has, where possible, been searched on foot for archaeological materials, with particular attention to rock outcrops as well as existing buildings and ruins. Sites identified in this manner have been located with a Global Positioning System (GPS) and plotted on a map of the locality (Figure 1).

This site was the only one found during the survey and consists of the remains of a substantial building (Fig. 1). The structure is identified on the 1:50 000 scale map (presently out of print) as Skuifraam and lies at 33° 54.4183'S; 19° 03.5646'E in virtually impenetrable bush. Owing to the vegetation very little can be said about this building besides that it is rectangular and subdivided into at least three rooms. It comprises a foundation of lightly dressed stone which is elevated downslope so as to achieve a level building platform. The
