**A HERITAGE SCOPING STUDY OF ERWEN 58, 64, 65, 66,  
67 & 596, ELANDS BAY**

**BKS (Pty) Ltd**

March 2005

**D.J. Halkett**

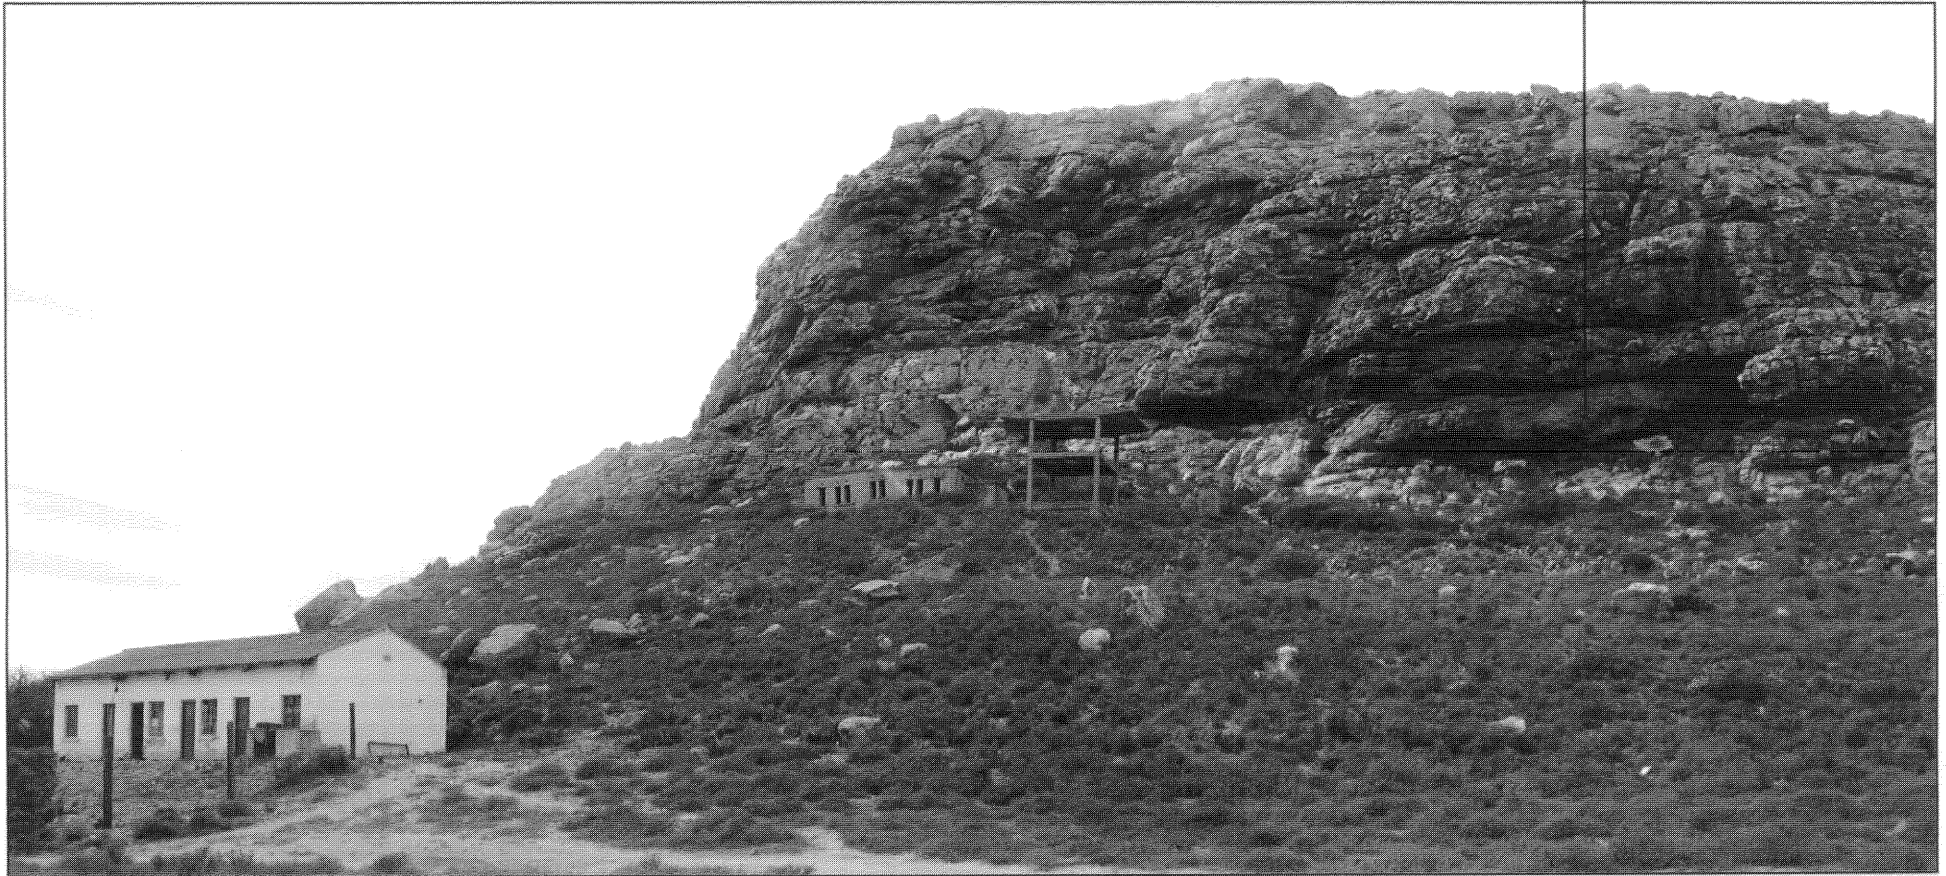
**Plate 2:** View of the Radar station and Elands Bay Cave

Erected during World War 2 as part of the coastal defence network, this was one of a few secret installations using technology developed in South Africa to provide early warning of the approach of enemy ships and aircraft. What remains today are the operations room and radar platform, 2 toilets, a building that housed a generator, a road and possibly a barrack (now part of the labour compound). Old cement fence posts and barbed wire still mark the perimeter in places. The borrow pit (described below) was provided material for the road.

**Significance:** One of the few remaining examples of these installations and probably the only one of this type left on the west coast. This has considerable significance from a military history perspective. The site will have local and national significance (and possibly international?).

**Mitigation:** If demolition is not permitted, some form of adaptive re-use may be considered. The buildings would function excellently as a site museum. A management plan for the resource would be required.

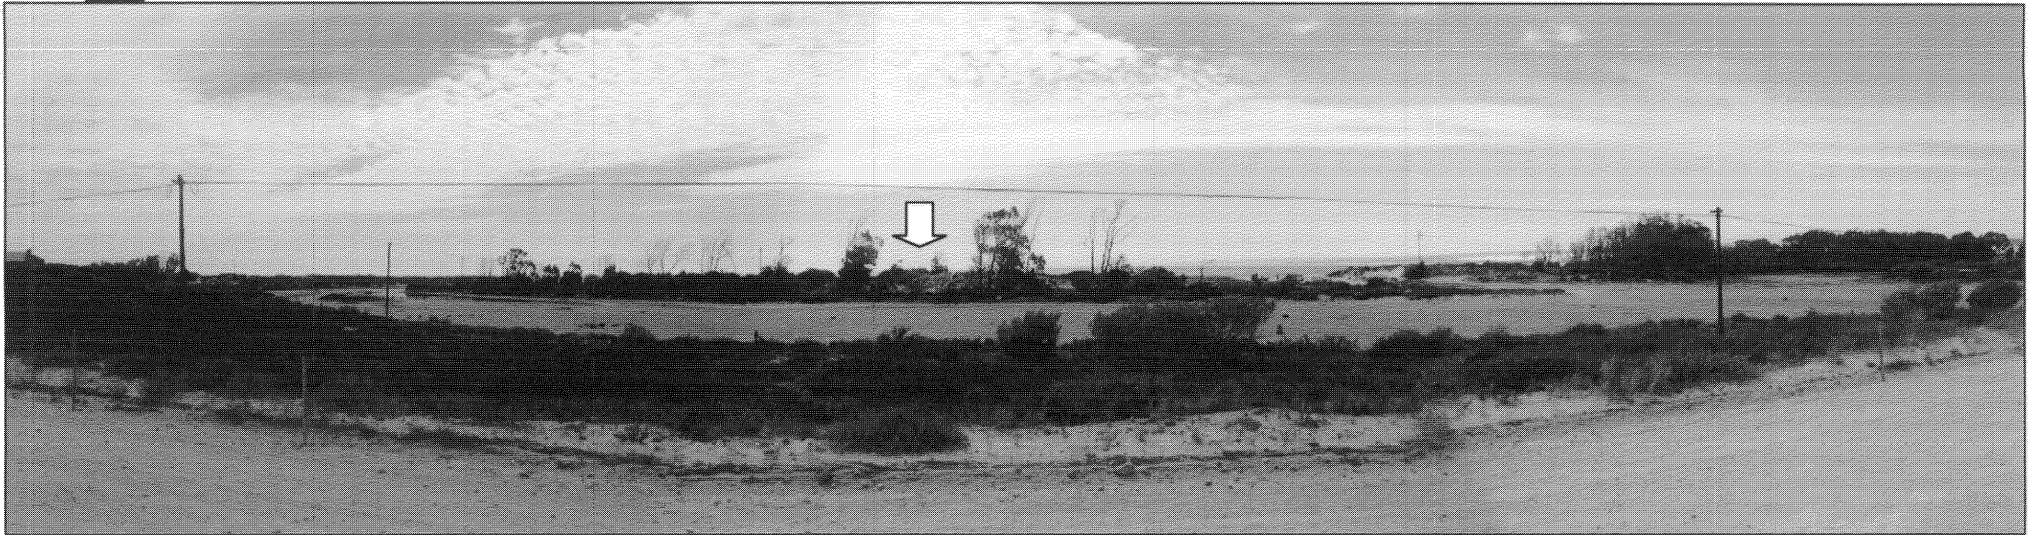
**Plate 7:** The "Island" shown surrounded by the Verloren Vlei (dry).

No archaeological sites are known to occur here. Views of the area are shown in Plates 7 and 8.
