PHASE ONE ARCHAEOLOGICAL INVESTIGATION OF THE VICTORIA JUNCTION SITE, SOMERSET ROAD

Newport Property Group

March 1995

Archaeology Contracts Office

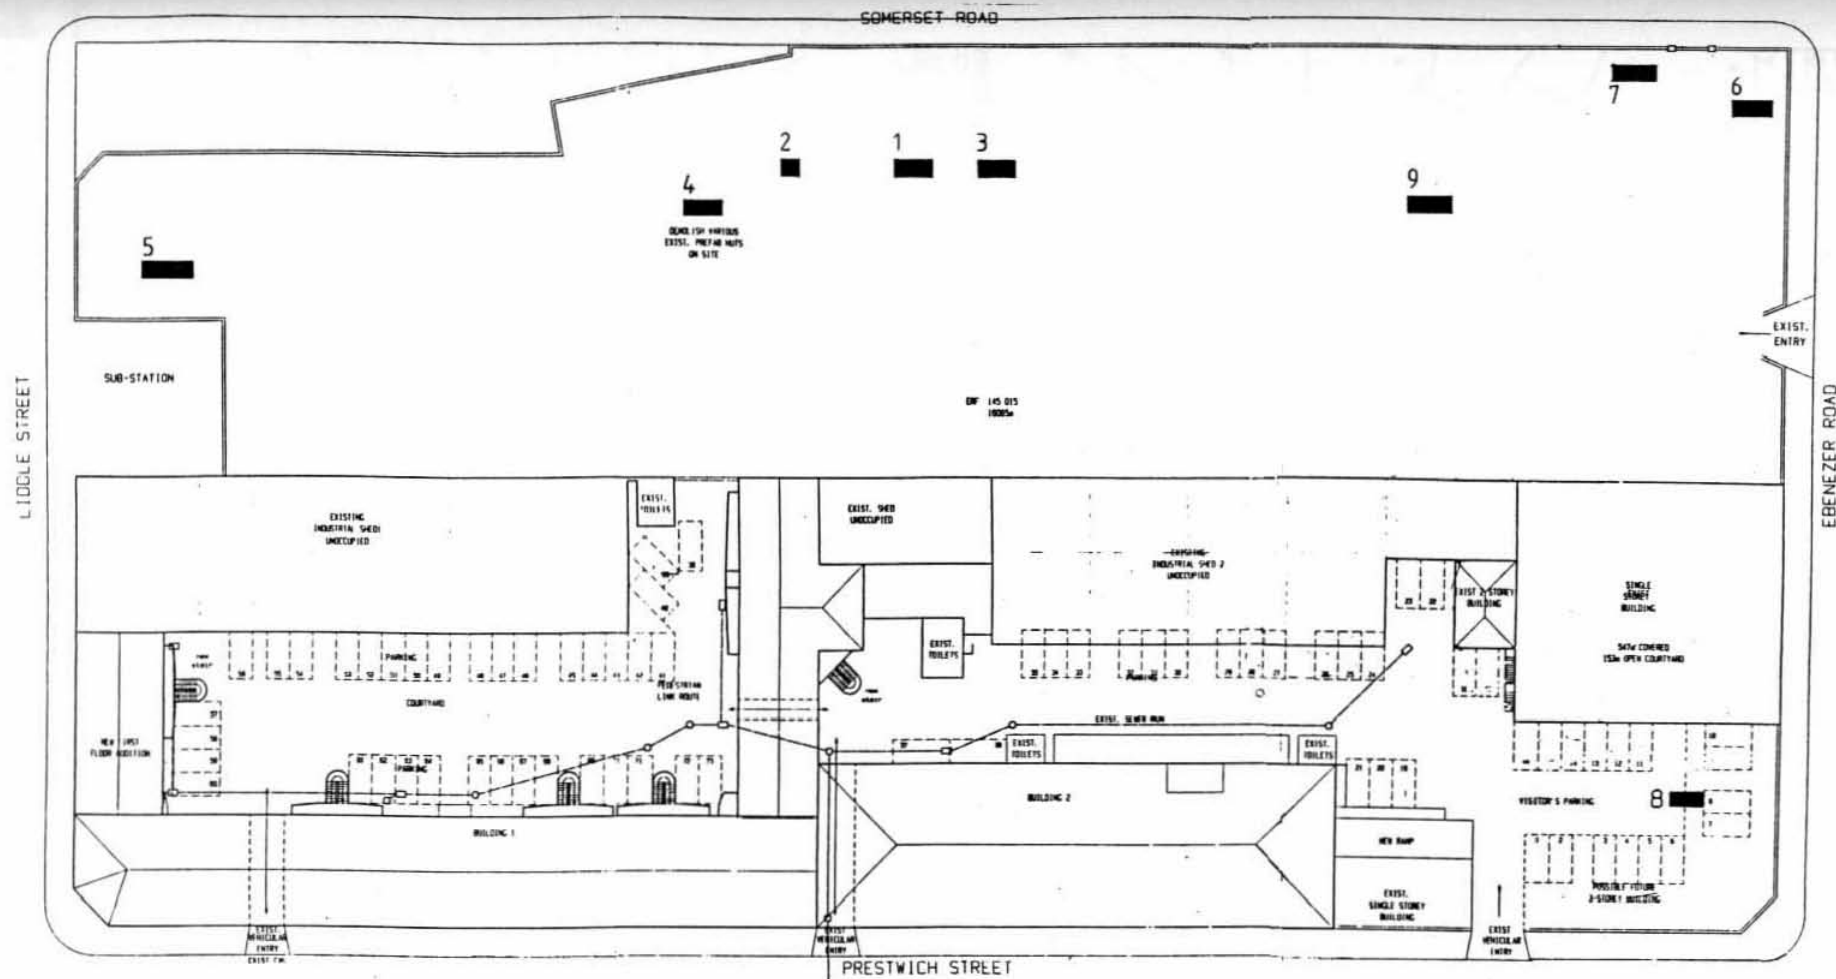
A total of 8 test excavations were located in this area and locations can be seen on Figure 10. Descriptions and general comments of the test holes follow below. The nature of, and a description of the deposits can be seen in the section drawings.

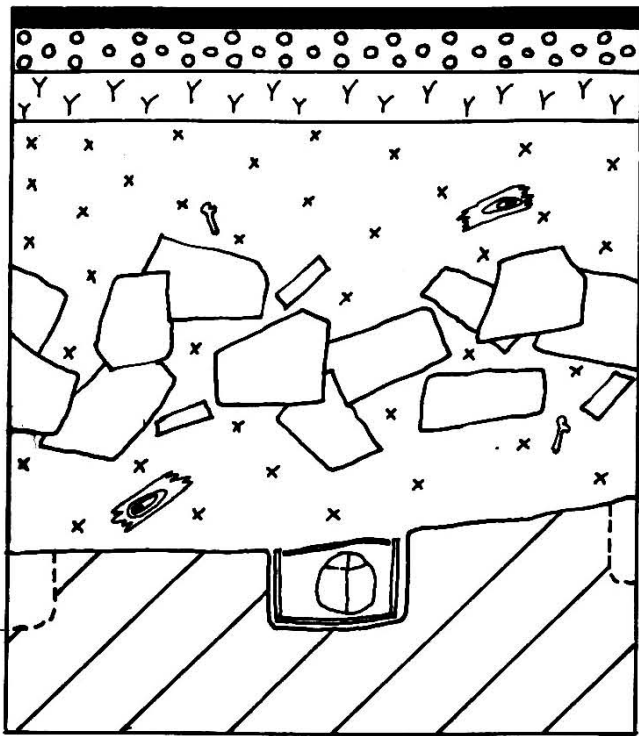
Section drawing - Figure 11a. The presence of a thick layer of rubble is noted at approximately 700mm below surface. This rubble includes many large shale blocks some obviously dressed. Bricks are also found and include a yellowish type with frog and impressed letters unfortunately illegible (as found in the gateposts of the Ebenezer cemetery) and a thin red type as used in the construction of a vault in hole 9. Many of the bricks and stones have traces of lime plaster adhering to them and have resulted from the demolition of some form of structure, probably vaults.

Undisturbed substrate is encountered at approximately 1400mm below surface. This consists of compacted clay with ferruginous inclusions. Clear outlines of three graves could be identified as cutting into this surface. All deposit above this layer has obviously been disturbed by a process other than normal burial practises. No evidence of burial shafts could be found in section. The depth of the grave bases suggests that original ground surface would have been somewhere in the region of present levels and perhaps slightly higher.

Although three graves were recognised, only one was opened to check for the presence of human remains. The orientation of the test holes meant that only portions of graves were exposed, in this instance the upper part. The remains of a coffin were clearly visible and human remains were present. These were left in place. While this body was intact, portions of another body were found lying above. These remains were disturbed and only portions of a lower leg and foot were preserved. Whereas the lower burial had the head towards Signal Hill the upper appears to have been lying in the opposite direction.

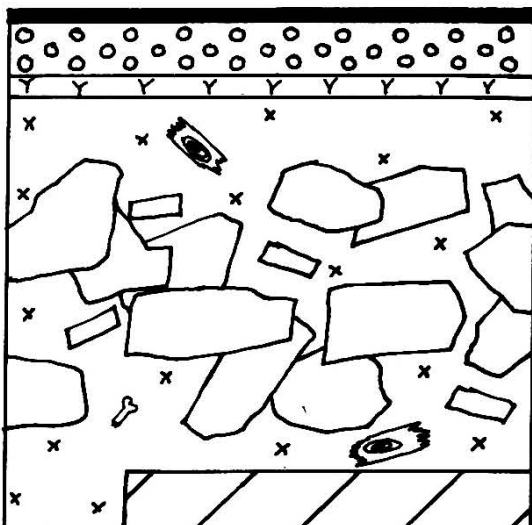
b

Section drawing - Figure 11b. At approximately 400mm below surface a rubble layer was again encountered. This consists of similar material to that in hole 1. Substrate is encountered at approximately 1300mm and a single grave is recognised cutting into this. Again the impression is of severe disturbance of the upper sequence with only the substrate and a small amount of material above left undisturbed. Again, no grave shafts visible in section. The single grave uncovered has the remains of a child present. Only the lower legs are exposed. The grave appears large for the internment of a child.

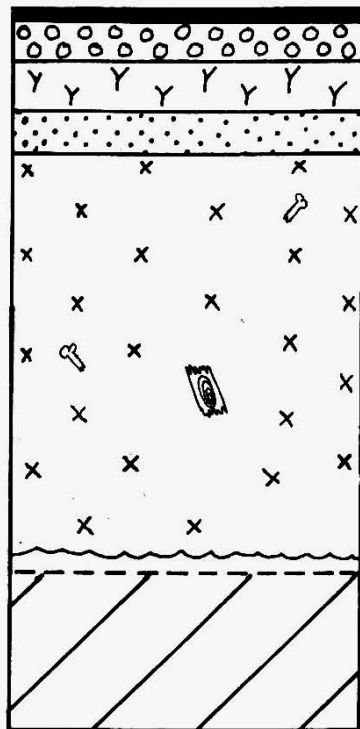
Section drawing - Figure 12a. No rubble was detected in this hole. No substrate was detected and excavation was stopped at a depth of 1710mm as water was encountered. All deposits resembled the upper deposits of holes 1 and 2 and suggested disturbance.

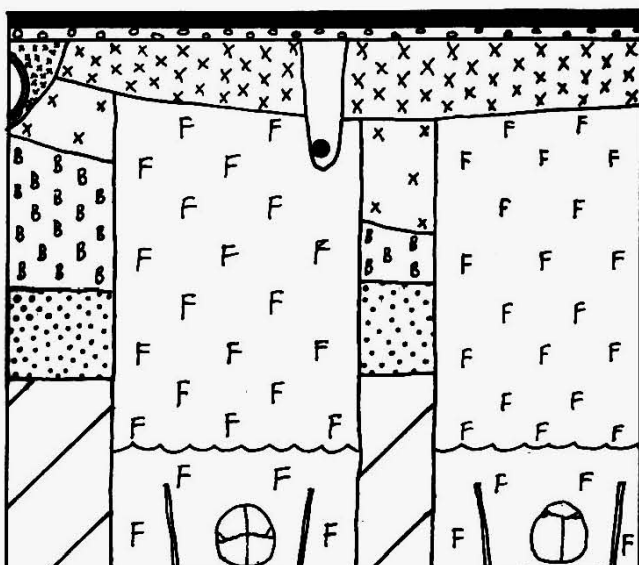
b

Section drawing - Figure 12b. This was perhaps the most useful hole in terms of determination of original deposits and original ground level. No rubble was observed and the traces of grave shafts could be clearly discerned in the sections. The traces of three graves could be identified cutting into the substrate at approximately 1300mm below surface. In situ deposits are found close to the surface with reworked fill being found in the grave shafts. The in situ material consists of a layer of light coloured sands overlying a dark brown clayey soil with ferruginous inclusions (the same sequence of deposit has been seen at a burial ground in Cobern Road). The bases of the graves are cut into the hard ferruginous substrate and water is present in the graves though not above. Human remains were detected in one of the graves and notwithstanding the water logging are in extremely good state of preservation. Traces of coffin wood are also detected. Burials have been left in place. A photograph (Plate 8) clearly shows the grave shaft and in situ deposit.

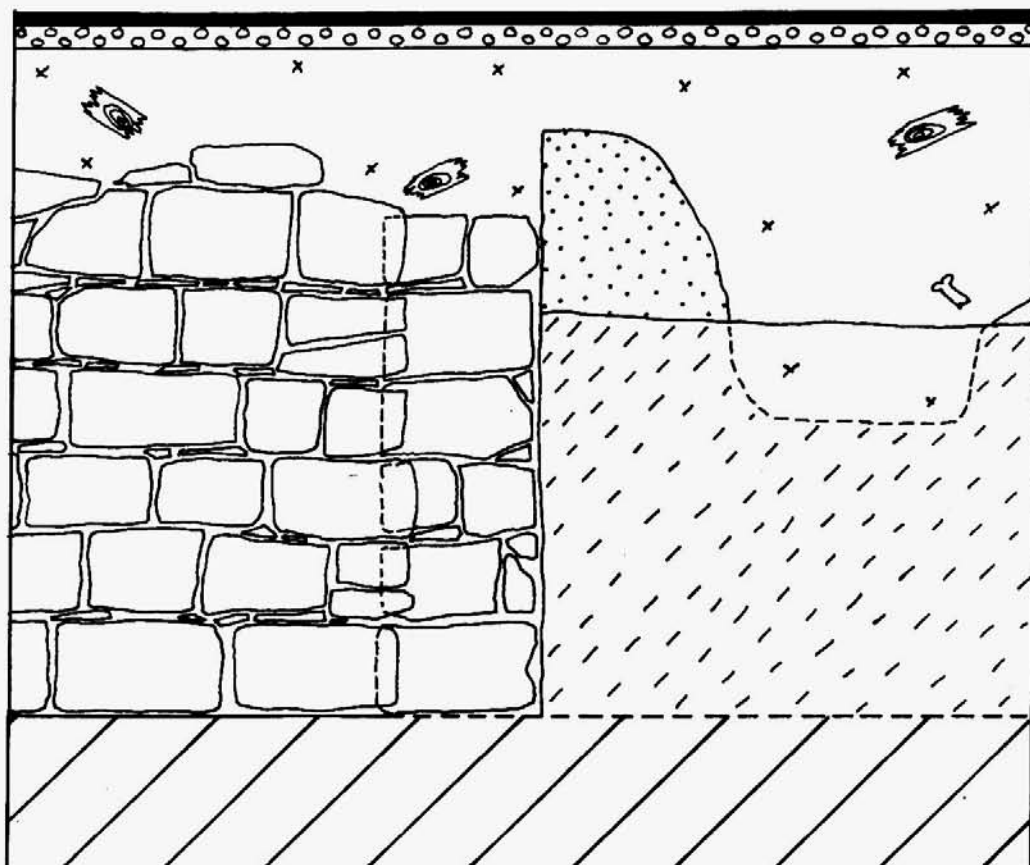
Section drawing - Figure 13. The original hole required extension as a result of finding some intact stone "walling" as well as the base of a grave shaft adjacent to this. The nature of the construction of the walling, having a very neat dressed face to the inside while the rear of the wall is rough, suggests a structure that is built against the sides of a hole. As our observations clearly show some in situ deposits on the west side, it is clear that this structure was at least in part below ground. The conclusion must follow that this is part of a burial vault. Only a part of this structure has been uncovered and further features will undoubtedly be revealed with further excavation. The portions that are visible show that the roof has been broken away. We must assume this to have had a vaulted roof probably constructed of brick. Both dressed stone and two types of yellow brick are found in the fill of what would have been the inside of the vault. Some of the yellow bricks have the letters "BTI" impressed into the frog. Photographs show the west section (Plate 9) and the stone walling (Plate 10).

No human remains were found. Fills were found lying on substrate at a depth of some 2000mm below surface. Substrate at this point consists of decomposing Malmsbury Shales with the overlying ferruginous gravels have been removed. These are still found in situ alongside. The stone walls have no foundations but are built directly on the substrate.

The base of a single grave is found alongside the vault, its base cut into the ferruginous substrate at approximately 1030mm. No human remains are present. The grave base is filled with a mix of soil and red brick suggesting that human remains were removed prior to the fill being introduced (Plate 11).
