# Report of Phase 1 Archaeological Impact Assessments

## Proposed Borrow Pits for Roads in the Still Bay and Vermaaklikheid environs, Hessequa Municipality, Western Cape Province

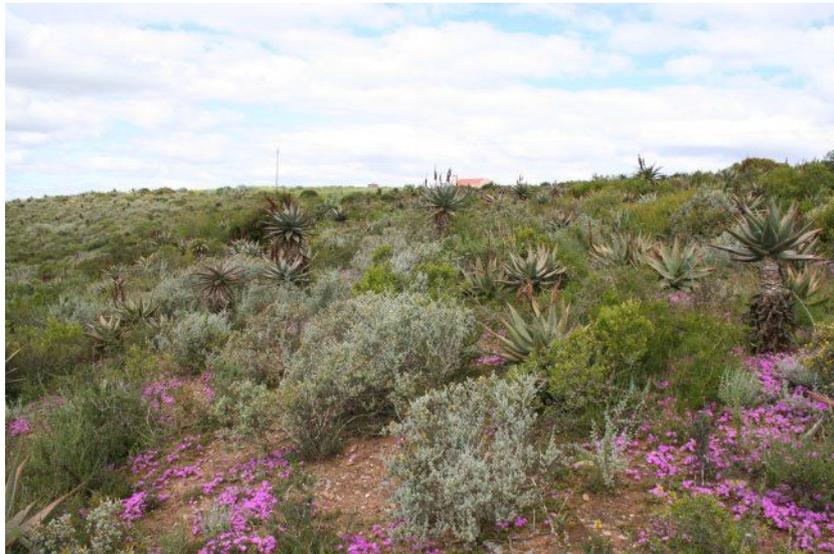
There is an existing quarry within the study area that is a few hundred metres in extent (refer to Figure 16 appended). As a consequence, there is extensive and intensive damage in this area. Natural vegetation occurs in the mostly undisturbed areas surrounding the quarry that will serve as much of the focus for extending the extraction of rock (refer to Figure 1). A lot of naturally occurring quartz lies around in the quarry as well as on the surrounding surface.

Rock in the quarry appears to be from the Bokkeveld Formation and, so there is a distinct possibility of non-vertebrate fossils for which the formation is well known at some localities.

Figure 1: BP01 showing the area with natural vegetation that is proposed as an extension to an existing quarry

This study leaves any steps with regard to the possible presence of invertebrate fossils to the decision of HWC, as the matter falls outside of our area of expertise.

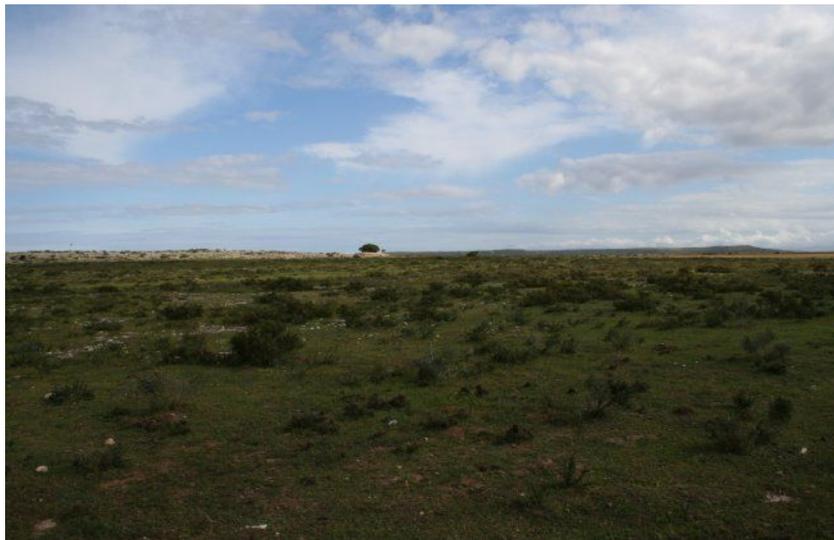
The study area is essentially flat with a low but distinct ridge nearby to the east (housing the eponymous trigonometric beacon) (refer to Figure 2 and Figure 16 appended). There is some likelihood that farmers may have ploughed this area at some point in the past, as presently it is covered by low grass and leafy vegetation (grazing?) and sparsely scattered bushes. Visibility in the study area is quite good.

There is an ubiquitous scatter of tabular calcrete chunks and slabs over surface and here and there there are concentrations of quartzite cobbles (cobbles are larger in size and more common in adjacent ploughed field to the west). Geomorphological context of the study area thus is ancient river terrace.

*Figure 2: View of study area for BP02*

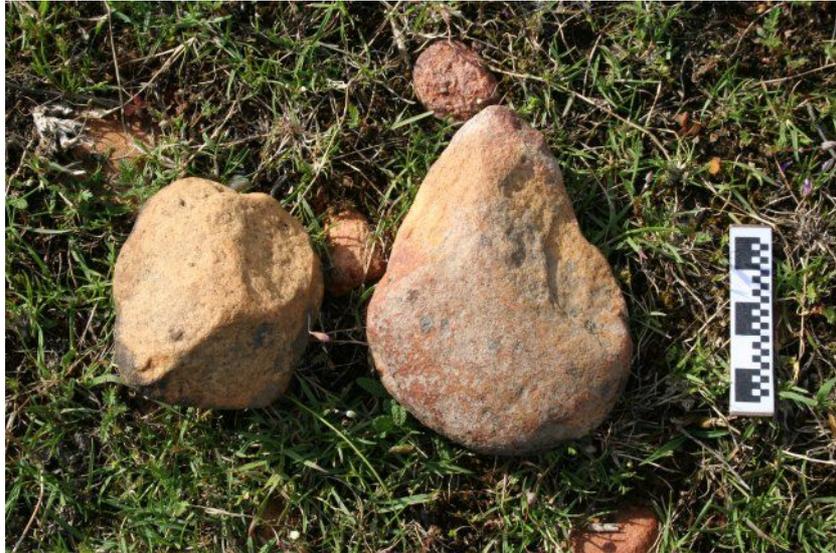
Very dispersed stone tools occur throughout the study area, usually in association with river cobbles. Observation 01 (refer to Figure 16 and Table 12 appended) is what passes for a "concentration" in this locality where a handful of artefacts lie dispersed over 30 to 40 m<sup>2</sup>. The best specimen seen comprised a rather lack lustre core and a chopper-like tool (refer to Figure 3).

Figure 3: Stone tools from BP02 – the item on left is a core, that on the right is a crude chooper made on a cobble.

Materials present in the BP02 study area fall into the Early Stone Age sub-stage of early human history and broadly date from 1 million to 300,000 years ago.

This report recommends no mitigation with regard to the occurrence of stone artefacts, as there would be few appreciable gains from such measures. HWC should inform the developer whether a permit for destruction of the stone tools is required.

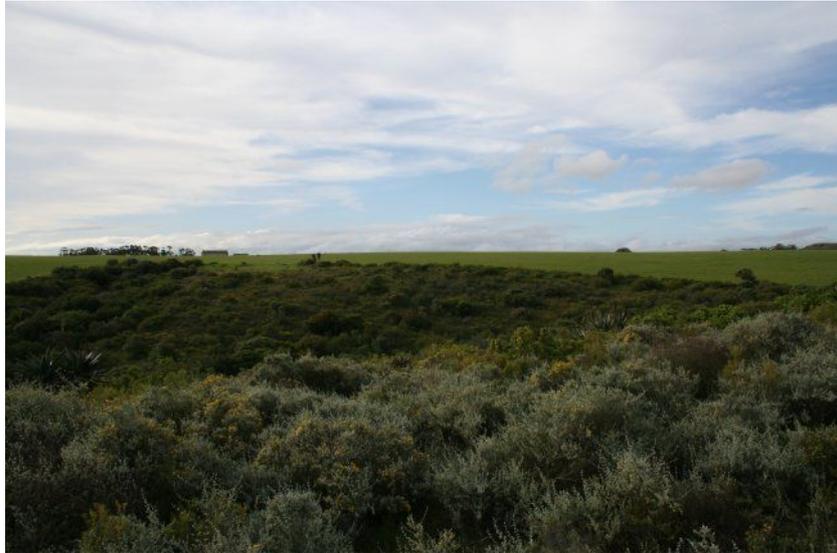
This study area straddles the head of a kloof leading down to the Uilenkraal River and mostly is undisturbed with the exception of the areas next to the adjacent ploughed fields (refer to Figure 4 and Figure 16 appended). Vegetation is quite thick, with both grass and bushes and visibility medium to poor. On the upper slopes of the valley a regular occurrence of open patches of soil facilitate the survey. Vegetation is substantially thicker in the valley bottoms and is thicker on the northern slope than on the southern.

*Figure 4: proposed BP03 area, from the southern side of valley across to the northern*

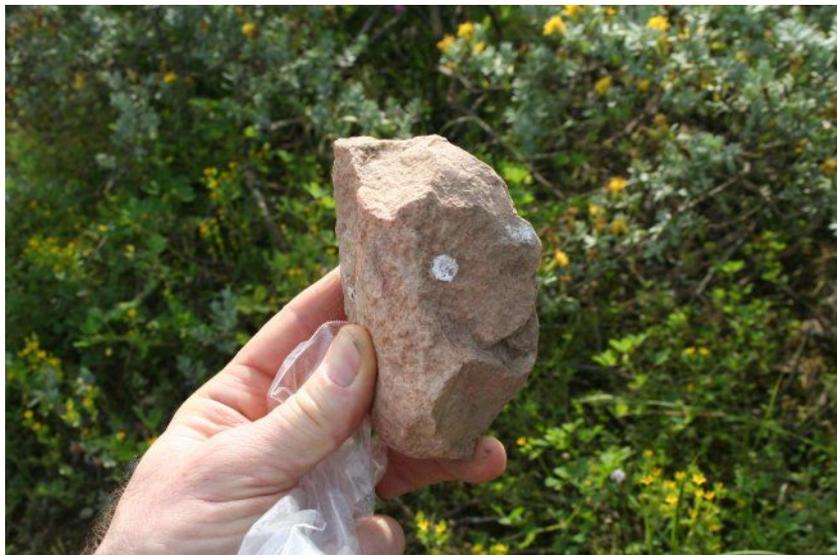
Observation 02 - quartzite core (refer to Figure 5)

*Figure 5: core made on quartzite, Observation 02*

This report recommends no mitigation with regard to the occurrence of stone artefacts, as there would be few appreciable gains from such measures. HWC should inform the developer whether a permit for destruction of the stone tools is required.

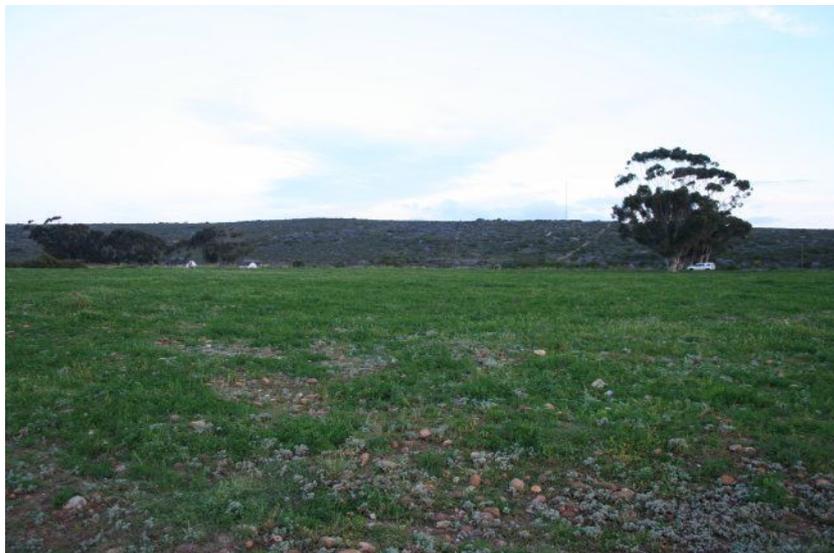
The study area consists of an extremely flat ancient river terrace that farmers have ploughed. This terrace is packed with cobbles varying in size from a few centimetres to a few tens of centimetres (30 cm or so being the outside) (refer to Figure 6 and Figure 17 appended). Given the situation, much plough damage can be expected on the cobbles at the very least.

*Figure 6: BP05 view of proposed site*

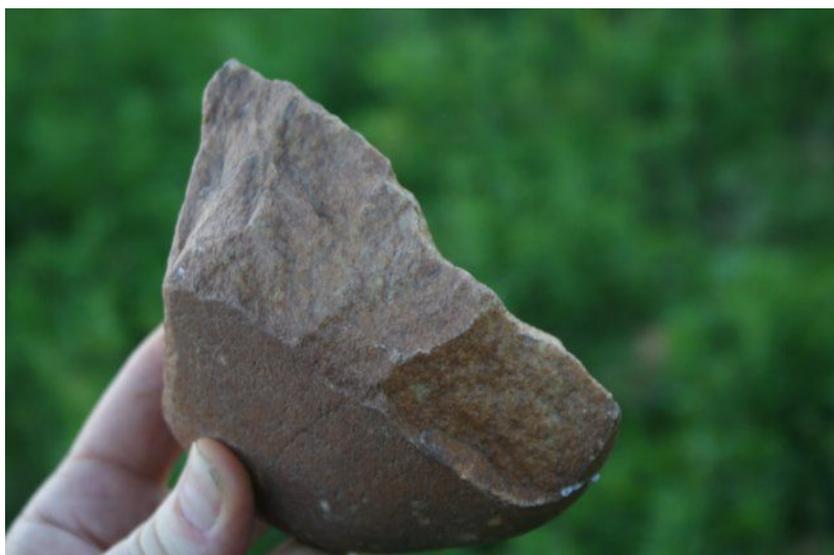
Observation 10 - quartzite core on a cobble (refer to Figure 7)

*Figure 7: clear core produced on a quartzite cobble*

The collection of stone tools within the BP05 study area are not mitigatable. A number of large cobble (and tool) piles lie along the periphery of the field enclosing the study area (refer to Figure 9). These are the results of clearing stone from the ploughed areas and must in part come from the study area field. The tools evident on the ground thus are a residue of the clearance operation and consequently are a distorted representation of the original assemblage composition. Short of collecting all tools from every plough pile and every artefact from each field that could have contributed to the plough piles, there is no way of reconstituting the original assemblage composition.

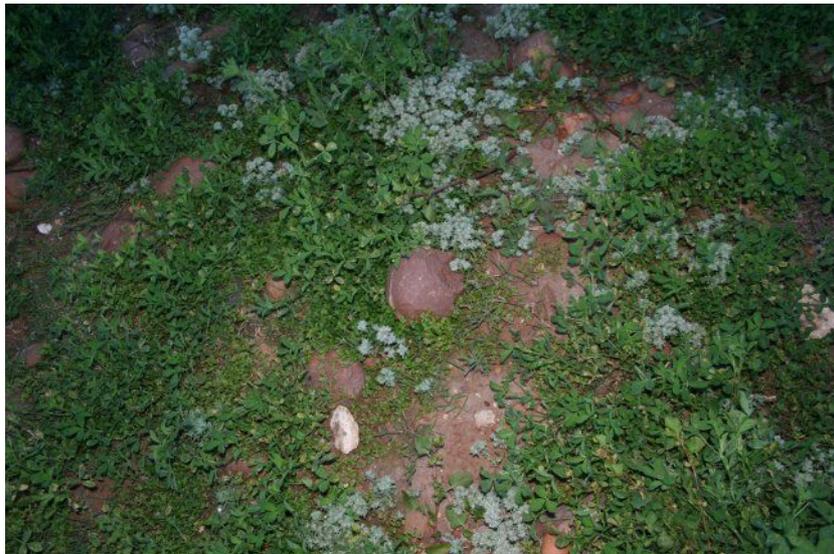
Observation 13 - scatter of cobbles with cobble core in centre (refer to Figure 8)

Figure 8: core on a cobble lying amongst unflaked cobbles

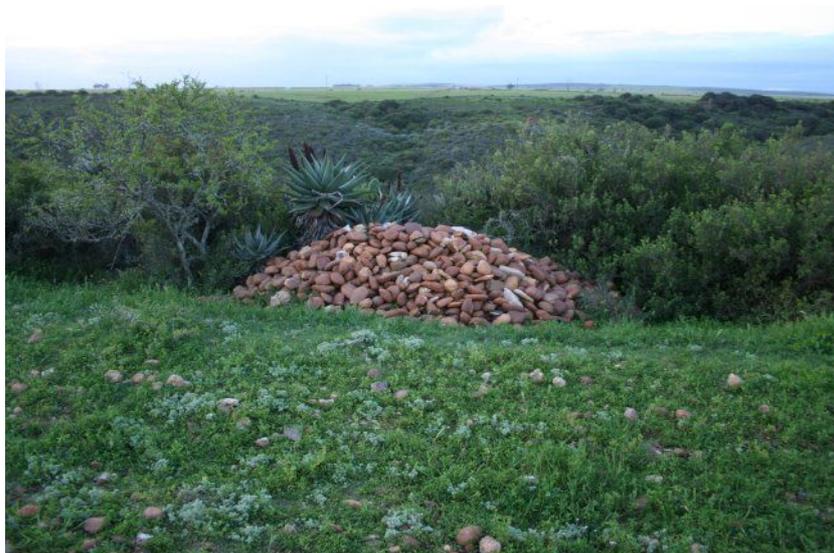
Figure 9: pile of cobbles and some tools collected by farm staff from ploughed fields such as that in the study area

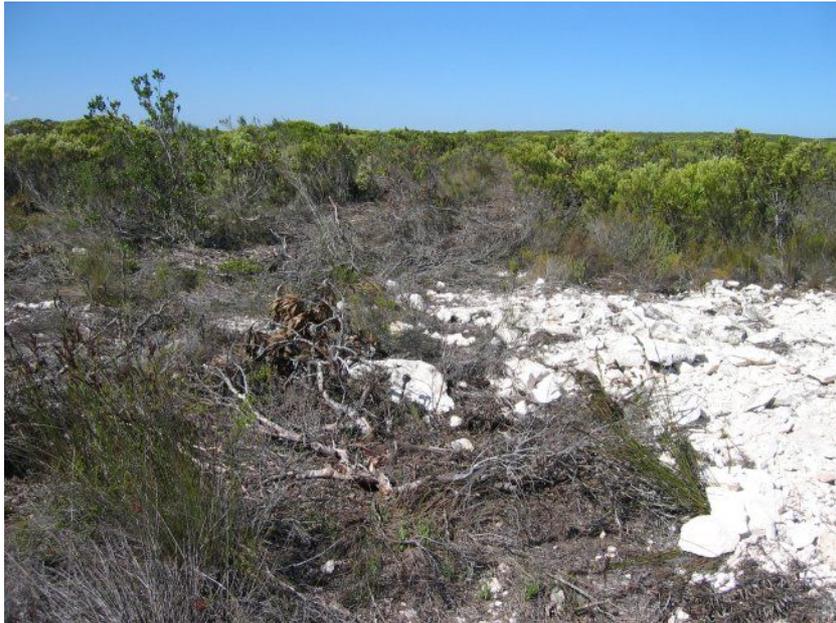
*Figure 10: BP06 view of filled rial hole and dense surrounding vegetation*

Prior to work commencing on the quarry, the developer should appoint a professional archaeologist to clear the two possible caverns of vegetation and remove the organic and recent infilling until the nature of the occurrence becomes clear enough to allow further recommendations regarding the mitigation required, if any. There is no need here for formal and time consuming excavation procedures as the work should cease upon demonstration of a fossiliferous content. Careful application of a spade will suffice.

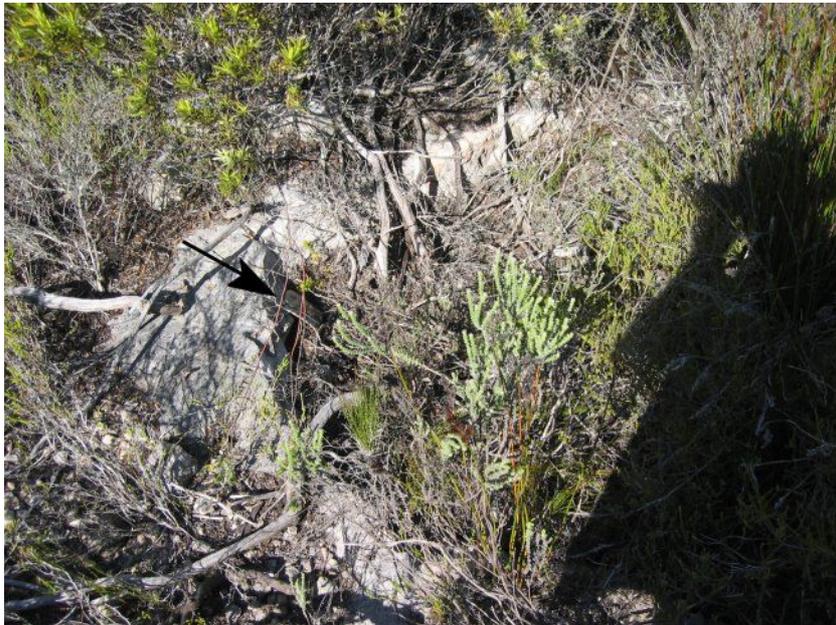
Observation 152 - another low cliff like concave feature penetrating the calcrete surface that could be the infilled remains of a cavern mouth.

*Figure 11: vegetation choked infilled hole within the calcretes – note low concave vertical face behind GPS (marked)*

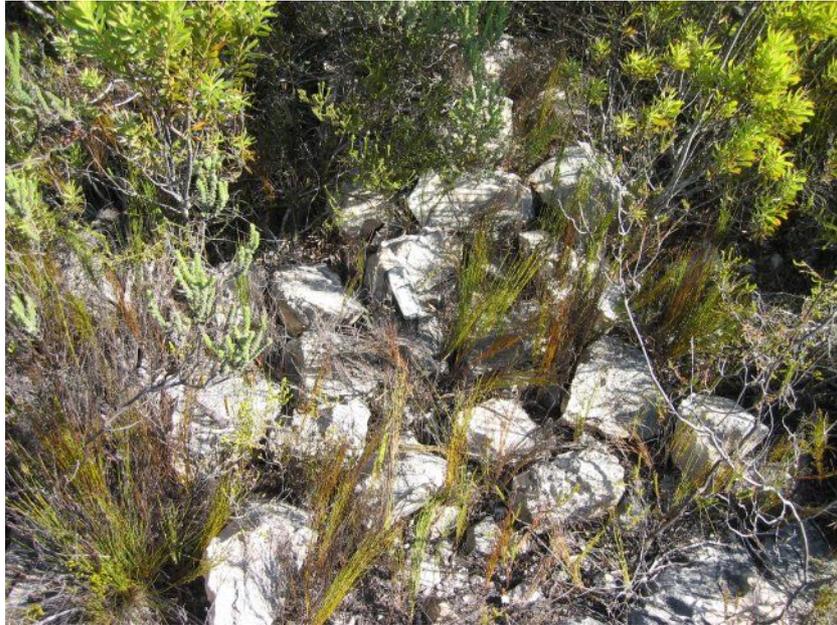
Observation 144 - area with loosely packed blocks of calcrete, which do not look natural. Do they represent rubble from an informal quarry; or are they the remnants of walling, and if so, of what era? Thick bush occurs in the area and not possible to tell at this point. (refer to Figure 12)

Figure 12.: pile of calcrete blocks – possible walling or informal quarry detritus

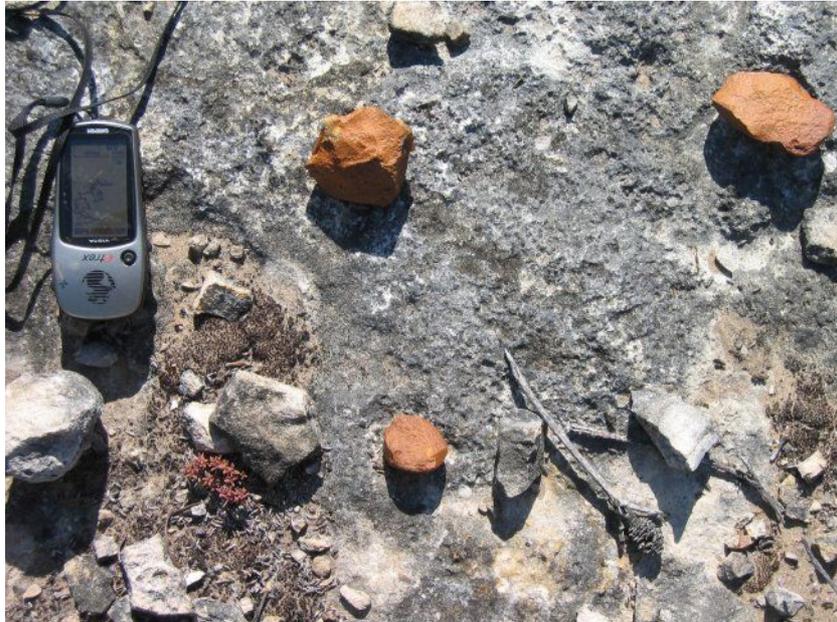
Figure 13: quartzite stone tools lying on calcrete surface. Item at top left is a Levallois or prepared core.

The collection of stone tools within the BP06 study area are not mitigatable, as they are too dispersed, the numbers too small and the condition of the tools too poor to warrant the time and expense.

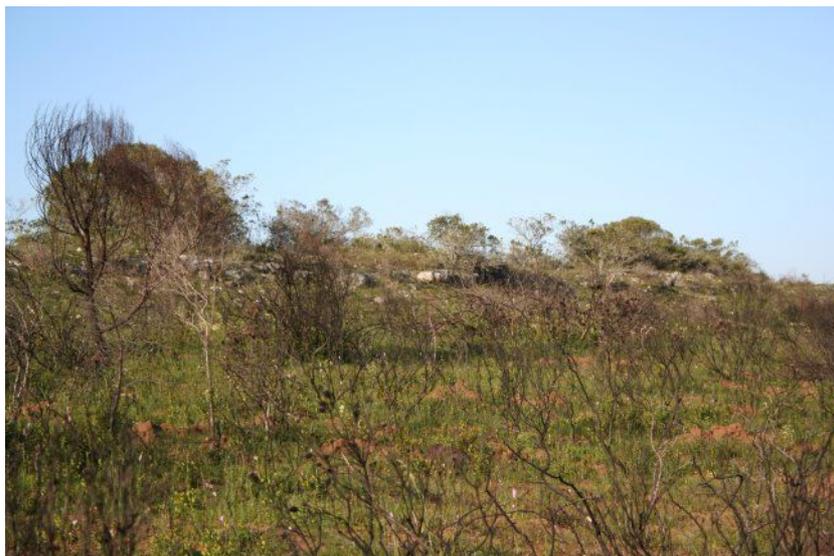
Calcrete forms a distinct elongated mound running SSE to NNW across the study area, with an elevation of around 3 m above the surrounds (refer to Figure 14). On the southern side of the mound there is an abrupt scarp-like fall off from the top whilst on the northern side there is an even, featureless slope.

The top of the mound is relatively flat and very even and in those terms, quite suitable for human occupation. Visibility is good here. The mound however, is not a local high point, as there is higher ground at some distance to the north and at about 200 to 300 m distant on the south side there is a low hilltop.

*Figure 14: BP08 with calcrete ridge*

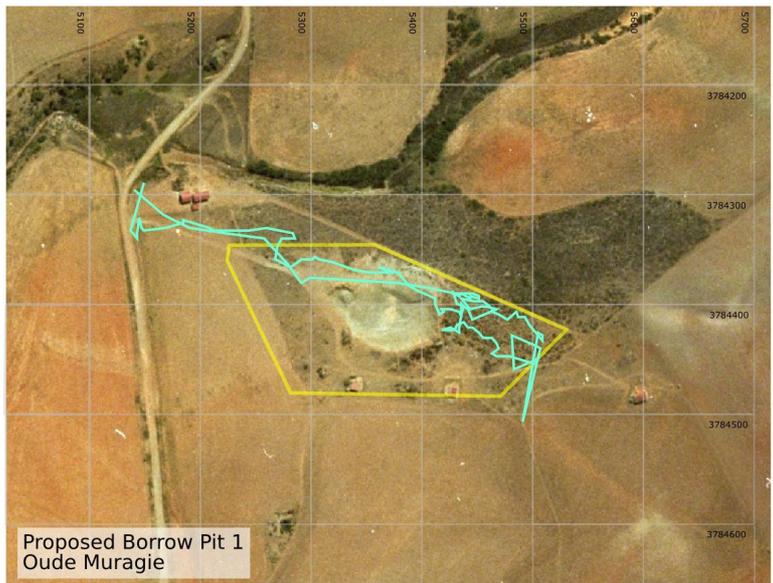
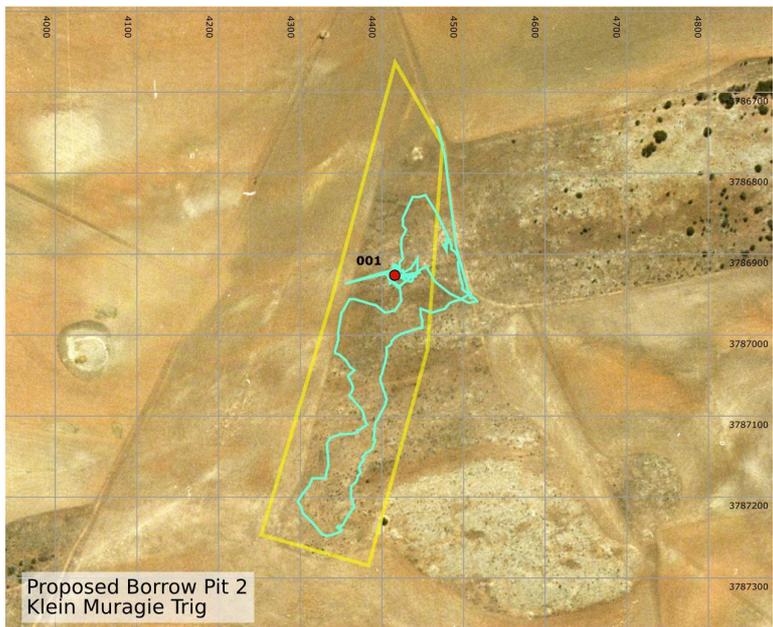
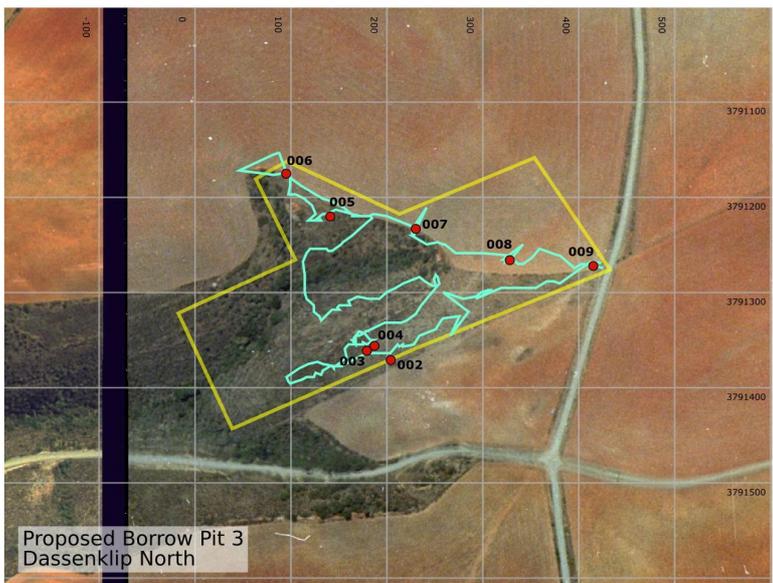
Figure 16: approximate boundaries (yellow), walkpaths (light blue) and observations (red circles) within study areas BP1,2 and 3. Grid intervals = 100 metres

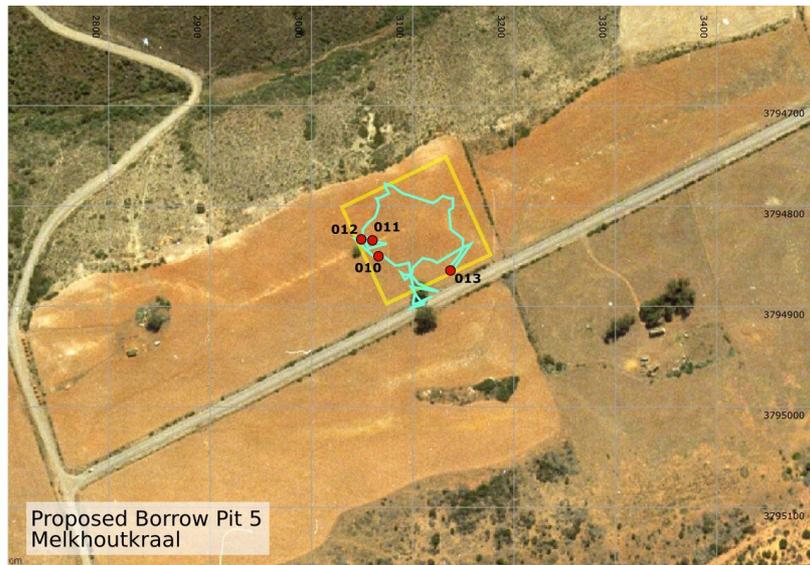
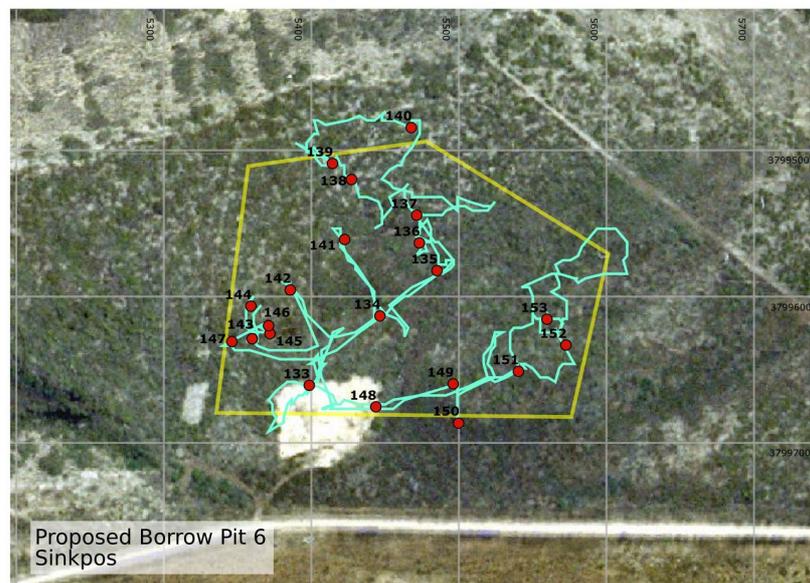
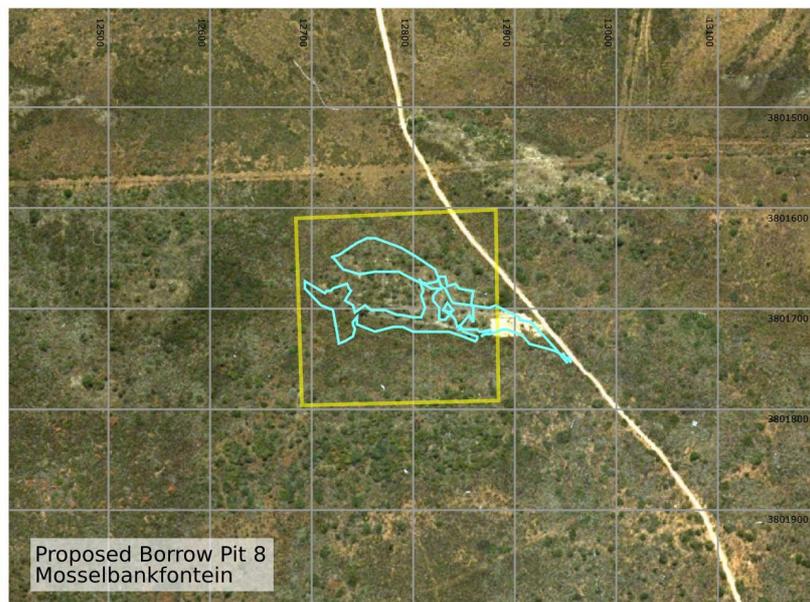
Figure 17: approximate boundaries (yellow), walkpaths (light blue) and observations (red circles) within study areas BP5,6 and 8. Grid intervals = 100 metres
