# A COMMENTARY ON THE VERNACULAR BARN SITUATED AT WILDE PAARDE KLOOF (FARM 31) ROBERTSON DISTRICT

**Mathew Cooke** on behalf of his client, Mrs A. Frater

January 2003

## **Archaeology Contracts Office**

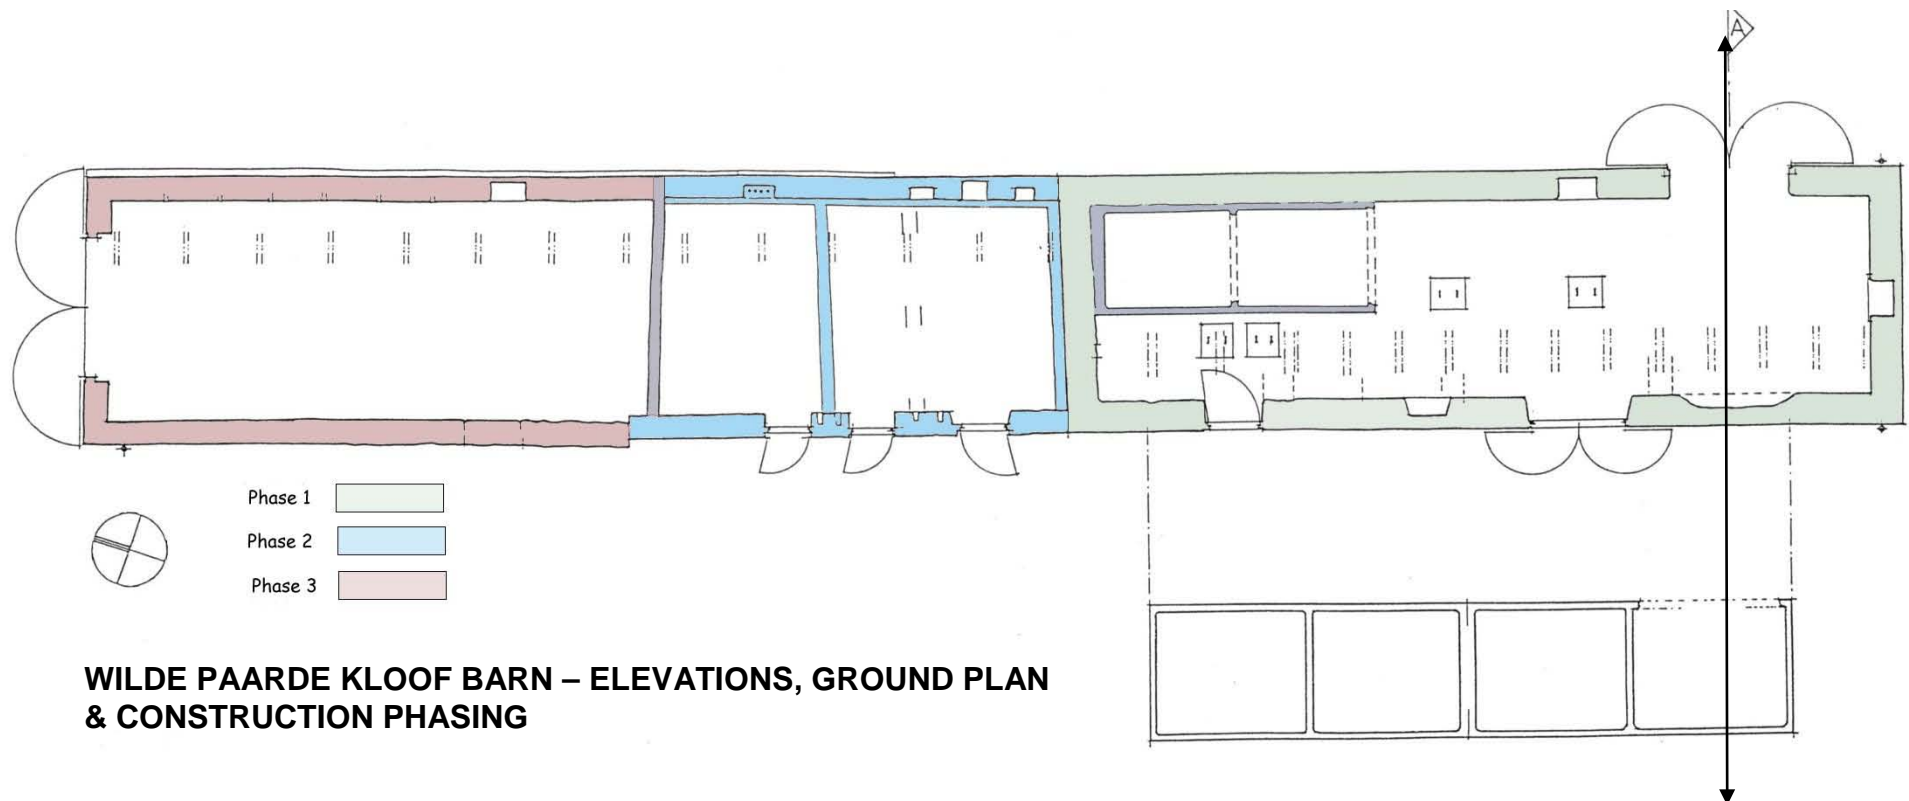
WILDE PAARDE KLOOF BARN – PHASE 1

This is the only part of the Barn with a pitched roof, end gables and *solder*. It is currently roofed with corrugated iron although the pitch angle is designed for thatch. Inspection of the *solder* showed that the early joinery (poles, rough-cut beams fixed with wooden dowels) is largely in place and very well preserved. The corrugated iron roof is attached by means of a supporting framework of more recent joinery. The broad ceiling boards are early (late 18<sup>th</sup>- early 19<sup>th</sup> century) and in very good condition. There is an attic door in the end gable. The walls are made of homemade bricks, floors on ground level are concrete, below surface area having been excavated out for installation of 4 underground concrete wine tanks (since flooded with ground water). Windows appear to have been casements but are currently bricked up. Early lintels have survived in two-window openings that are visible. An internal staircase on the south end provided access to the *solder*. Three walls/partitions have been demolished inside the Barn, converting it from a 3 or 4 roomed structure into a single space.

Uses: Phase1 of the Barn clearly started its life as a mixed dwelling and work place and probably remained so into the mid-late 19<sup>th</sup> century (internal partitions, Victorian wall paper). The northern portion was partitioned off from early on to accommodate (what was in all likelihood) a Blacksmiths forge. The forge area originally consisted of a space without ceiling that was open to roof height. A large hearth and chimney was built against the north end-gable. Although little of the physical fabric of the forge has survived, wall and beam blackening and the scars where fabric and joinery has been removed are visible and easily interpretable. The forge area had separate access from the interior. We know that at some time in the 20<sup>th</sup> century 6 concrete wine tanks were installed (4 below ground, 2 above ground). This involved demolition of interior partitions to create a single large space used as a wine cellar. Today the above ground tanks are partially demolished while the below surface tanks have been flooded with groundwater.

1. Demolished interior wall separating blacksmith from dwelling area
2. Demolished interior wall in dwelling area
- 4-7. Underfloor wine tanks (openings)
8. Wall cupboard (muurkas)
9. Location of demolished staircase
10. Location of demolished hearth and chimney

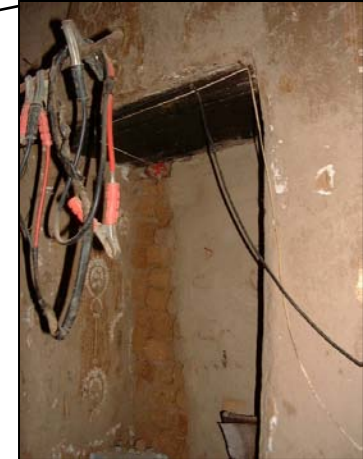
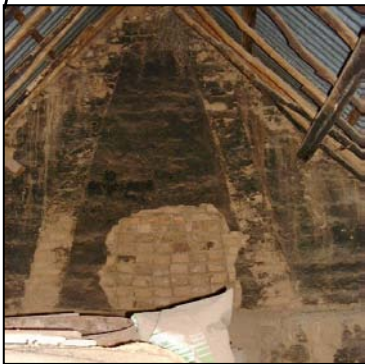
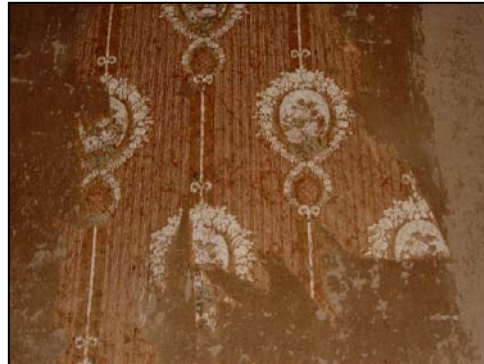
Early openings  
Recent openings

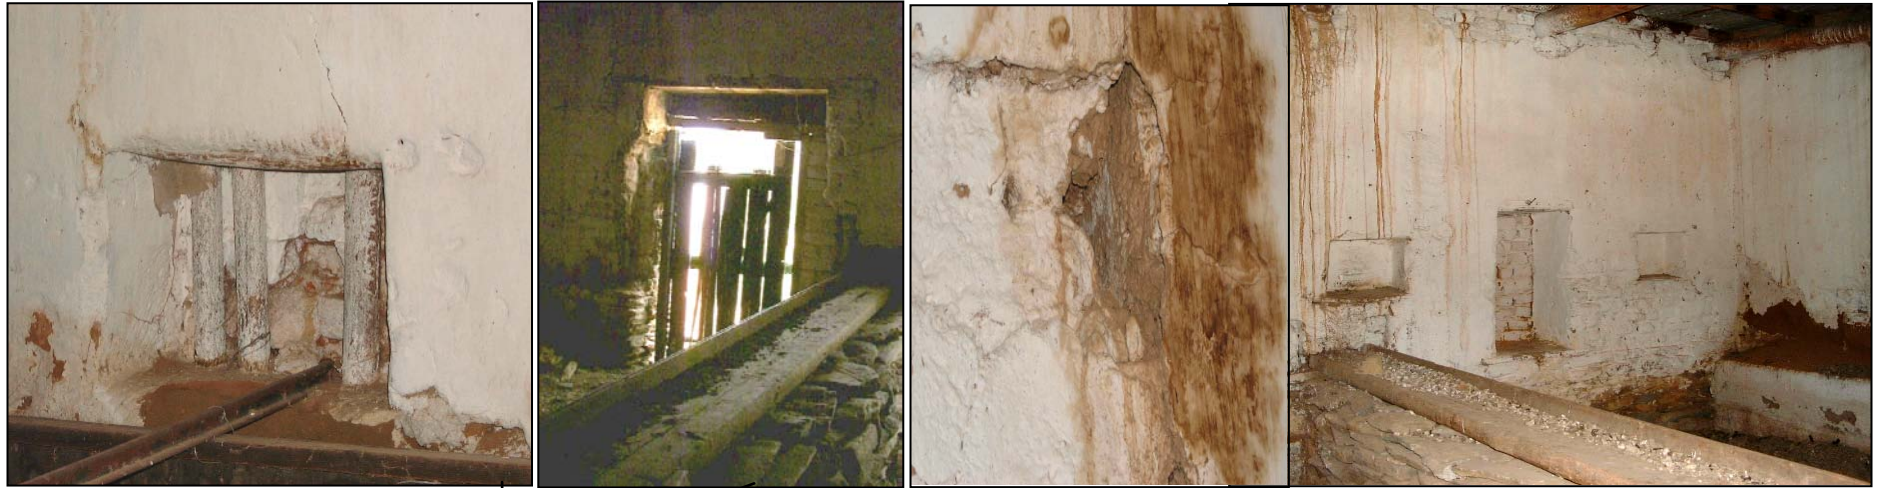
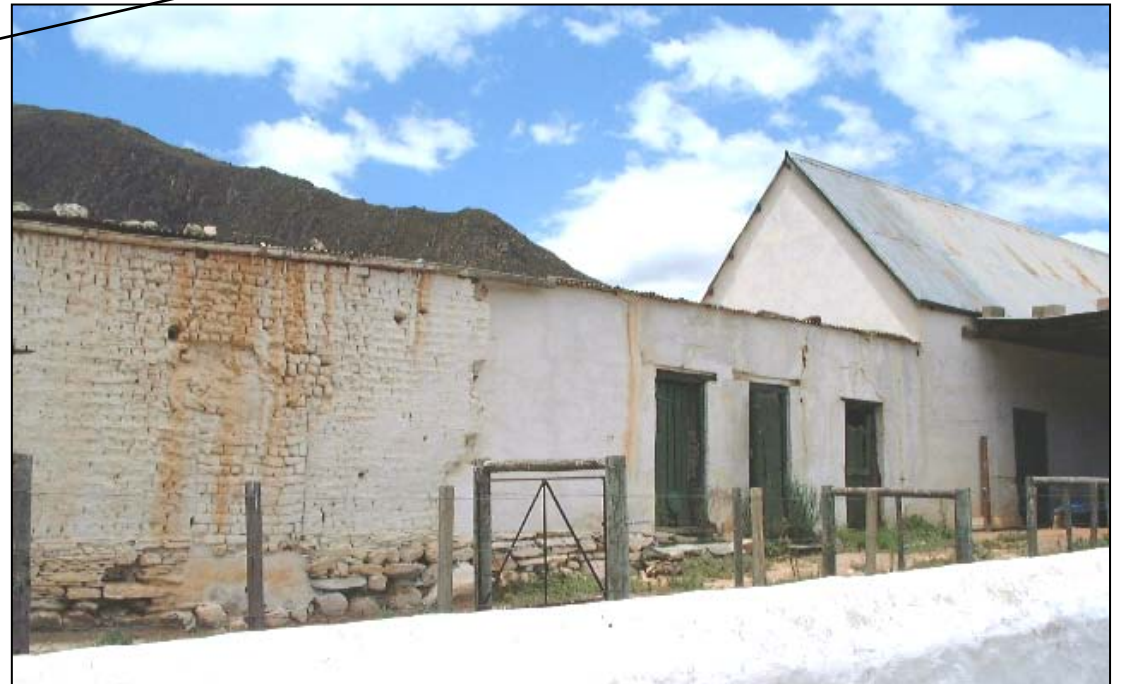
**WILDE PAARDE KLOOF BARN – PHASE 2**

Phase2 was added onto the northern end gable of Phase1. Its current appearance is more humble than Phase1 having a flat corrugated roof. Its uses have changed over time although it is unclear what these were. Originally this area may have had some form of pitched roof as there is evidence that the end-gable of the forge was crudely punctured to create a walk-through opening. Our interpretation of the changes that took place through time indicates that Phase2 may also have served as a humble dwelling. This is implied by the remains of a *stoep* (stone slabs) on the west side as well as some small barred windows visible from the interior east side. At least one interior wall has been demolished as is indicated by the lie of the plasterwork on the east wall interior. This wall would have created two small rooms, the southern most of which had a separate entrance, two small barred windows and a central *muurkas* (cupboard).

*Uses:* It is difficult to pin an absolute date on the date of construction of Phase2 apart the fact that it is built from homemade materials and in vernacular style (predating advent of standard bricks and other materials). An early 19<sup>th</sup> century date is a possibility. Originally this may have been a servants quarter appended onto phase1, but its most recent use appears to have been a cowshed.

- 1 Originally a room separated by a wall (since demolished)
- 2 Demolished wall replaced by low stone wall and feed trough
- 3 Low stone wall
- Early openings
- Recent openings

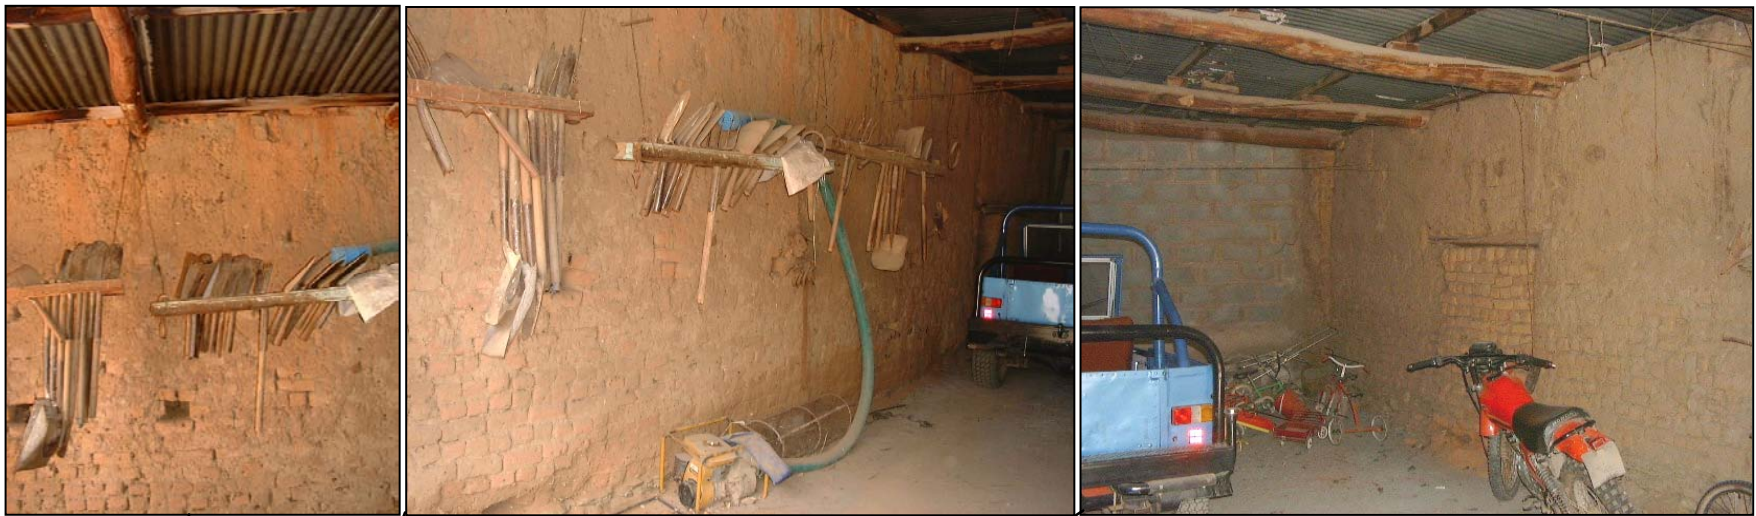
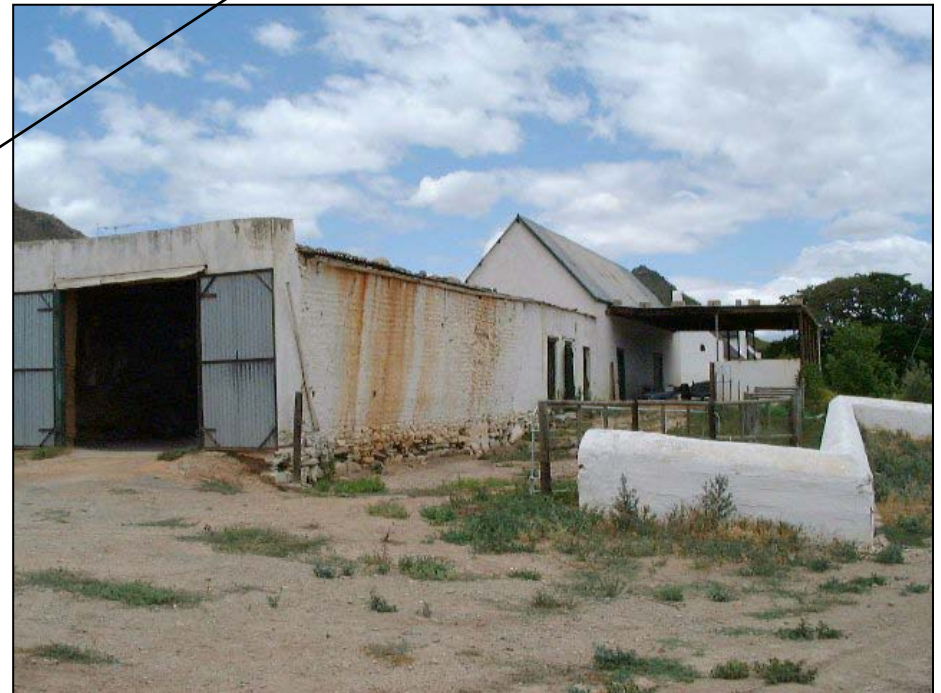
**WILDE PAARDE KLOOF – BARN PHASE 3**

Built as a wagon shed, Phase3 continues to serve as a garage. Beam slots are visible at the top of the un-plastered walls at the east side interior indicating that this building also had a pitched roof and possibly a *solder*. In recent years the tops of the walls, particularly on the west side, have been shaved down to accommodate a gently sloping corrugated iron roof. There are no signs of demolished partitions apart from the fact that the interior wall (separating Phase2) has been recently rebuilt with concrete blocks. There are two bricked up casement windows (each side) with wooden lintels. Beam slots at waist level near the entrance (east wall) indicate that a framework once stood here – possibly some horse operated agricultural device. The west wall is leaning outwards and will need to be buttressed.

*Uses:* Dating of Phase3 is difficult as bricks and materials are vernacular however a 19<sup>th</sup> century date is suggested. Furthermore, there is a possibility that Phase3 was once a separate building which was linked to Phase1 by the insertion of Phase2. The opening, which is wide enough to get a wagon/vehicle through, suggests that this structure was built to accommodate wagons or bring loads of goods in and out.

- 1 Original opening of wagon shed
- 2 Bricked up opening
- 3 Bricked up opening
- 4 Rear wall rebuilt with modern concrete blocks
- 5 Beam slots at roof level indicate that wall on west side was lowered to accommodate flat corrugated roof
- 5 Beam slots at waist level indicate frame work - possibly storage racks or machinery
