**PHASE 1 ARCHAEOLOGICAL ASSESSMENT OF
LAND-EN-ZEEZICHT (REMAINDER OF ERF 4070)
SOMERSET WEST, WESTERN CAPE**

April 2004

Archaeology Contracts Office
Department of Archaeology
University of Cape Town
Private Bag
Rondebosch
7701

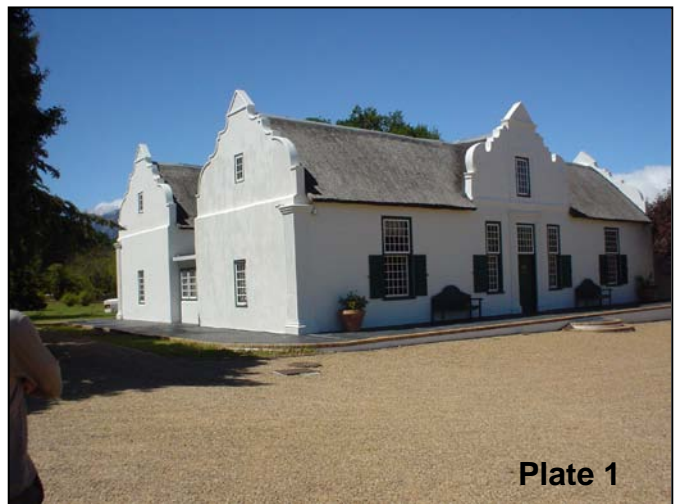
with an “H” shaped layout and neo-classical gables (Plate 1). The out-buildings consist of a winery (Plate 2) which has been converted into a cottage, as well as the groundsman’s residence. There is also a tennis court and swimming pool. The garden is planted with lawn and a variety of trees (Plate 3) many of them very recent; however several camphor trees allude to elements of an earlier landscape.

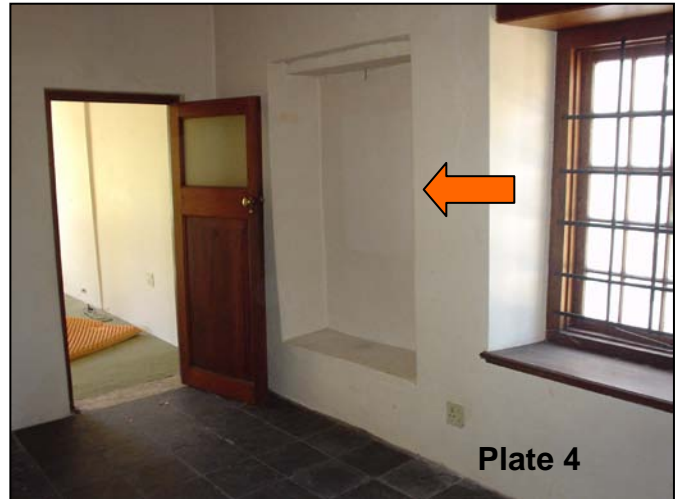
This vernacular structure which is situated next to the main house has been extensively altered by being converted to a cottage. The exterior walls of the building are fairly thick and probably contain early fabric. Virtually all the interior walls and divisions are contemporary as is most of the joinery and architraves. Vernacular style and joinery has been emulated during the recent alterations making the building sequence very difficult to “read”. Only one bricked up opening (perhaps a *muurkas*) was identified as being of 18th-19th century origin (Plate 4). There is evidence of a *stoep* around the exterior of the winery.

If changes are made to the standing structures, plaster will need to be removed and the structures analysed to determine how the buildings developed and how they changed over time. From this information good design informants can be generated to ensure that changes

- Although very little is visible on the surface, buried material may well exist on the property, especially within 50 m of the main house. Trial excavations must be conducted within this radius if construction or landscaping is to take place. Any material that is older than 100 years of age is protected by the National Heritage Resources Act. Period inspection of service trenches in other parts of the erf by an archaeologist must be included within the development plan.
- If any renovations are required in the historic structures, fabric analysis should be done to try and establish whether any proposed changes will impact original elements of the buildings.
