HERITAGE STUDY 7 and 9 DROSTDY STREET, STELLENBOSCH

ERF 6171

Heritage Study
7 and 9 DROSTDY STREET
STELLENBOSCH
PROPERTY OF: WOLFFSONG TRUST

May 2004

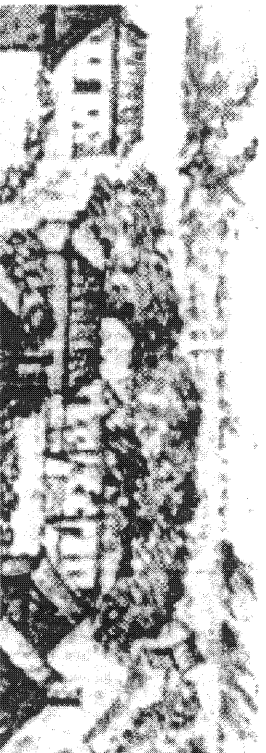
1710 Stade detail

Ryneveld Street runs across the page. Facing it on the left is Schroeder House. Next is the lane that became the extension of Church Street. Next to the right is the rear of a building on the other side of Ryneveld Street. The land opposite is vacant and has a fair amount of vegetation stretching up to the as-yet uncreated Drostdy Street. Next in line along Ryneveld Street is a building with a gable which is Morkel House. Last in line is oldest Colony House, then Dorp Street.

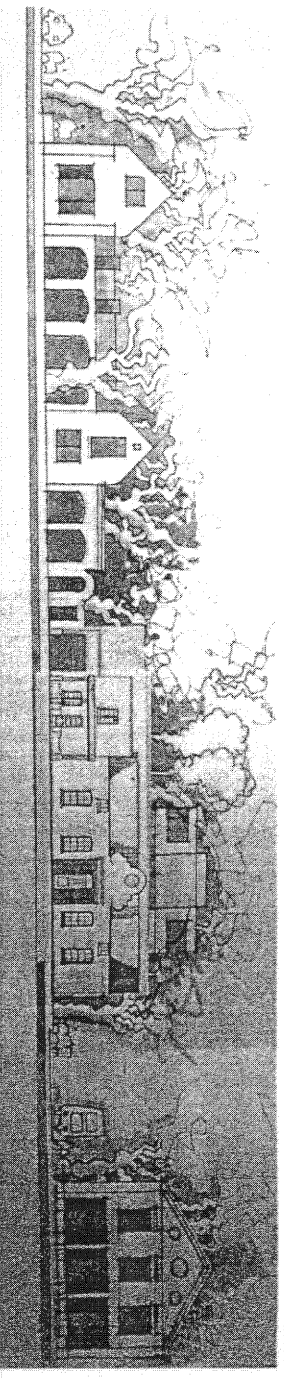
*Dorp St barn (Leeskamer) barn (No 5) barn (No 7) (No 9) Church St
Drawing by Hannes Meiring with façade of 7-9 Drostdy Street dropped in. The rhythm set up by the three surviving vertically-proportioned old barns, each with a long infill-building attached, is an important historical “memory” of 18th C Stellenbosch and is characteristic of the streetscape*

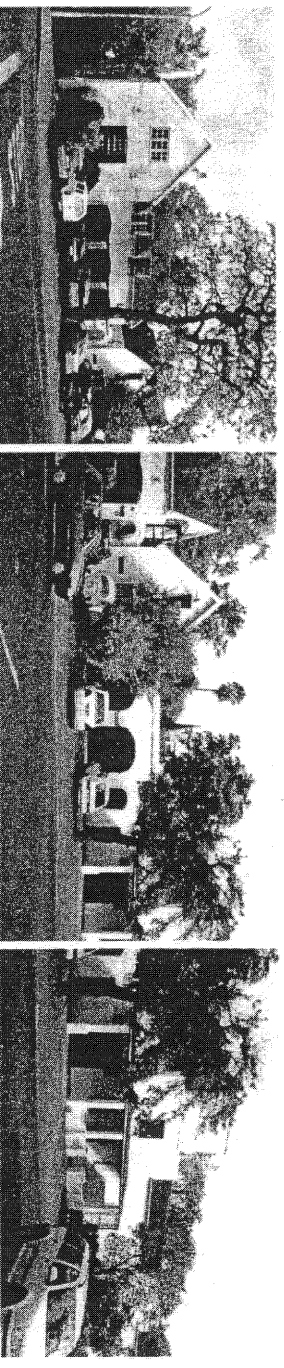
Photographs taken down the street emphasise that 7-9 is part of a characteristic pattern and a rhythm.

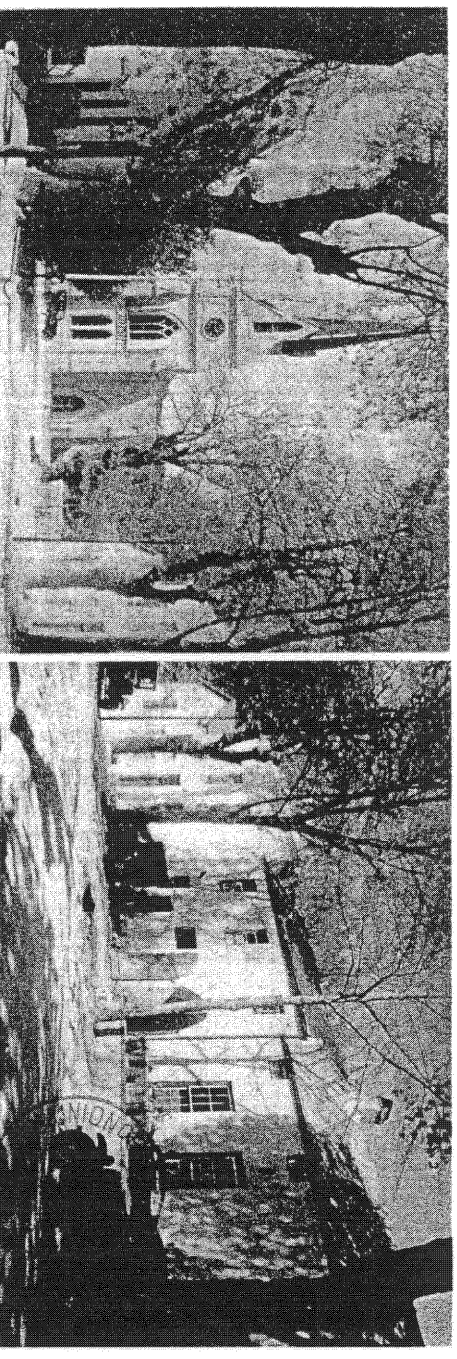
Arthur Elliott photographs of the 1920s. Left: looking up Church Street on the axis of the Moederkerk. The end gable of No 9 is seen between a hedged garden and part of Van Niekerk House on the right of the photo. Right photograph shows No 9 on extreme left. The townscape is characterised by slight irregularity – in the way roofs meet, the uneven facades, and the syncopated rhythms of attic windows. Courtesy Cape Archives E2175, E3028.

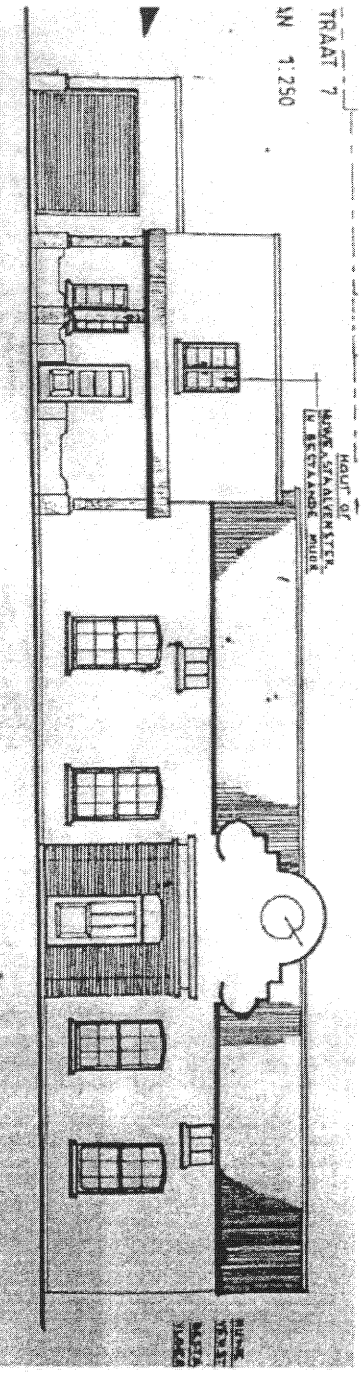
Architect's drawing 2000. Left is garage, then flat roofed no 7 (the verandah extends across the garage as well). Further right is No 9 with 1956 gable central.

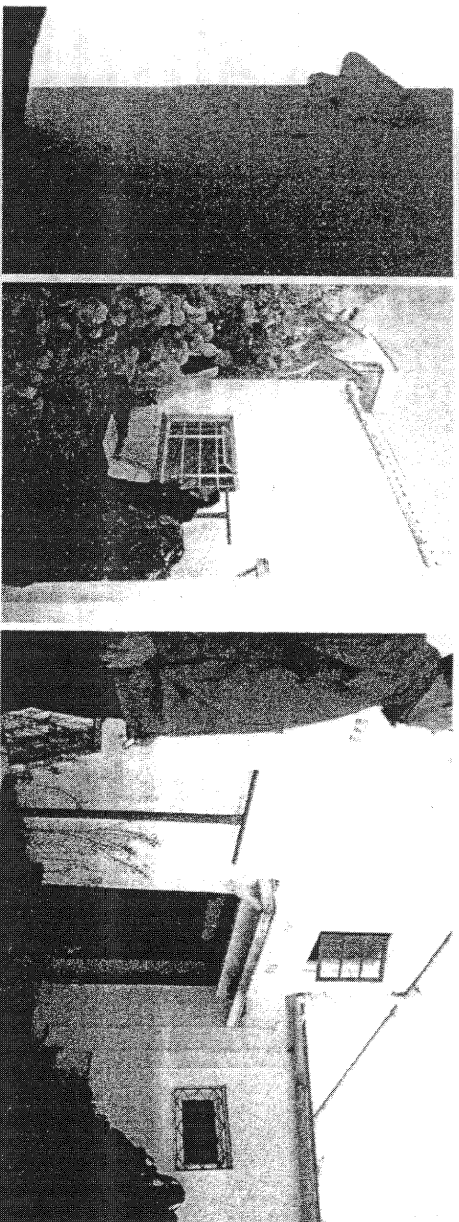
Remnant moulding at rear. Courtyard with long steel window to rear room of main unit, "slaapkamer". Courtyard with door to middle room, bathroom projecting on the right.

- The remnant plaster mouldings at the rear of No 7 should not be disturbed.
- There may be remnants of previous occupation in the rear courtyards and under the present flooring. Archaeological investigation is recommended but an alternative strategy is not to disturb the ground but leave it for some future time. Should the ground be disturbed, an archaeological investigation is essential.

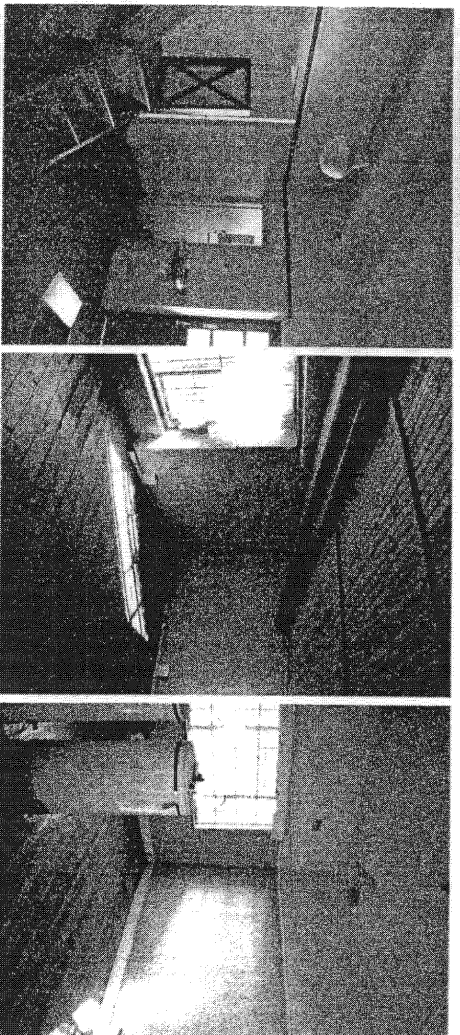
Central room with Victorian beams. Attic room above central room and front room. Rear room with modern ceiling and window.

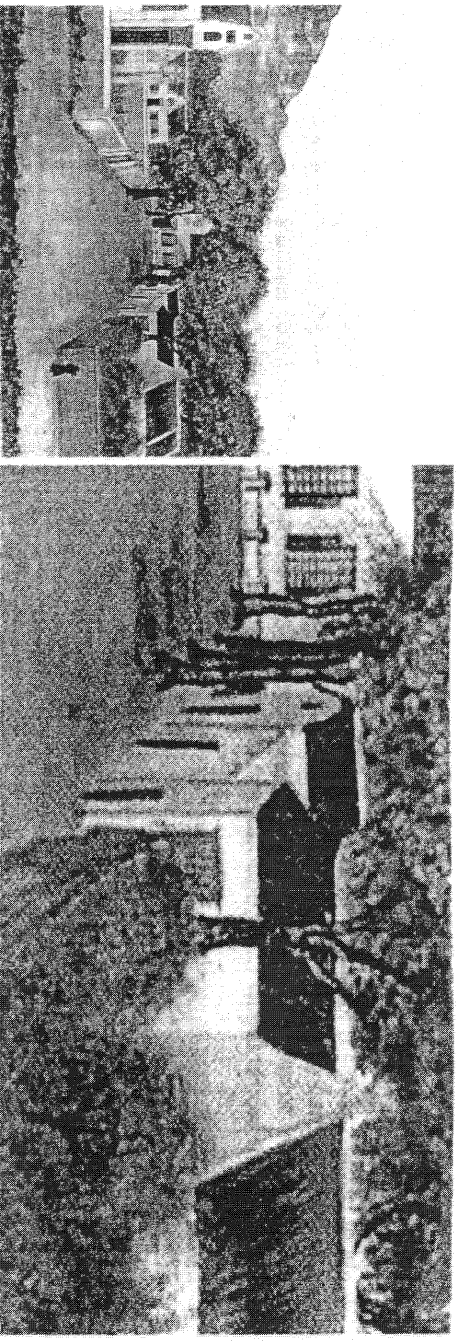
Drostdy Street 1757 Copy of copy of anon painting, Stellenbosch Museum (Smuts 1979:82).

In the detail (right) there is great foreshortening. From the left: the windows of the Drostdy and Dorp Street are seen. Then there is a line of trees which hides the southern part of the block. The next building is thought to be No 7 Drostdy Street. It is an outbuilding that butts end-on to the street and has a thatched roof. It has a small wolfend end-gable in which there is a small attic window. Below is an asymmetrical door and window. Next in line is a wall to a roofed courtyard with a single door to it. Then there is another end-on outbuilding on the corner of Church Street. It has a hipped thatch roof, a single door to Drostdy Street and a much larger door to Church Street. Next in line, across Church Street, is the end-gable of a house later incorporated into OM Bergh House.

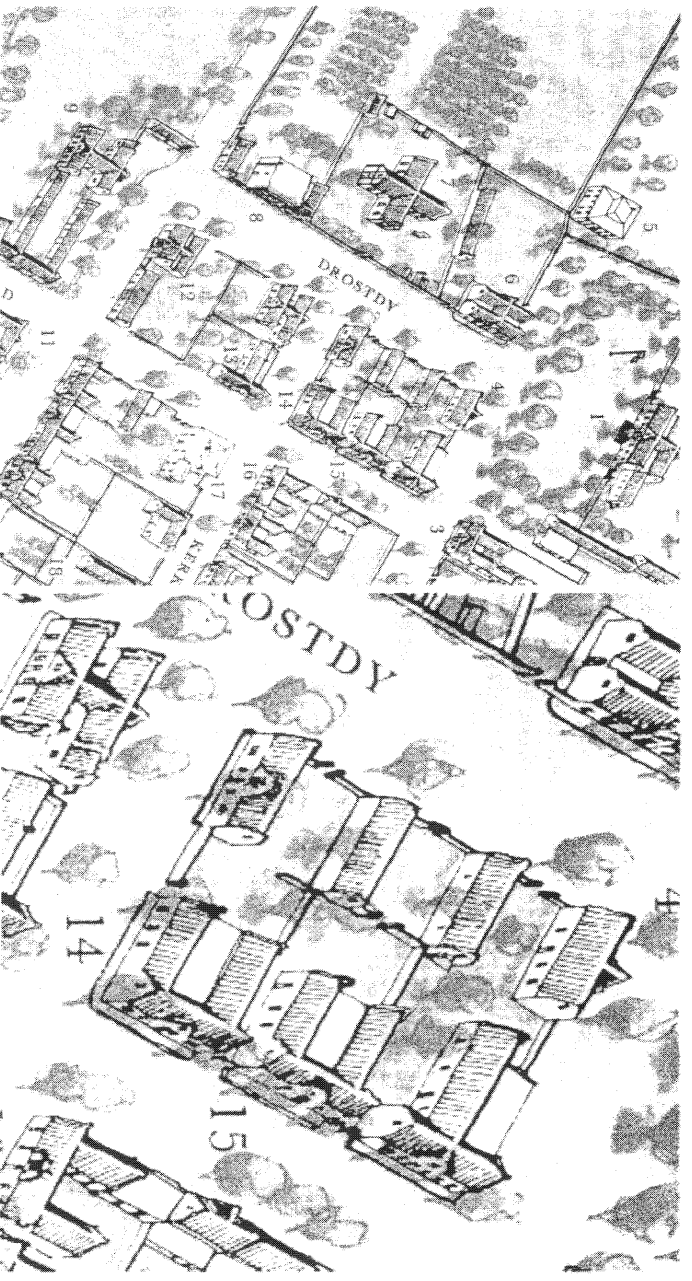
c1860 imaginary axonometric (Stellenbosch 300 Aksie/Action, 1974)

In the detail (right) 14 is Concordia. 15 is Morkel House, behind which is the thatched outbuilding and rear entrance gateposts.

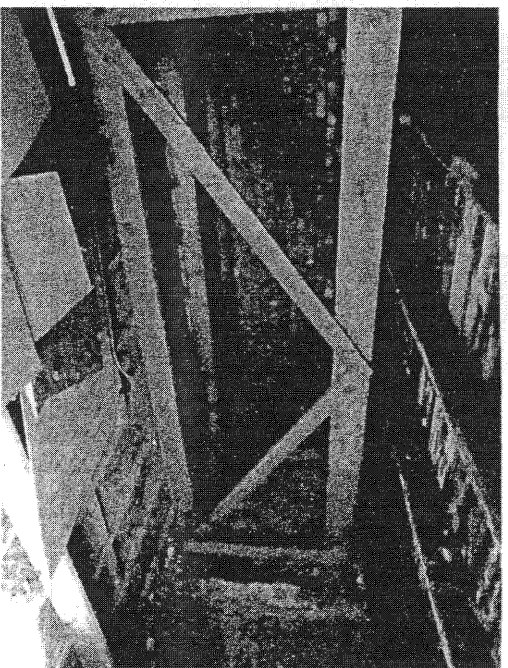
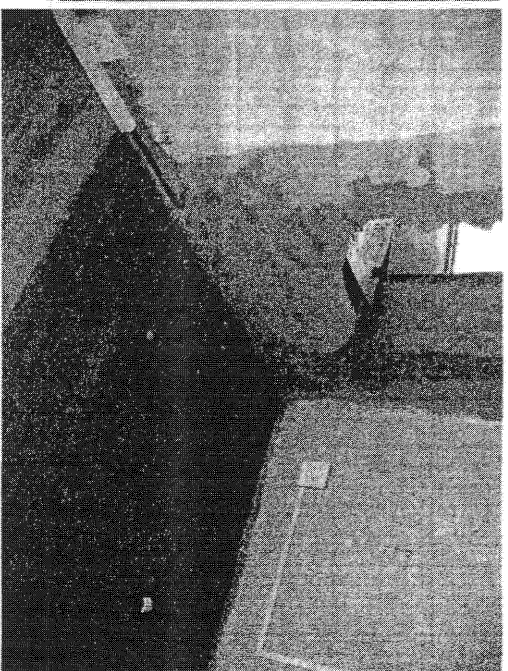
Left: In the ceiling space a recent truss supports old beams and boarding; floor is battens of the rear room ceiling below. Right: rough opening through old brick wall between upstairs room and ceiling space.

The outbuilding in 1757 had a pitched thatched roof. At some time this was replaced by a flat roof, perhaps in a series of building episodes. One intriguing clue is the remnant moulding on the rear façade (part of a lower parapet? the straight end-piece of a gable?); another clue is that ceiling beams^s are of a similar period to No 9 (which is believed to date to the 1870s); and above the modern roof truss is older boarding construction with signs of water-staining. Further examination of the fabric by specialists (selective removal of plaster, examination of bricks and roof construction, remnants of older beams, possible fire damage, etc.) would reveal more.

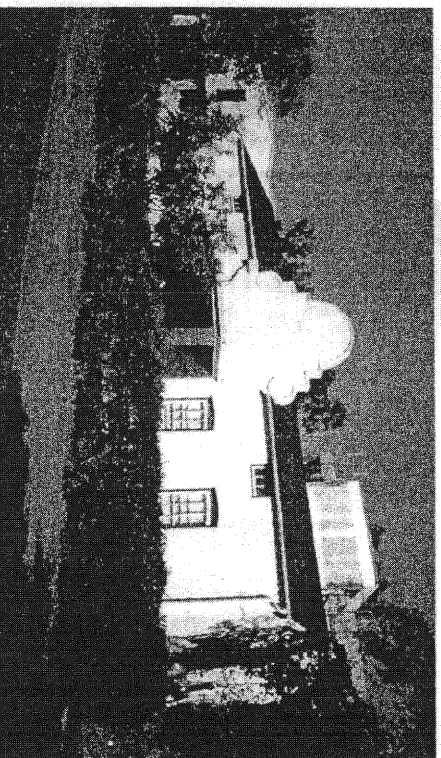
Left: front elevation of No 9 from Drostdy Street. Right: Church Street elevation

The building runs parallel to Drostdy Street. It has a central door with arched head and strong bolection moulded panels, a simple fanlight above. The central door has a 1956 concrete-roofed porch added to it with glazed orange brick pillars, the façade under the porch roof has also been faced with these. Each side are two 4x3 sash windows with arched heads like the door and internal shutters. Lighting the roof space are two 1x3 timber attic windows.

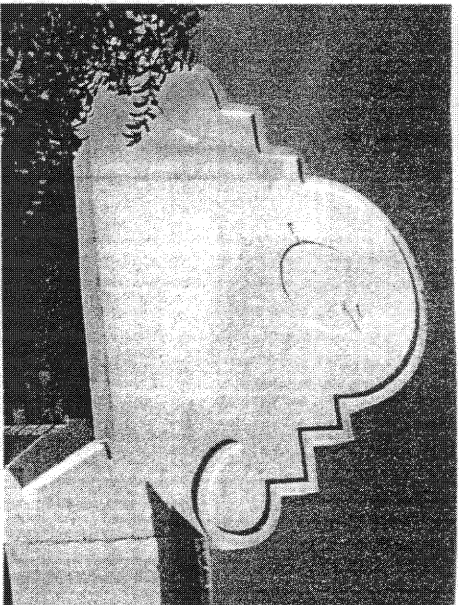
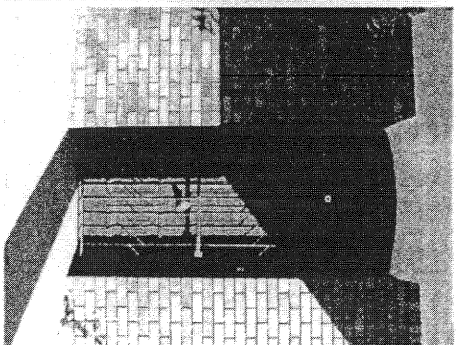
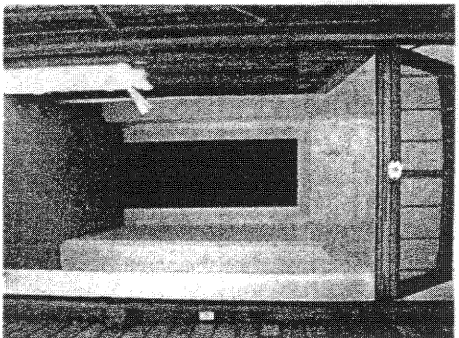
1956 gable. Front door and glazed brick. Entrance Hall from stoep.

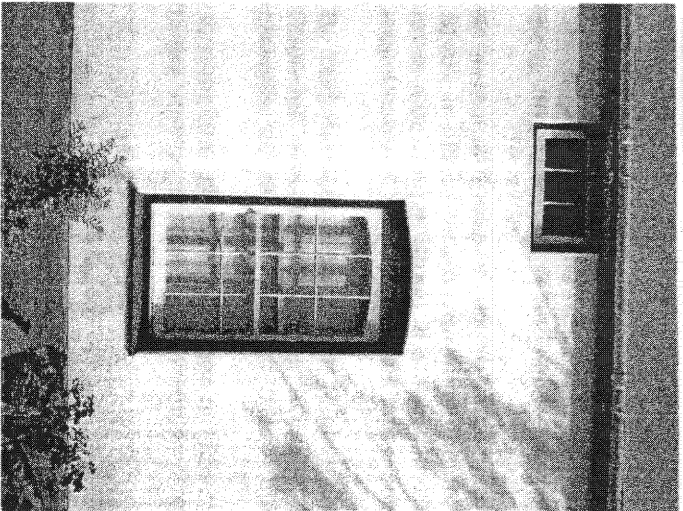
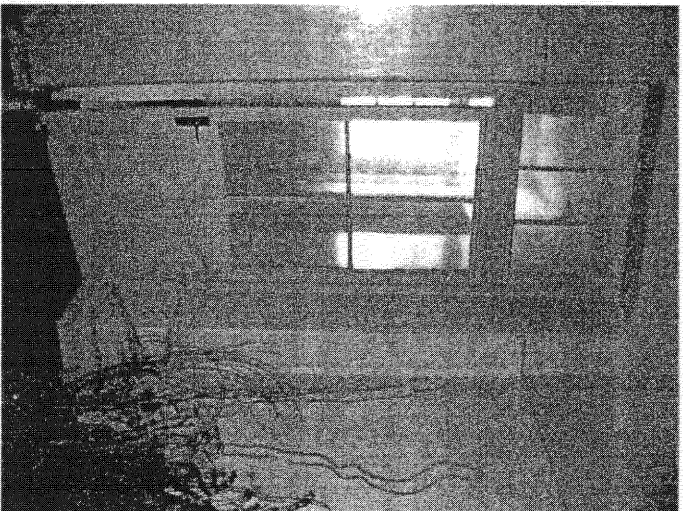
Front elevation sash window and irregularly placed attic window above. Glazed internal door.

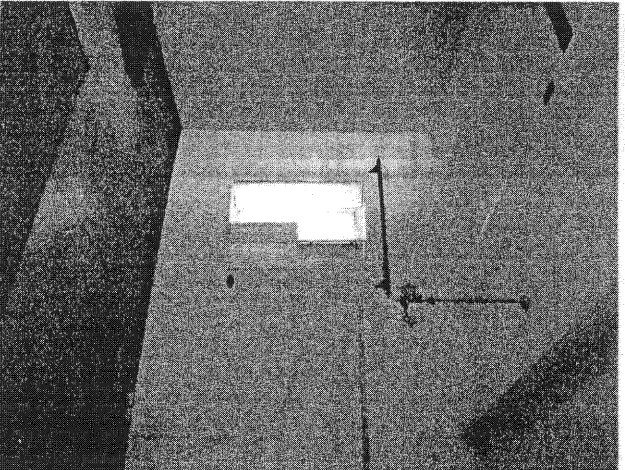
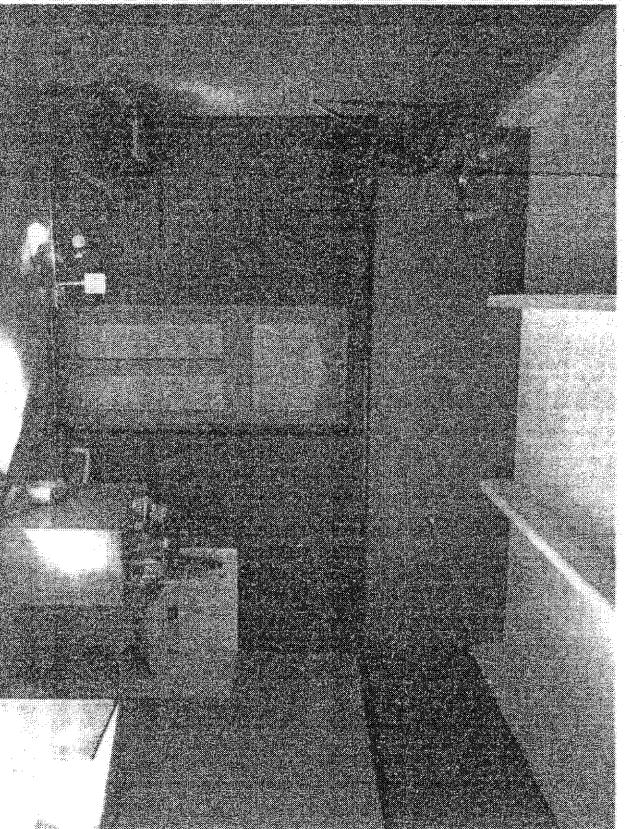
Left: Room to the right with internal shutter window and ceiling beams. Right picture: Room beyond room to the right with ceiling beams and 20th century panelled door.

Internally the house has many period features such as Victorian pattern ceiling beams with timber ceiling above, panelled doors with moulded architraves, a fine glazed back door with fanlight, picture rails, etc. It also has 1930s features such as panelled doors and chandelier.

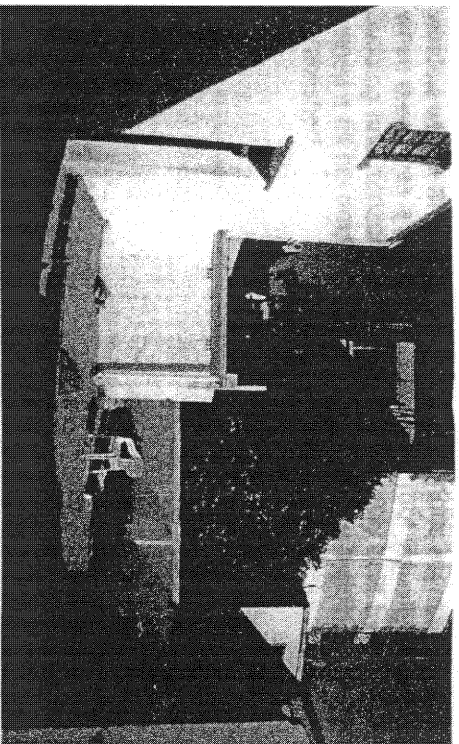
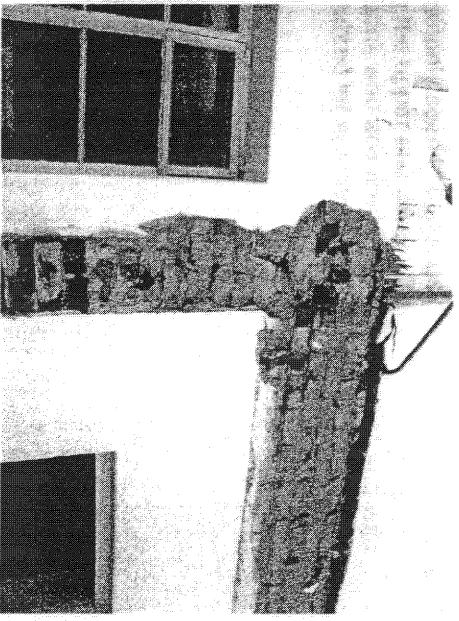
Left: Rear courtyard with side of No 7 on the left (loft window above), the projecting storeroom and cranking wall to Van Niekerk House. Right picture: exposed brickwork on rear facade.

The rear façade has a door to the courtyard and a mixture of windows that include a sash window with internal shutters, a steel casement, a small window at ceiling level, and attic windows like those on the front (one closed up). There are two low, flat roofed projections into the courtyard which house a bathroom and store room (a similar kitchen extension has been demolished). The chest-height courtyard wall cranks along the boundary with Morkel House. It is plastered brick with interim supporting pillars.

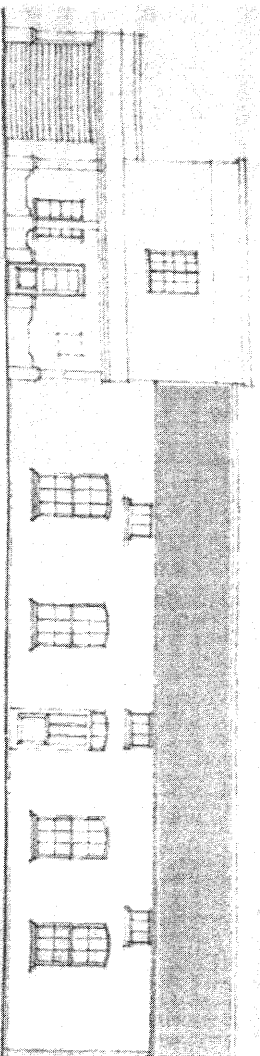
Reconstruction of what the façade of No 9 may have looked like before the gable and porch were added.

window where the gable now is. This curious asymmetry is commonly seen in buildings of the period⁶, especially when there was a continuous verandah roof visually separating the upper and lower windows. Essentially, the building had horizontal lines. It was probably built by Cornelis Brink who acquired Concordia in 1871 and who owned it till his death before 1890⁷. The new building was undoubtedly let to tenants: who they are has not been established.

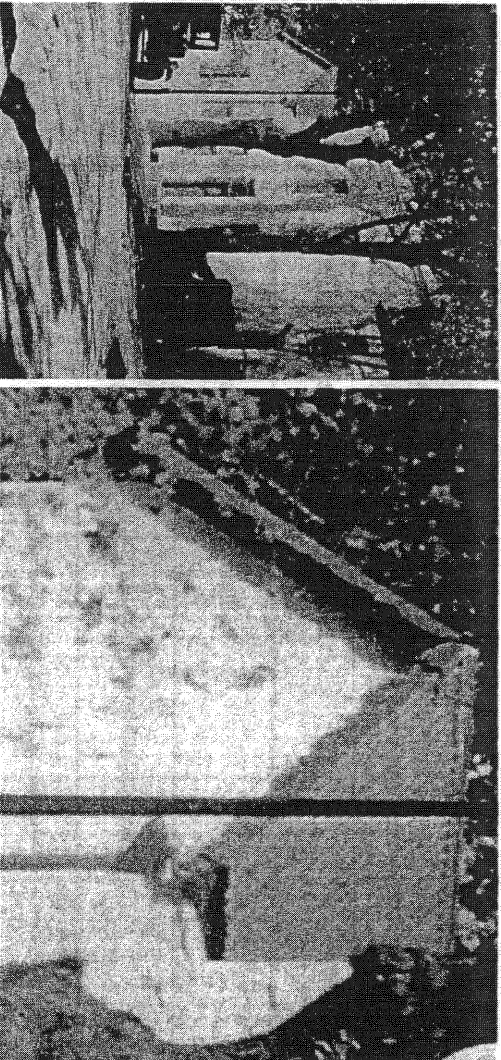
1920s view of end gable (Elliott photograph). Right: enlarged detail of barge board. Courtesy Cape Archives E3028
