ASSESSMENT OF THE MAIN HOUSE AT MORGENHOF

Wessels Albertyn Du Toit Architects

August 1993

Archaeology Contracts Office

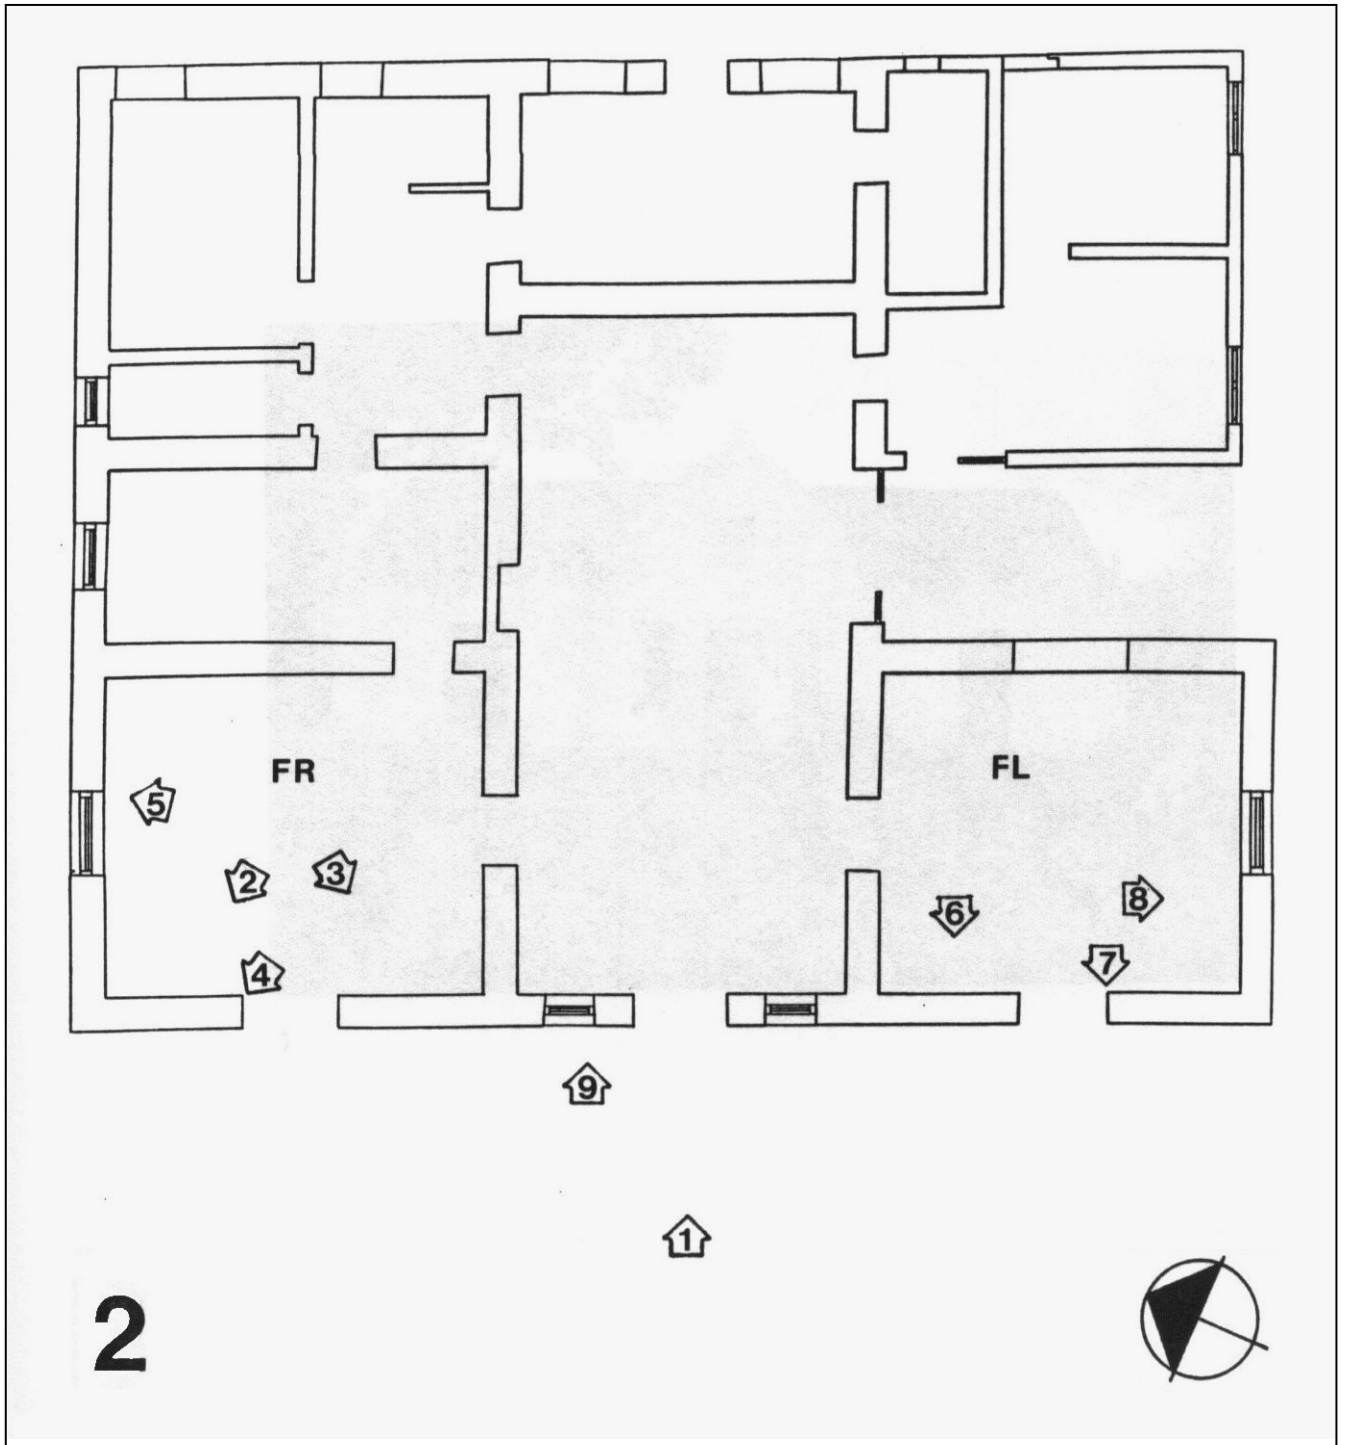
A plan of the house as it appeared prior to renovation has been used to annotate the results of the fabric examination³ (Figure 2):

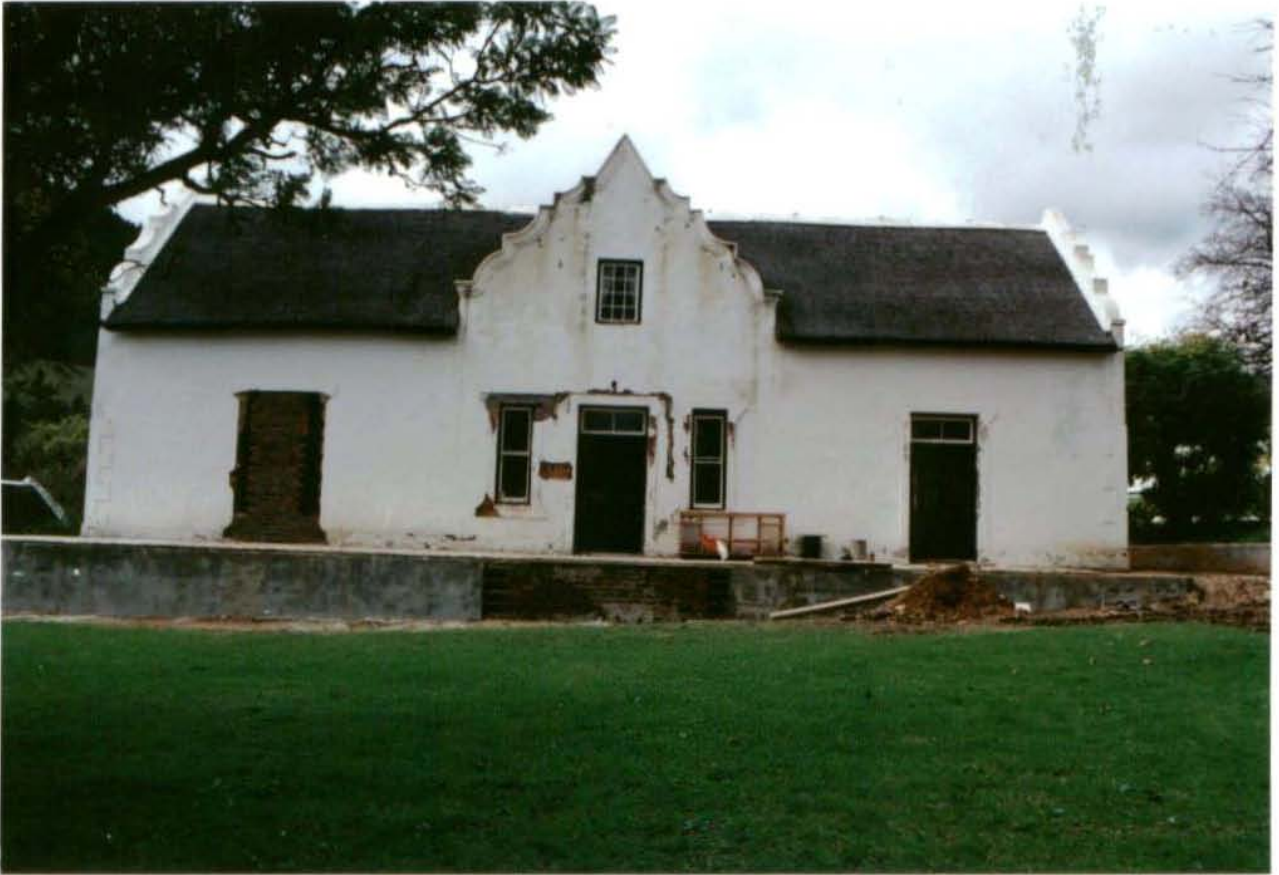
1

The contractor was requested to remove a strip of plaster approximately 400mm wide along the length of the front facade of the house to facilitate study of the brickwork around the windows and doors. The contractor was also requested to remove a similar strip of plaster down the gable located above the mid-point of the front door. The architect requested that we conduct plaster removals inside as the heavy rain which was being experienced could have caused erosion of the old mud mortar and unfired bricks. The architect informed us that the gable consisted of new brickwork and had been built some time previously to replace one that was structurally unsound. At this time a pitched asbestos tile roof had been replaced with thatch and extra courses of brick had been added to the walls at the level of the tops of doors and windows (Plate 1). As a result of this information plaster was not removed from the gable.

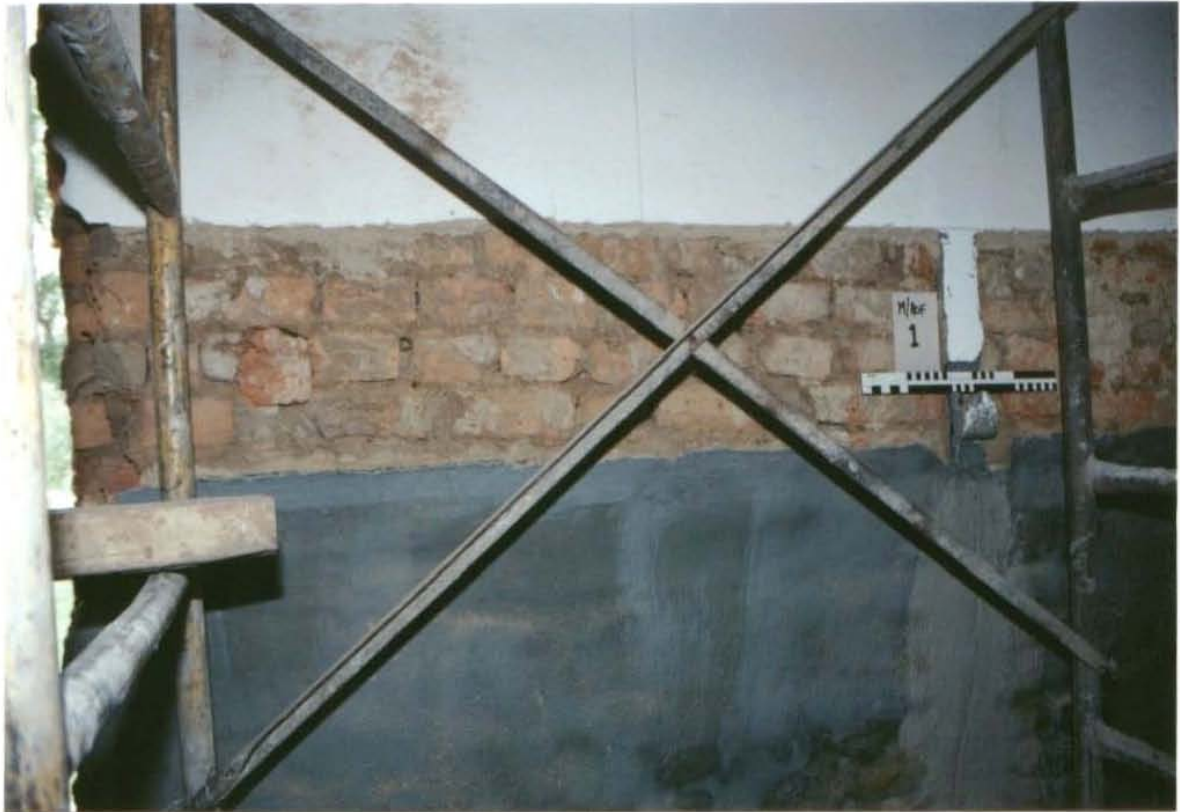
(a) The brickwork exposed on either side of the French door (removed), shows no signs of variation which would suggest any bricked in apertures (Plates 2 and 3). Mud mortar is used throughout this section and no variation in the colour or type is noticed. The bricks used consist of a mixture of reddish, fired and brown sun dried varieties. A detail of the bricks are shown in Plate 4.

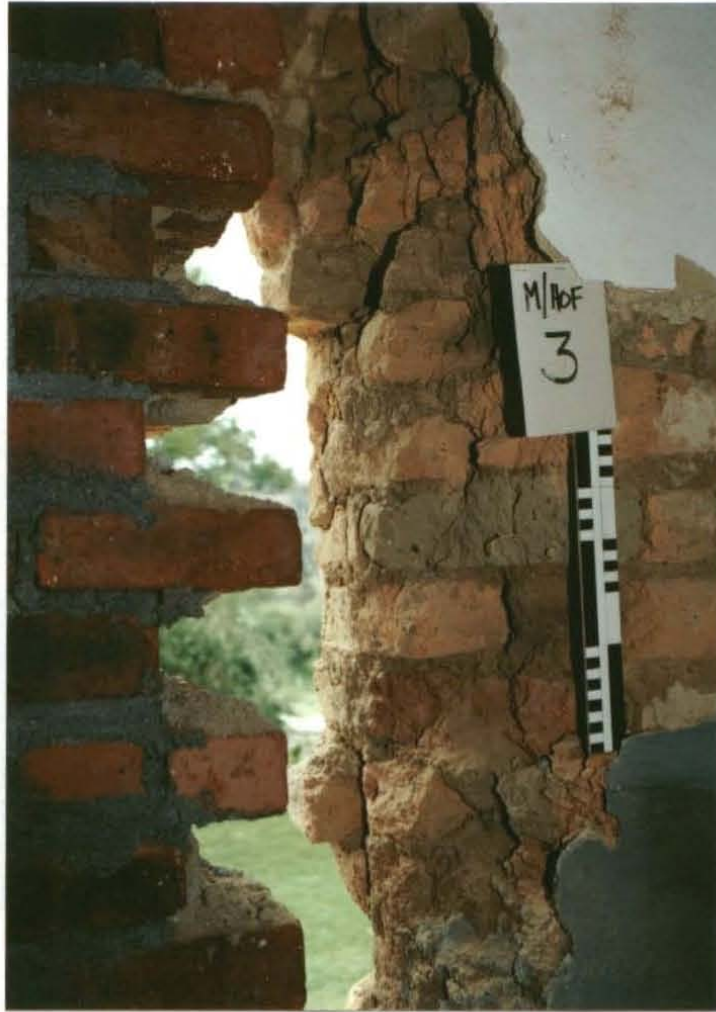
4

The plan of the house suggests that it may originally have taken the form of an "H" or a "T". House plans of this type are common in both the 18th and 19th centuries which means that they cannot be used for precise dating.⁴ The fired bricks which are used in the building are very large having dimensions of 290x130x85mm. The only other house where we have seen

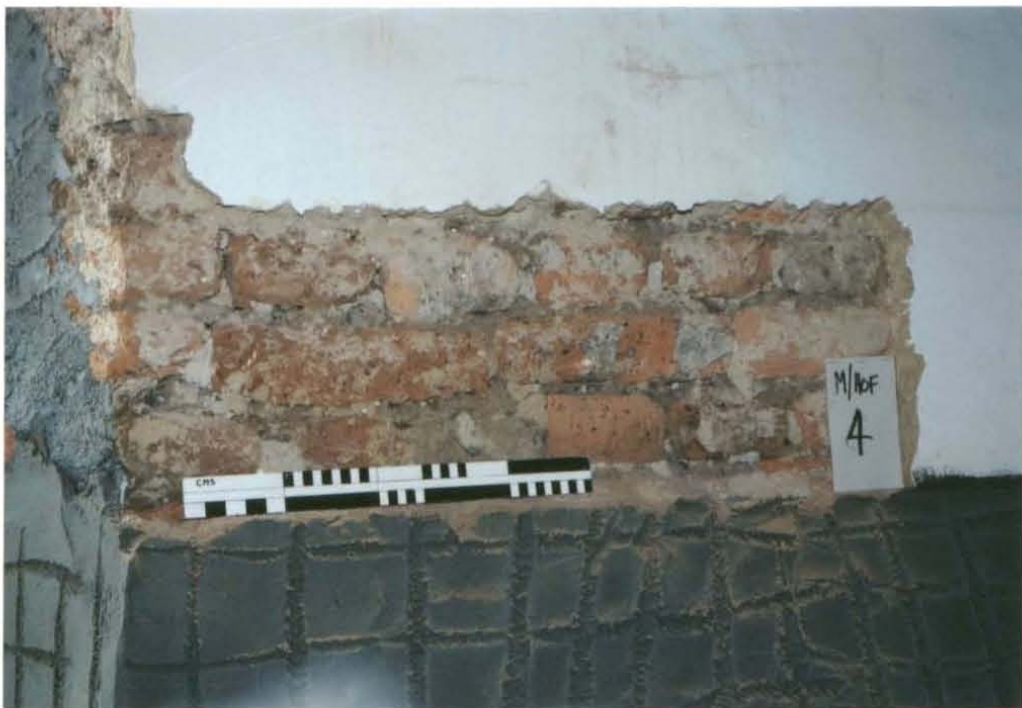
5

(b) The brickwork exposed on the side of the window shows no sign of variation. Mortar and type of brick is the same as the exposures described in (a). (Plate 5)

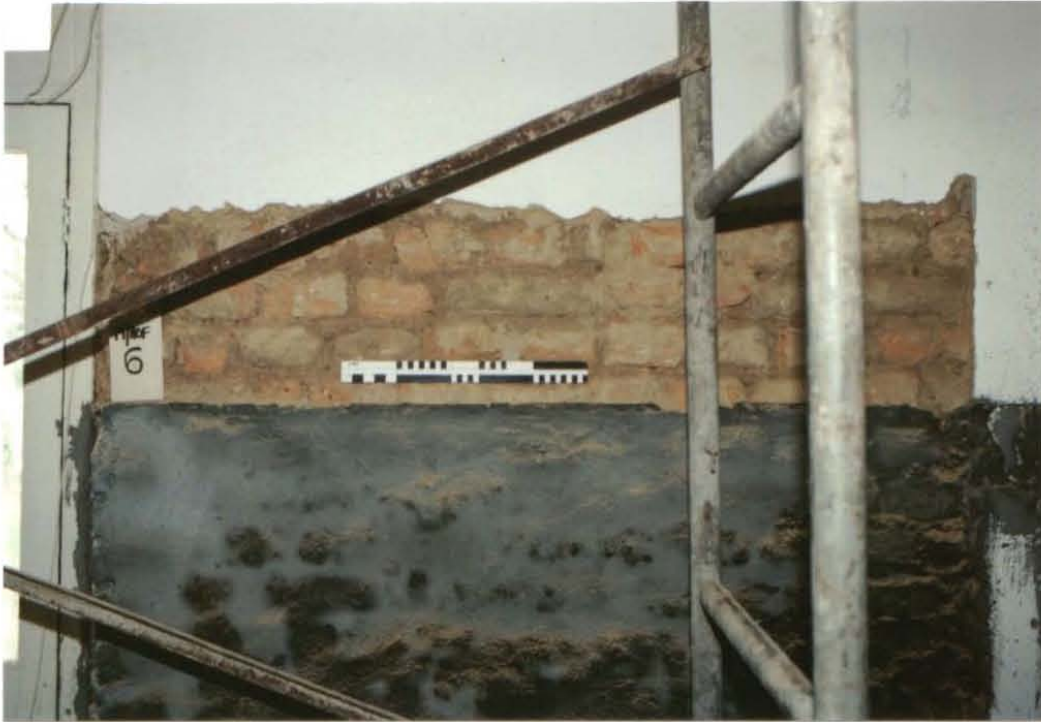
6

(c) Brickwork on the right hand side of the French door shows no signs of variation (Plate 6). That on the left hand side however shows that the French door has been fitted into a wider aperture (Plate 7). Soot is present on some of the bricks of the original edge. Some whitewash is also noticeable. The original aperture was approximately 1420mm wide whereas the French door frame is 1280mm wide. New brickwork at the base, as well as at the top of the frame makes it impossible to determine whether the door was fitted into an aperture that originally held a window.

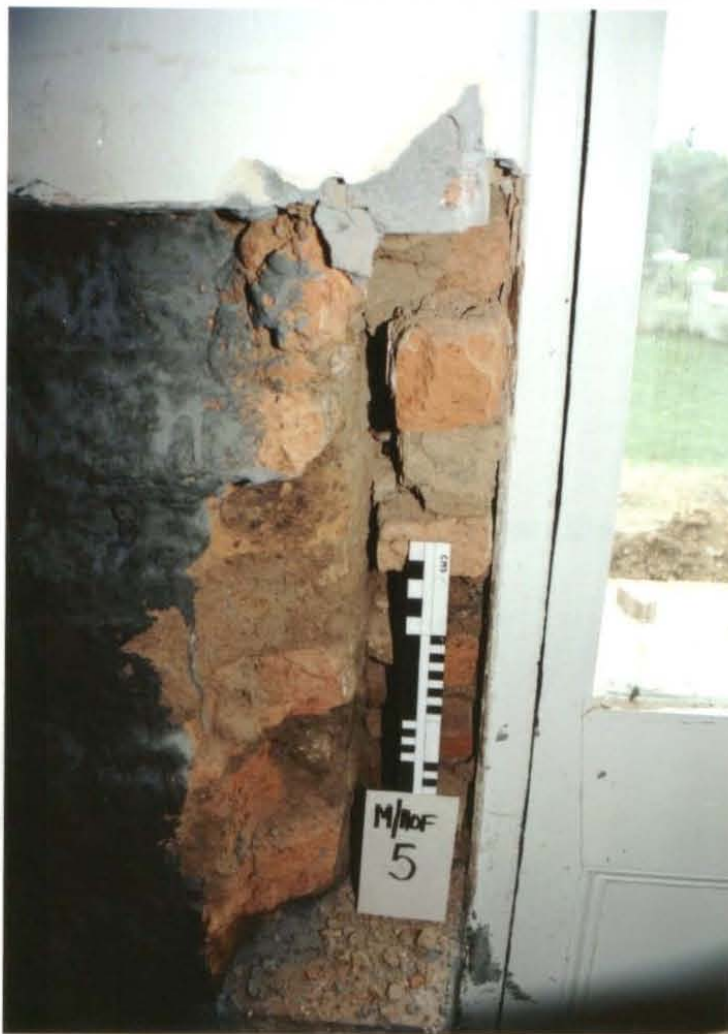
7

Examination of the original fabric (concentrated mainly along the facade of the building) has indicated that no additional windows were ever inserted or closed up along the front facade or on the side walls of the facade. There is evidence that the French doors were fitted into wider apertures which probably contained windows at some stage in the past. It is not possible to say what form these windows would have taken. The small sash windows on either side of the front door are presumably later than other modifications as the mortar is different. These may also have been added to existing cavities which certainly never contained windows much bigger than those which exist.

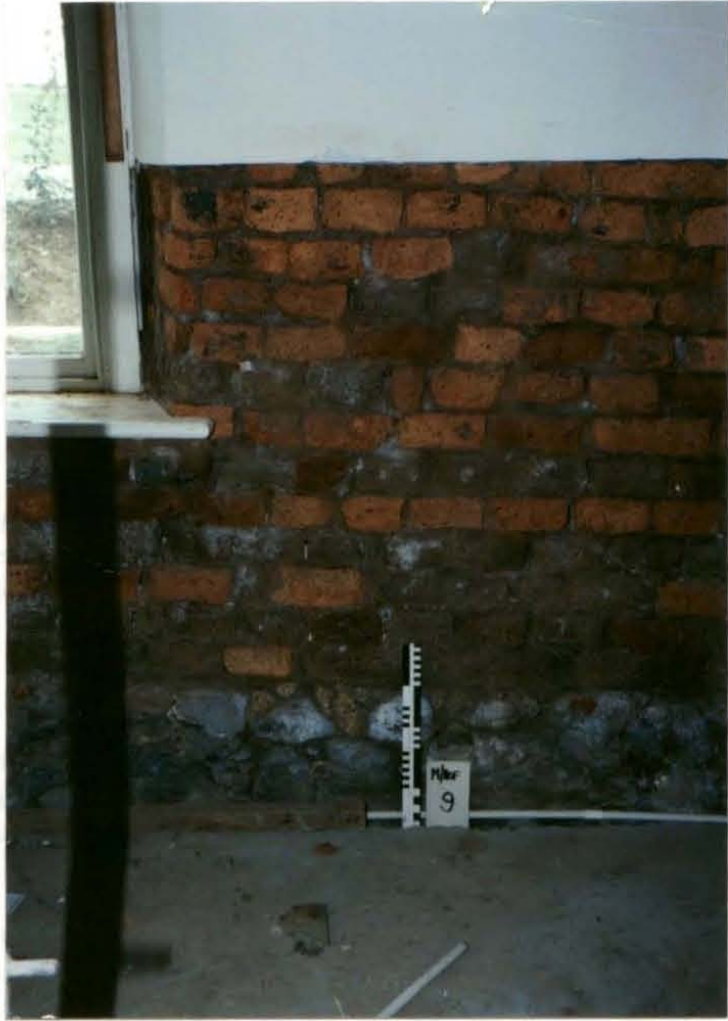
8

(d) Brickwork around the side window shows no signs of variation (Plate 8). Clearly visible is the stone footing of the wall. The variation in the brick is similar to other locations.

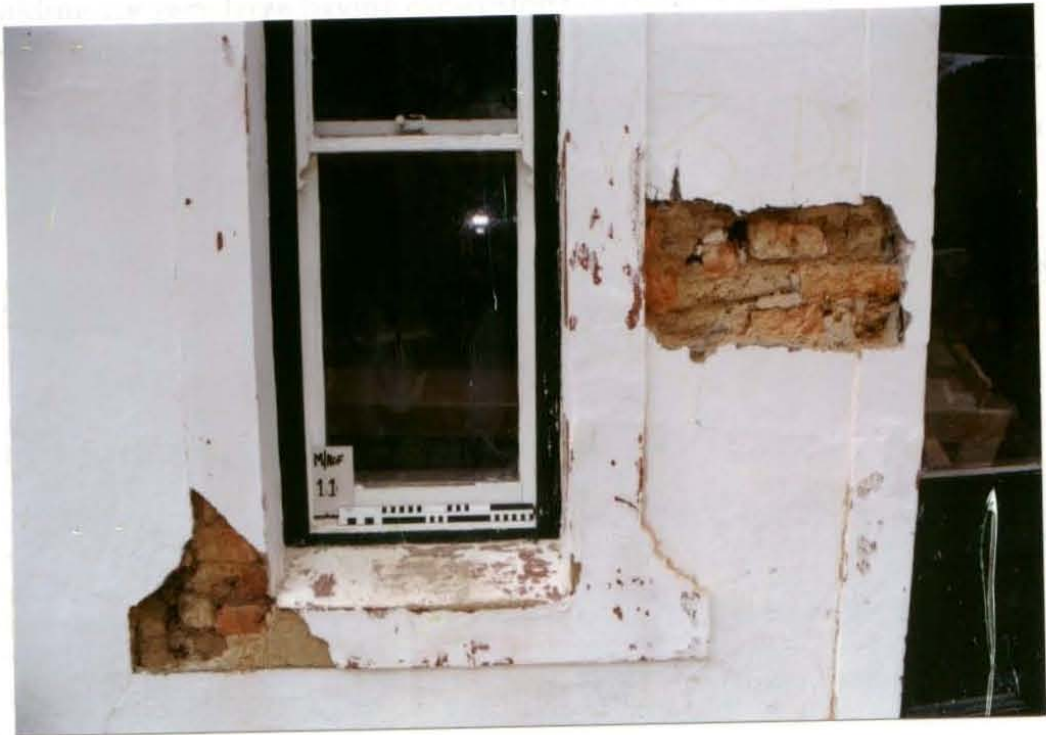
9

(e) Variation in the mortar used is discernible on the right hand side of the sash window. The mortar here is yellowish and does not crumble like the mortar in most of the rest of the house. No variation in the mortar adjacent to the front door frame is noticed (Plate 9).
