**A PHASE 1 ARCHAEOLOGICAL INVESTIGATION OF  
FARM 1062 (PREVIOUSLY 967)  
PATERNOSTER**

**BCD  
Town and Regional Planners**

May 1998

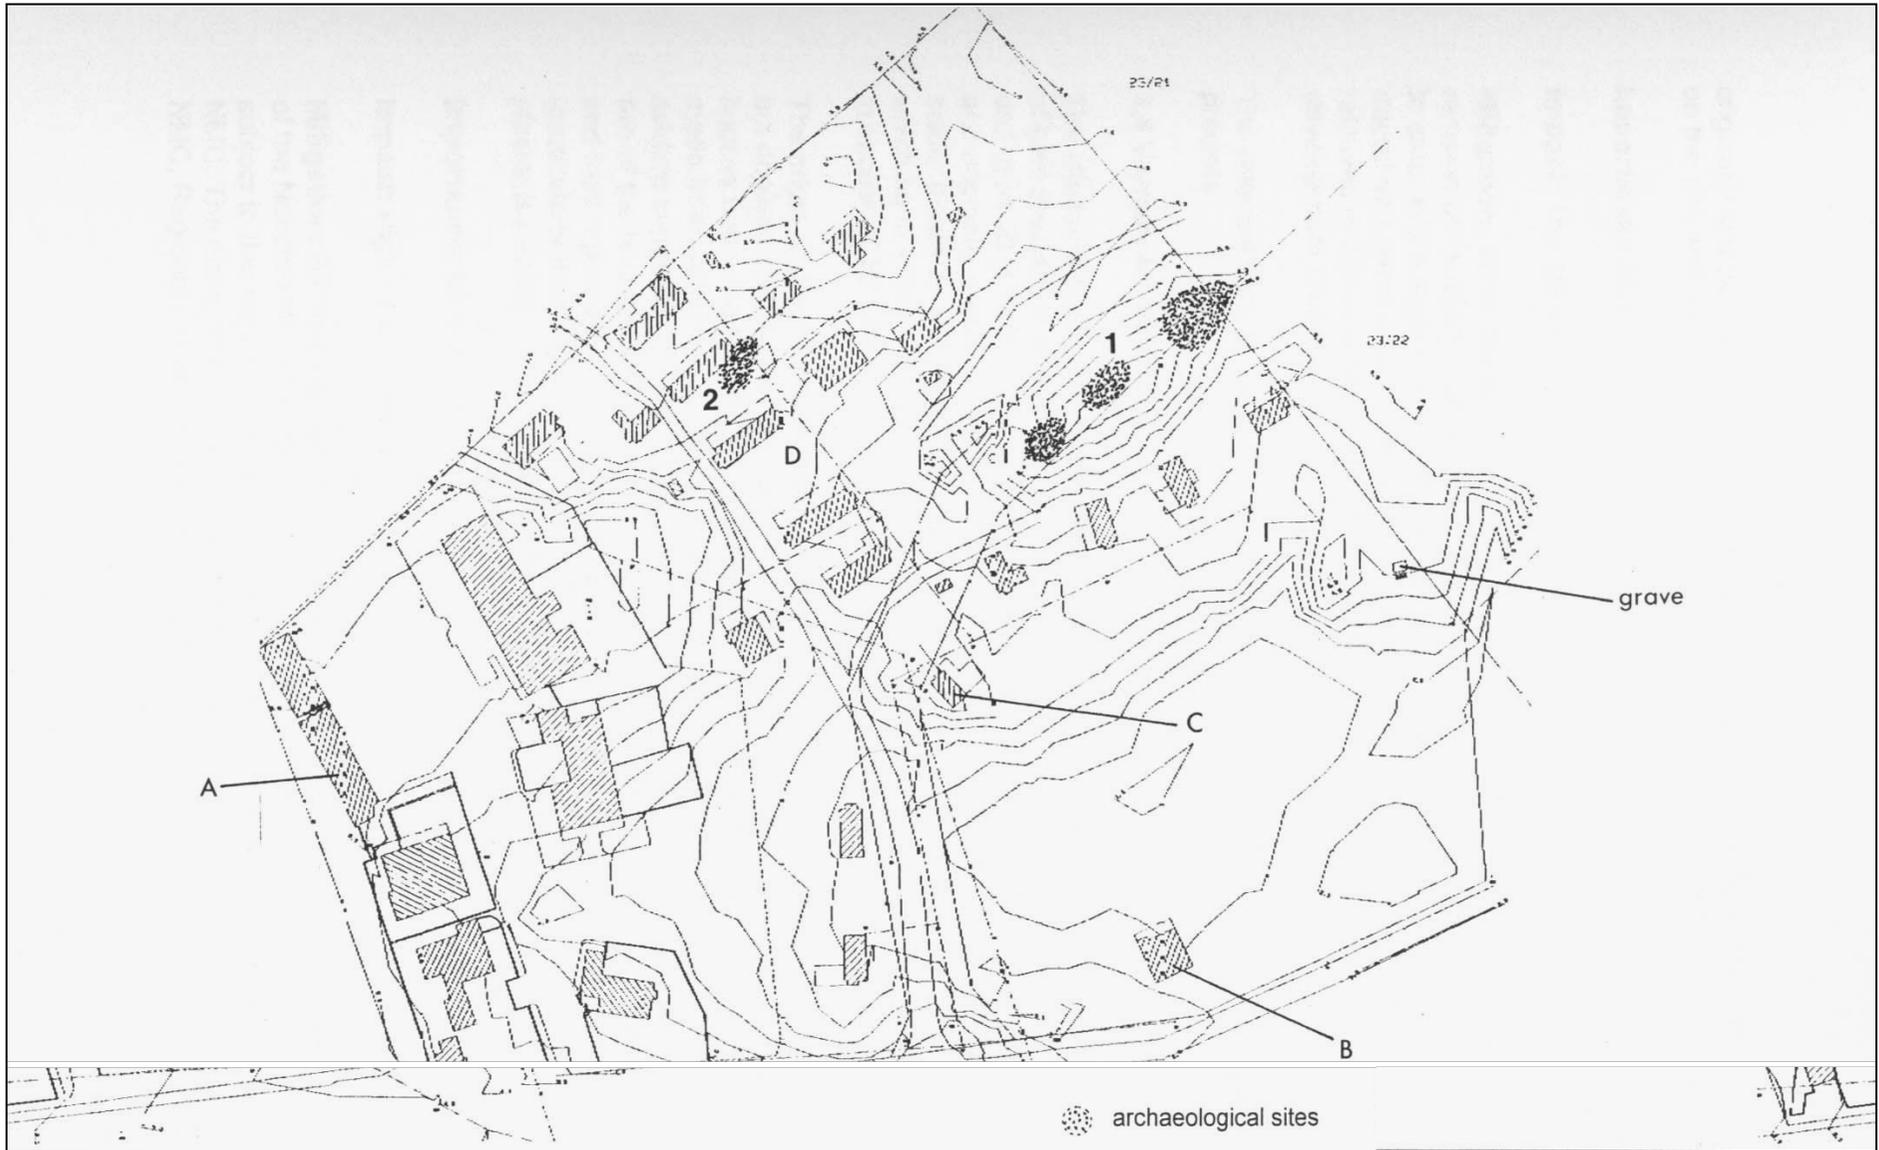
**2**

062 (formerly farm 967), Paternoster.  
 Scale: 1:500 (reduced)

Area of investigation - Farm 1  
 Reference: BCD plan 2.249

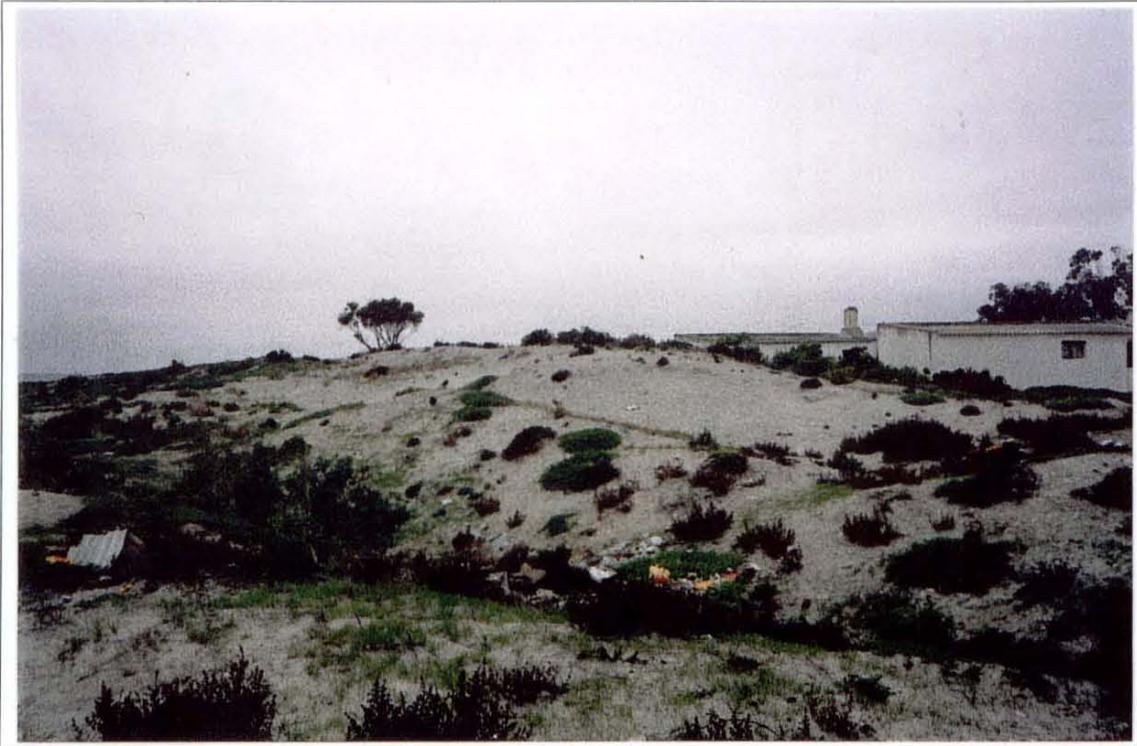
This is a Late Stone Age shell midden located on top of a prominent mound in the middle of the village (Figure 2, Plate 1). This mound is a remnant of the old dune cordon that originally ran through the Vaalplaas settlement. It has been flattened in places to facilitate the building of houses in the past. Three dense areas of shell were noted on the mound. A small test excavation at one of these patches revealed that below the surface the lens of deposit was approximately 200mm thick. The dominant shell species on the site is *Choromytilus meridionalis* (Black mussel), while limpets (*Patella grantina*, *Patella granularis* and *Patella cochlear*) occur in lesser quantities. A small quantity of flaked quartzite was observed and bone was also present. No indigenous ceramics were seen.

**Importance:** Medium

**Impact:** This site is likely to be destroyed by development.

**PLATE 1:** Pre-colonial shell midden capping the dune in the center of the village. Despite the proximity to modern occupation, some portions of the site have remained undisturbed.

**Mitigation:** Each of the dense areas should be sampled. Samples should be of suitable size (approx. 4m<sup>2</sup> each) to adequately document the content.

5.1 Archaeological material at Site 1 must be sampled prior to any form of development.

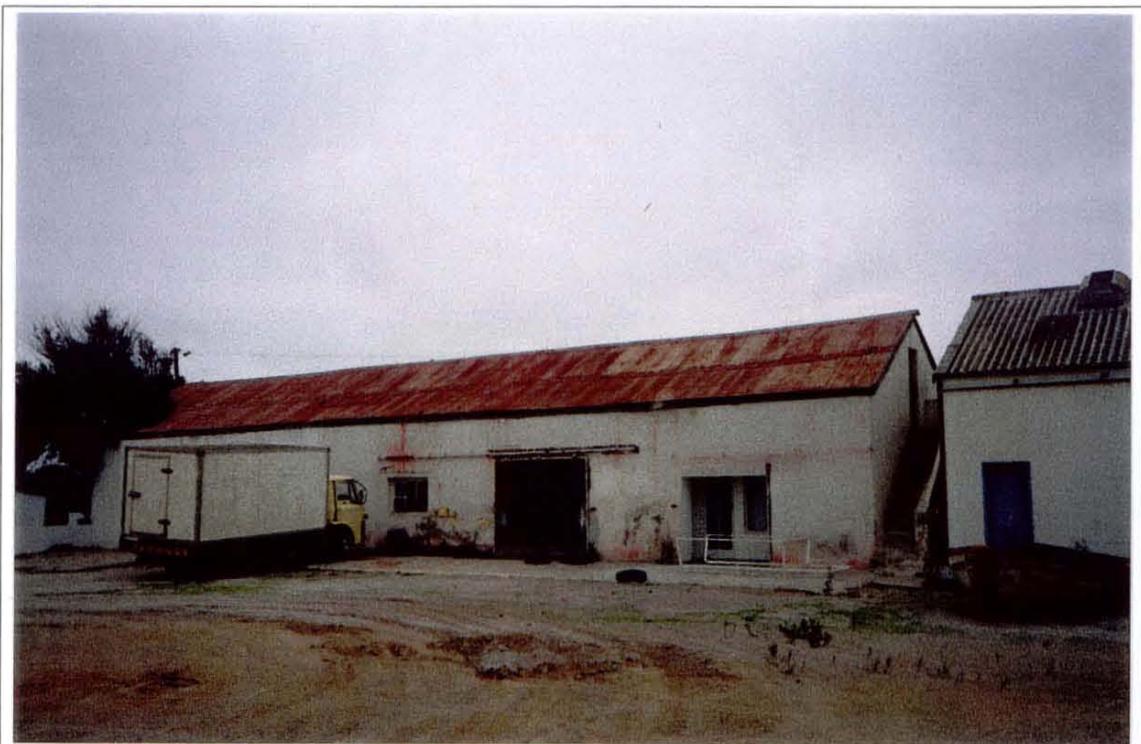
The cluster of buildings on the western side of the site are mostly modern and consist of both residential and either agricultural, or factory sheds. One of the sheds (building A on Figure 2) is visibly older than the others. It is built out of dressed limestone blocks and originally probably had a thatched roof. A set of steps on the one end leads up to a *solder* (Plate 2). It is likely that this was part of a farm complex, the other buildings of which have either disappeared or been subsumed within existing structures. It is clearly in excess of 50 years old.

**Importance:** Medium - high

**Impact:** High - if demolition is intended.

**PLATE 2:** Shed (A on Figure 2). Built with dressed limestone and with structural features which suggest that originally the roof would have been thatched.

**Mitigation:** All buildings which are older than 50 years are subject to the 50 year clause of the National Monuments Act of 1969 (as amended). Briefly, any building which is subject to this regulation may not be demolished or altered without permission from the NMC. The demolition of any of the above buildings will need to be sanctioned by the NMC, Regional Plans Committee.

5.3 Development plans must be submitted to the Regional Plans Committee of the National Monuments Council for a decision on the buildings subject to the 50 year clause.

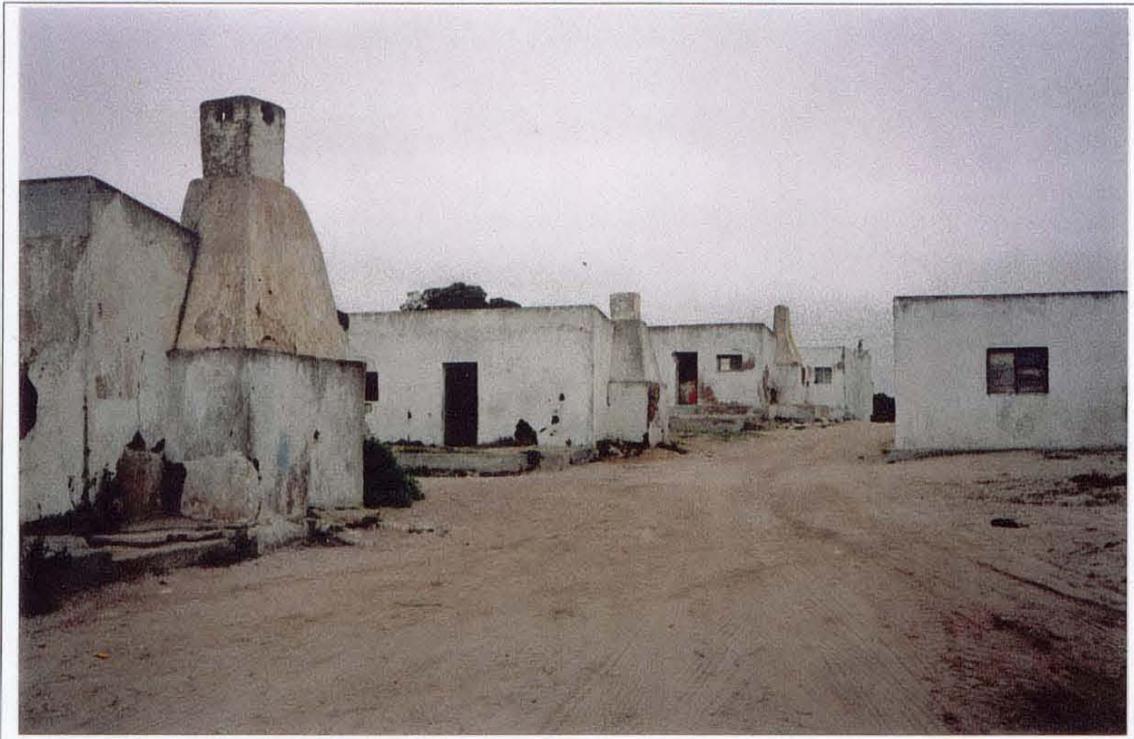
The origin and age of the small settlement (called Vaalplaas by the locals) is unclear, but original inhabitants may have worked for the owner of the farm and have lived in houses that were built for them. It would appear that all the dwellings (excluding those made from wood) are in excess of 50 years old. More than one style of building is evident suggesting that construction took place at different times (Plates 3 & 4). At least two of the houses are built with dressed limestone blocks (buildings B & C on Figure 2) and may represent some of the earlier buildings on the site. Most of the other buildings (particularly those around point D on Figure 2) are built from brick. In these cases plaster is peeling and structural detail is visible.

**PLATE 3:** One of the vernacular housing styles in the village with lean to roofs and end chimneys. These all seem to be constructed with a combination of brick types but some stone is also present.

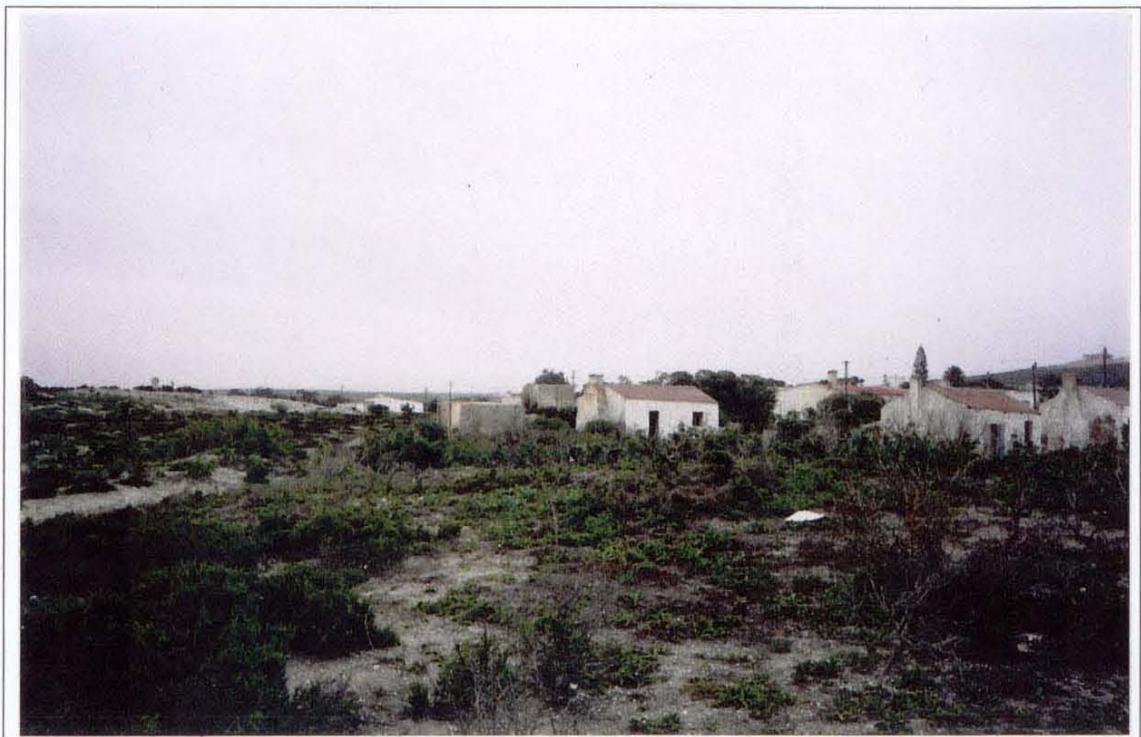
**PLATE 4:** A second style of house which is found in the village. Also constructed with a combination of brick types. These tend to be on the eastern side of the site.
