# Agency for Cultural Resource Management

**19 April 2005**

## **REPORT: VISIT TO INSPECT AND MONITOR EXCAVATIONS FOR BULK SERVICES CAPE ST. MARTIN DEVELOPMENT VREDENBURG DISTRICT**

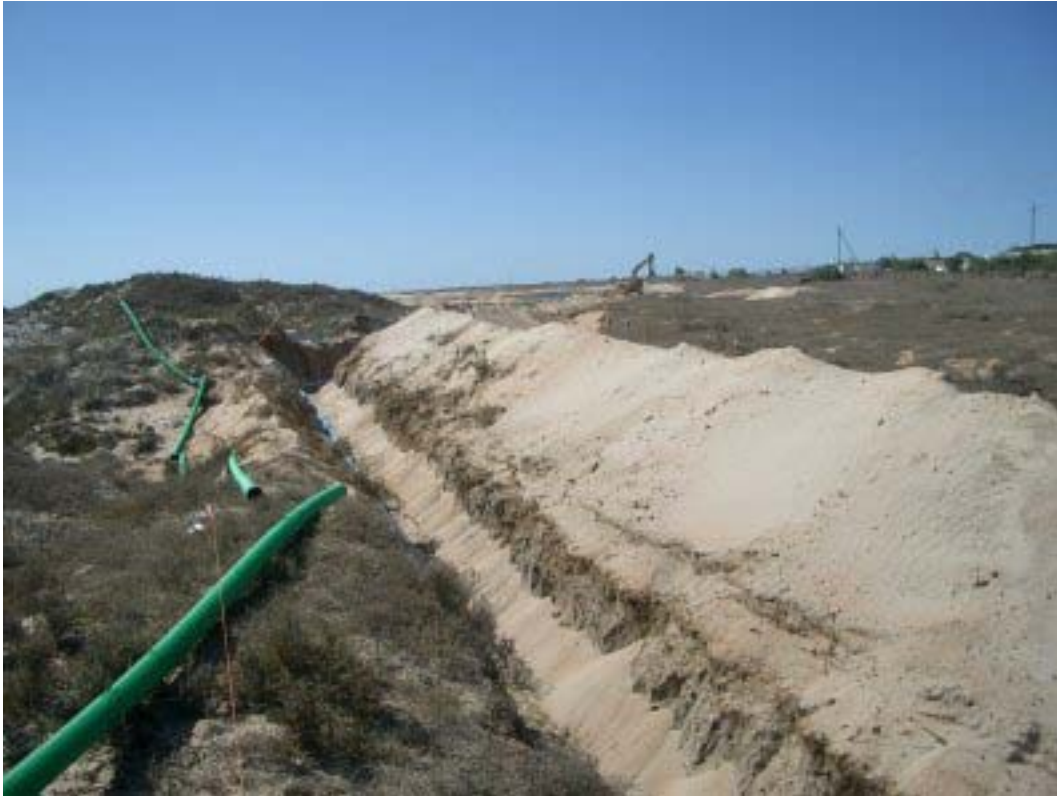
Most of the trenches are located behind the barrier dunes on the property (Figure 1), well away from the demarcated shell middens, but a section of the service trench in the southern portion of the property has been excavated over the dunes.

Figure 1. Excavation trenches in the southern portion of the property.

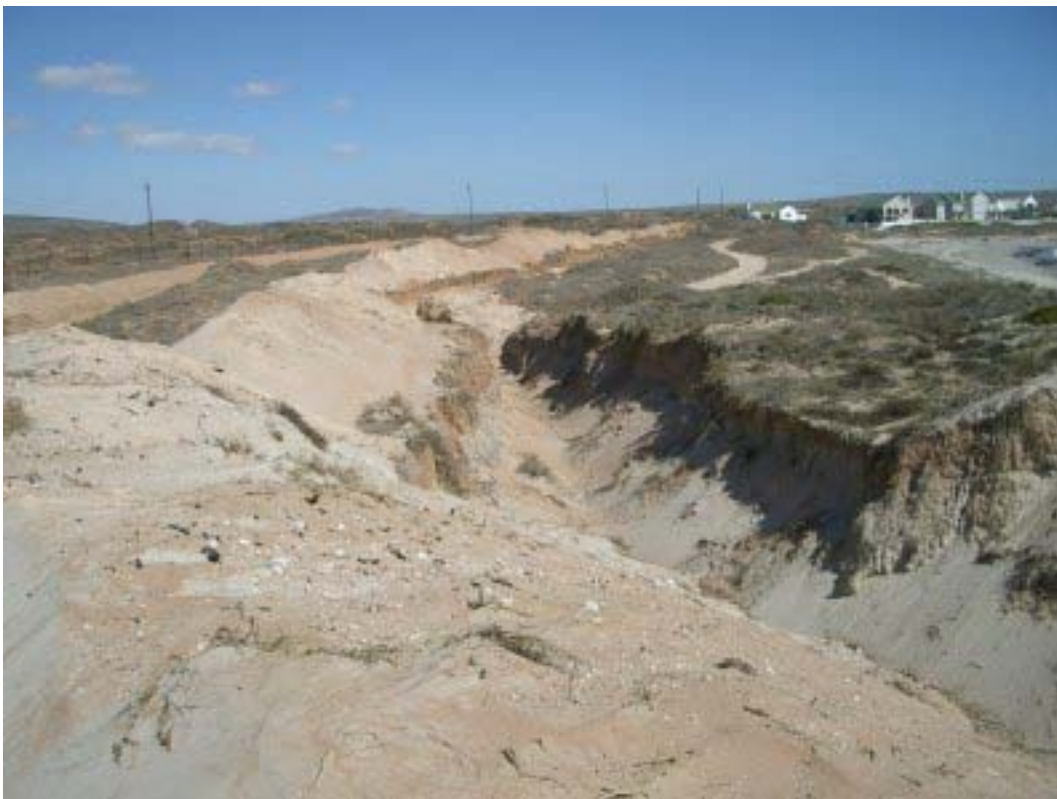
While no archaeological heritage remains were located during inspections of the trenches behind the barrier dunes, archaeological shellfish remains were noted on some of the spoil dumps alongside trenches excavated over the dunes in the southern portion of the property (Figure 2).

Figure 2. Shellfish remains on spoil dumps in the southern portion of the property.

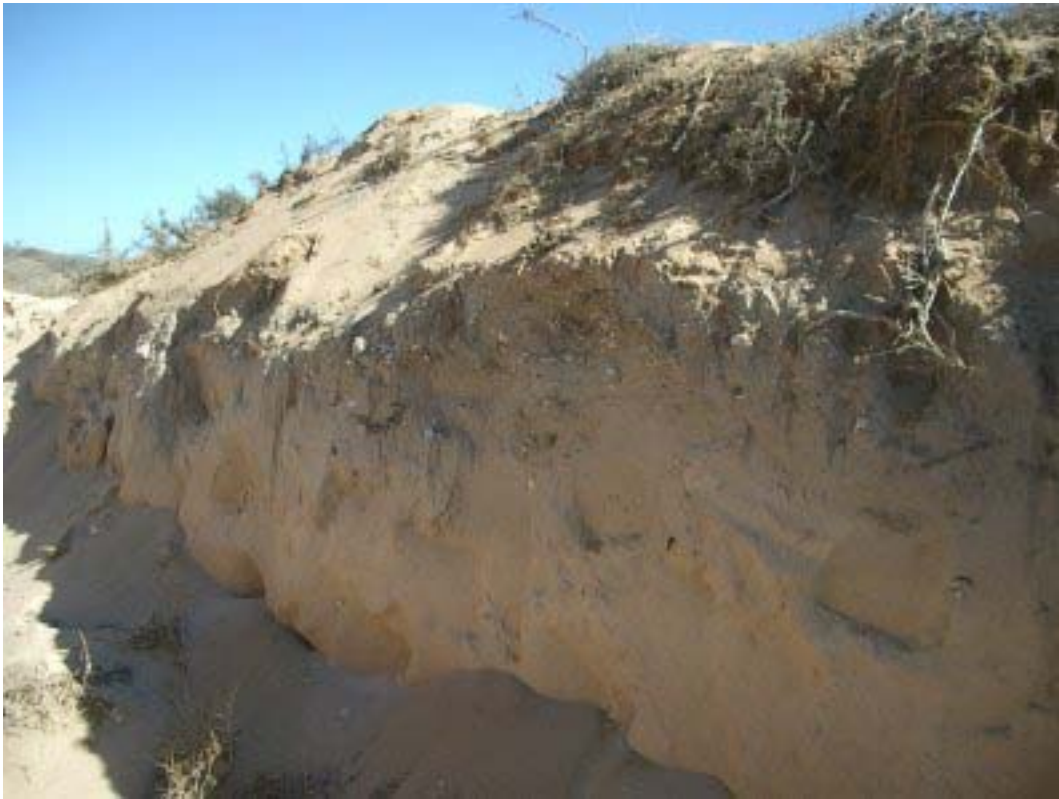
A thin (2-3 cm thick), discontinuous layer of in-situ shellfish (mainly Black Mussel) with some stone tools (broken quartzite cobbles) was noted in several places in the excavation profiles in this portion of the property (Figure 3). These layers of shellfish occur about 70 cm below the surface of the dunes, in a soft white windblown sandy deposit.

No evidence for any human burials was noted during careful inspection of the trenches.

Figure 3. In-situ shellfish remains in trench in the southern portion of the property.

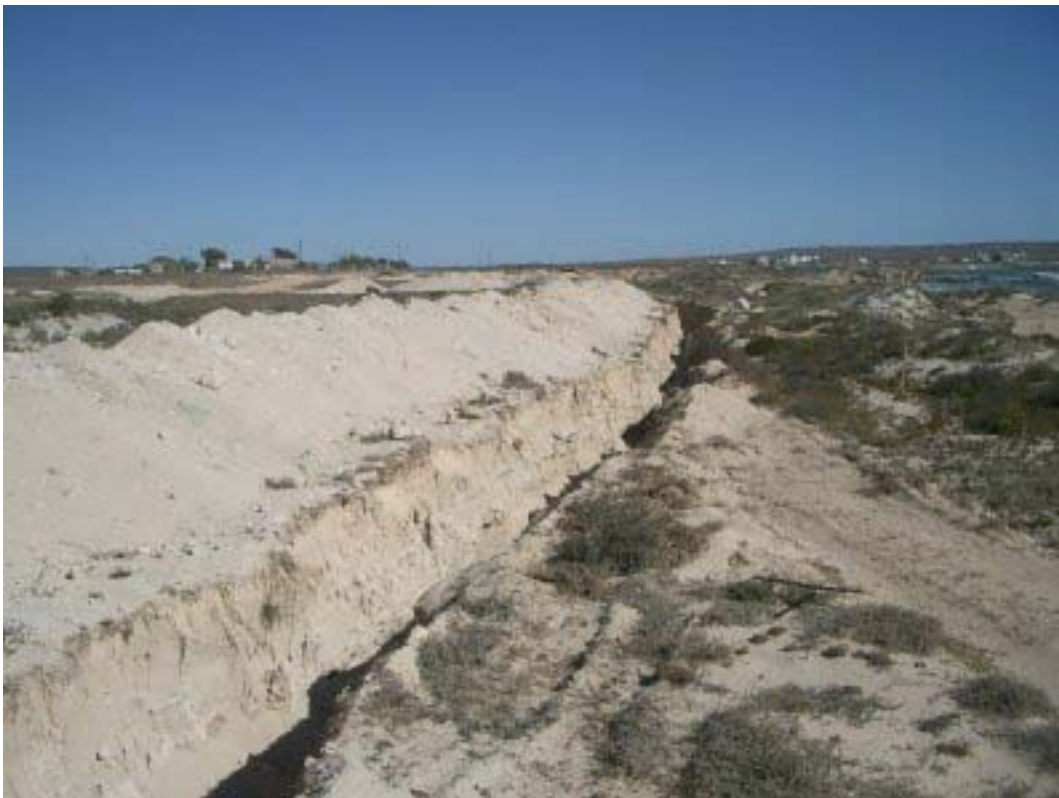
Monitoring of bulk earthworks in the northern portion of the property did not locate any archaeological heritage remains (Figure 4).

Figure 4. Deep excavation trench in the northern portion of the property.

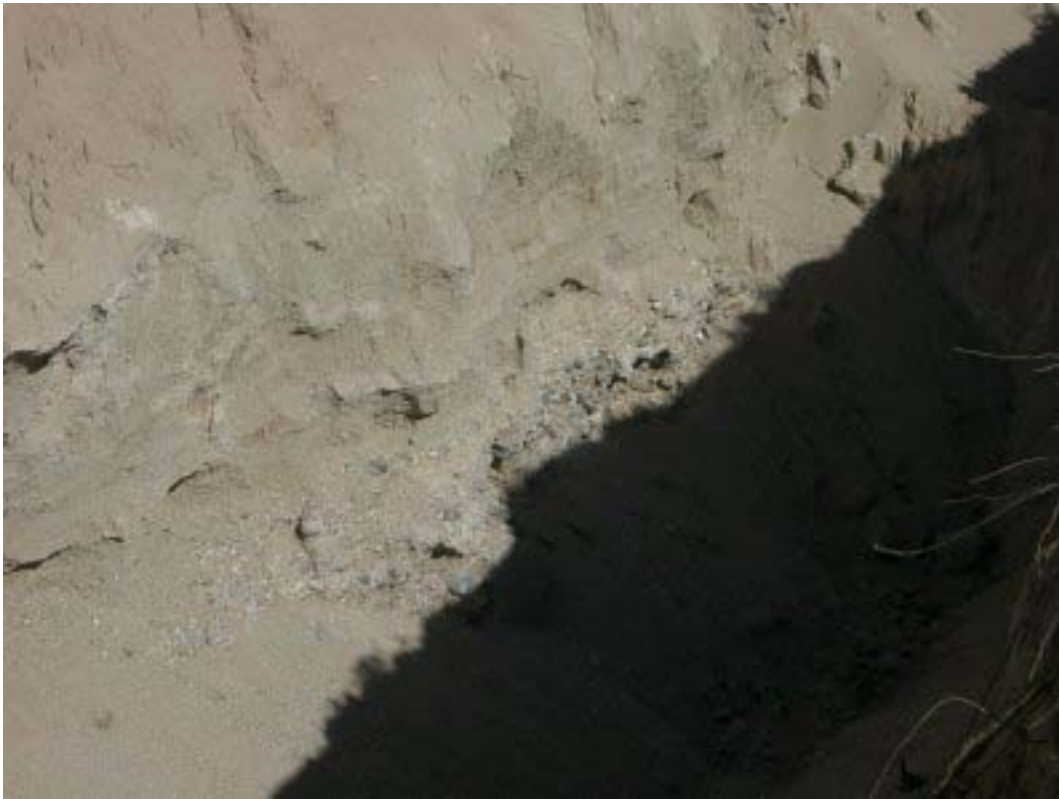
The remains of a old beach deposit (possibly of late Holocene age) of round quartzite cobbles and shell underlying a layer of fossil dune several meters thick was noted in the deep excavation trench in the northern portion of the property (Figure 5). The deposits in these deep trenches contrast markedly with the soft wind blown sandy deposits in the southern portion of the property.

Figure 5. Cobble and shell beach deposit underlying layer of fossil dune.
