EIA FOR THE PROPOSED REZONING AND SUBDIVISION OF A PORTION OF ERF 1556, HOUT BAY

HERITAGE SPECIALIST STUDY

March 2004

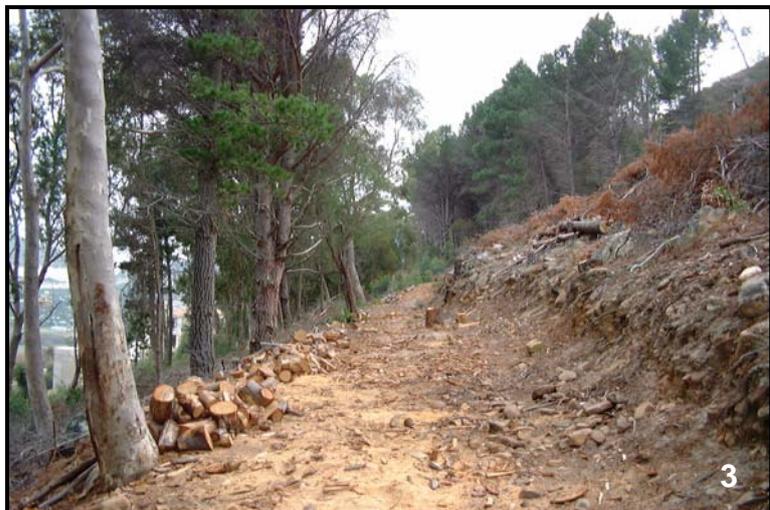
The site is located on a steep mountain slope and is largely covered by alien vegetation, primarily Eucalyptus and pine trees (Figure 3). These are a remnant of earlier plantations in the area. Most of the area falling above the CPPNE boundary has been cleared by the Table Mountain National Park authorities. A forestry road also runs through the site (Figure 3).

Although the road cutting (Figure 3) provided a good opportunity to search for ESA material, no Stone Age material of any sort was found on the site. Several features pertaining to the recent historic period, however, were recorded. These include a small ad-hoc reservoir (S 34° 02' 19.5" E 18° 22' 01.2"; Figure 4) and path alignment (Figure 5) as well as the cultural landscape of both the greater Hout Bay area and the area immediately surrounding the site.

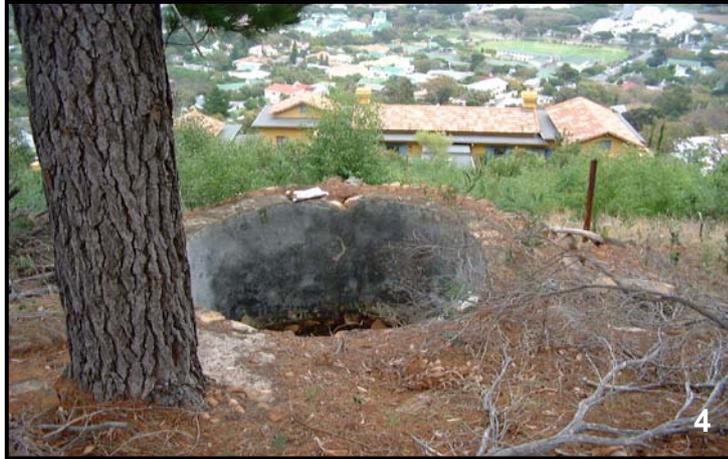
Jeremy Blood of Crowther Campbell & Associates mentioned that this area, due to its altitude and location on a steep slope, has traditionally experienced water shortages due to low pressure. As a result, many local residents have resorted to local water storage and sourcing from the mountain as a means of overcoming the shortages. He suggested that this reservoir might represent such a water storage scheme used by earlier residents of the area, a suggestion with which we concur. The reservoir clearly dates to some time in the earlier half of the 20th century since the galvanised pipe and brass tap built into it (Figure 6) probably date to the 1930's or 1940's. The reservoir is constructed from local cobbles and boulders of Table Mountain Sandstone. The innermost rocks are partly cemented with Portland cement and a plaster layer has been applied to seal the inside (Figure 7). The remainder of the wall towards the outside is dry-packed (Figure 8). The approximate position of the reservoir on erf 1556 is indicated in Figure 9.

Description of effect: Any construction or landscaping activity has the potential to affect the reservoir.

Assessment: In terms of local heritage, the reservoir is not considered worthy of conservation. Any impact would therefore be of very low significance. “Alternative C”, however, has the greatest likelihood of impacting the reservoir.

Mitigation: Preservation of the reservoir would result in a zero impact, but considering the low intensity of the impact before mitigation, none is suggested.

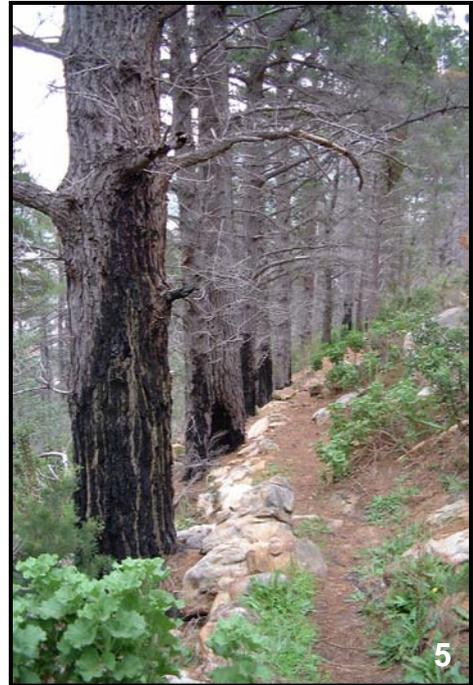
The pathway (Figures 5 & 9) is a roughly constructed one, with the lower side built up with rocks to stabilise the edge. Upslope from the forestry road a row of pine trees lines the lower edge of the path. The path runs past both reservoirs, but was cut through by the forestry road destroying any direct links. The modern PVC pipe has been laid along this path. It is uncertain whether the path is younger or older than the reservoirs.

Description of effect: Any construction or landscaping activity has the potential to affect the path.

Assessment: In terms of local heritage, the path is not considered highly conservation-worthy and furthermore, a considerable portion of the path does extend beyond the current site. However, since the path is part of the cultural landscape, and has probably been in regular use for some time, a low to medium intensity impact would be experienced. The developer has proposed linking the access servitude with existing pathways, and as such, losing the section of path falling within erf 1556 would be of low significance.

Mitigation: Ideally, the path might be preserved and incorporated within a public servitude, thus resulting in a zero impact. However, bearing in mind the relatively low intensity and significance of the impact before mitigation, ensuring public access to the remaining portion of the path to the east of erf 1556, via a suitably sited linking pathway, would be a suitable mitigation requirement.

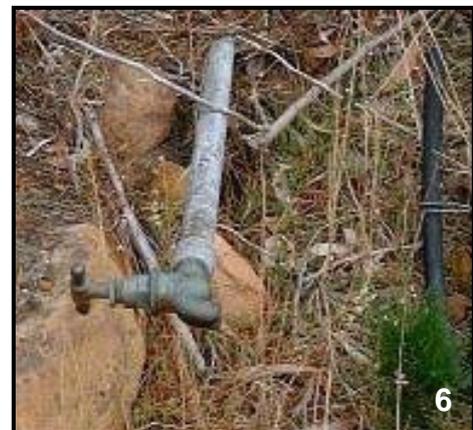
This reservoir is linked by means of a modern PVC pipe (part of which is visible in Figure 6) to another smaller reservoir located upslope to the south-east, but well off the property (Figures 9 & 10). The PVC pipe (now broken in several places) also runs downslope from the lower reservoir and

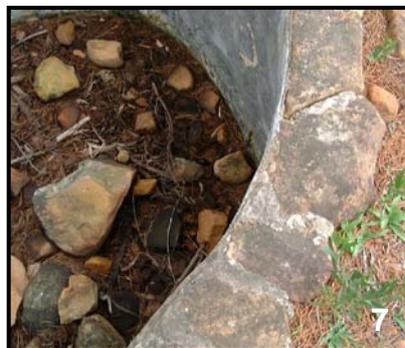
indicates that the system has been maintained and used in recent years. The approximate position of the second reservoir is also shown in Figure 9. By virtue of its construction materials, this reservoir is possibly younger than the lower one.

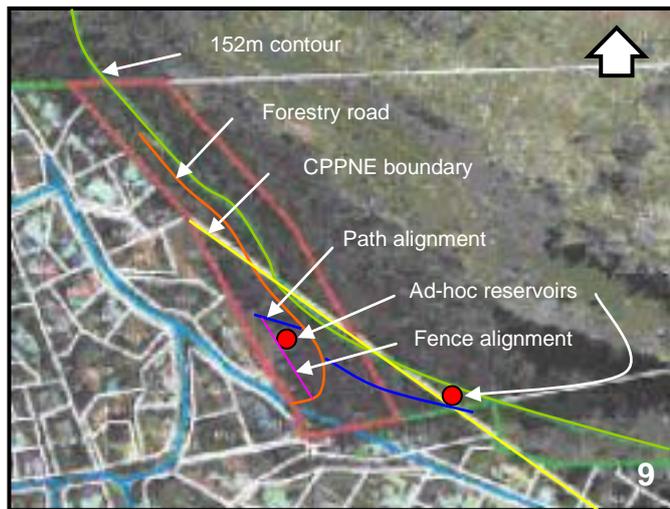
Please note that the path, reservoir and fence positions are only approximate

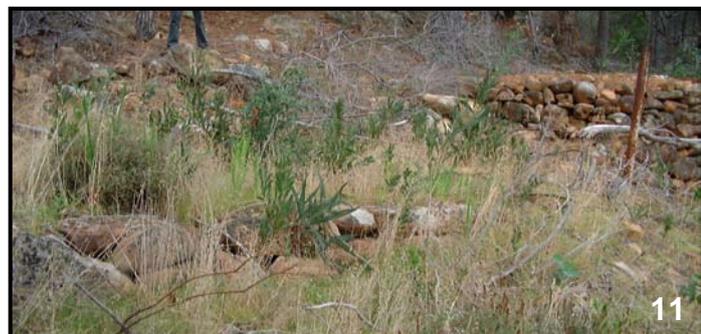
A further feature related to the lower reservoir is a small platform edged with rocks (Figure 11) that was possibly constructed to create a flat area on which to site the reservoir. This platform coincides with an old fence line that runs directly across the front of the reservoir extending only a few metres to the north-west, but ending to the south-east to the edge of the forestry road (S 34°02'22.0" E 18°22'03.1"). The fence line is of iron poles, and strands of rusted barbed wire are evident in places. Since the fence does not coincide with an erf boundary, it is likely to be an informal division within a property.

Description of effect: Any construction or landscaping activity has the potential to affect the fence line.

Assessment: In terms of local heritage the fence line is not considered worthy of preservation. Any impact would therefore be of very low significance.

Mitigation: Preservation of the fence line would result in a zero impact but considering the low intensity of the impact before mitigation, none is suggested.
