AN ARCHAEOLOGICAL IMPACT ASSESSMENT OF SLOPES REQUIRING STABILISATION ON VICTORIA ROAD (MR103), BETWEEN CAMPS BAY AND HOUT BAY

Megan Anderson Landscape Architects

March 2004

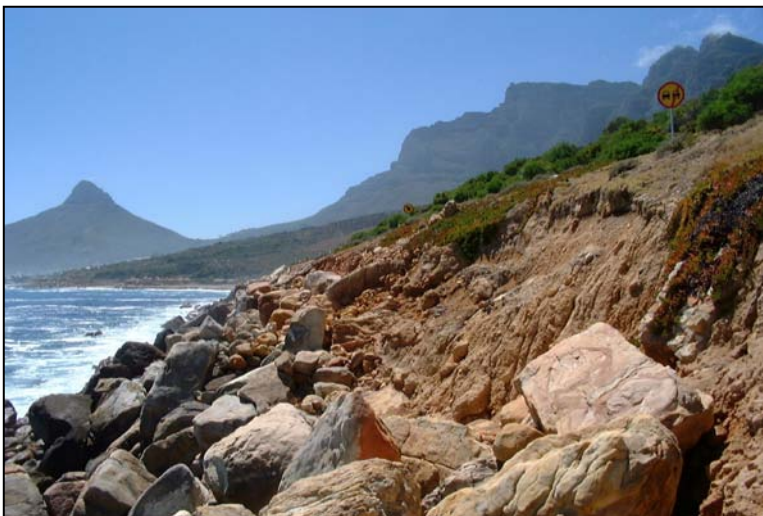
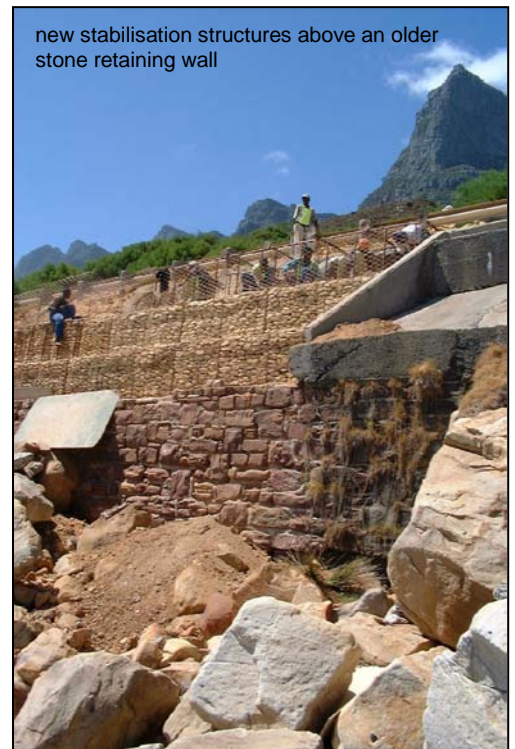
Nature of the site: The slope requiring stabilisation lies on the seaward side of the road. The slope is characterised at the top by secondary fill from previous road cutting activities, which in turn overlies *in situ* and secondary large boulders, and *in situ* scree slopes containing numerous smaller rocks and cobbles.

Observations: No stone age or any other artefactual material was observed in cut/erosion sections or amongst loose material.

Comments: Portions of older stone retaining wall is present in places in this area. The walls are made with dressed Table Mountain Sandstone with cement grouting between the blocks. It was noted that in places, the walls are constructed on a cast concrete foundation. While the walls indicate an earlier attempt at stabilising the slope, they are not believed to have significant historic value. They are being left in place.

Mitigation: No further archaeological intervention is required at this site.

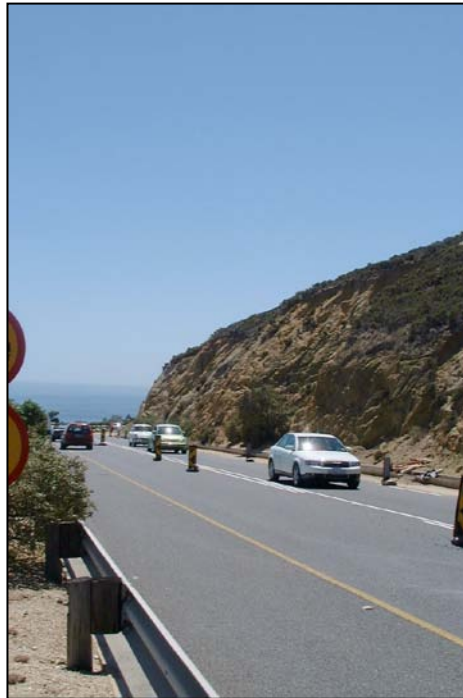
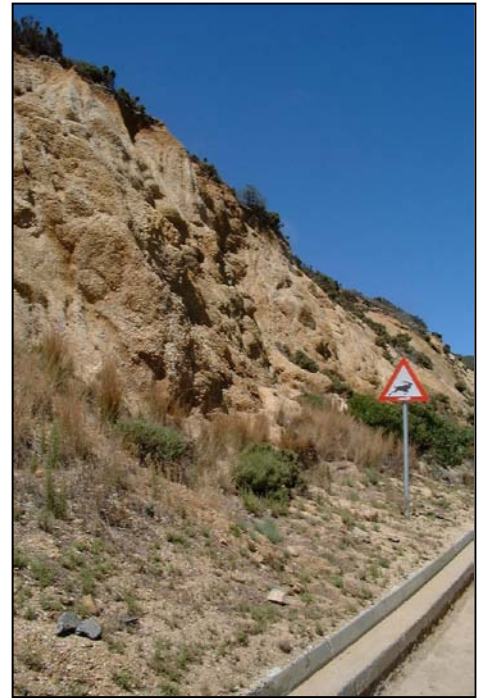
The slope requiring stabilisation lies on the landward side of the road. The slope is composed of decomposing granite.

Observations: No stone age or any other artefactual material was observed in cut/erosion sections or amongst loose material.

Mitigation: No further archaeological intervention is required at this site.
