A PHASE 2A ARCHAEOLOGICAL INVESTIGATION OF THE OLD ADMINISTRATION BLOCK AND FOREMAN'S HOUSE ALBION SPRINGS, RONDEBOSCH

Revel Fox and Partners

August 1993

Archaeology Contracts Office

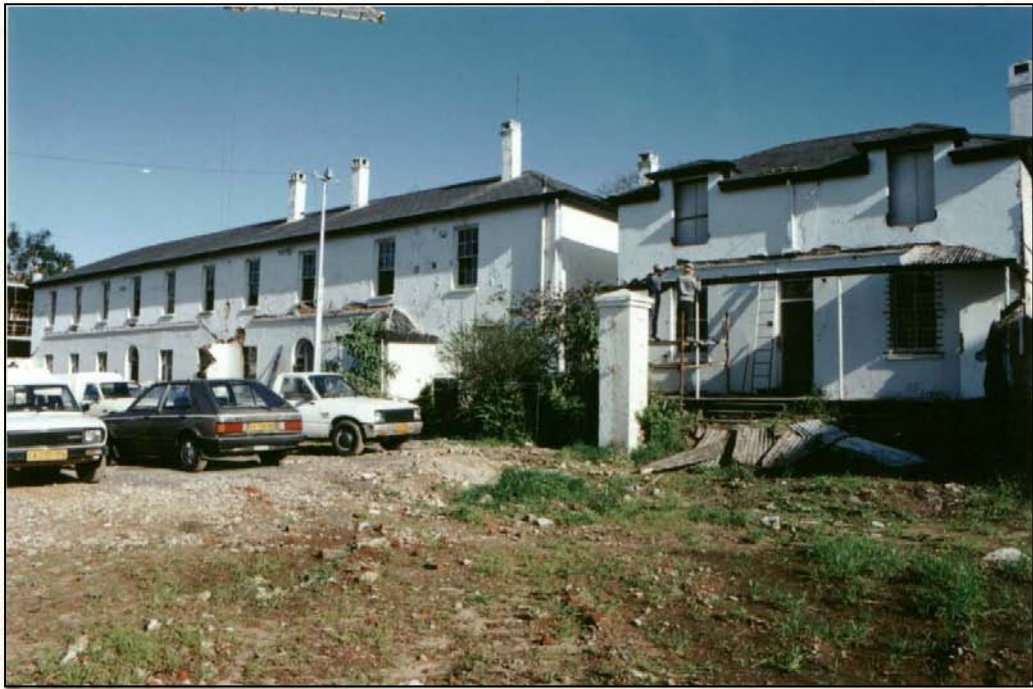
1

On appearance the Administration Block (Lot 1) can be described as an elongated double story building (Plate 1) with a small extension forming a "T" (now demolished) at the rear and 2 entrances opening on to an elongated stoep (with corrugated iron curvilinear canopy). Both the first and ground floor until recently contained offices, most with sash windows, and some with fireplaces. Some architectural features on the ground floor, including the front entrances, some of the joinery and architraves, are characteristic of the mid-19th century or earlier, while other features are considerably later.

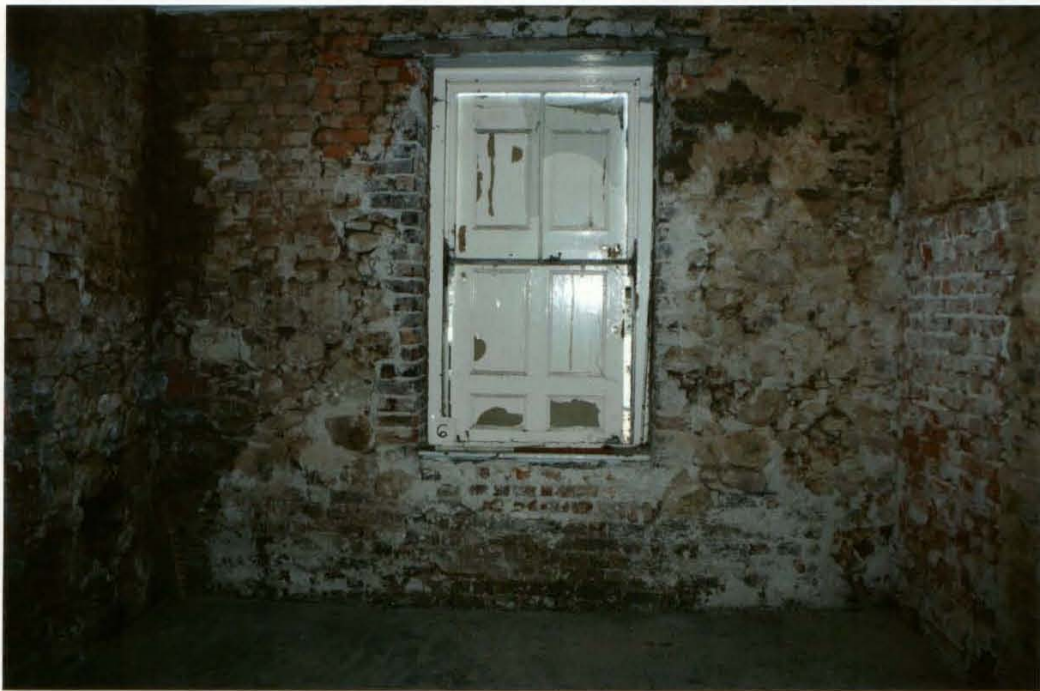
2

b. The sash window (ww5) is inserted into the wall (Plate 2). This is of a type that became popular at the turn of the 19th century (Appendix A).

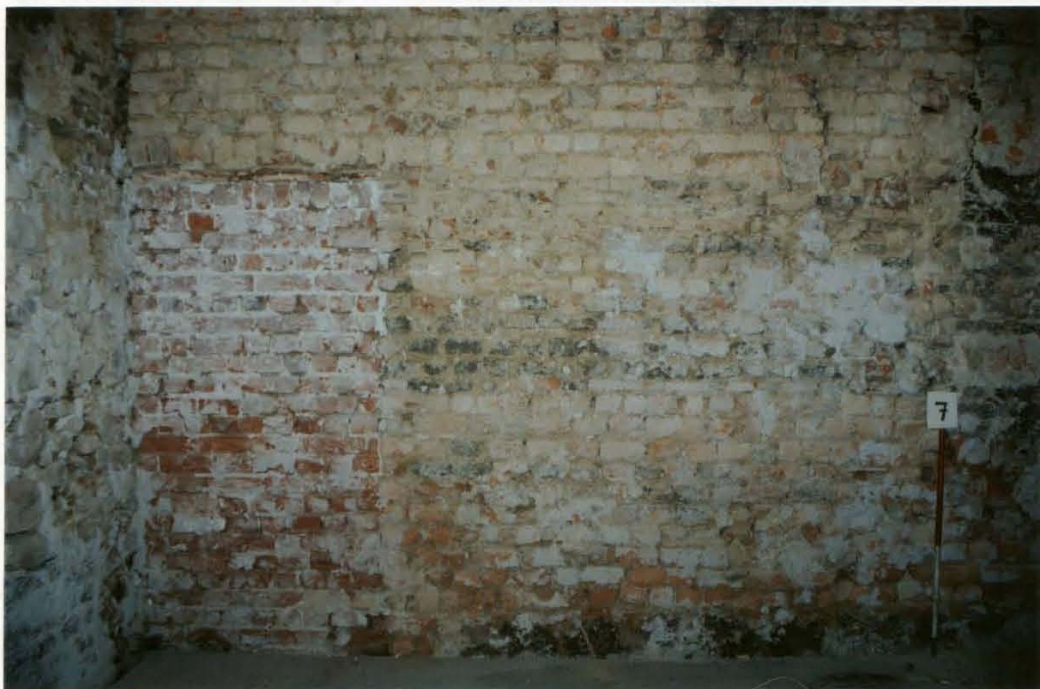
3

c. An interleading door between rooms GF 5 and GF 6 (south east corner) has been bricked up - probably late in the last century (Plate 3).

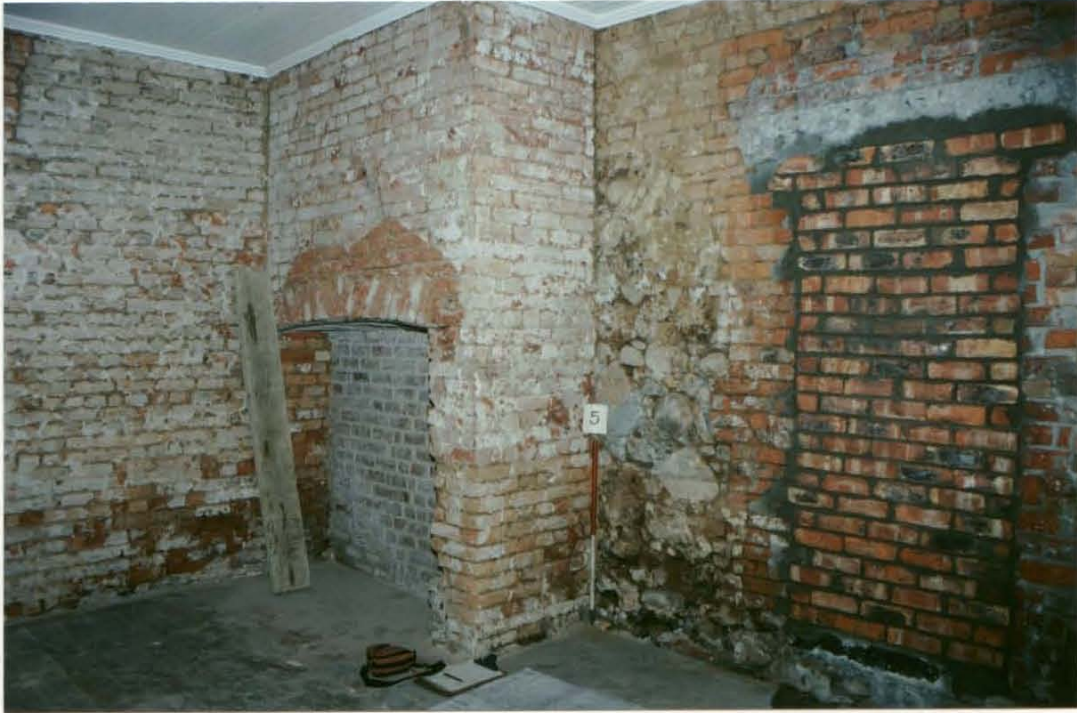
4

d. This is a large hearth built into the south east corner of the room (plate 4). This was probably built in the later 19th century to accommodate a range. Some original green paintwork exists behind the bricked area towards the back of the hearth.

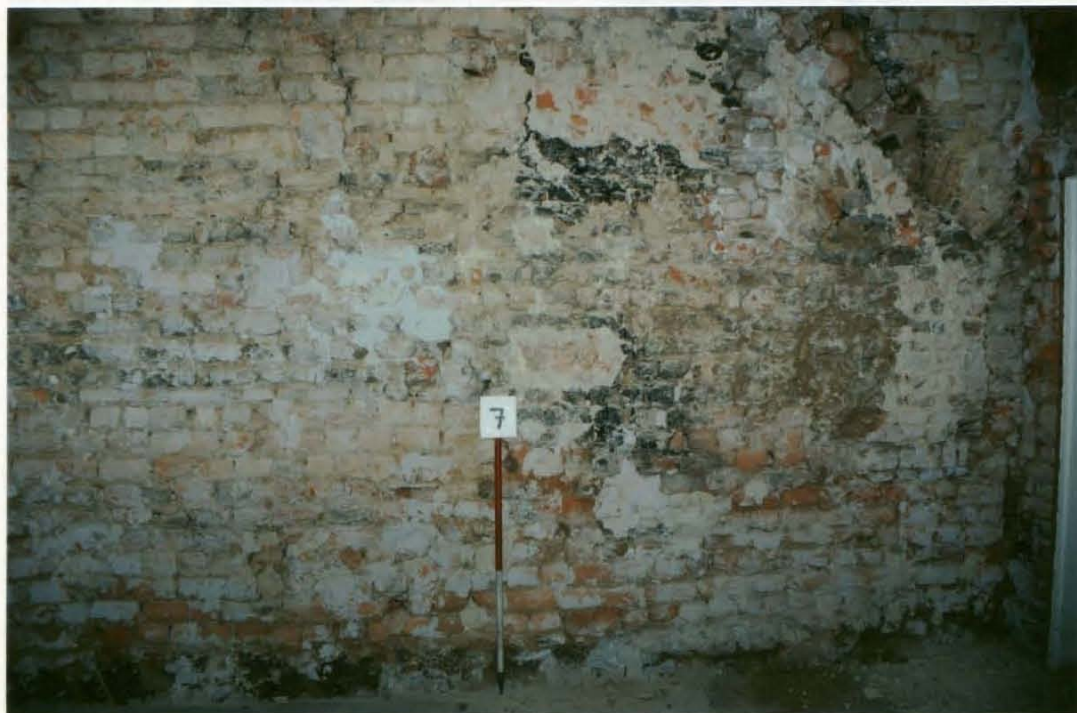
5

e. There is evidence that an earlier hearth was built into or against the north wall. This is indicated by the remains of an oven, and a diagonal chimney stack line above it. Traces of soot were visible on the wall before re-plastering (Plate 5). Further evidence of this feature may exist under the present floor.

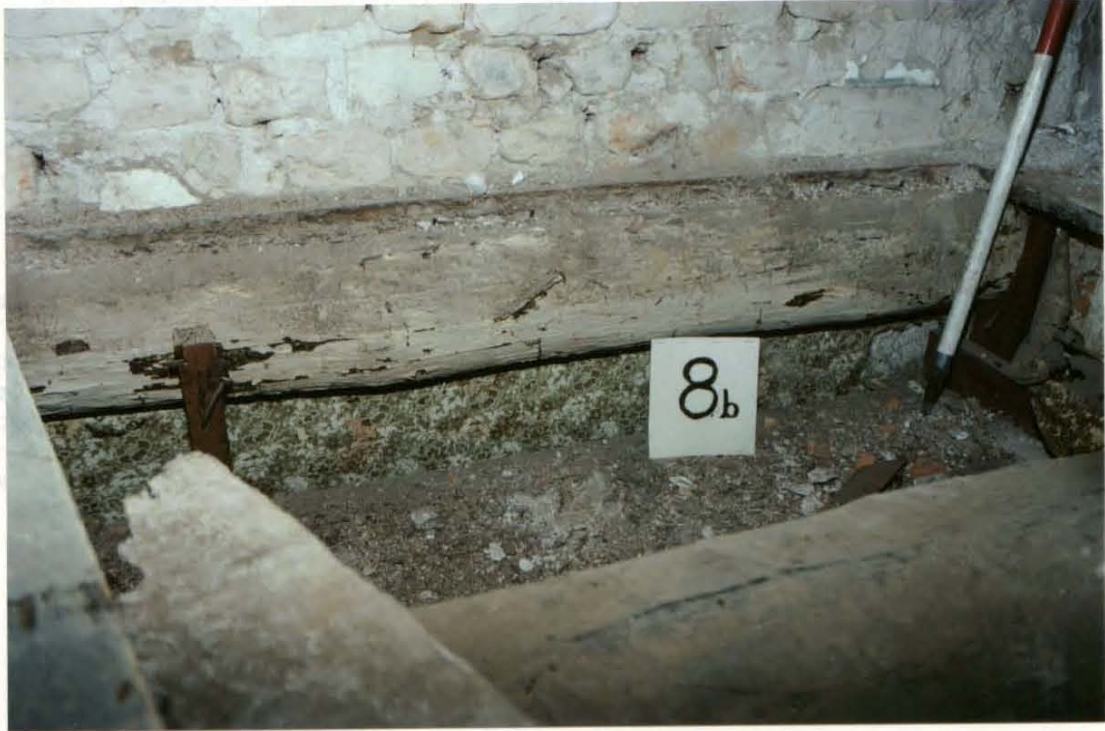
6

The existing fireplace is a later fixture, the bricks used in its construction match that of the fireplace in House built in 1890

- d. The existing fireplace is a later fixture, the bricks used in its construction match that of the Foreman's House built in 1889.
- e. As in Room GF 6, the window has been inserted towards the turn of century.

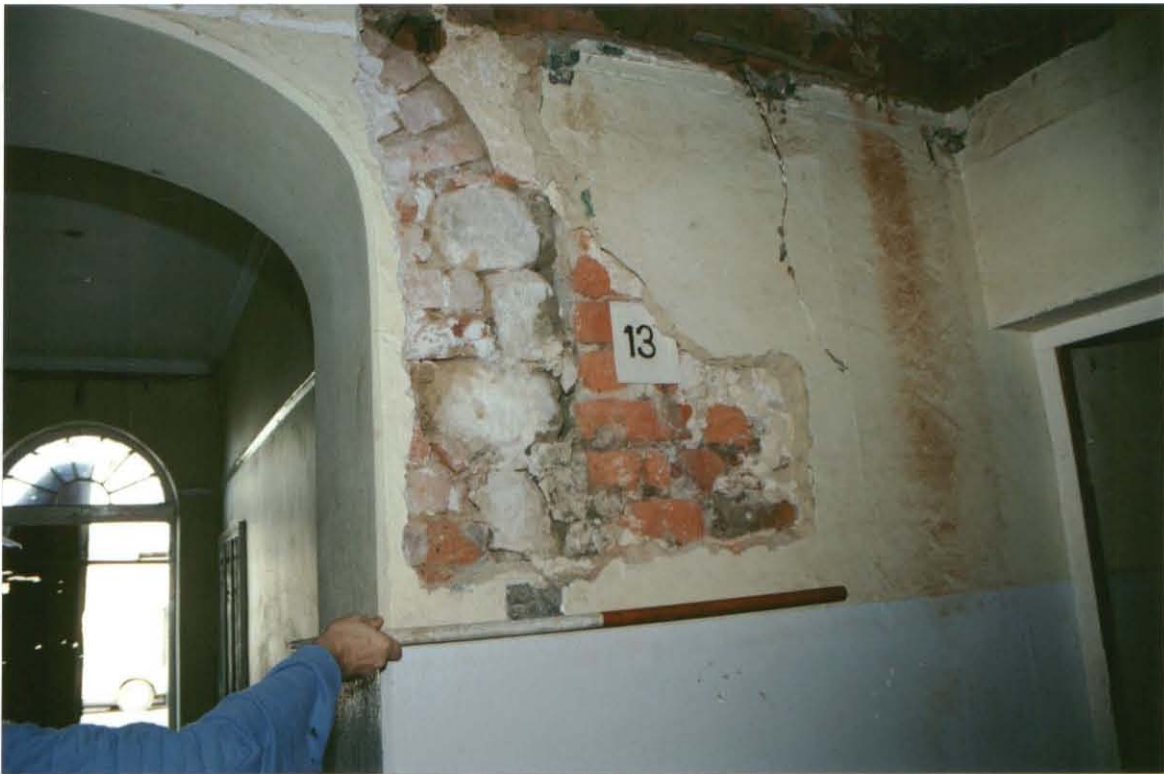
8

- a. Plaster removal shows that the wall (GF 4-north) separating Room GF 4 from passage 1 is very thick - some 560mm. It is likely that this was an outside wall.
- b. An arched doorway separates passage 1 from the rear corridor. Plaster removal at this point shows that the arch is constructed from a mixture of stone (TMS) and bricks. This abuts against the plastered outside of wall GF 4-north (Plate 8).
- c. It is likely that the arched doorway contained a door and semi-circular fanlight characteristic of the mid-19th century (Appendix A)

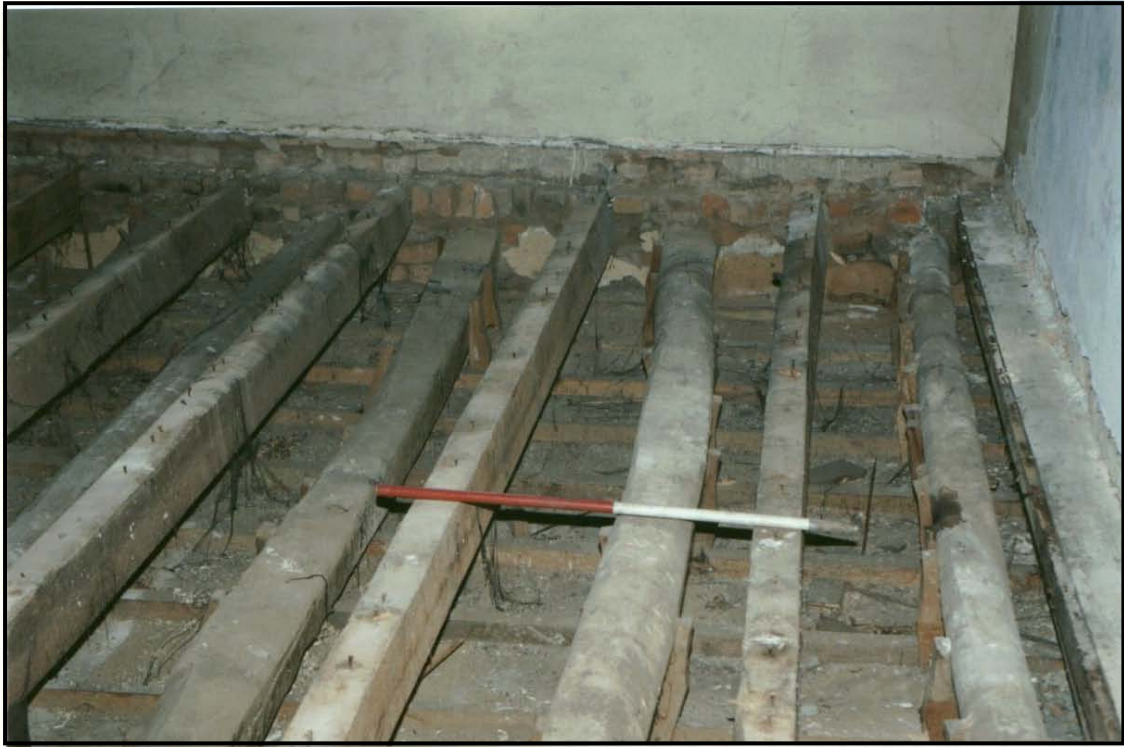
11

- e. Inspection of offices in first floor showed that the ceiling was suspended from uneven unshaped poles (Plate 11). The general level at which these are placed is slightly lower than that of section 1. The architects report (Appendix A) mentions the possibility that this structure had an open thatched roof before the first floor was added.

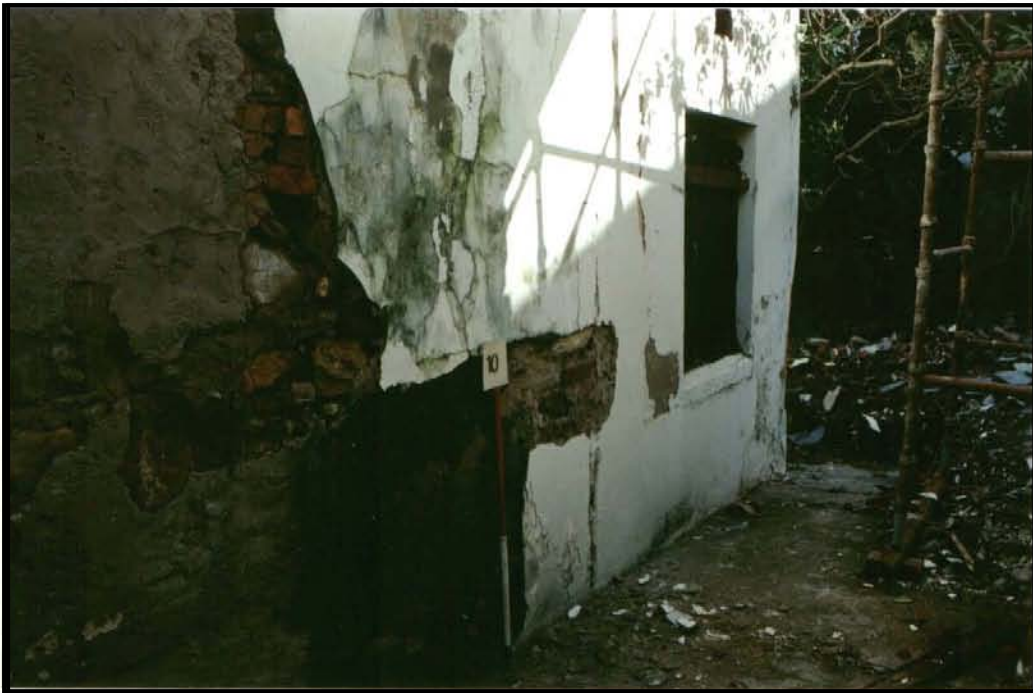
12

- a. Plaster removal on the northern wall of section 1 shows that the rear corridor is a brick addition to the largely stone wall of room GF 6 (Plate 12).

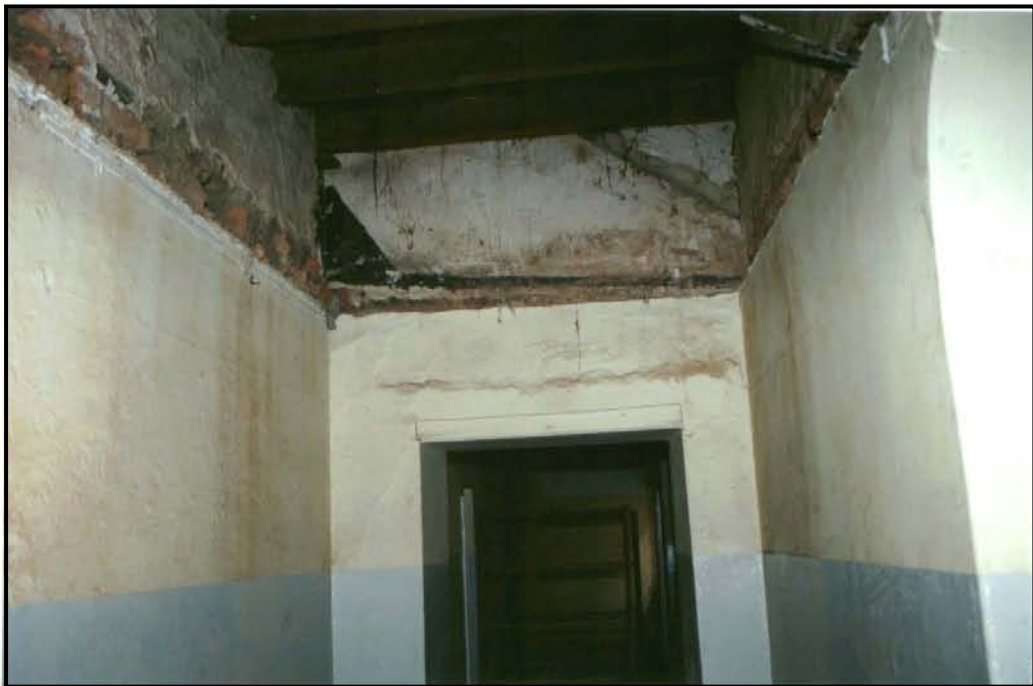
13

c. The unshaped tie beams of Sections 1 and 2 do not extend into the rear corridor. Removal of plaster and paint on the east wall of the rear corridor has shown that this was once a whitewashed exterior wall. A paint line and beam slots indicate that a verandah may have may have existed at the rear of the building and was removed when the rear corridor was built (Plate 13).

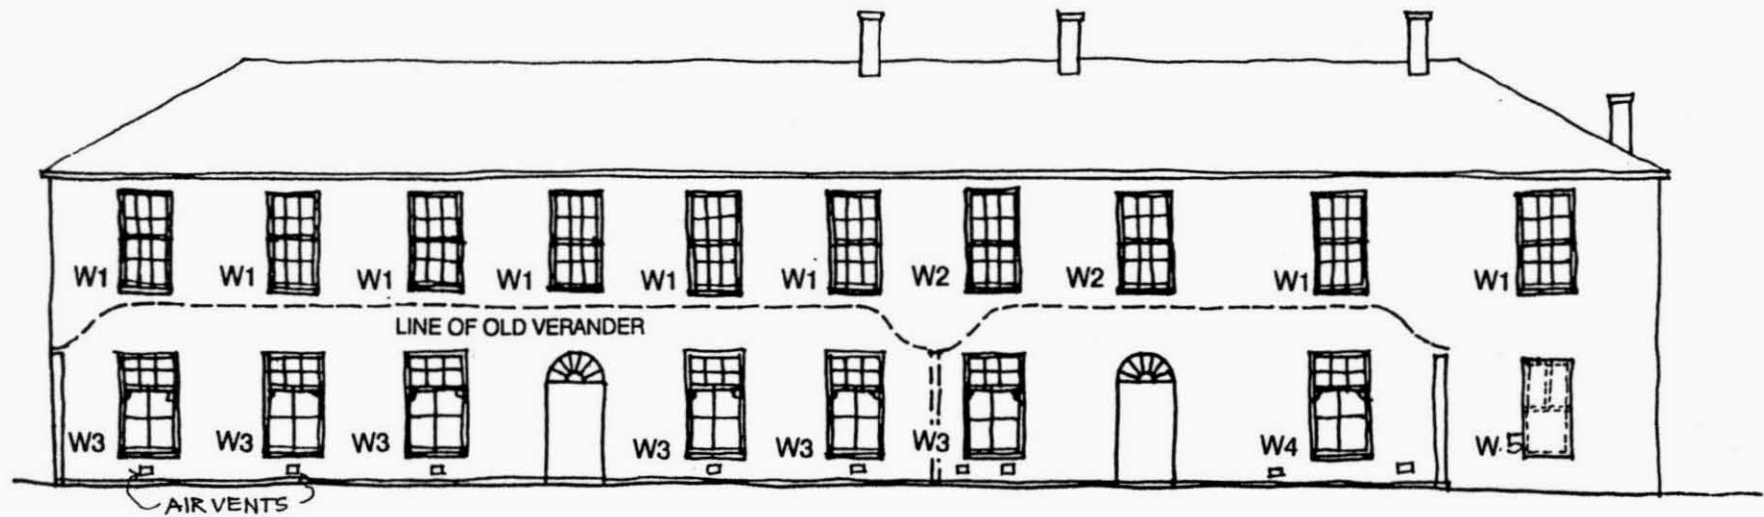
FIG. 2

EAST ELEVATION
