**ARCHAEOLOGICAL ASSESSMENT OF A GROUND
FLOOR ROOM (AN OLD COURTYARD) AT 72 & 72a
KEEROM STREET, CAPE TOWN.**

Prepared for

Horne Lutz Architects

May 1997

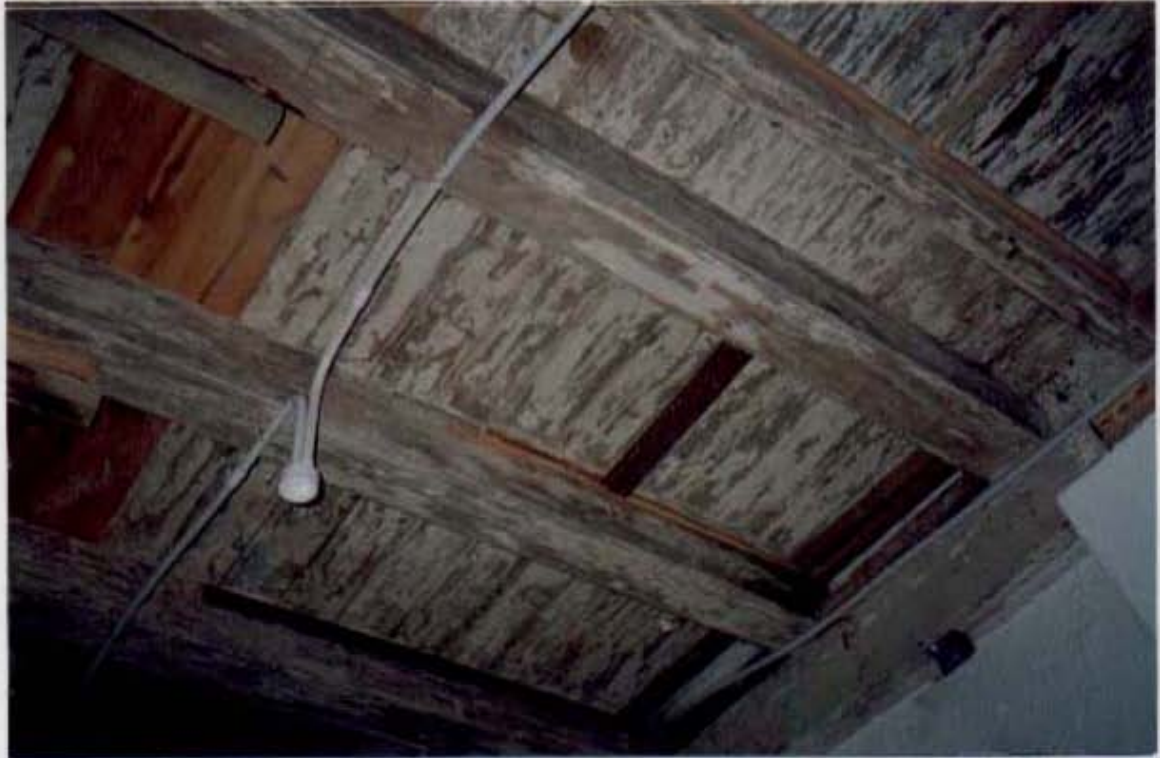
Plate 1: Photograph illustrating some of the yellow-wood beams in the ceiling dating to between the late eighteenth and early nineteenth centuries.

These pre-1860 buildings were evidently built along the edge of the property line illustrated in the 1819 map (Figure 5). Indeed, the fabric of the ceiling of the ground floor of no. 72a Keerom Street (the shaded area in Figure 8) is indicative of fabric found in buildings dating to late in the eighteenth or early in the nineteenth century. A portion of this old ceiling is shown in Plate 1. It thus seems that part of no. 72a was originally a storeroom, wagon house or barn associated with the dwelling illustrated on the map in Figure 5. This small storeroom seems to have originally extended all the way across no. 72a to the thick wall adjacent to the more recently built staircase although the yellow-wood beams of this ceiling which still exist only extend across the shaded area in

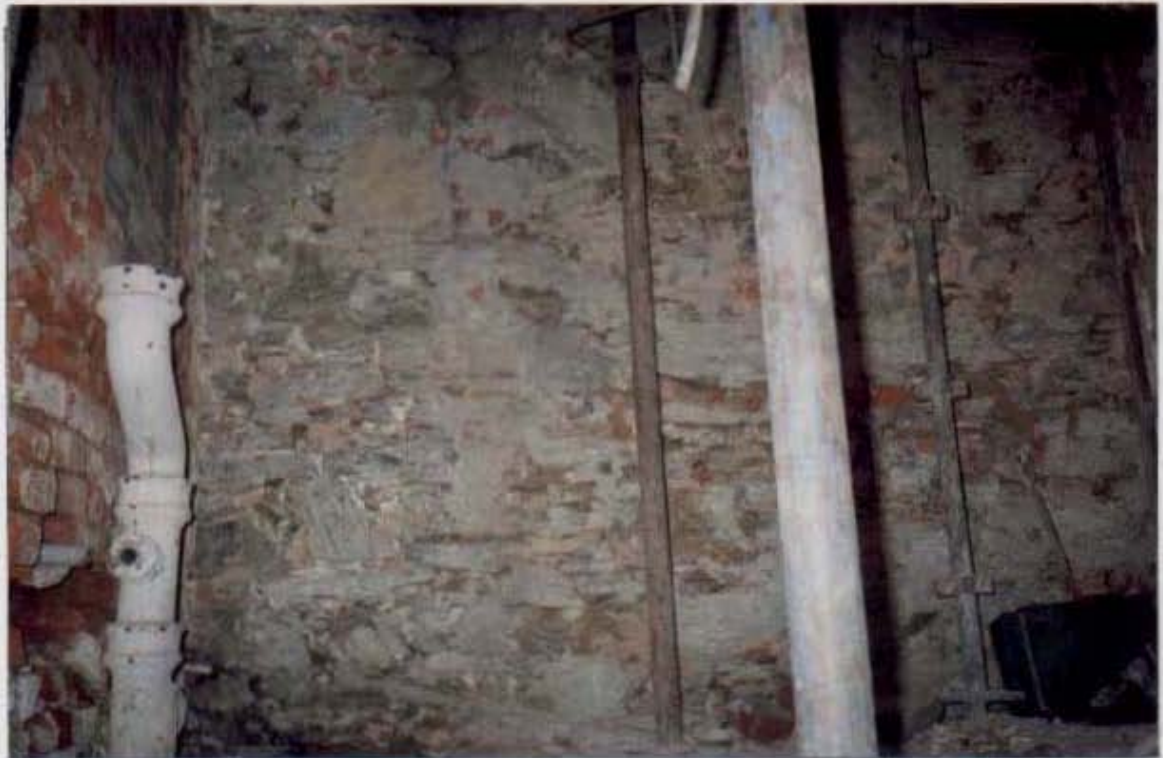
Plate 2: Some of the stone-walling revealed in the courtyard area during renovations.

Generally, the outside walls designated on the Snow survey can be readily identified on the modern building as they are much thicker than other walls. Precisely when the other parts of the building illustrated on the Snow survey were built is unclear, although the existence of stone walling in several places (Plate 2) do point to a relatively early date. Sections of this stone-walling were revealed when plaster was removed during renovations. It seems possible that the elongated section of the building (in the Snow survey) was built first along the property line indicated in the 1819 map (Figure 5). This building probably housed labourers working in the adjacent house or gardens, and a possible doorway is indicated in Figure 8. The extension closest to Keerom street was possibly built sometime towards the middle of the nineteenth century.

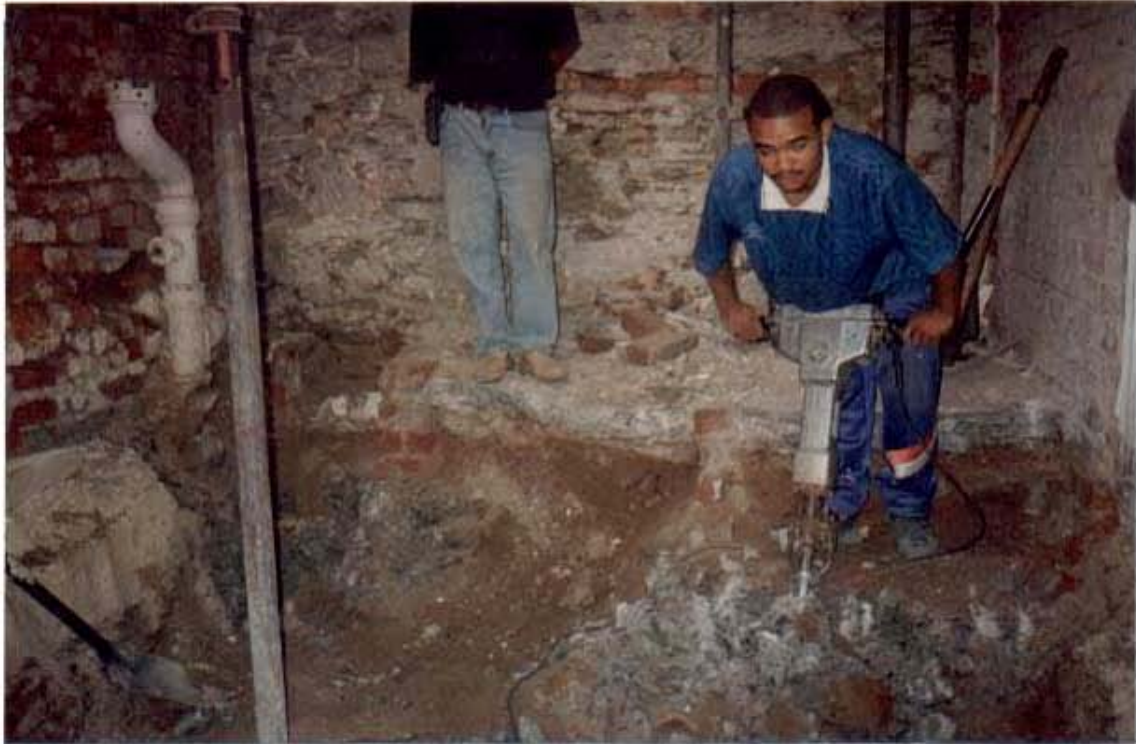
Plate 3: Photograph illustrating the disturbed nature of the deposit. The contractors in the photograph are breaking up the foundations for the toilets built in the courtyard.

Test excavation was thus limited to a small section of the courtyard between the old toilet foundations and the drain junction (see Figure 10). The concrete slab was removed and the deposit below was excavated. The deposit consisted mainly of rubble and plaster between which small amounts of bone, ceramics, glass and metal were recovered. These are detailed below. No stratigraphic layers could be identified and it was clear that this deposit had also been extensively disturbed. Several pipes criss-crossed the section being excavated and a large drain pipe crossed the corner of the excavation and extended deep into the deposit (to a depth of 65an). The disturbed nature of this deposit is illustrated in Plates 3 and 4.

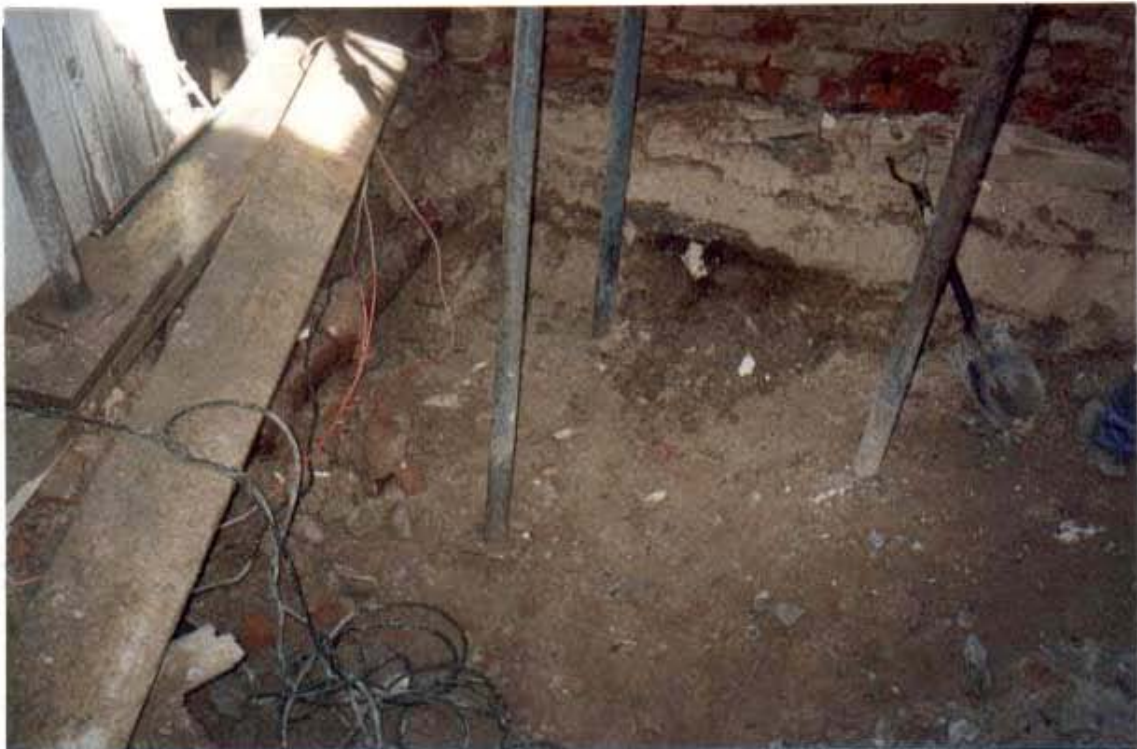
Plate 4: The position of the test excavation (parallel to the planks in the photograph). Note the pipes intruding deep below the surface.
