A FIRST PHASE ARCHAEOLOGICAL INVESTIGATION OF NO 4 BEXHILL RD, WYNBERG

**Prepared for the City Planner,
Cape Town City Council**

June 1992

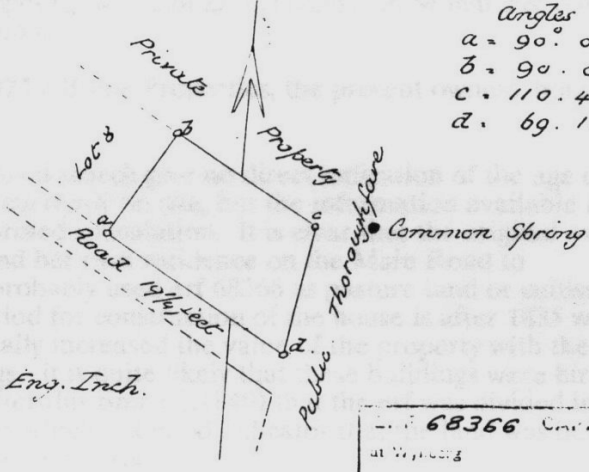
Figure 2.3

The above figure abcd represents 52 Square Rods of ground situate near the Wynberg Railway Station, being Lot 9 of the ground granted on perpetual quitrent to S. Willemse on 20 February 1832, and now held by Leah Anderson by Deed of Transfer dated 28th December 1857

- Bounded NE by Private Property.
- W . Public Thoroughfare
- SW . Road
- NW . Lot 8

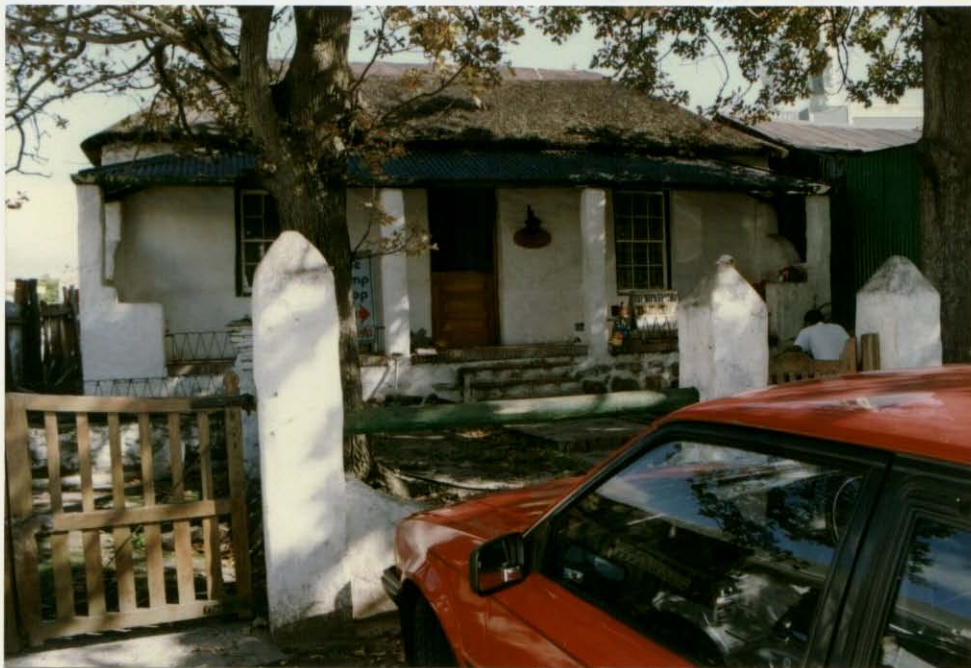
The front aspect of the house has been heavily renovated with modern materials. Cement plaster has been roughly applied so as to create an illusion of age. As far as can be established the walls and adjoining pillars at the end of the stoep have been constructed using contemporary bricks and plaster. Stoep seats, besides being a feature of dutch period dwellings at the Cape, exist among the 19th century dwellings of the Bokaap in Cape Town. Although it is possible that bench seats could have been an original feature of no 4 Bexhill, the existing benches appear to be modern replicas. Extensive plaster removal and controlled disassembly would be needed to confirm this.

Figure 3.2: Front facade and garden.

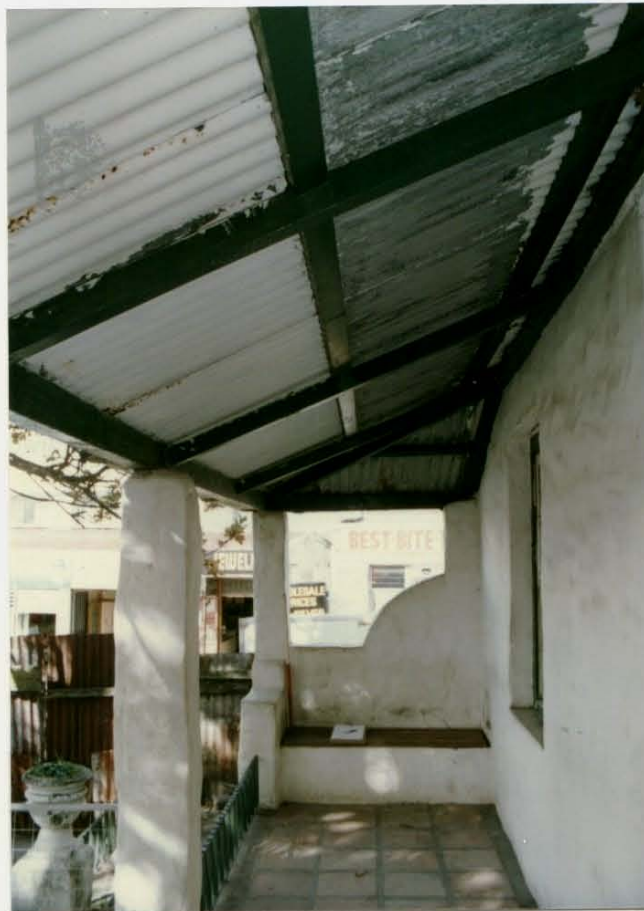
Access to the stoep and entrance to the house is via 3 steps. Bench seats have been built into low walls on either end of the stoep. The floor is paved with modern red ceramic paving stones. The stoep walls and entire facade of the house has been roughly plastered with a

Figure 3.3: Stoep and bench.

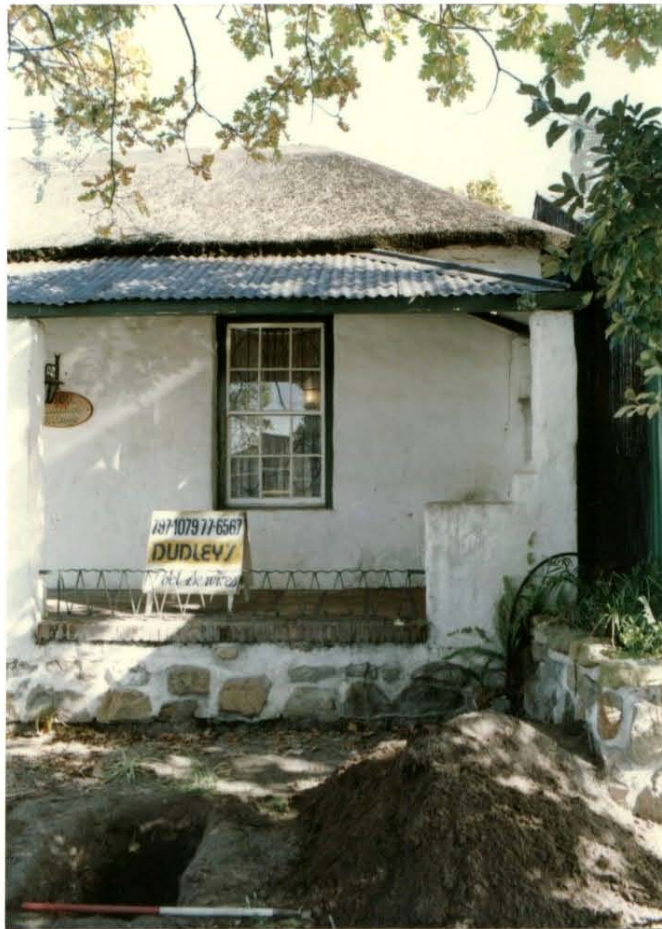
Figure 3.4: Front facade - detail.

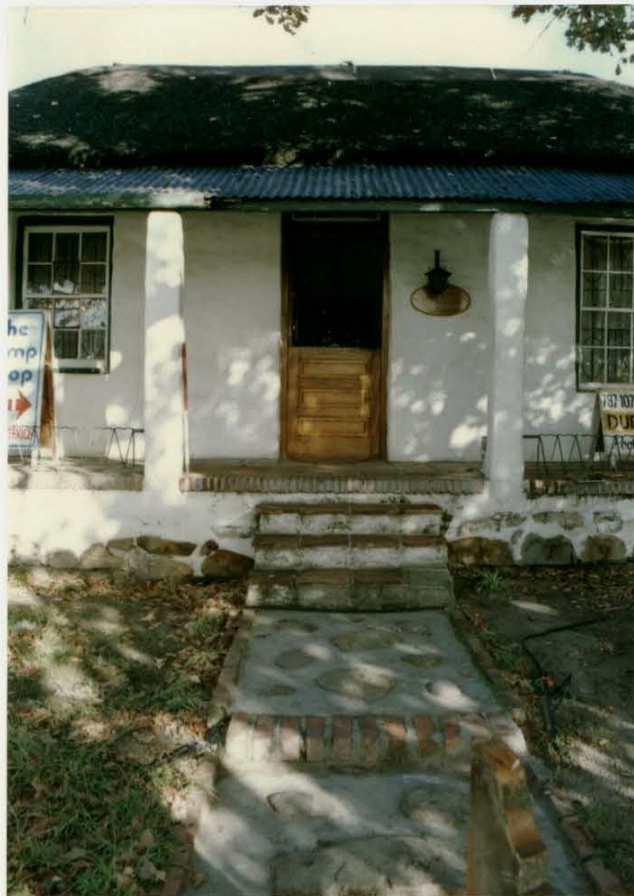
Figure 3.5: Front facade - detail.

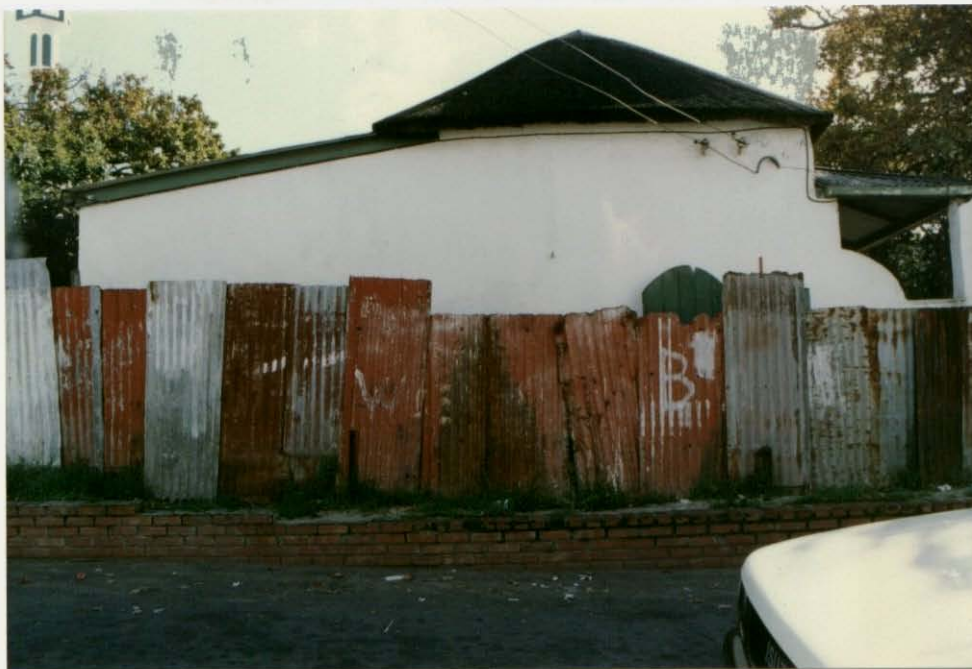
Figure 3.7: Side profile of house.

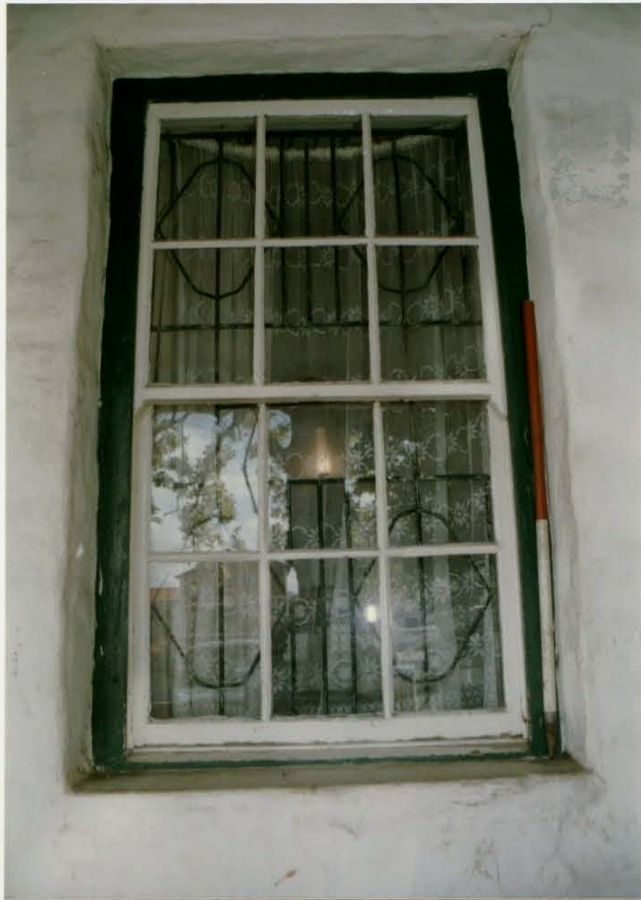
Both sash windows of the front rooms have sills front and back. While the window frames are of British proportion, the windows themselves are typical of those seen in Victorian houses of South Africa. It is possible that both frames and windows may have been replaced at some stage but this can only be verified by plaster removal.

Figure 3.8: Sash window - detail.

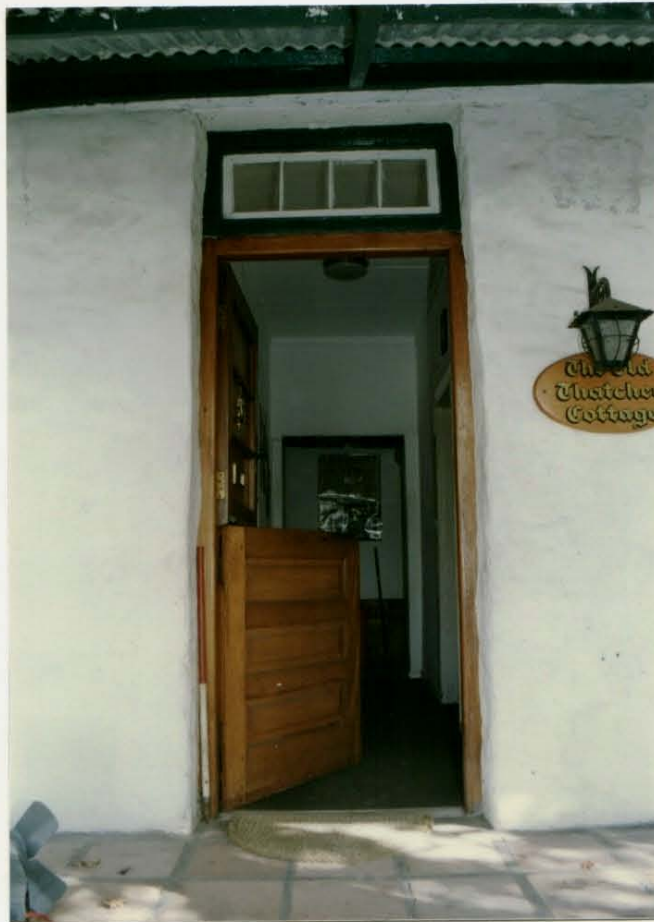
This consists of two rooms (used as office space) with doors leading onto a central passage. The front door itself is modern but the square fanlight window and lintel could be part of the original structure. The ceiling of the passage may be of some antiquity as it consists of flush fitting timber boards (not tongue and groove) aligned laterally across the width.

Figure 3.9: Front door

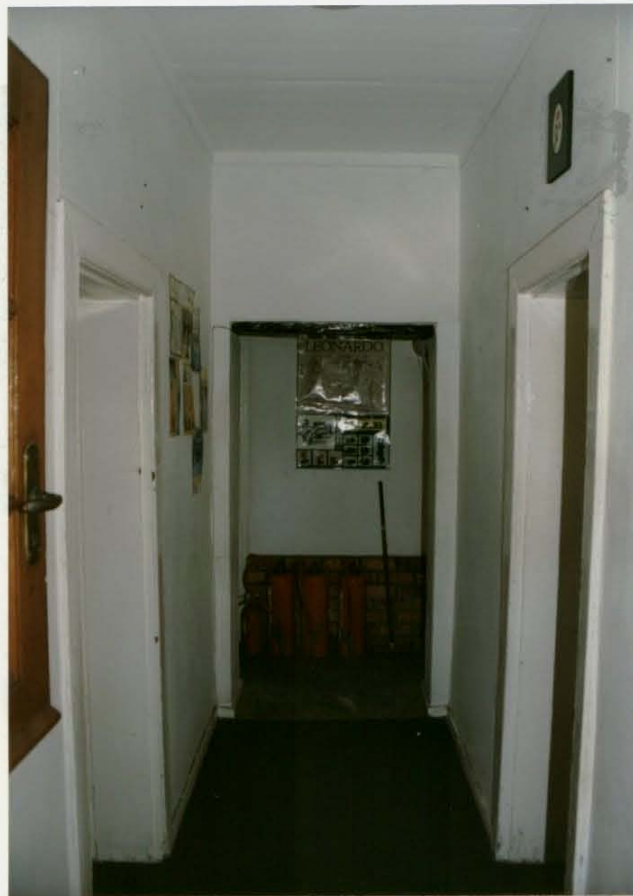
Figure 3.10: Hall passage

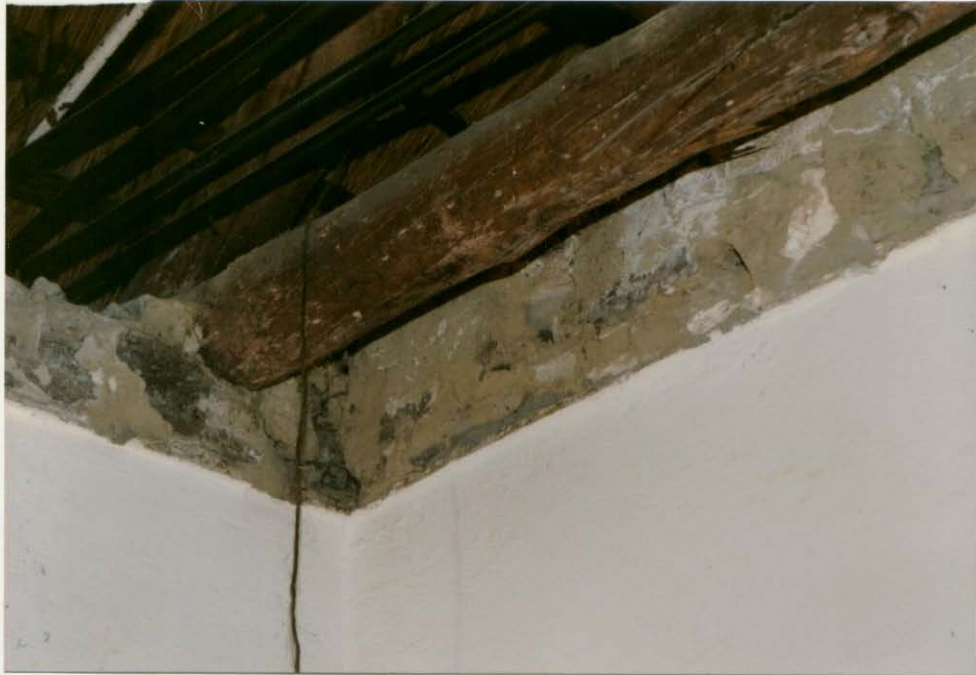
Figure 3.11: Beam and older plaster.

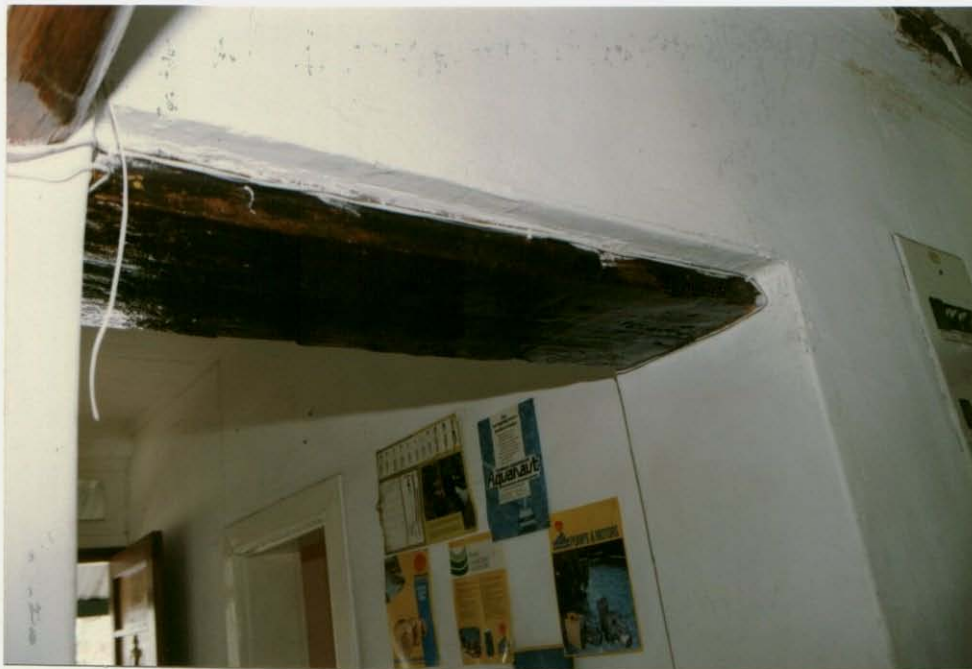
At the rear end of the passage is a doorway. Both door and frame have been removed during modern renovation but the plastering has been accomplished in such a way here as to leave a wooden lintel exposed - no doubt the intention here was to create an atmosphere of 'rustic charm'. Beyond this point is the bathroom, the walls of which are board. This is a new addition as the original lavatory is in the backyard.

Figure 3.12: Lintel

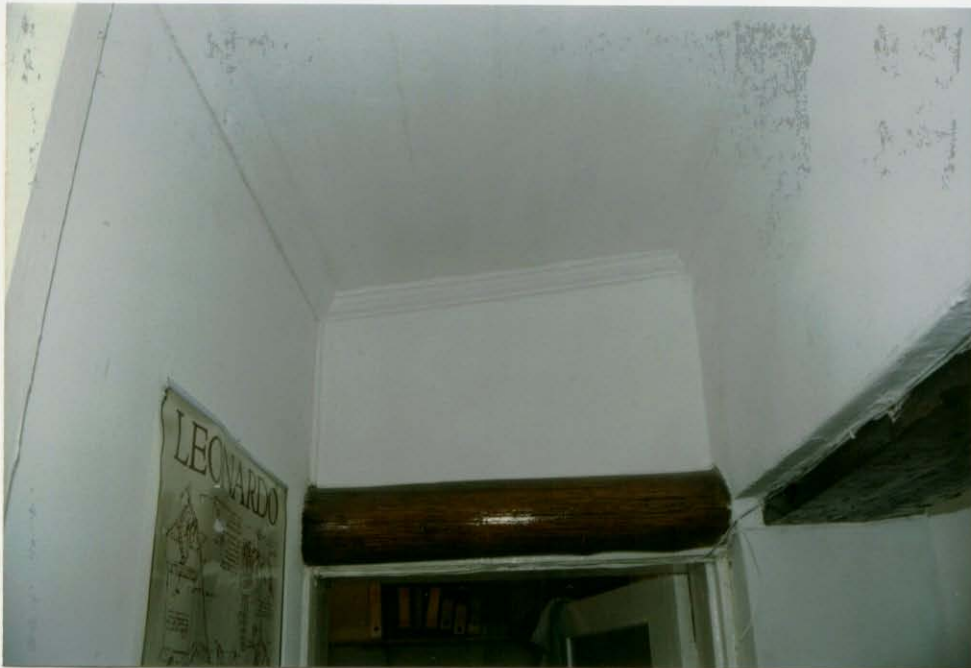
The doorway to the rear north room (office) has an artificial lintel that has been plastered into a position on the outside of the door frame. As far as can be ascertained, the lintel (a section of eucalyptus pole) is of no structural value. We consider it to be a modern decorative feature.

Figure 3.13: False lintel.

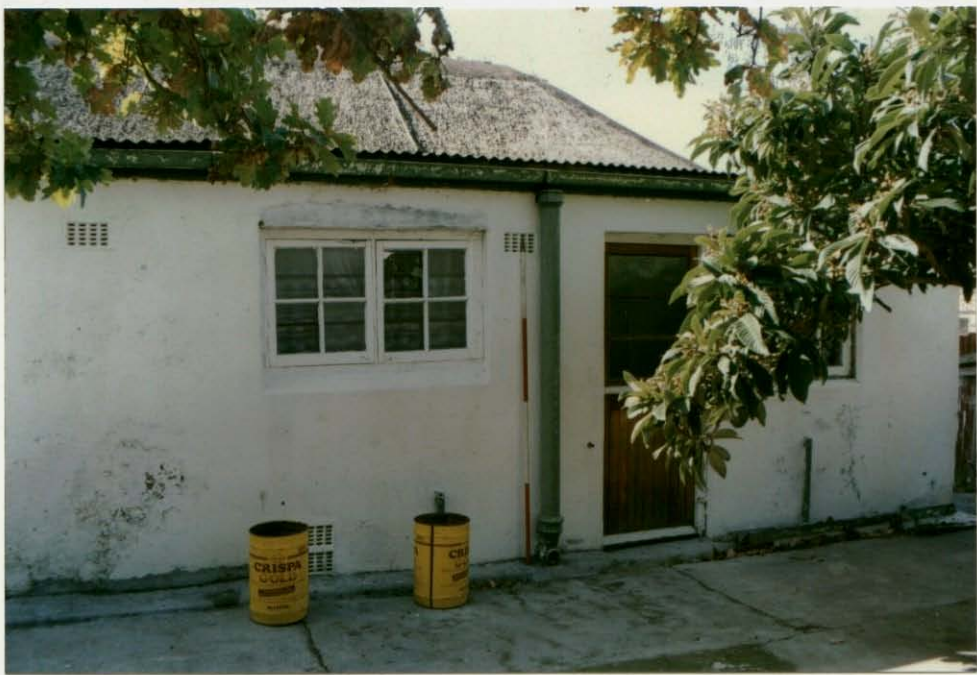
The rear portion of the property has undergone renovation on a number of occasions in the past. The back wall, door and windows are all modern. The ceiling in the rear kitchen and office slopes from south east to north west in accord with that of the corrugated iron roof. Unlike that of the passage, the ceiling consists of tongue and groove imported pine boards and mouldings. This may indicate that the rear rooms of the house may have added or modified after the turn of the century.

Figure 3.14: Rear facade - detail.

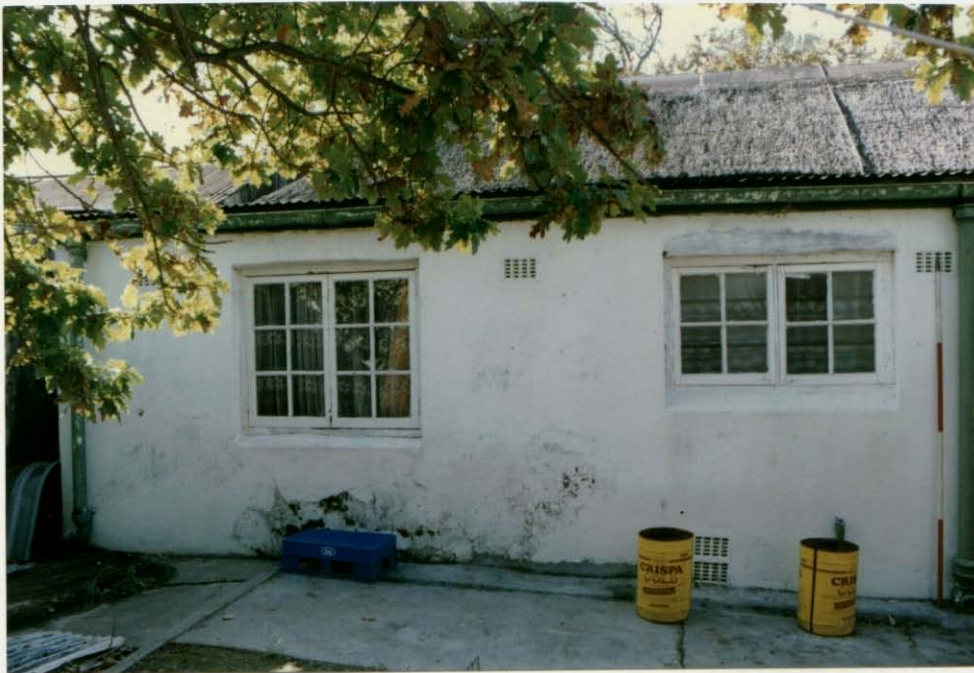
Figure 3.15: Rear facade - detail.

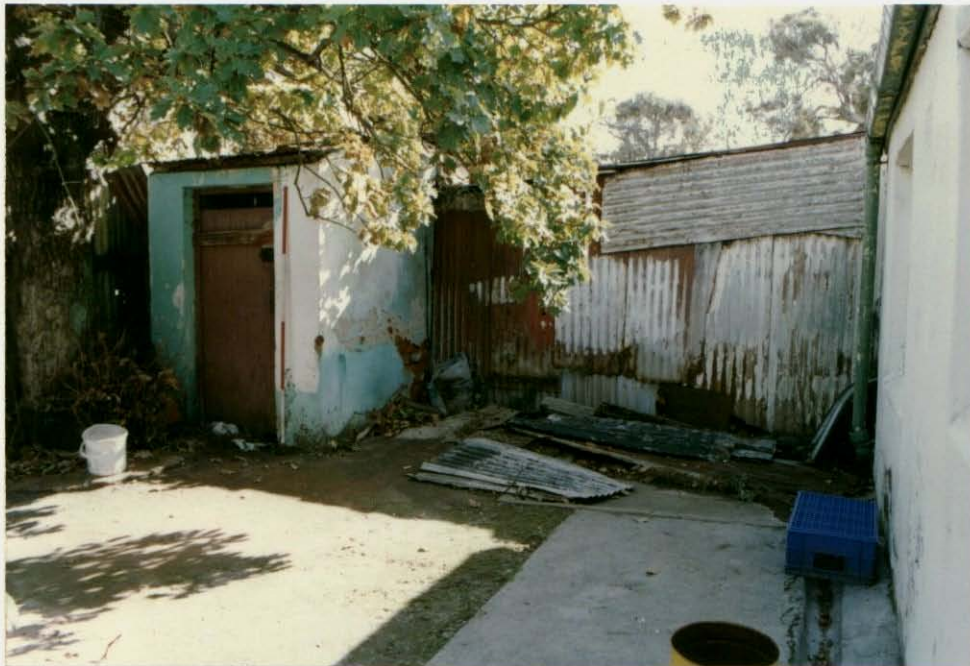
The outside lavatory is a simple flat roofed brick structure. The door is sealed at present which prohibited us from investigating the facility in detail. An inspection cover nearby shows that the lavatory is connected to a sewerage system. In the past it is likely that a simple pit drop would have sufficed here.

Figure 3.16: Rear yard with outhouse.

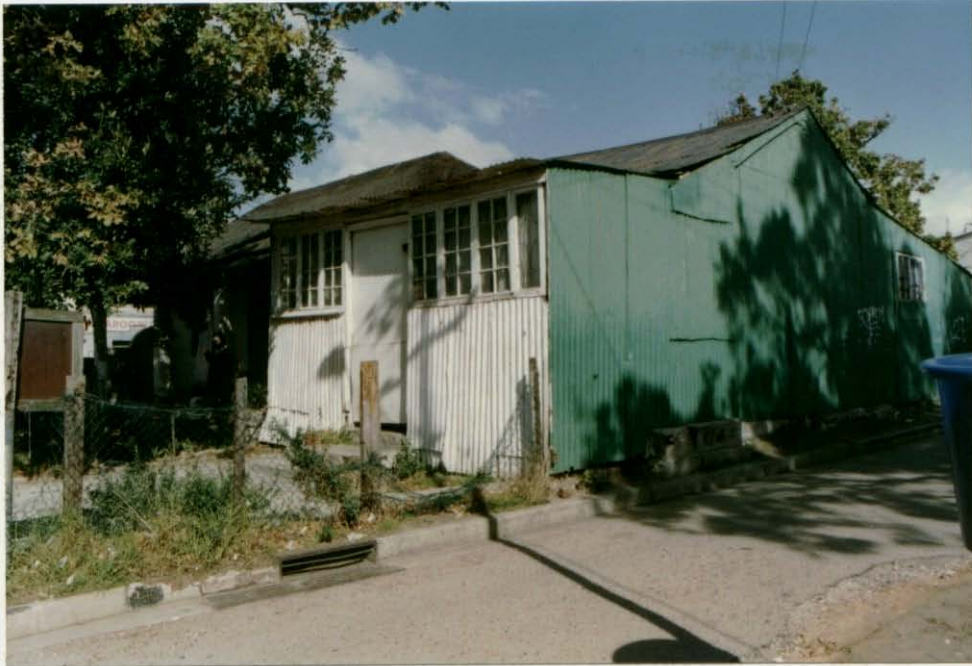
The neighboring corrugated iron building that presently serves as a Tailor's workshop is mentioned here as it could be quite old. The building although narrow, extends the entire length of the house and backyard of no 4 Bexhill.

Figure 3.17: Corrugated iron structure.

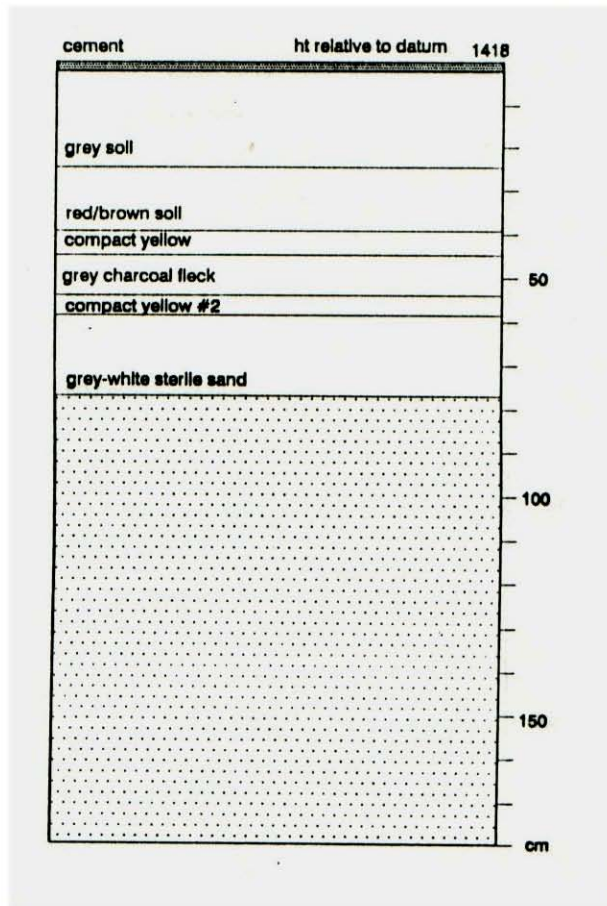
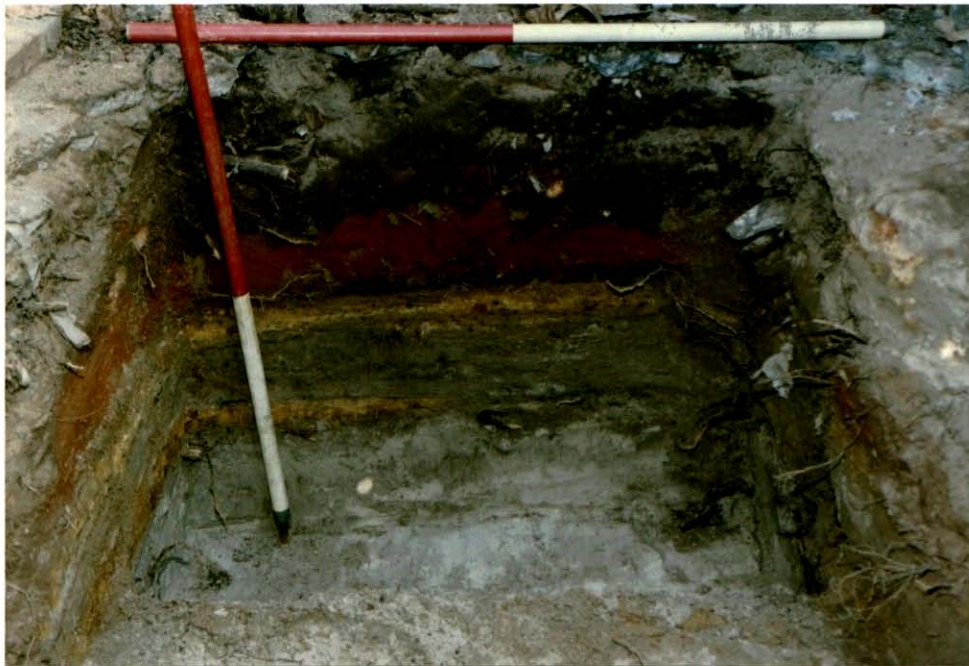
This is the only excavation which provided us with some *in situ* artefactual material from a stratified context. Although some disturbance had occurred in the form of two pits, these occurred at the edge of the square and thus had little influence on our findings. Two layers of the intact deposits are of interest, namely the "compact yellow" and the "grey charcoal fleck". We interpret the "compact yellow" to represent the level of an original prepared surface which had been laid on previously leveled ground. The ground which had been leveled in this area, "grey charcoal fleck", contained elements of the underlying sterile soil but also contained artefactual material and charcoal which can be interpreted as refuse which was spread around as surfaces were leveled. This part of the site would have needed more fill to bring it more or less level with other parts and probably explains why this deposit is localised.

Amongst the artefactual material from the "grey charcoal fleck" layer are a number of fragments of refined earthenware of English manufacture which were common in households during the latter half of the 19th century. A list of the artefacts, excluding ceramics, is presented in Table 4.1. A short report and listing of the ceramics is presented in Appendix 2.

Figure 4.2: Section - excavation area 1.

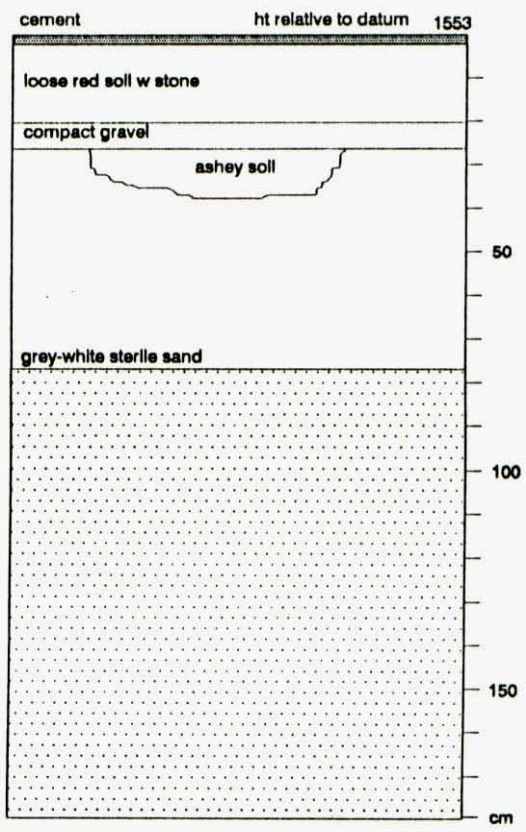
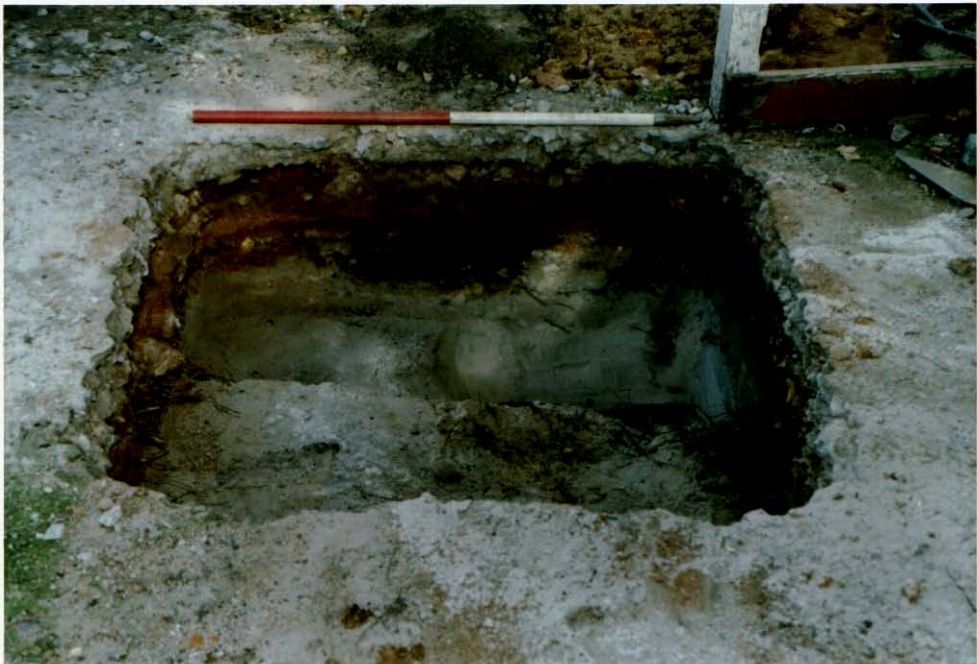
Although only 2,5 meters away from area #1, the deposits in this excavation were not a duplication of those in area #1. Both excavations however contain layers with a red soil matrix. It is our opinion that these have a common origin and that variations in the inclusions are the result of later disturbance. Similarly the "compact yellow" and "compact gravel" probably represent one unit. Variations in the depths of these units in the two excavations can be ascribed to the slope of the ground (north - south). The sections represented in the photographs are those at the southern side and thus do not show this slope.

Only one fragment of refined earthenware was recovered from this location. It should be noted that the bulk of the artefactual material in Area #1 came from one layer, namely "grey charcoal fleck" which does not extend through to area #2. This has probably occurred as a result of the artefact bearing deposit being used to level off the dip in the ground prior to surfacing.

Figure 4.3: Section - excavation area 2.

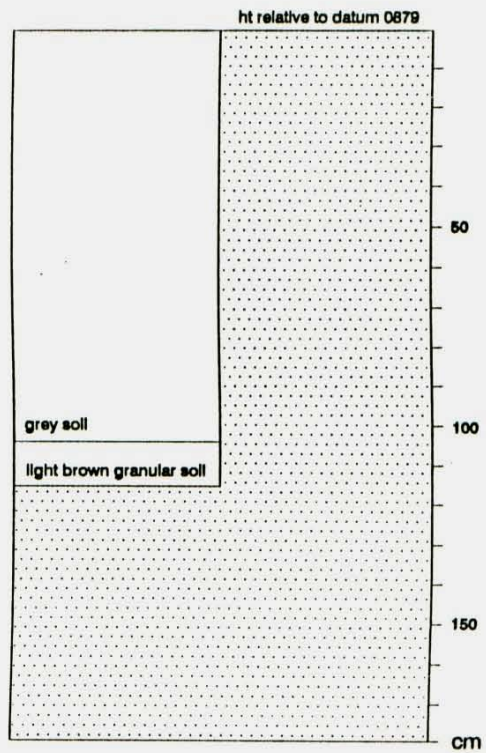
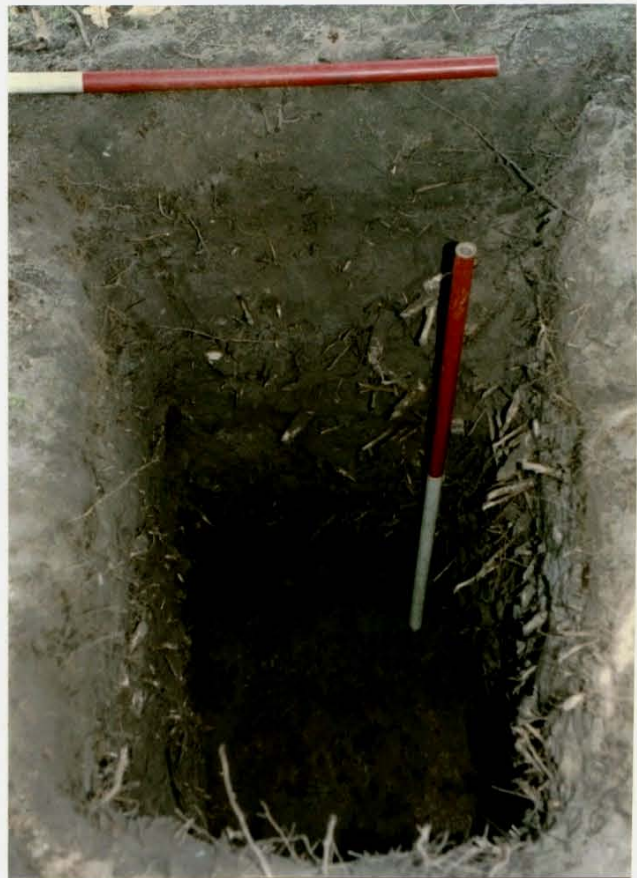
There is little variation in the deposits in this excavation. There is transition directly from a sandy grey soil to a light brown granular basal deposit. Some artefactual material is present in the grey soil but the context is doubtful. A great number of roots are present and are probably responsible for the uniformity of soil colour in the upper deposits.

Figure 4.4: Section - excavation area 3.

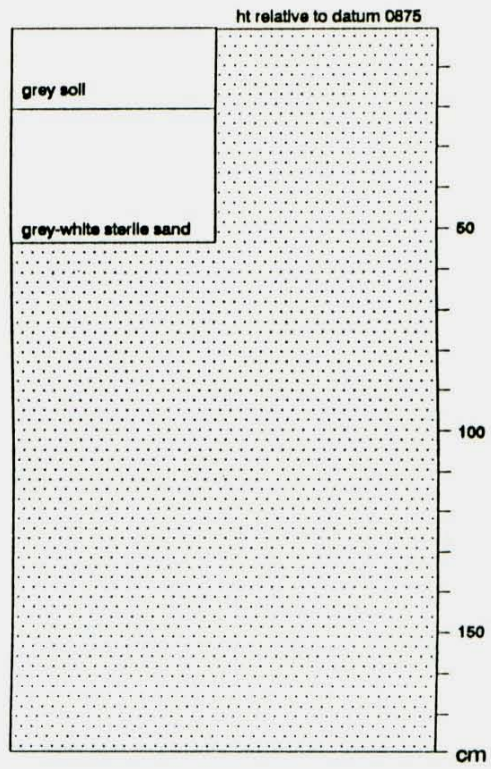
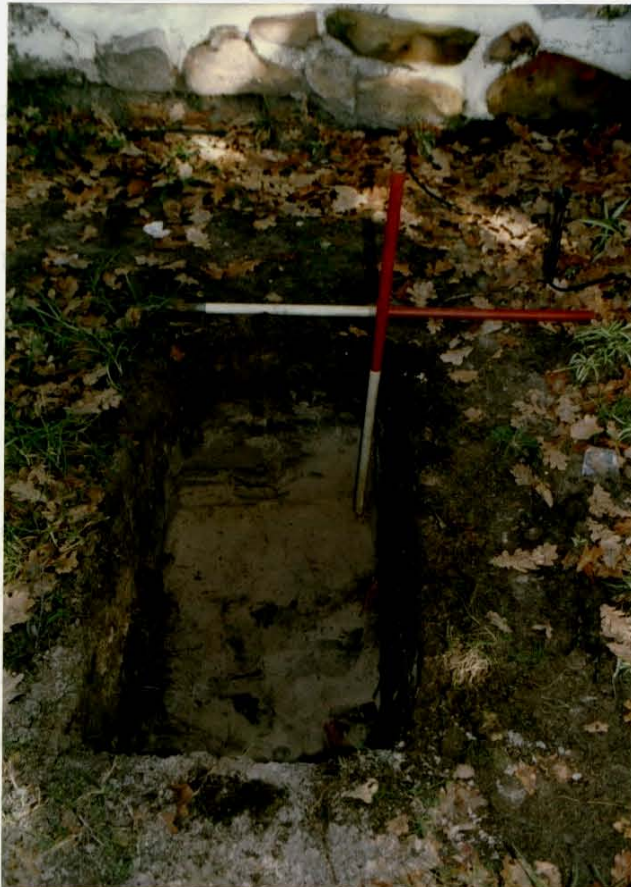
The deposits are similar to area #3. Here however the grey soil grades into white sand. Few roots are present and the deposits are sterile.

Figure 4.5: Section - excavation area 4.
