AFRICAN HERITAGE CONSULTANTS CC

20 November 2004

SCOPING REPORT OF CULTURAL HERITAGE RESOURCES OF THE FARM LAKENVLEI

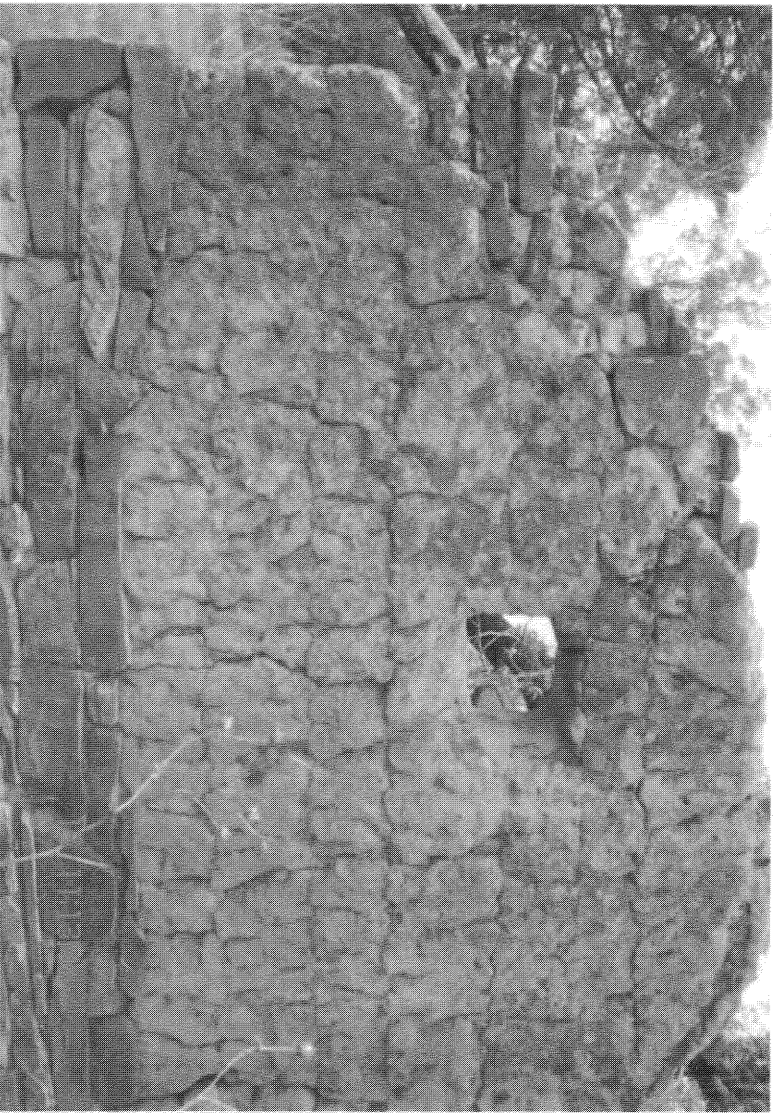
two windows in the opposite wall. Later another section was added to the house, which had two stonewalls while the gable walls were of layered clay (size 5.1m x 4.5m). On the one gable wall the position of a baking oven is still visible. On the inside there is a type of hob girder and on the outside the hole had been closed up with stones. This addition has a wide wagon house door and a window similar to the one in the original structure. It is believed that the building originally had a thatched roof and a reed ceiling. The interior was plastered with mud. The buildings roof does not exist any more. Two large willow trees have fallen on the gables, which have been badly damaged. This is the only existing building of its kind in Mpumalanga and only one of two known examples north of the Vaal River (see photograph 1 & 2).

No 2 Detail of gable of 1860 house with layers of clay clearly visible

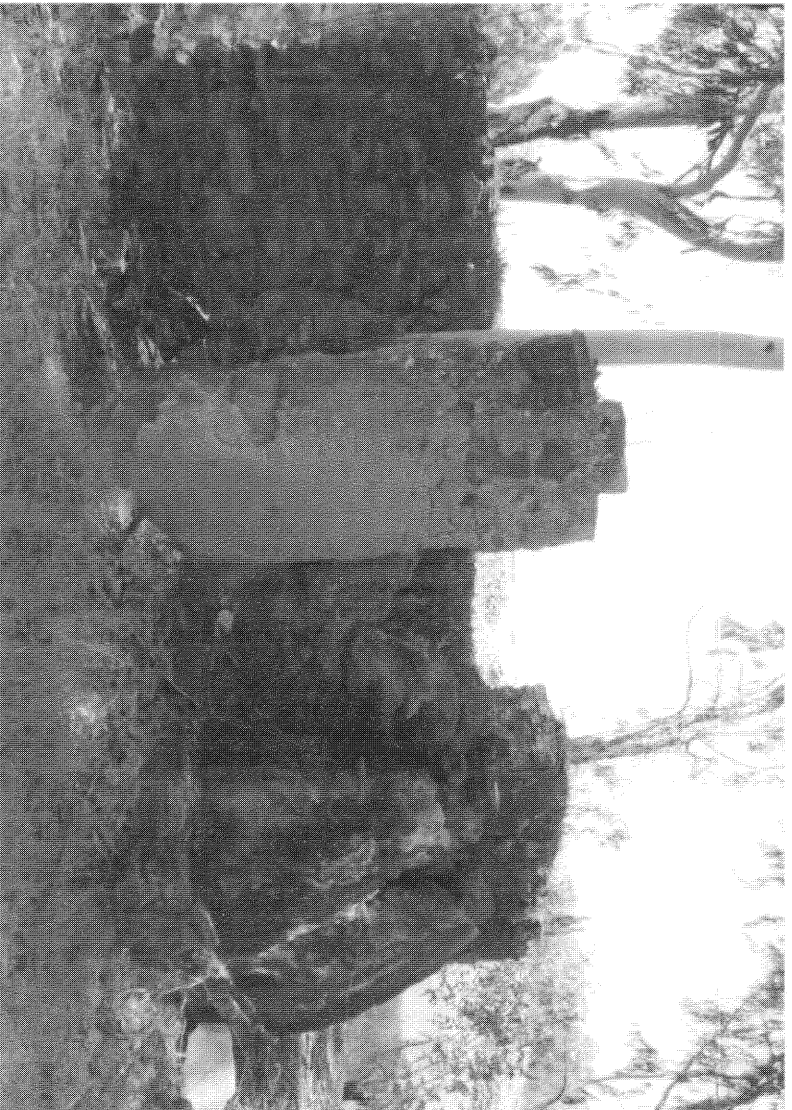
Close behind the house is a large outside oven that could have been built around 1880, since the bricks that were used are similar to those of the 1880 house. This oven, in which 36 loaves of bread could be baked at a time, was used well into the 1940s. Today it is without a door. On the one side the oven adjoins a wall, which is part of a now ruined structure. This could have been built at a later date (see photograph 4).

No. 4 Outside oven with ruins of a later structure on the left

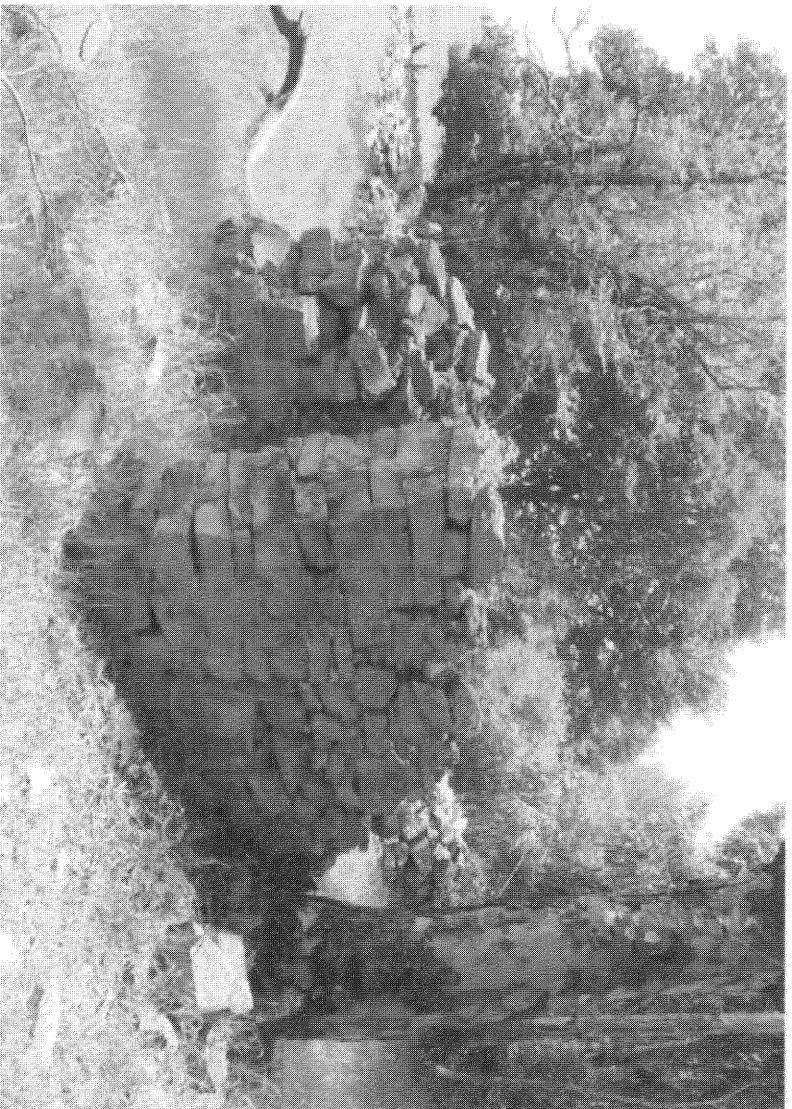
Some 20m to the east of the house is the ruin of an outside toilet (long drop) (S25° 36' 05.1" E 30° 04' 19.0", see photograph 6).

No. 6 Remains of the outside toilet (long drop)

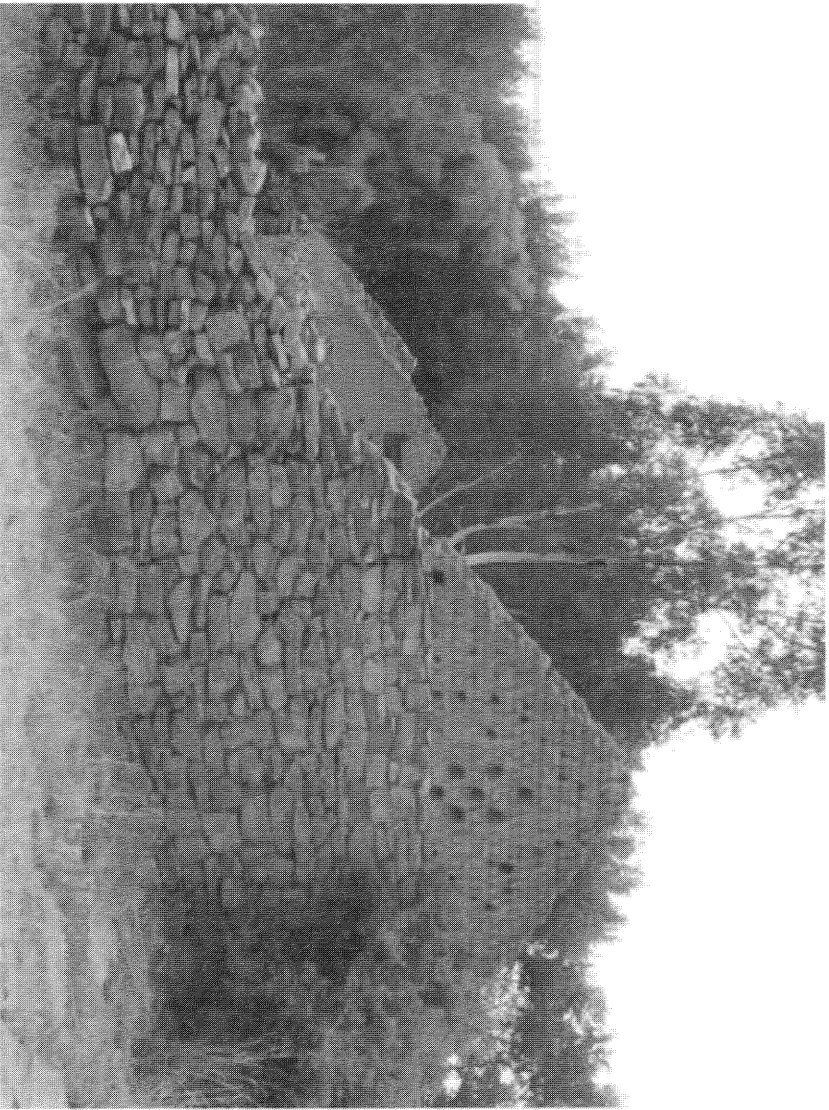
The walls of the shearing shed are towards the south of the 1880 house. It appears as if it has been built in two phases. It is 13.40 meters long and 4.50 meters wide (60.30m²). The roof and beams of the building have been stolen. According to oral information wool was stored in the shed and once a year taken by ox wagon to Pietermaritzburg to be sold (S25° 36' 08.6" E30° 04' 18.8" see photograph 7).

No. 7 Shearing shed

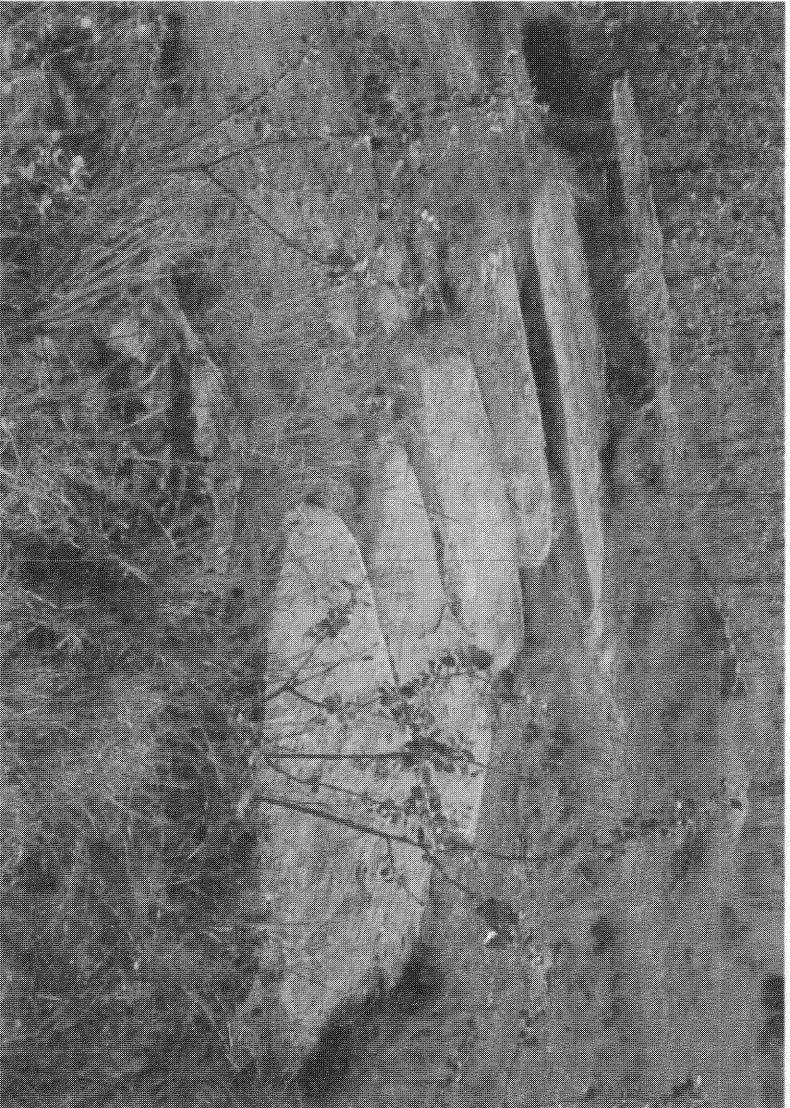
The most important need at pioneer settlements was a good supply of fresh water. Before any construction started, a water furrow was dug from which fresh water was supplied to the proposed settlement. The house was always built on the higher ground and the gardens towards the lower ground. The water furrow on Lakenvlei starts at a fountain at S25° 36' 24.9" E 30° 04' 26.7", past a canal sump at S25° 36' 11.5" E30° 04' 21.7", underneath a stone bridge at S25° 36' 10.6" E30° 04' 21.5" and ends in a dam just east of the 1860 house. This dam was used to store water for daily use and the irrigation of an orchard and vegetable garden east of the dam. From the dam another furrow extends northwards right up to the graveyard. From this furrow large stonewalled fields could be watered. Wheat, maize and other crops were planted here (see photographs 10 & 11).

No. 10 Stone bridge over water furrow

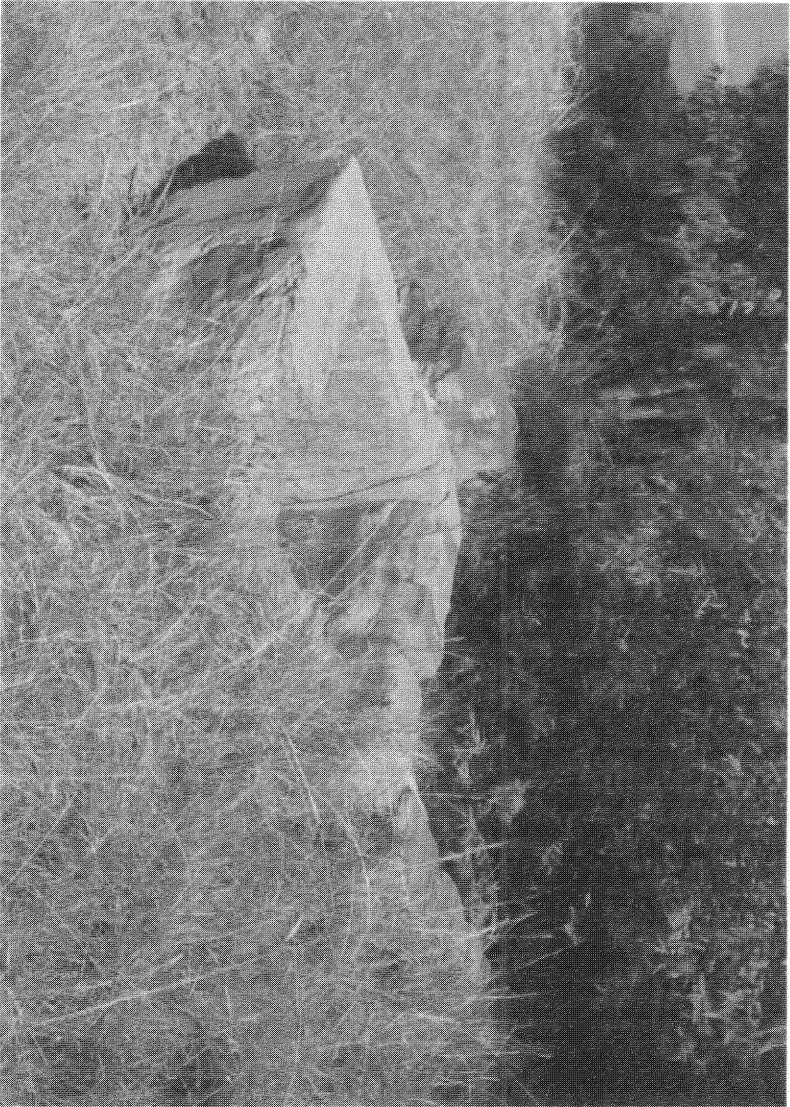
No. 11 Sump and water furrow

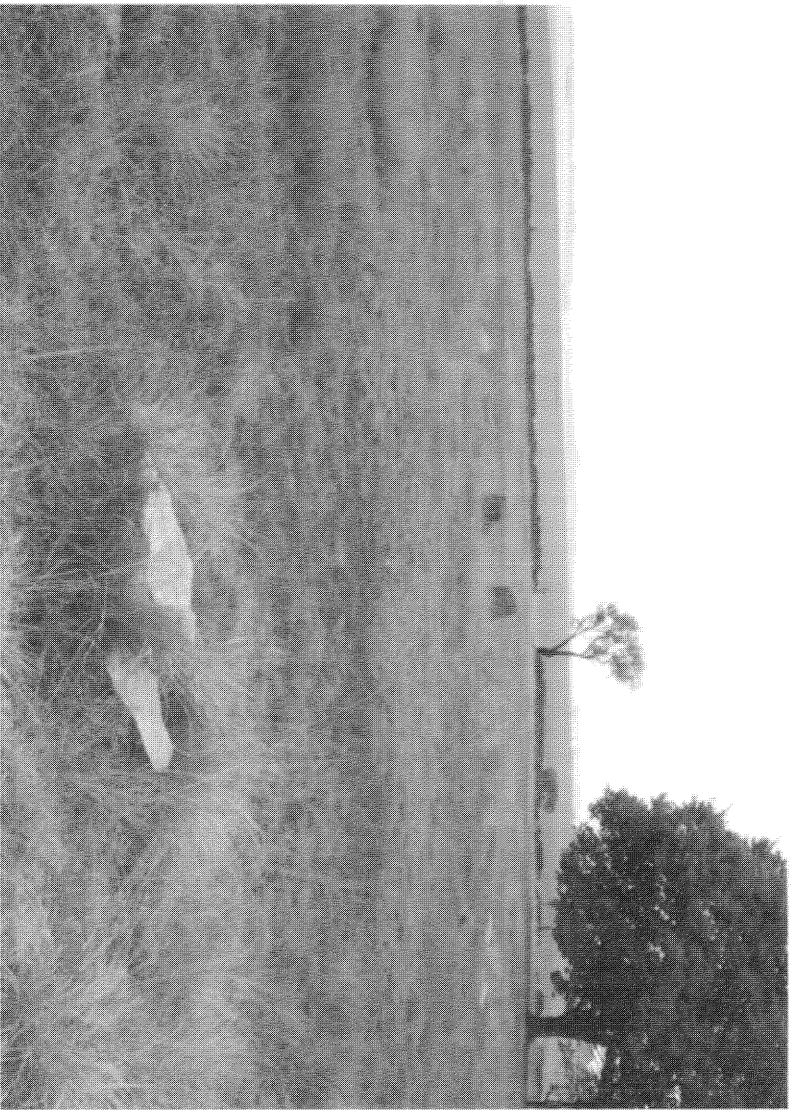
Halfway between the 1880 house and the graveyard is the remains of a threshing floor. This is the only original threshing floor the author has ever seen in the area previously known as the Transvaal. The floor is 19 meters in diameter (S25° 36' 01.6" E30° 04' 17.5" see photograph 15).

No. 15 Remains of the threshing floor

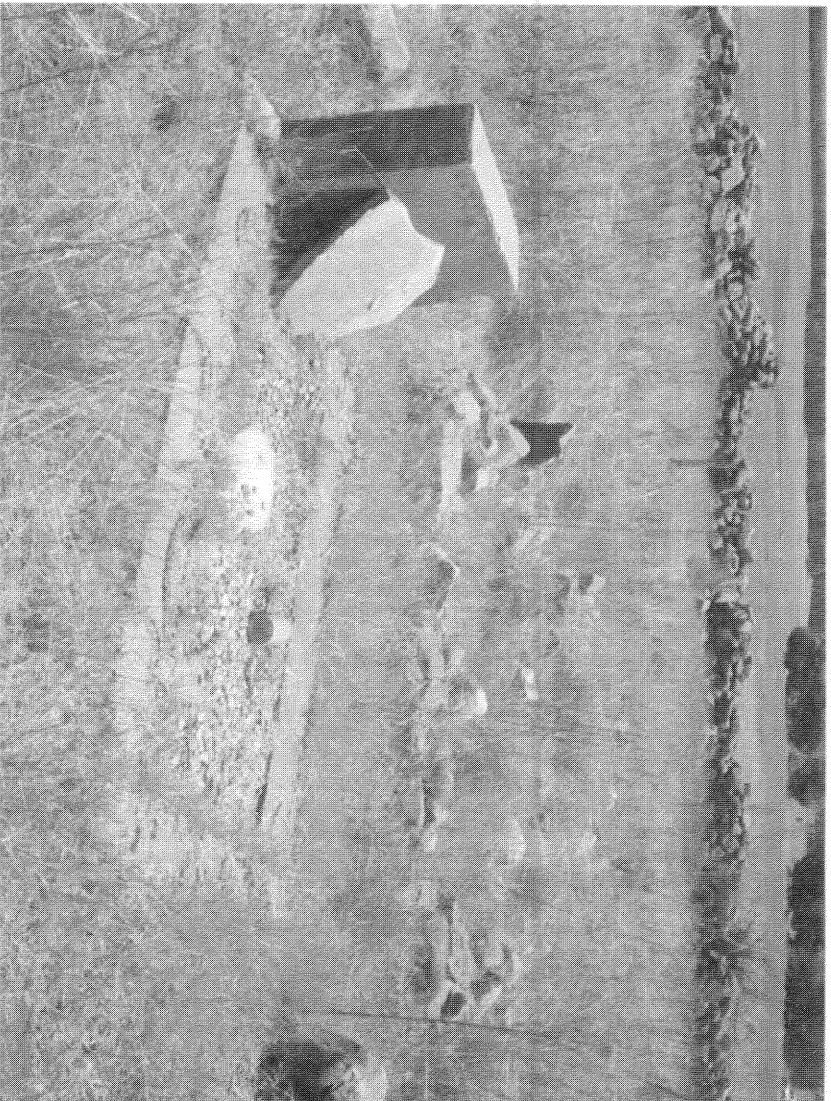
There are the ruins of some of the farm worker houses towards the south of the large stone kraals (S25° 36' 12.6" E30° 04' 17.7"; see photograph 16). Just south from here are two short sections of stonewalls at S25° 36' 28.6" E30° 04' 32.5". Another two farm worker settlements were found at S25° 36' 28.6" E30° 04' 22.9" and S25° 36' 26.0" E30° 04' 41.3". Near the last mentioned one a stonewalled cemetery was found containing eight graves (S25° 36' 28.6" E30° 04' 42.2"). Only one tombstone had a surname, namely Sithole. According to oral traditions this is the Sithole graveyard. The family lived at the nearby ruined settlement (see photograph 17).

No. 17 Graves of the Sithole family

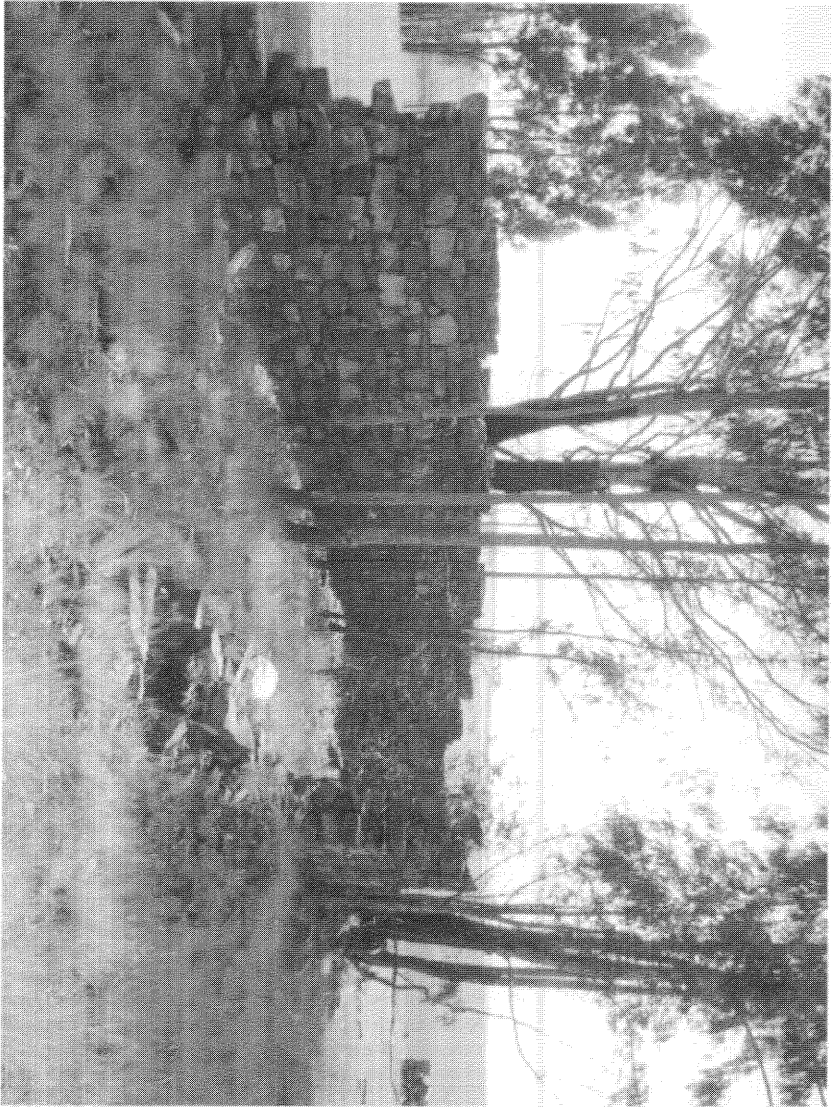
The wagon house is also built of stone (size 42m²). Like the house only the walls remain (S25° 35' 45.5" E 30° 04' 24.2", see photograph 19). Just east of this building is the remains of a stonewalled pigsty (3.60m x 5.00m = 18m² S25° 35' 45.6 E30° 04' 25.3". A large cattle kraal, built of stone is south of the wagon house (size 13.70m x 6.00 = 82.2m², (S25° 75' 48.8" E30° 04' 23.3).

No. 19 Remains of sub farmers wagon house

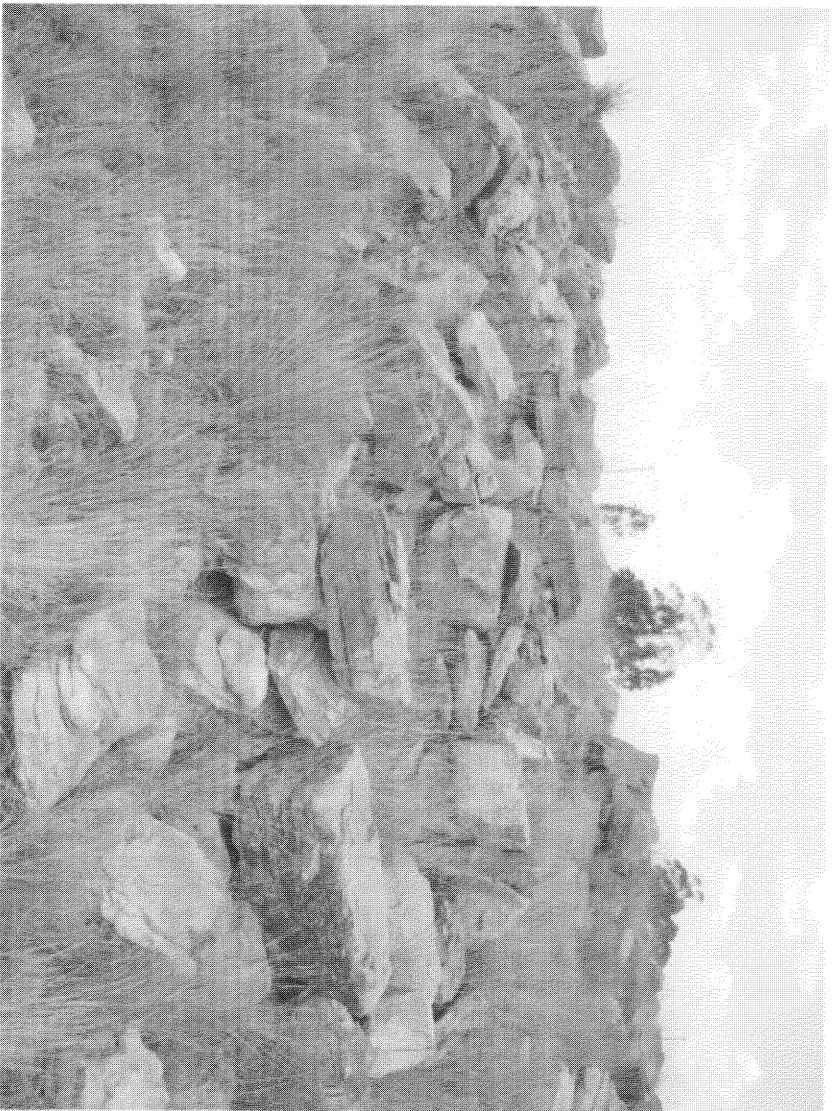
The original road to Lydenburg passed through the farm Lakenvlei and is still clearly visible. The road crossed the bridge at S25° 35' 48.3" E30° 04' 0.08" (see photograph 21). South east of this bridge three Boer redoubts were found at S25° 35' 53.1" E30° 04' 05.7" (see photograph 22). The rest of the Boer redoubts were built to the south of the bridge on a high lying sandstone ridge. From here the Boer forces had a good view towards the south, the road and the bridge. Some of the Boer redoubts have been destroyed or partially destroyed by workers of the Department of Water Affairs during a project for the rehabilitation of the Lakenvlei wetlands. The workers had to collect stones for the building of gabions. Though the workers have been told not to use the stones of the redoubts, such a large number of stones have been removed from redoubt sites, that it is impossible to determine their exact number.

No 22 Anglo Boer War redoubts south of the bridge

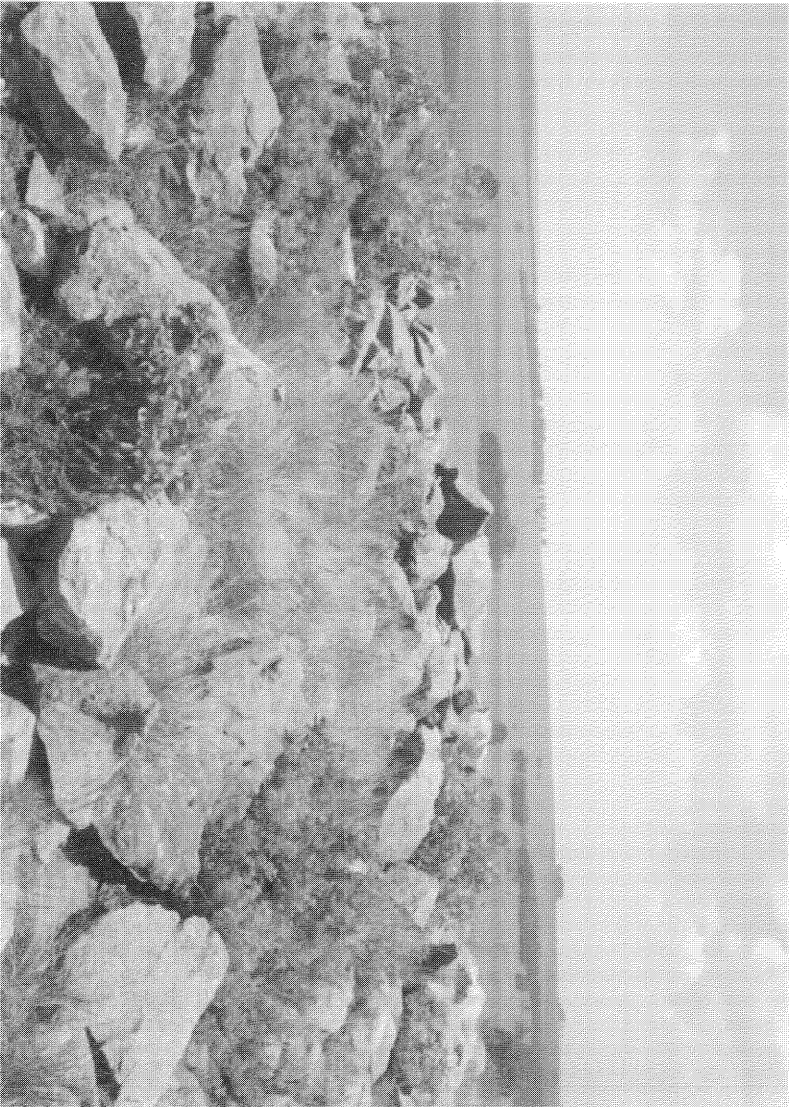
Redoubts were found at the following localities (see photographs 23 & 24)

No. 23 Anglo Boer War redoubt north of the bridge

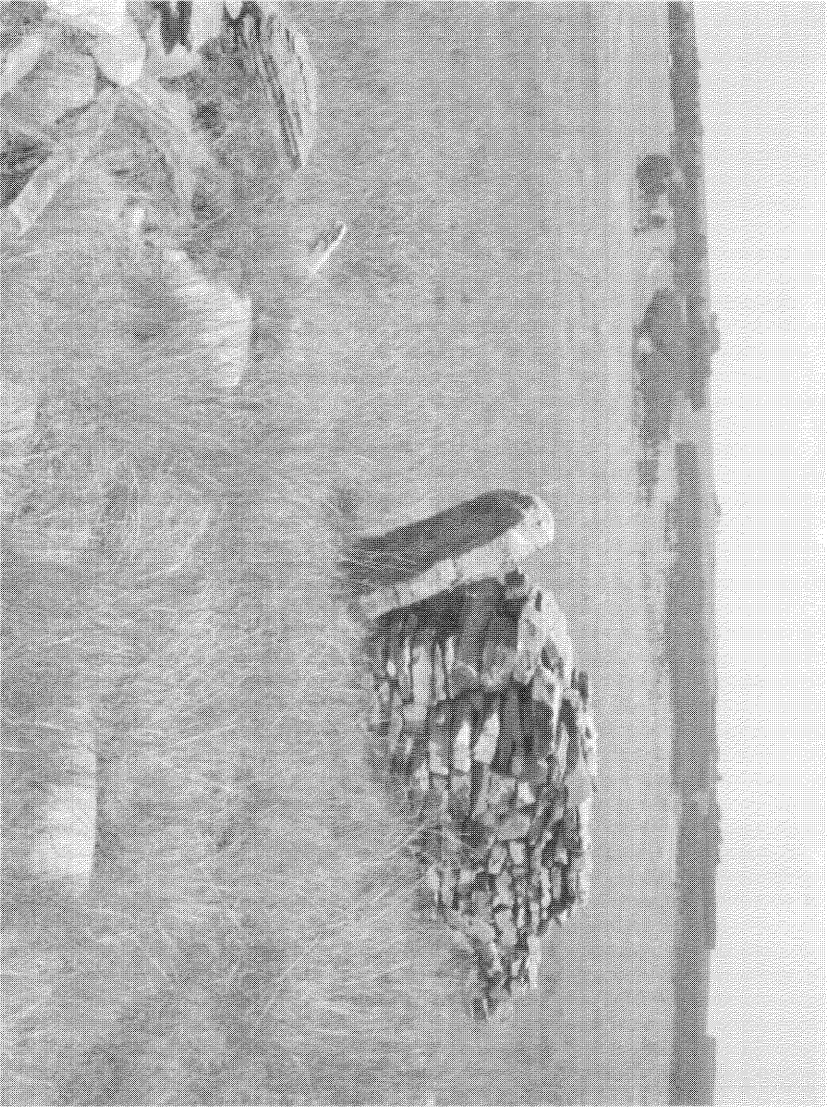
The remains of a neatly built stone structure was found at S25° 35' 36.2" E30° 03' 46.1" (see photograph 25). This structure was most probably a sheep kraal.

No. 25 Remains of the structure, probably a sheep kraal
