LEVEL 2 (SPECIALIST STUDY) HERITAGE REPORT: PROPOSED HUDDLE PARK GOLF COURSE DEVELOPMENT, JOHANNESBURG

DATE OF SUBMISSION: 22 AUGUST 2005

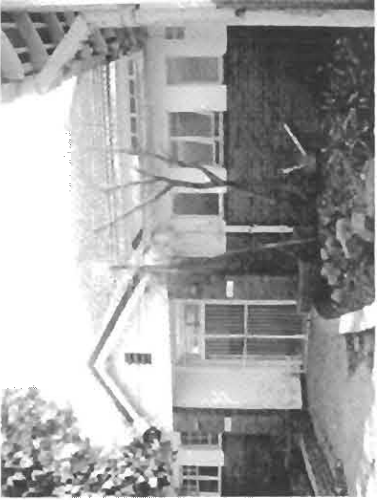
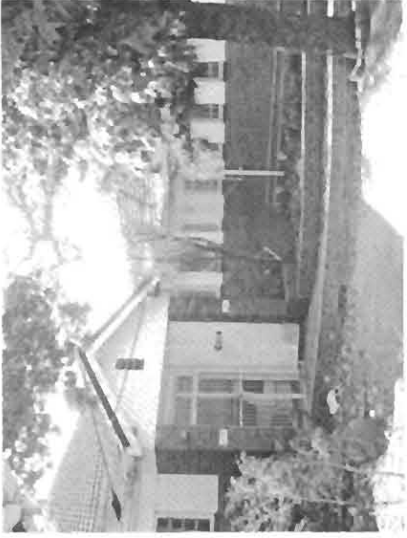
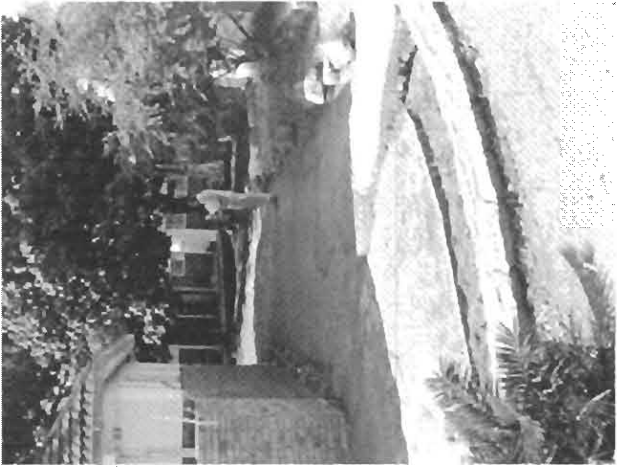
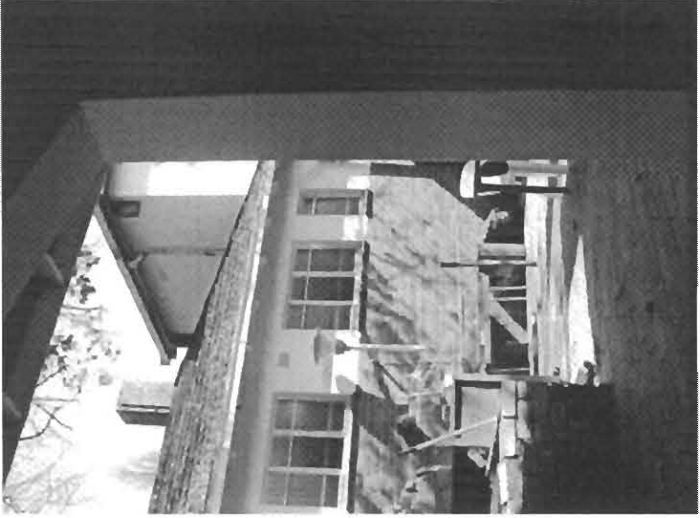
Views of the Clubhouse

Alterations: Most of the alterations relate to the addition described below. However, during that phase of the work the original slate shingles of the Clubhouse were removed and replaced by Harvey tiles, and the interior of the ablutions were extensively renovated.

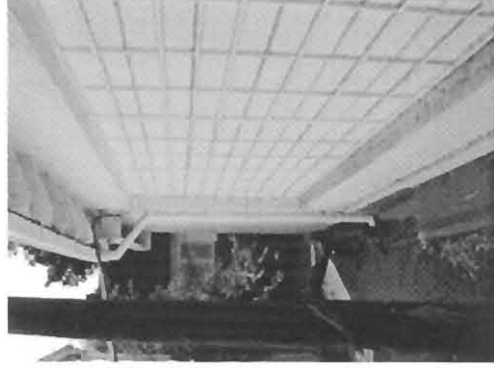
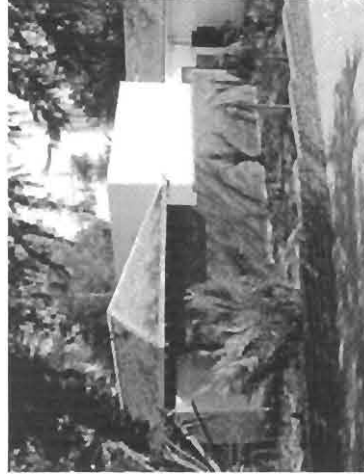
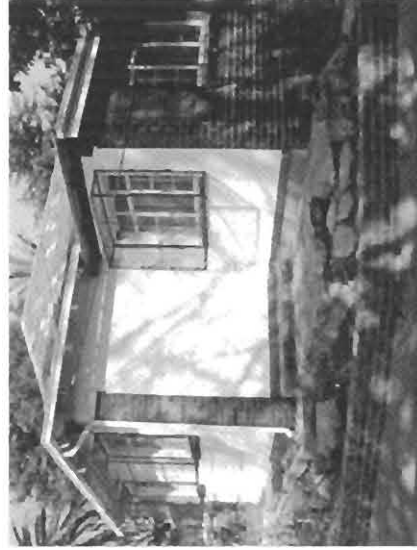
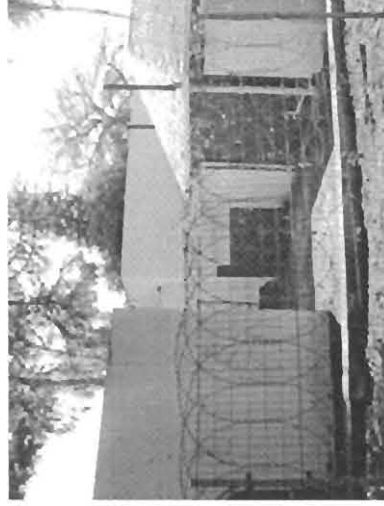
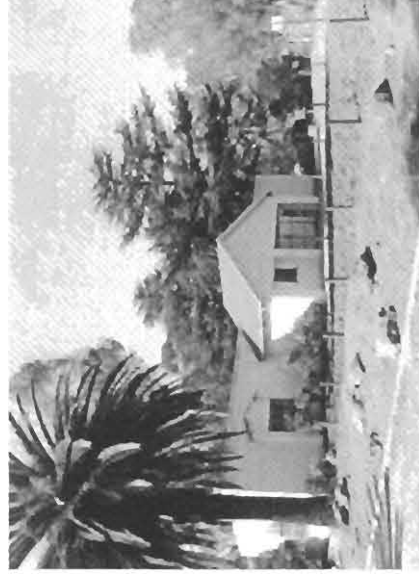
Views of the Pro shop and caddy centre:

SITE/ITEM 2 **Pro shop complex with later alterations and additions**Location:

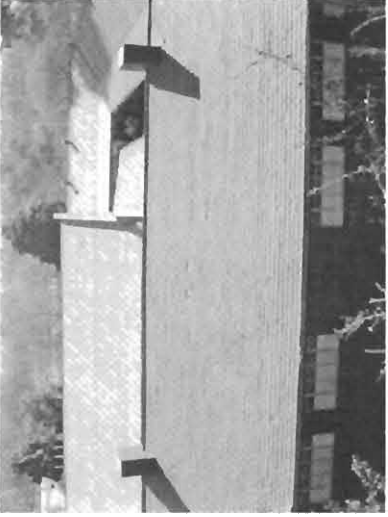
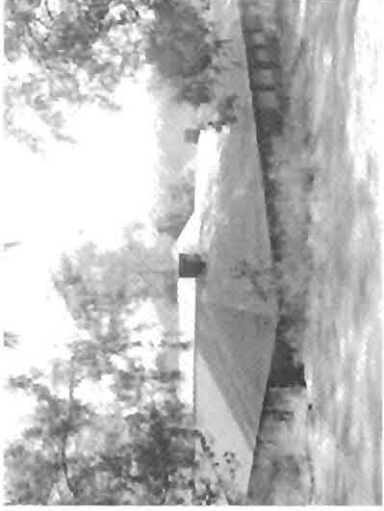
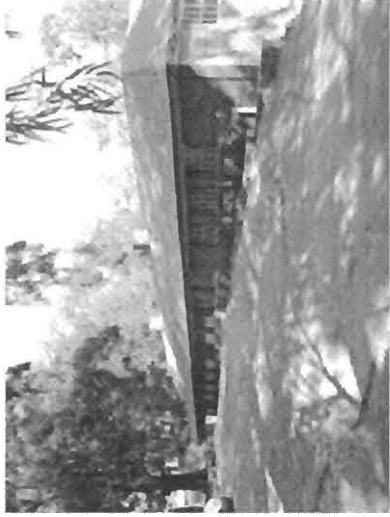
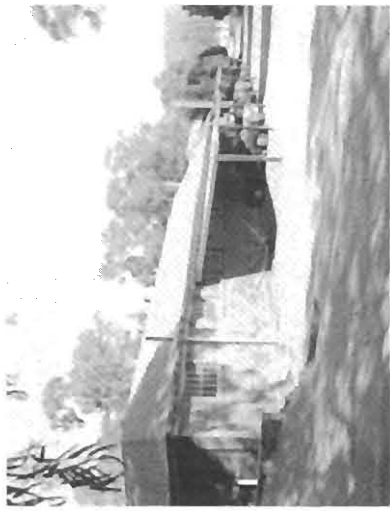
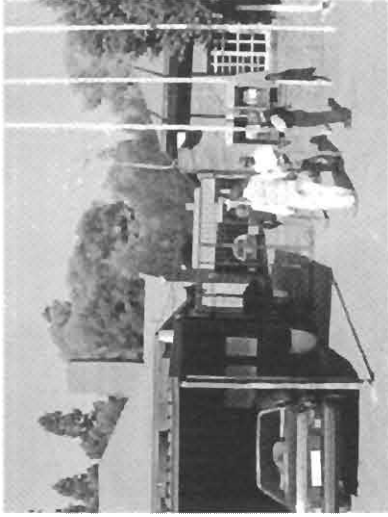
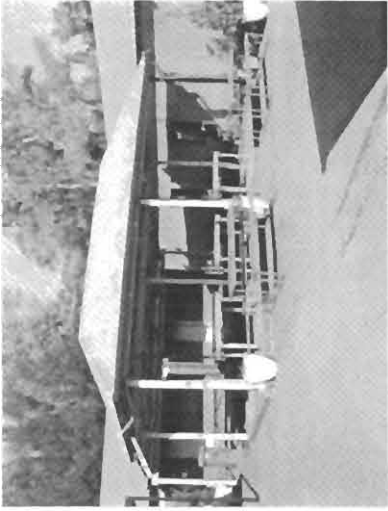
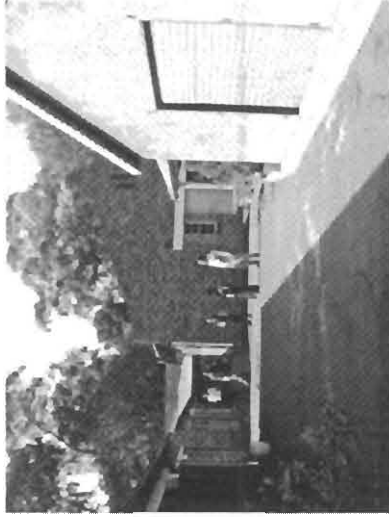
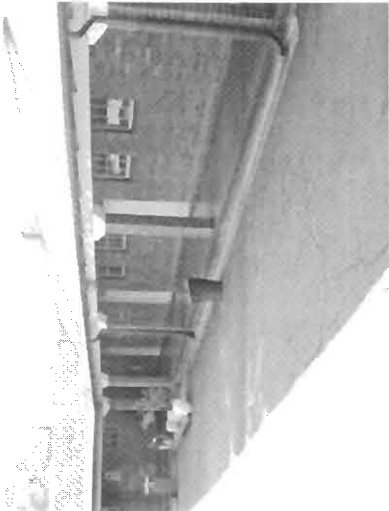
Views of the Caddies Compound

ITEM 3 Historic 'Caddies' Compound' with later alterations and additions

- The architectural typology known as 'Native Compound' was found in the mining and railway industries, and here a rare example in the municipal sport and recreational sector – the type has now become rare due to altered social values, labour practices and township development;

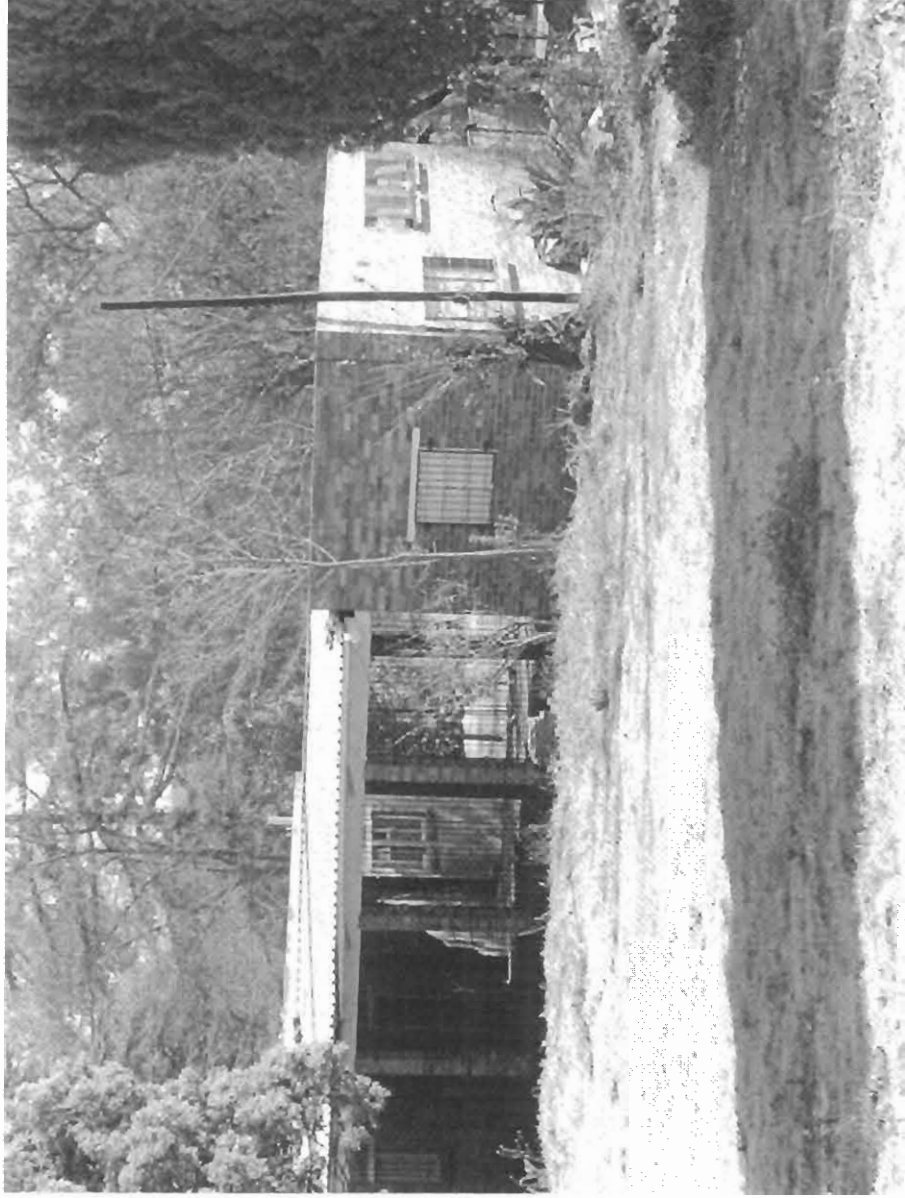
ITEM 4 Ticket office

The Ticket Office consists of two rectangular structures of yellow/brown face brick in stretcher bond with a flat concrete roof with parapet walls, and with a connecting structure of brick colonnades covered with a shallow pitched IBR sheet metal roof. The windows are steel framed, are placed irregularly, and have thin concrete lintels above. No plan drawings of the building could be traced. From the details and the design composition, as well as the difference in design relative to the other golf park buildings, it is clear that the building was built after the others, and most probably in the late 1940's to 1950's. The building has some value due to its particular functional design.

From the assessment, its demolition will be supported of so required. The building should be recorded in full before demolition. Apply mitigation in terms of planting new non-invasive trees and a marker signifying the location and appearance of the Ticket office.

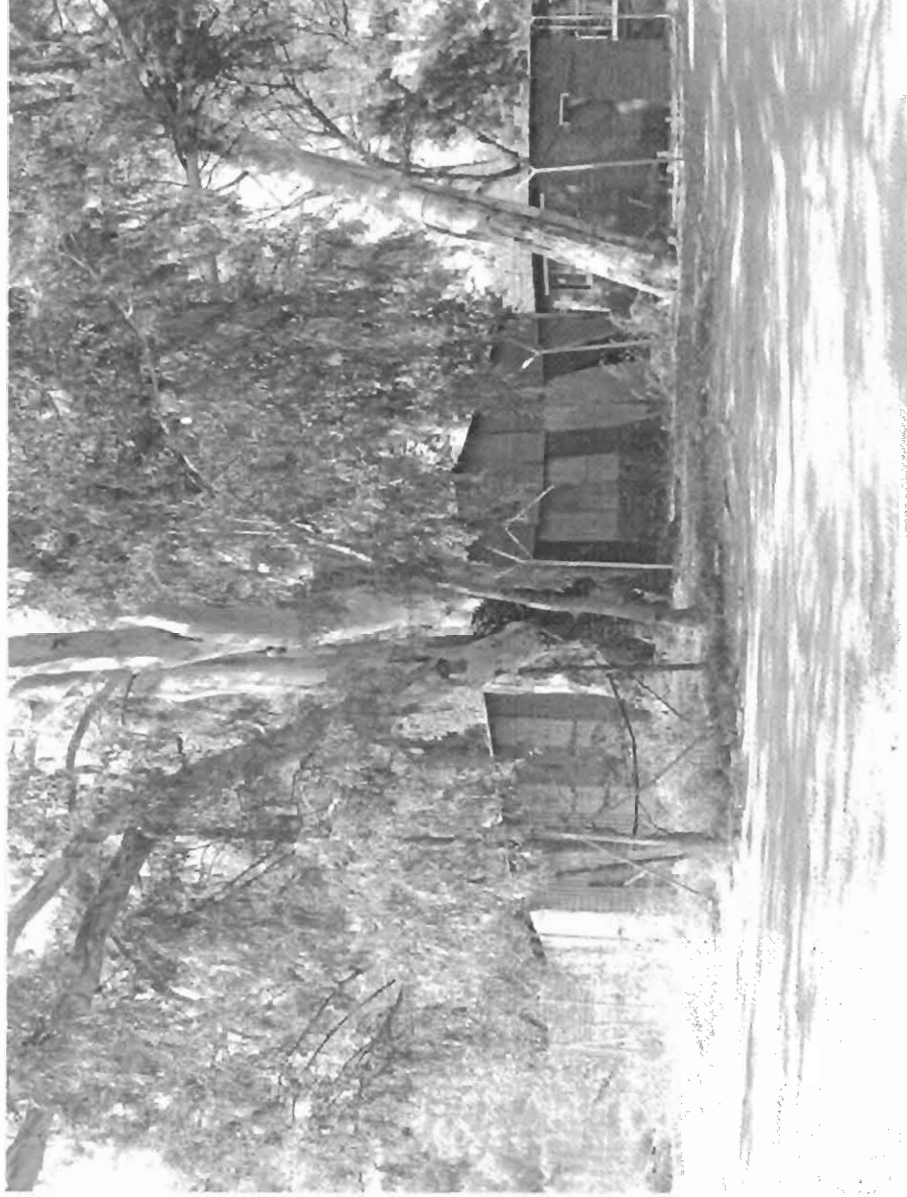
ITEM 5 Stores

The stores consist of two structures: The first is a large rectangular corrugated sheet metal shed with lean-to extension of the same material. The building is in a very dilapidated state. The second is a large rectangular face brick structure with a shallow pitched corrugated sheet metal mono-pitch roof, with small steel framed windows with thin concrete lintels, and timber framed access doors. No plan drawings of these structures could be traced. The structures are most probably part of the original development, if the materials and window details are anything to go by – only the lean-to structure may be of a later date. One may safely say the structures are older than 1945, ie older than 60 years – The building therefore enjoys general protection under the provision of the NHRA - Section 34(1) of the NHRA applies. The buildings are not unique.

From the assessment, their demolition will be supported of so required. The buildings should be recorded in full. Apply mitigation in terms of planting new non-invasive trees and a marker signifying the location and appearance of the stores.

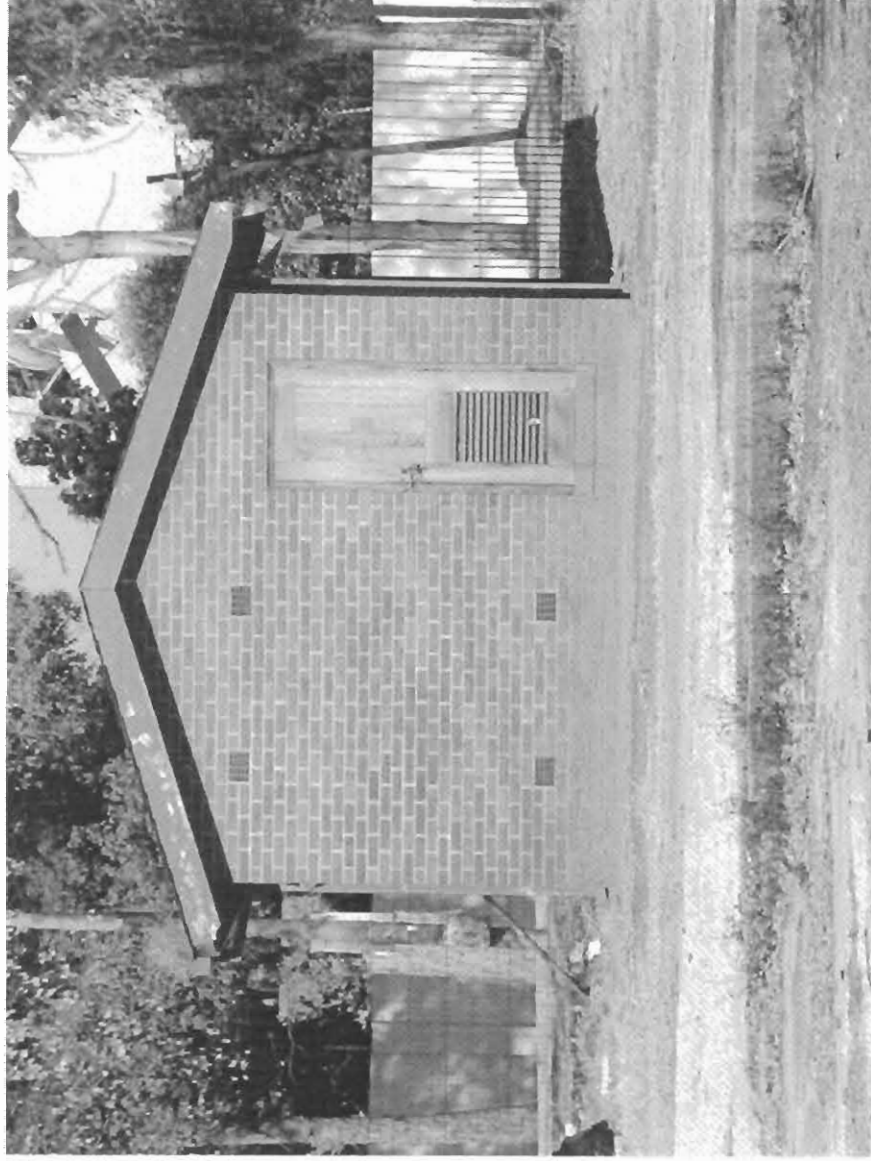
ITEM 6 Electrical substation

The electrical substation is a small rectangular structure of rock-face brickwork in stretcher bond, with a saddle roof of concrete tiles with timber fasciae and galv sheet metal gutters and down pipes, and a framed and battened solid hardwood door, situated along the main road alongside the golf park.

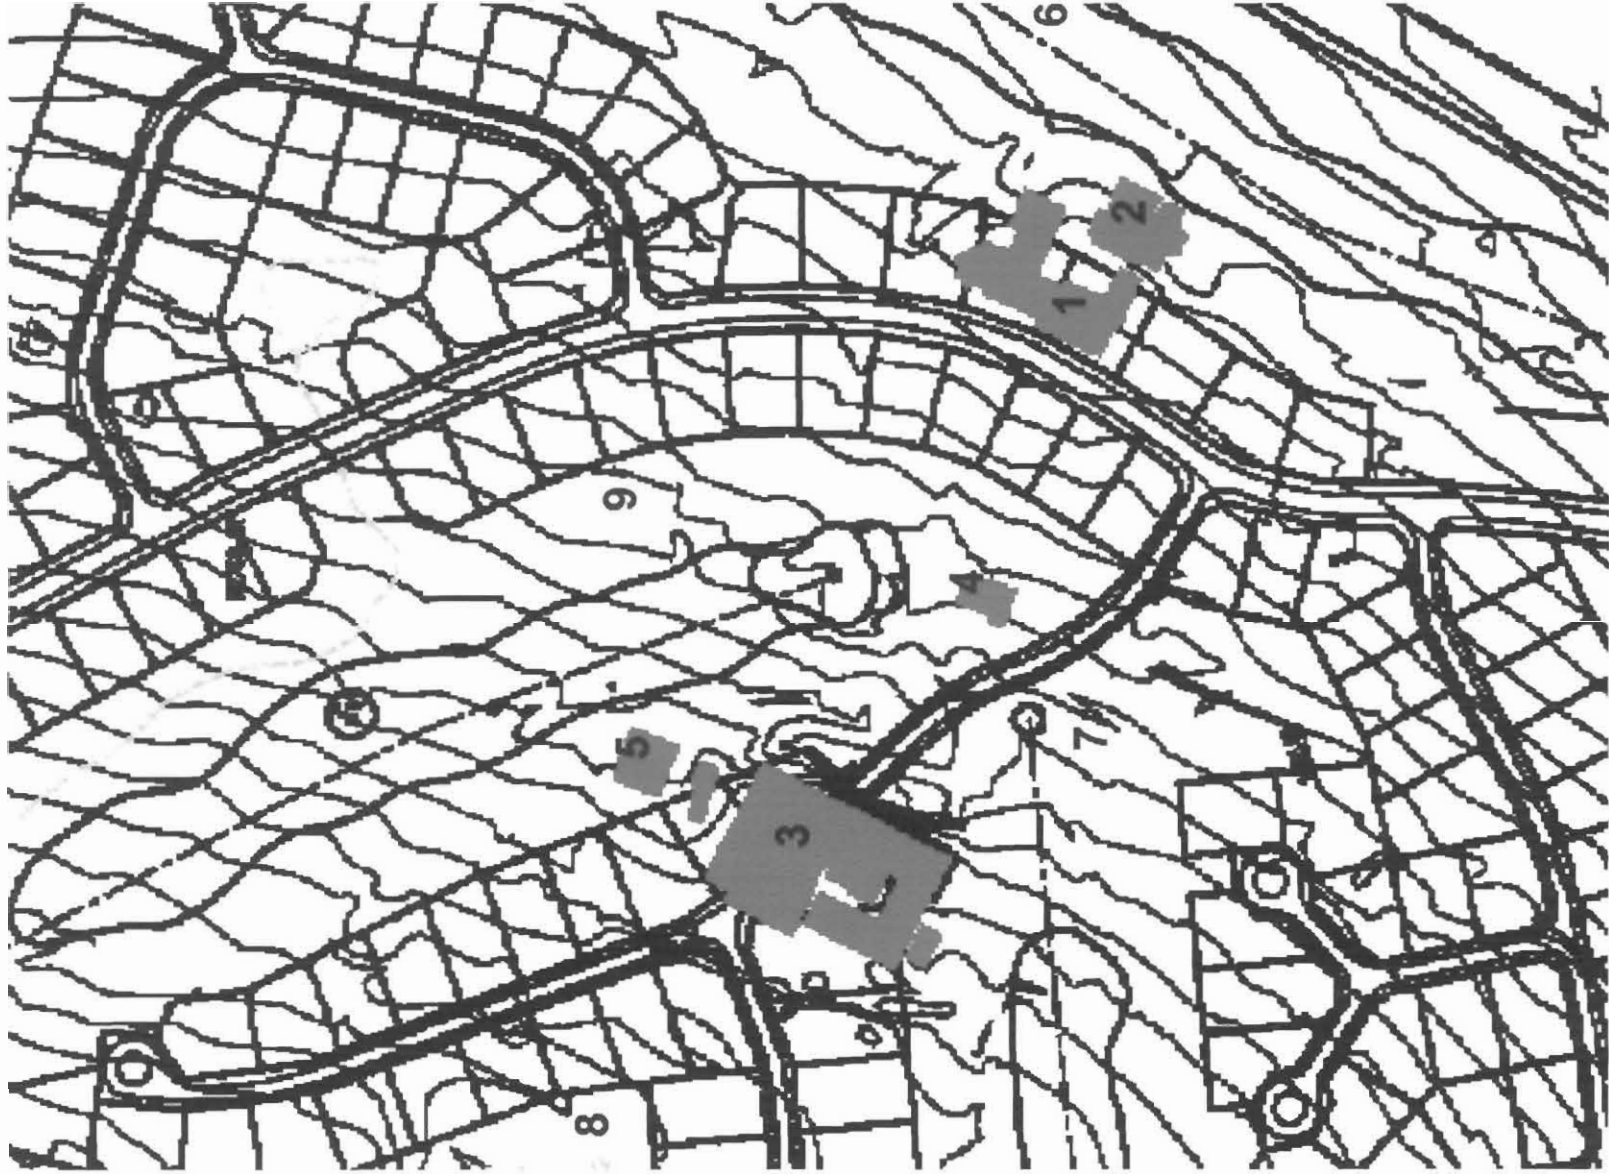
FIGURE 5: Location of individual heritage features - 1 = clubhouse, 2 = caddies' shelter, 3 = caddies' compound, 4 = ticket office, 5 = stores, 6 = electric substation, 7 = water furrow, 8 = stream and dams, 9 = planted vegetation (entire site)
