**PHASE 1 HERITAGE IMPACT ASSESSMENT ON PORTIONS OF
THE FARM HARTEBEESTSPRUIT 235-JR, GAUTENG PROVINCE**

Compiled by: P.D. Birkholtz

Date: 7 November 2006

Archaeology Africa CC

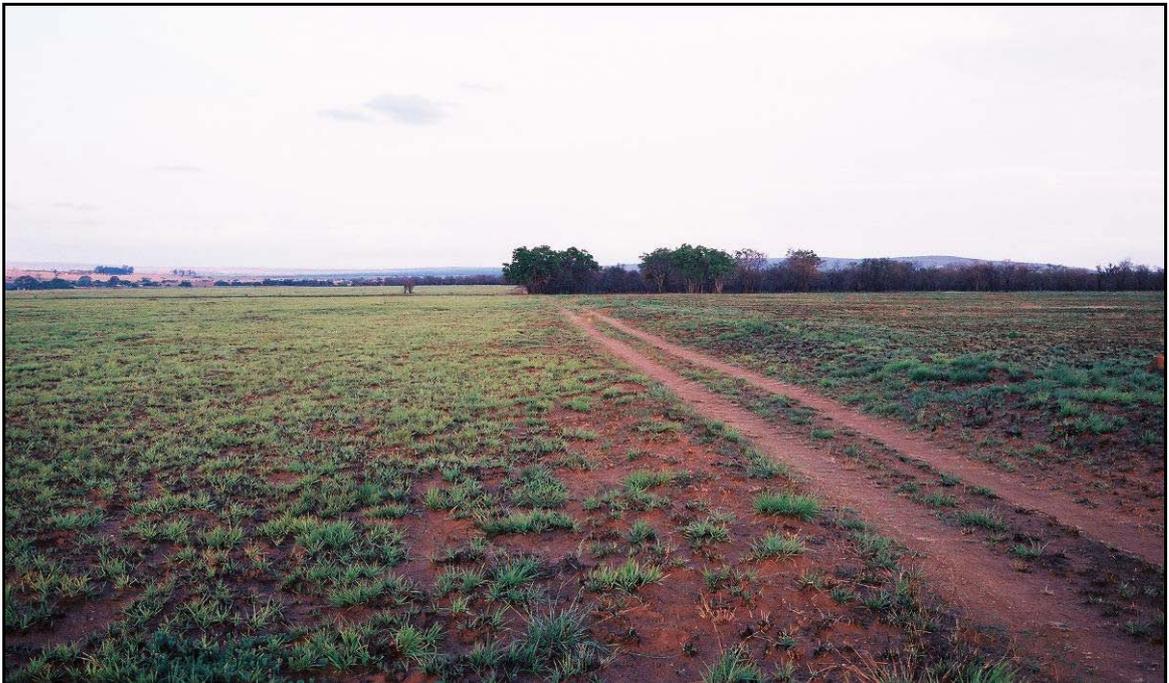
Plate 1 Typical view of the study area. Note the large sections of old agricultural fields with small pockets of woodland in-between.

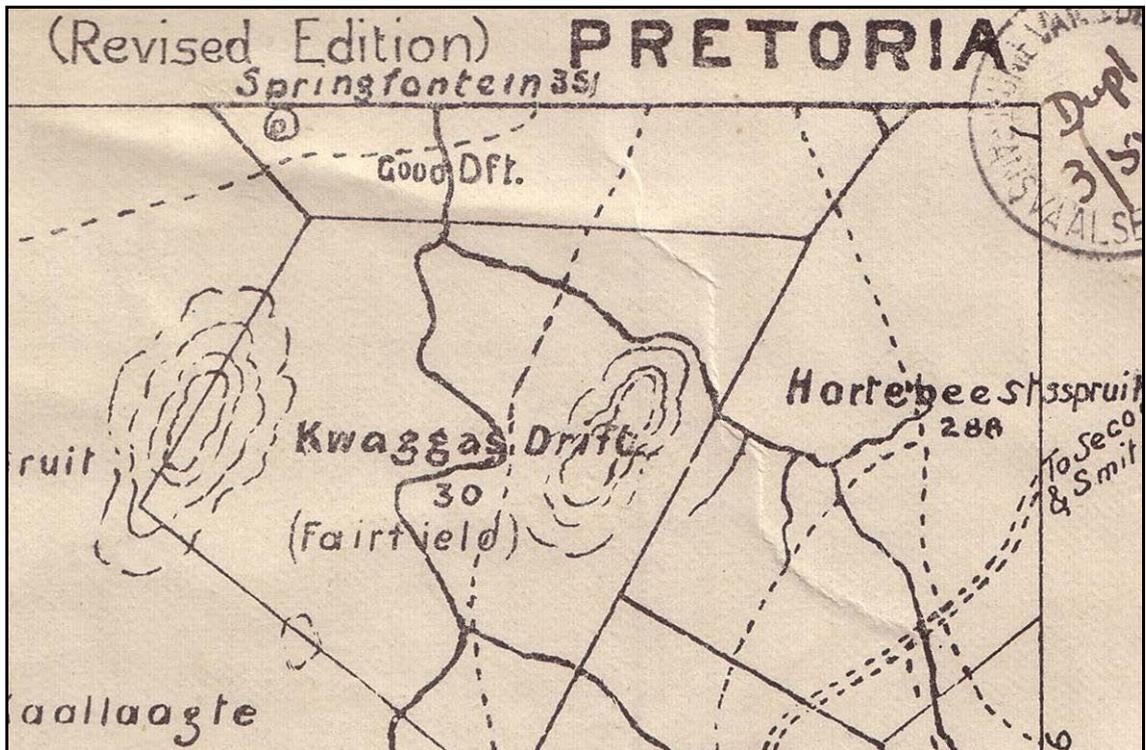
The following features are shown within and directly surrounding the study area:

- The main road between Pretoria and "Secoconisland".
- A secondary road which crosses the study area and the Hartebeestspuit.

Figure 1 "Pretoria" sheet of the Major Jackson Series dated June 1902.

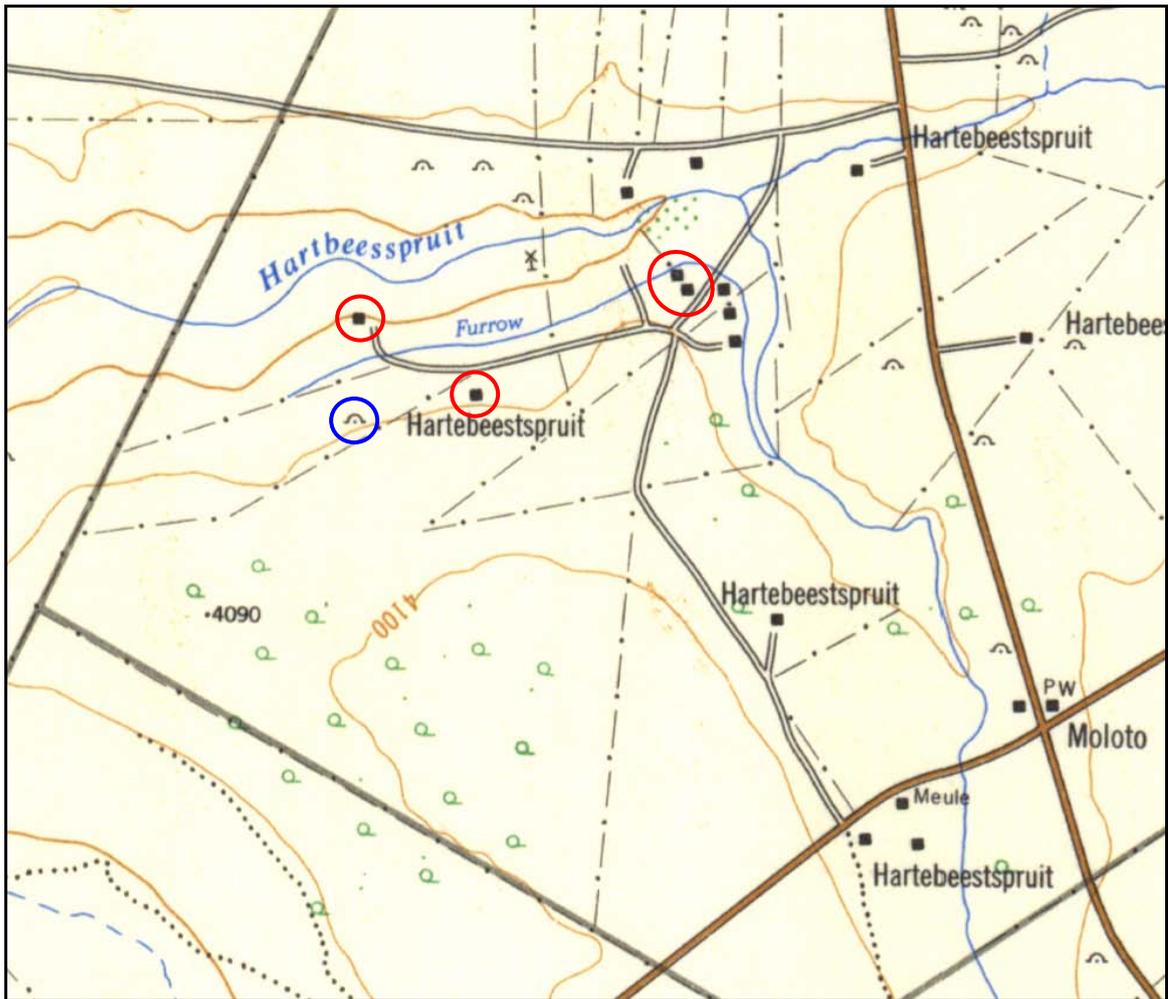
- One hut is depicted within the study area. This feature is marked in blue. No sign of this hut could be found during the survey. This can probably be attributed to the fact that in recent times this entire area was ploughed and used for agricultural purposes (refer Figure 4 below).

- The map shows that the largest majority of the property's farm workers used to reside north of the Hartbeesspruit. This was confirmed during consultations with local residents (Monnama, pers. comm.). The farm worker's burial ground is also situated north of the river.

- Interestingly, no agricultural land is shown on this first edition map. It appears possible that large-scale agriculture as evident in the ploughed fields today, only came about in 1968. Before that livestock farming may have taken place.

Figure 2 2528BCD 1:50 000 Topographical Sheet, surveyed in 1967.

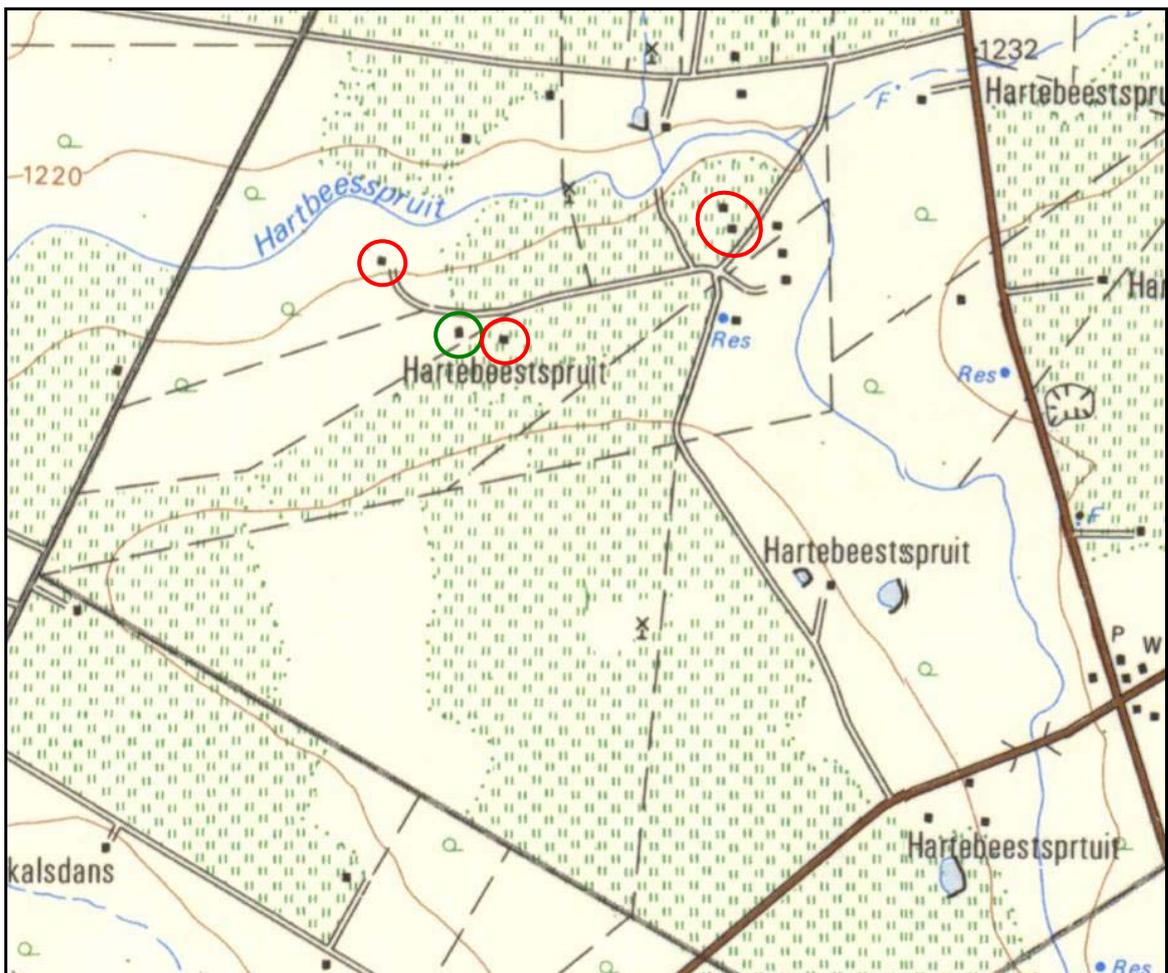
- Five farmhouses are depicted in four different localities. The four buildings depicted on the previous map are all marked in red. While one of the oldest farmhouses on the property (refer Section 4.4.4) is not depicted on this map, an additional house is shown (and marked in green).
- No huts are depicted within the study area.
- Large sections of the study area are shown to be used for agricultural purposes.

Figure 3 2528BC 1:50 000 Topographical Sheet, dated 1986.

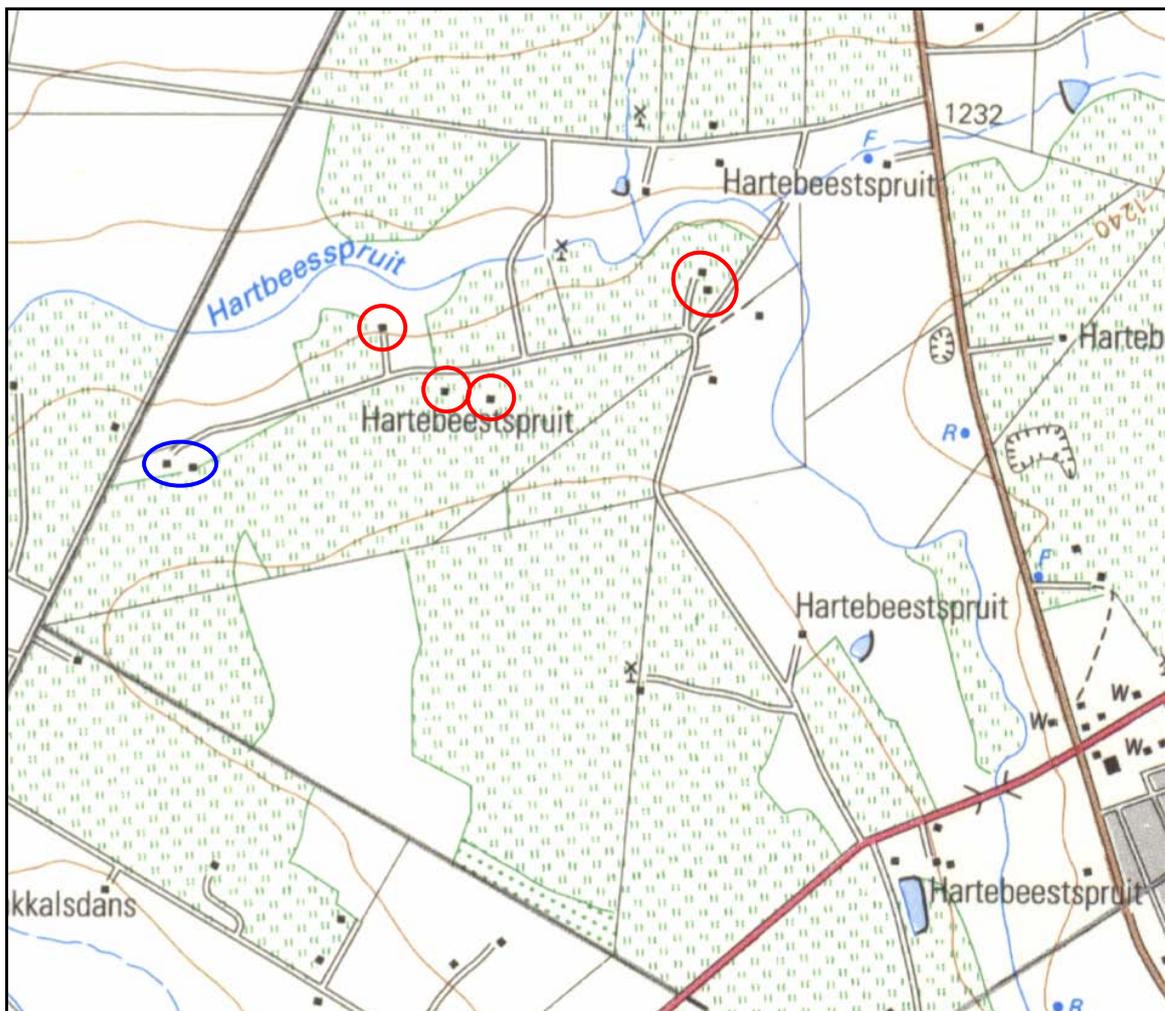
- Five farmhouses are again depicted in four different localities. These features are all marked in red. One of the oldest farmhouses on the property (refer Section 4.4.4) is still not depicted.
- Two huts are depicted within the study area. The remains of both these structures were located during the field survey, and according to local resident Mr Simon Monnama, these features were only constructed during the 1980s.
- The area used for agricultural land has increased since the previous map.

Figure 4 2528BC 1:50 000 Topographical Sheet, dated 1996.

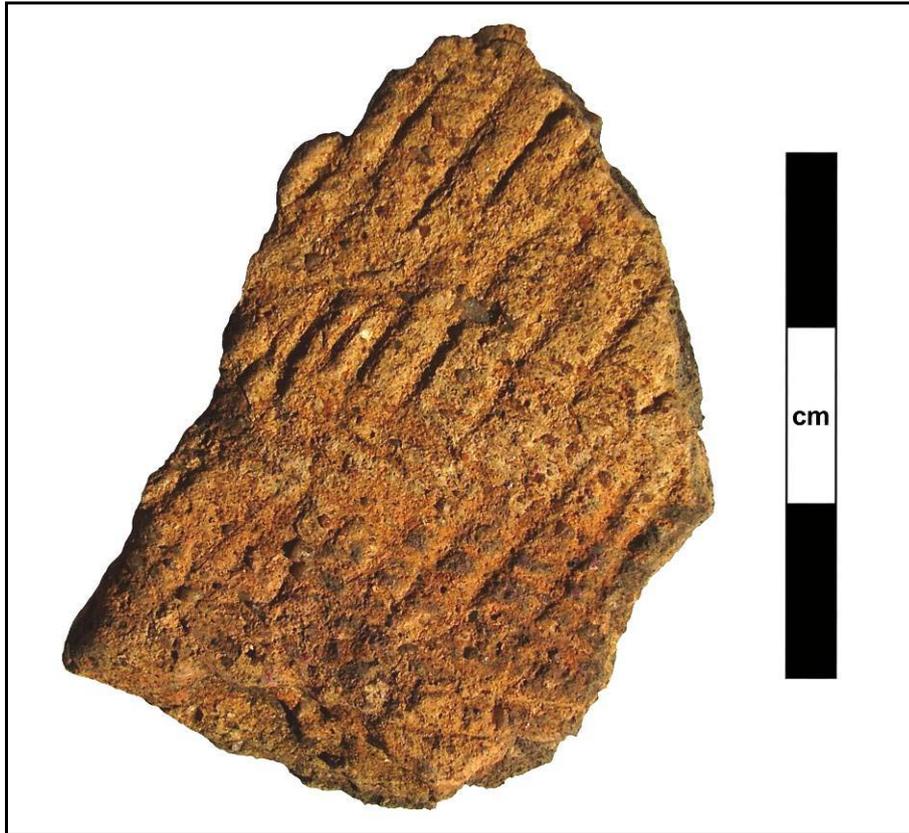
HBS-1 consists of a surface scatter of decorated and undecorated clay potsherds that were exposed by past ploughing activities. The decoration appearing on the ceramics include diagonal and herringbone incisions with cross-hatching also present. Two stone artefacts (lithics) were furthermore observed in-between the ceramics. The site is situated on a watershed, a short distance north of the study area's southern boundary.

The decorated ceramics observed here show characteristics associated with the Middle Iron Age's Eiland facies. Eiland sites are commonly dated between 1000 and 1300 A.D. (Boeyens, pers. comm.).

Plate 4 Decorated ceramic fragment from HBS-1. The decoration motifs visible on this sherd include incised bands of cross-hatching and herringbone.

The site has been identified as belonging to the Eiland facies, and dates from between 1000 and 1300 A.D. As this period of Southern Africa's Iron Age sequence is still not very well understood, as much scientific information contained in the site as possible must be obtained before it may be destroyed. The following phased process is recommended:

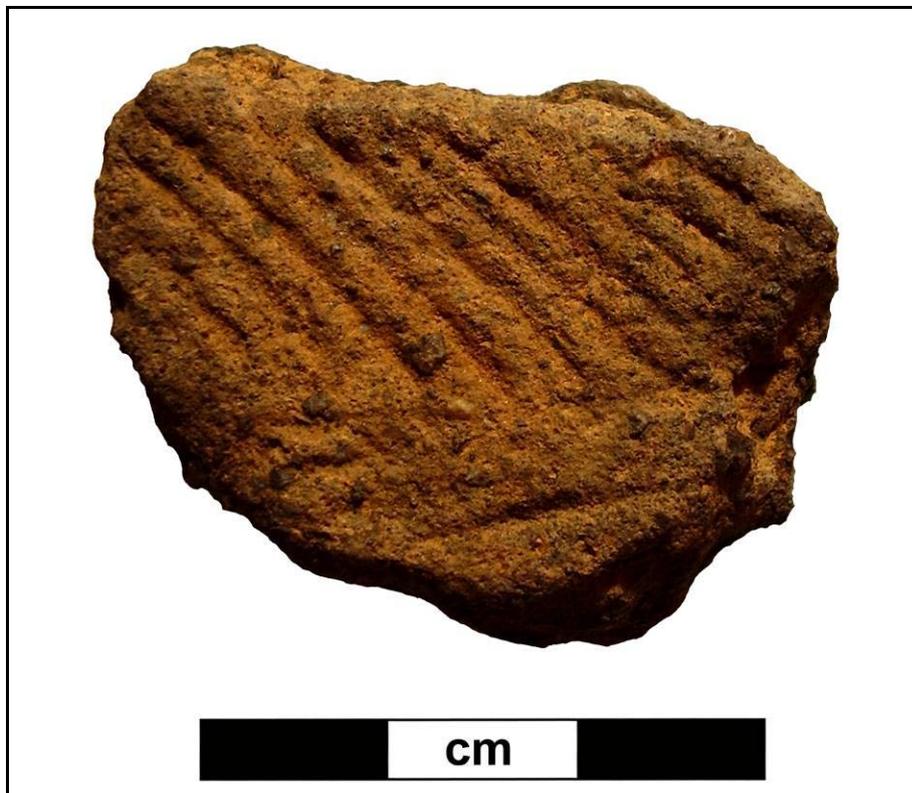
Plate 5 Decorated ceramic fragment from HBS-1 with what appears to be more than one incised band.

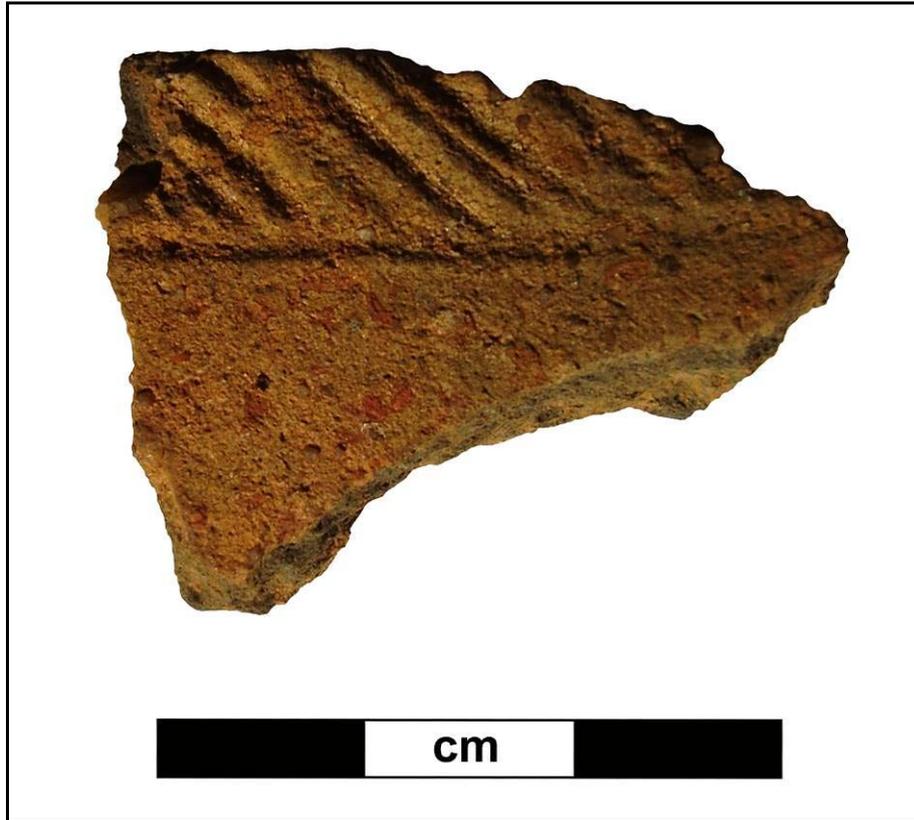
Plate 6 Decorated ceramic fragment with a single incised band visible.

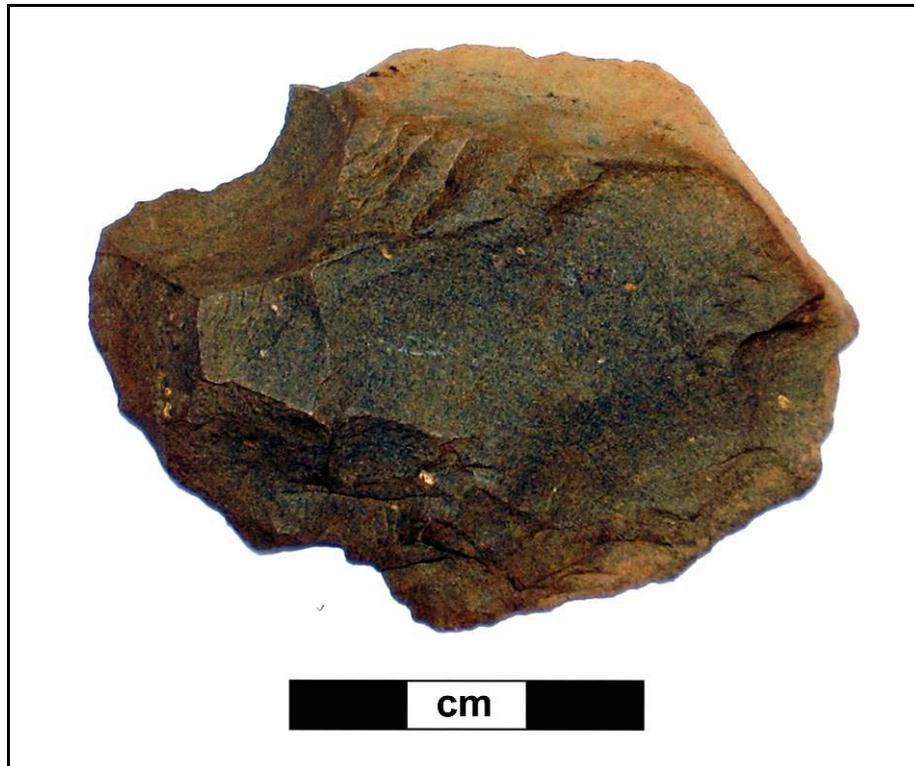
Plate 7 One of the stone artefacts observed on the surface of HBS-1.

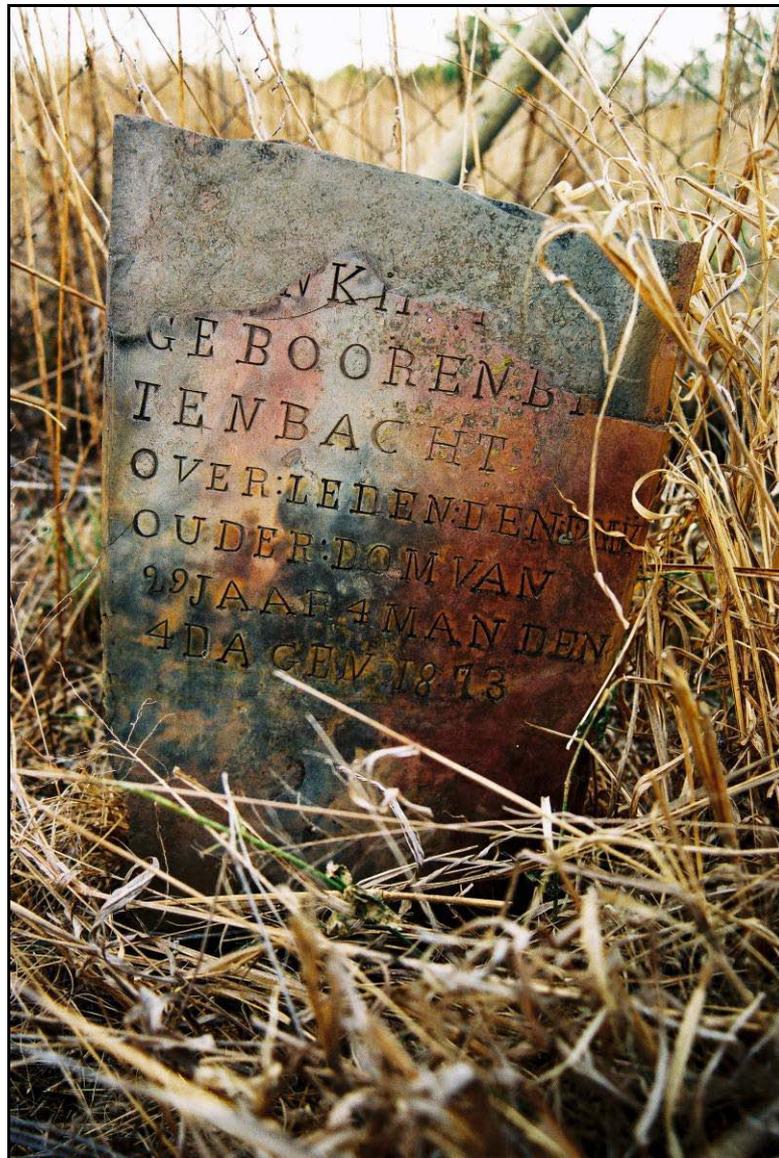
The burial ground is fenced and has a gateless opening on its south-western side which provides access. The entire fenced area is severely overgrown. The general condition of the graves is good.

Plate 8 The headstone of the oldest located grave. The grave dates from 1873.

The best practise in dealing with historic cemeteries such as HBS-2 is to preserve it *in situ*. The preservation of the site during the Pre-Construction, Construction and Operational Phases would require the following mitigation measures:

- Although the cemetery is fenced, a locked gate must be placed in its present entrance.
- A site management plan must be compiled with which the cemetery's conservation during the Construction and Operational Phases can be ensured. The management plan would address aspects such as site monitoring and the clearing of vegetation from the cemetery.
- Monitoring of the site's continued preservation must also be undertaken. The frequency of monitoring visits will be outlined in the site management plan.

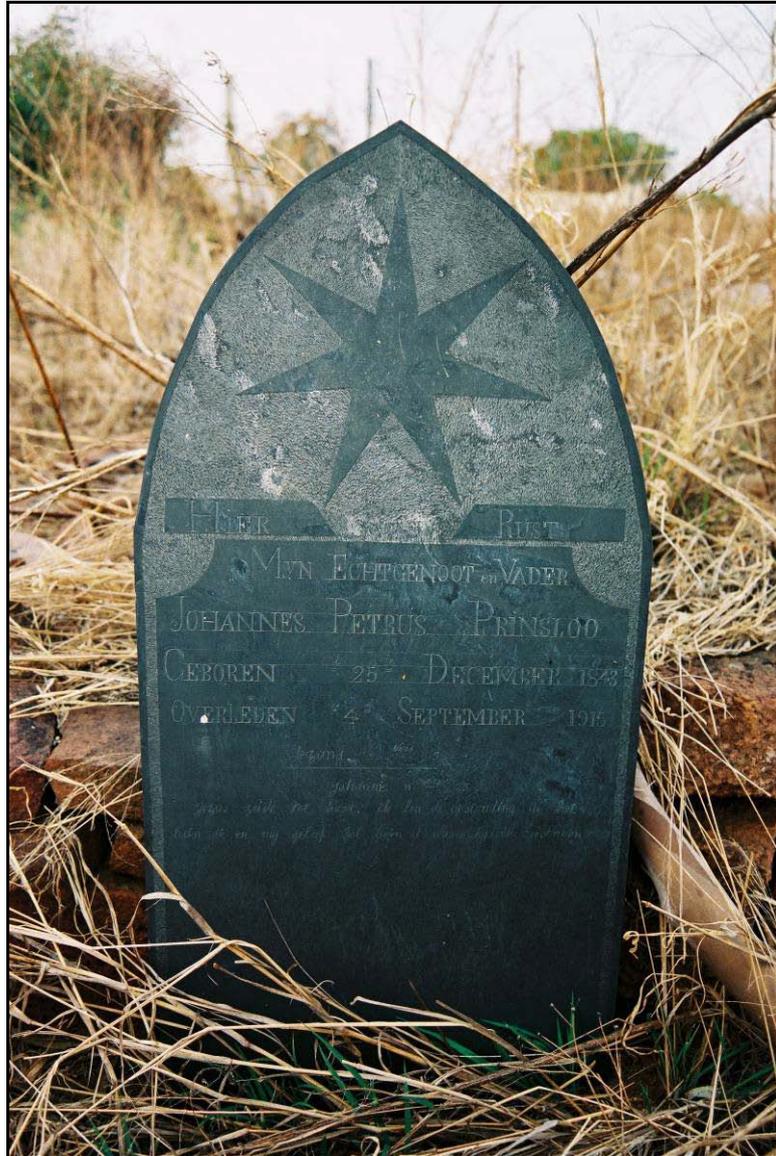
Plate 9

The grave of one of the earliest landowners of the farm Hartbeesspruit, Johannes Petrus Prinsloo (1843 – 1915).

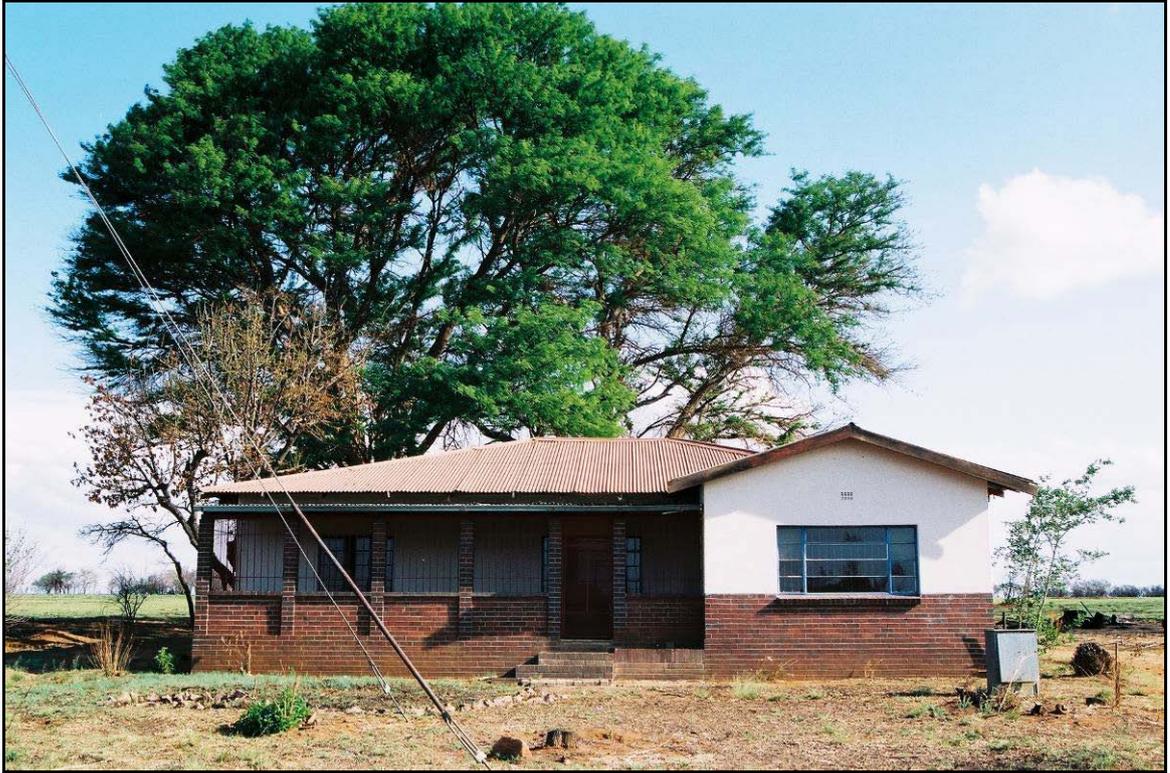
A farmstead is situated here which is comprised of a well-preserved dwelling, foundations for a second dwelling, a pump-house with water reservoir, brick-built dam, small milking shed and the remains of a barn.

Plate 10 The front (southern) elevation of the dwelling at HBS-3.

No mitigation measures are required.

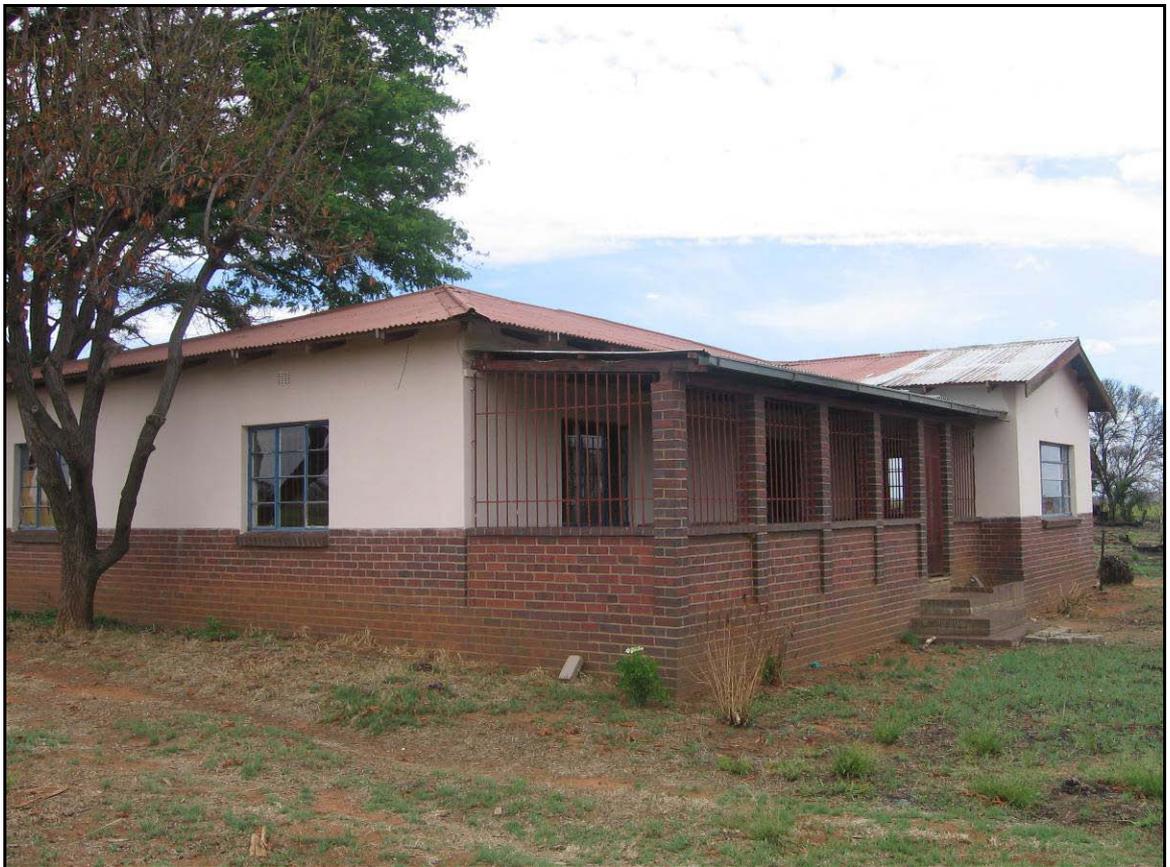
Plate 11 Angled view along the southern elevation of the dwelling at HBS-3.

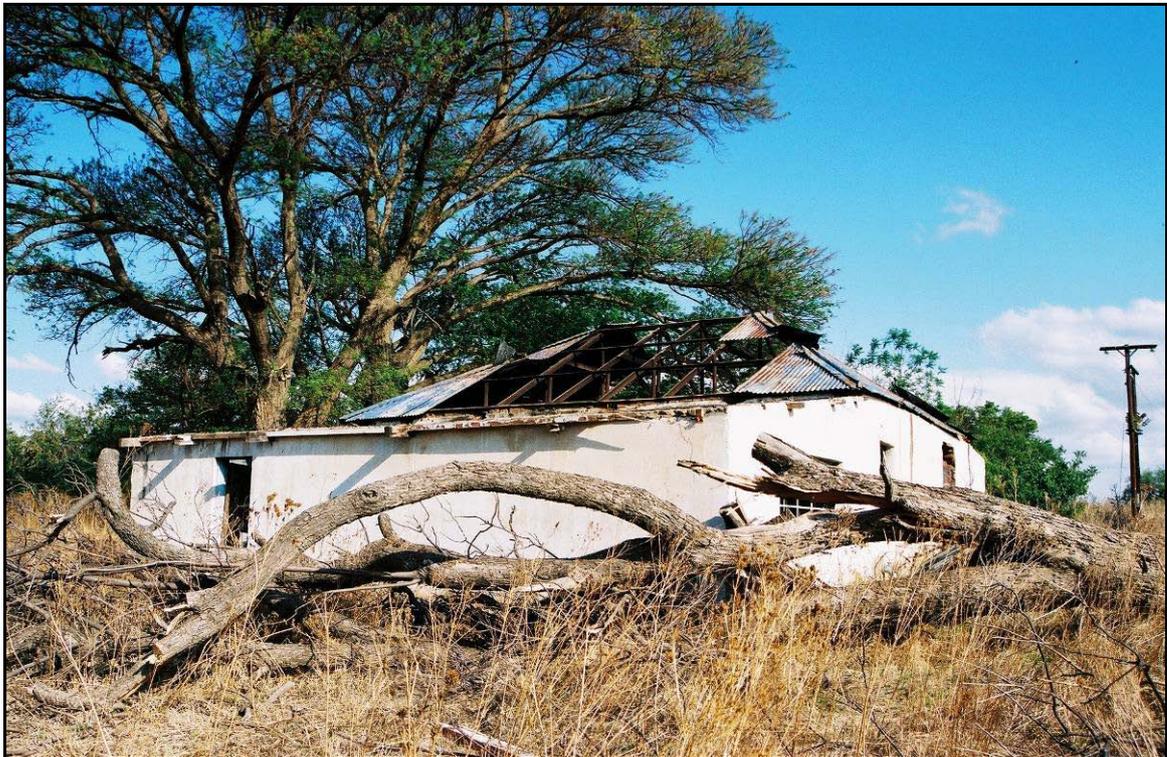
Although the farmhouse is likely the oldest farmhouse (or at least one of the oldest farmhouses) on the entire farm, its condition can almost be characterised as a ruin. Some of the walls have collapsed, most of the corrugated iron roof has been removed and almost all of the architectural elements such as doors and windows are missing. The site is of historic significance and the dwelling reflects several layers of additions and

Plate 12 Northern elevation of the farmhouse at HBS-4.

The building is older than 60 years, and as a result a permit must be obtained from the relevant heritage agency. Before such a permit application may be made, the following mitigation measures must be undertaken:

- Recording of farmstead layout plan, including the farmhouse, outbuilding(s), planted trees and section of water furrow closest to farmstead.
- Detailed recording of the dwelling elevations and floor plan.
- Photographic documentation of the farmstead.
- Compilation of all recorded data in a report.
- Submission of report with permit application to relevant heritage authority.
- Only once the permit has been issued may the farmstead be demolished.

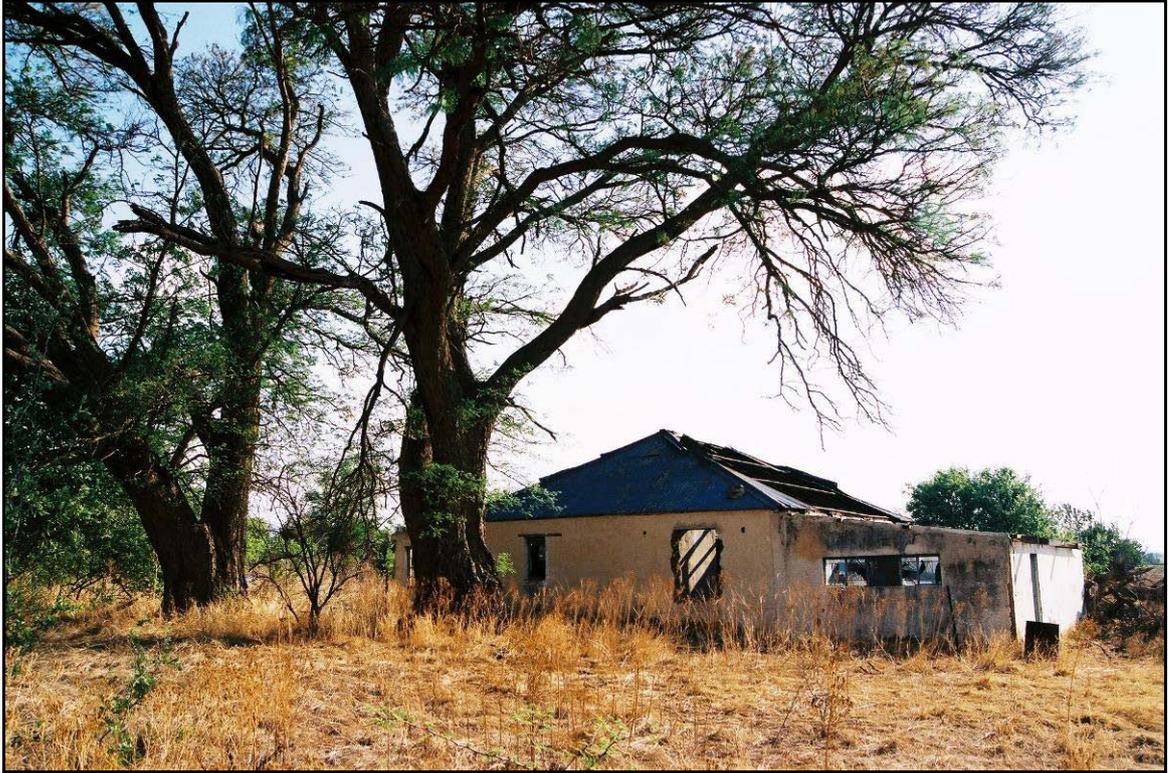
Plate 13 The farmhouse's eastern elevation. Note the two large trees.

All attempts must be made to preserve the two mature indigenous trees directly adjacent to the dwelling.

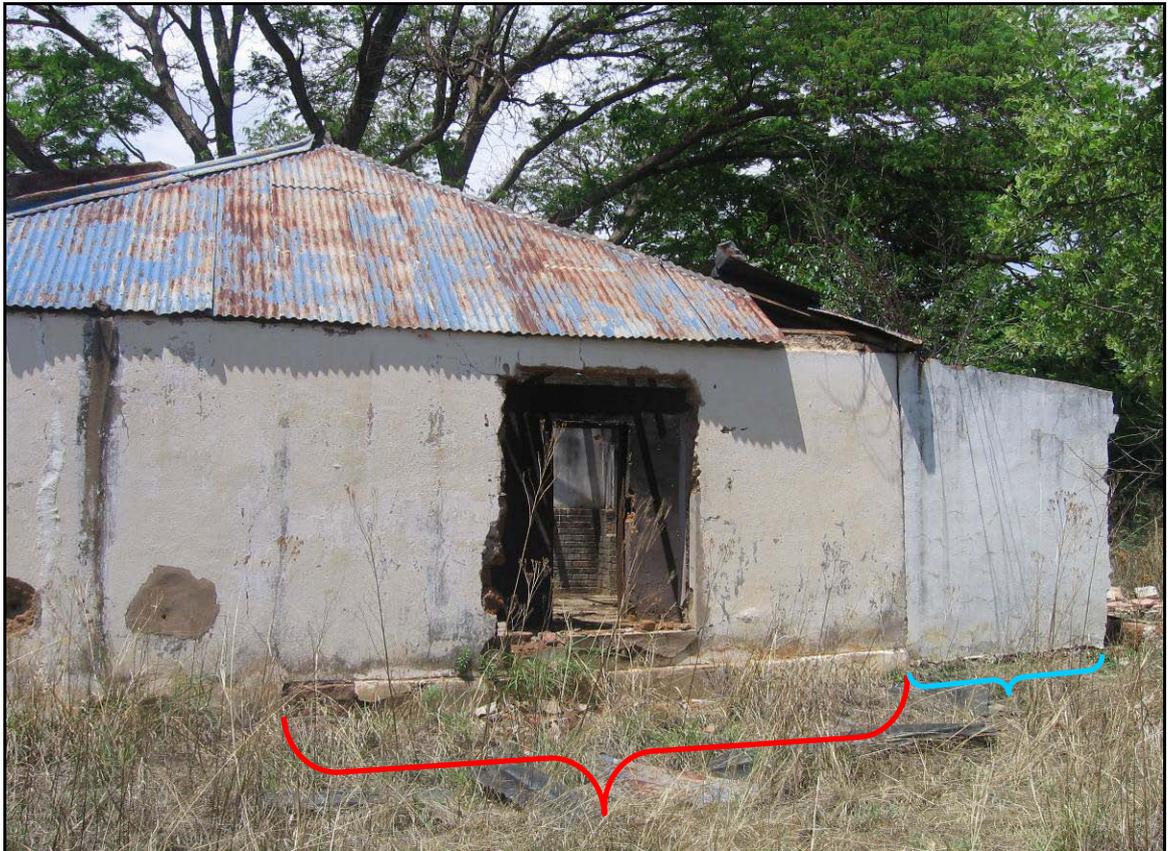
The core of the farmhouse is a small rectangular section on the southern end of the dwelling. This appears to have been comprised of a dwelling area (approximately four meters wide) with two to three rooms and an outside veranda along its southern façade. The foundations and sections of walling from the original building were built with locally obtained stone known as "ouklip". The upper parts of walling of this section were built of homemade clay bricks. Only one preserved section of wall was found in which one of the original windows must have been located. These late 19th century windows were typically comprised of wooden sash windows. Although the faint outline of the original window and wooden lintel can still be observed, the larger window opening was reduced and replaced with a small iron frame window.

Plate 14 Western elevation of a section of the farmhouse. The section marked in red represents the original pre-1900 dwelling, and the one marked in light blue the associated veranda. Note the stone foundation and plinth along the base of the original dwelling.

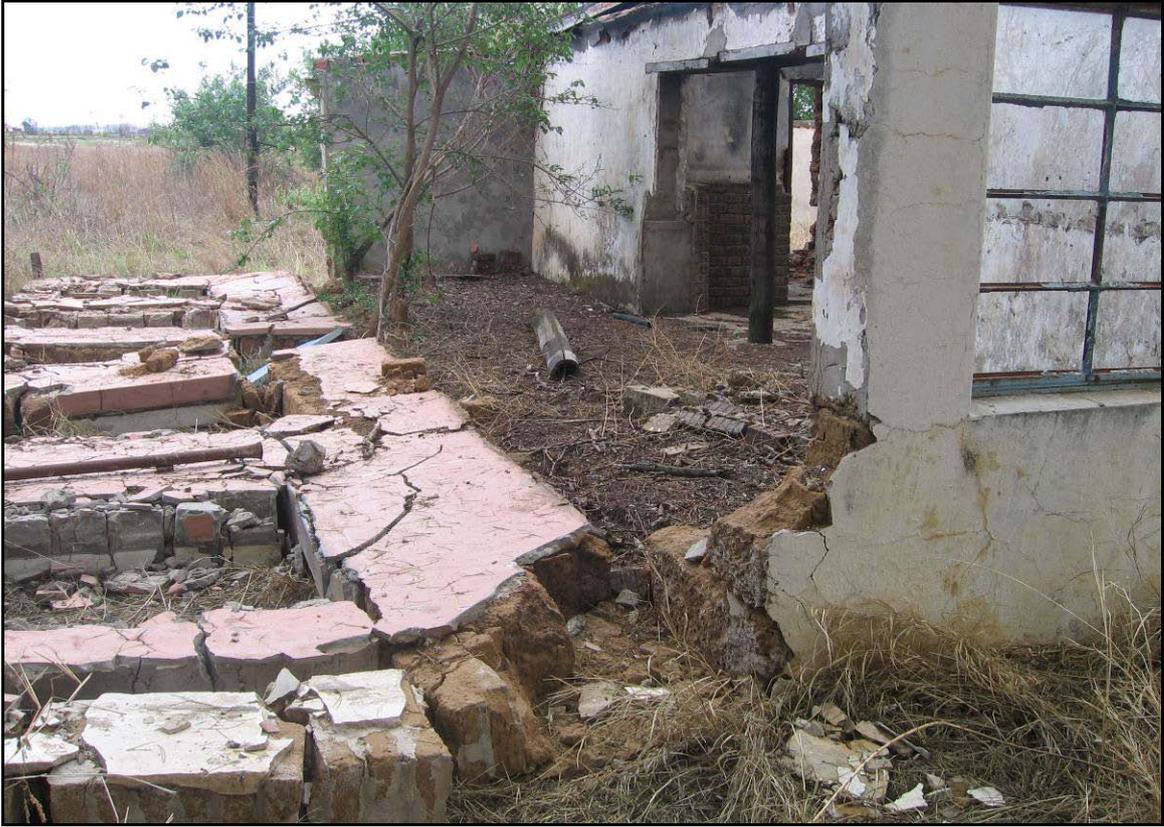
Plate 15 View of the farmhouse's southern façade. The collapsed outer wall originally built to close the veranda is visible on the left.

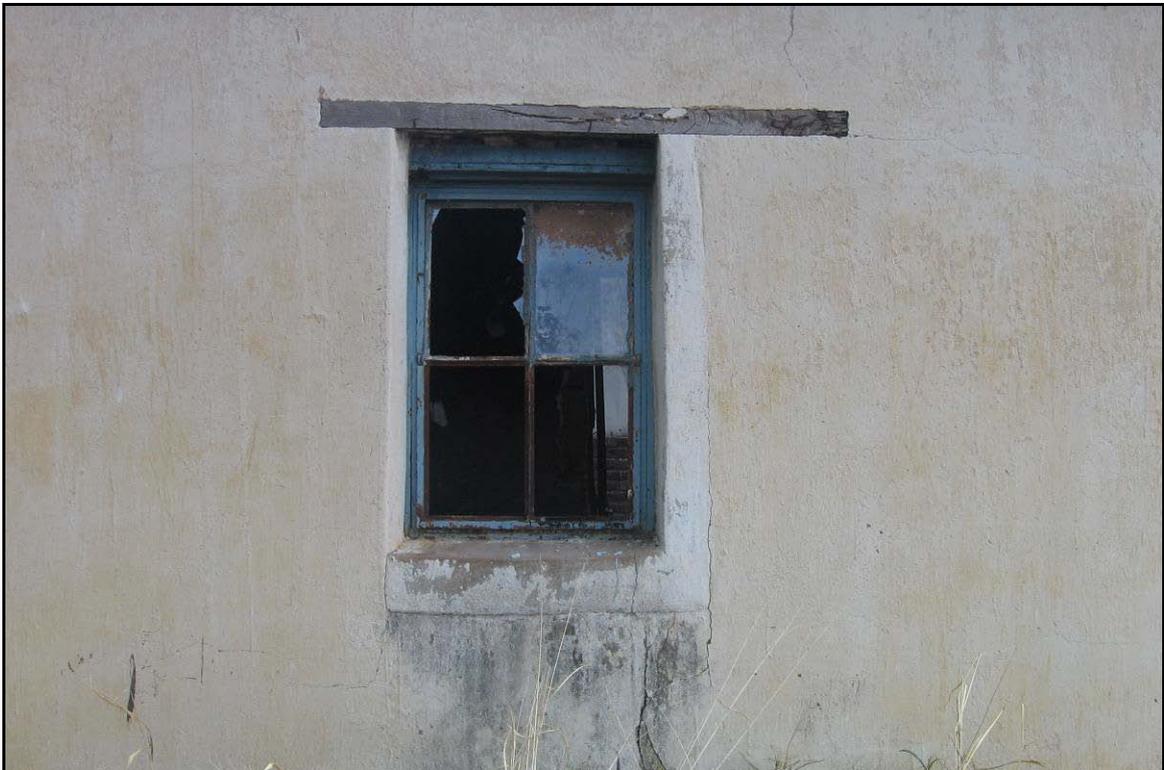
Plate 16 View of a section of the farmhouse's eastern façade. The faint outline of the original pre-1900 window is just visible, while the original wooden lintel can still be seen.

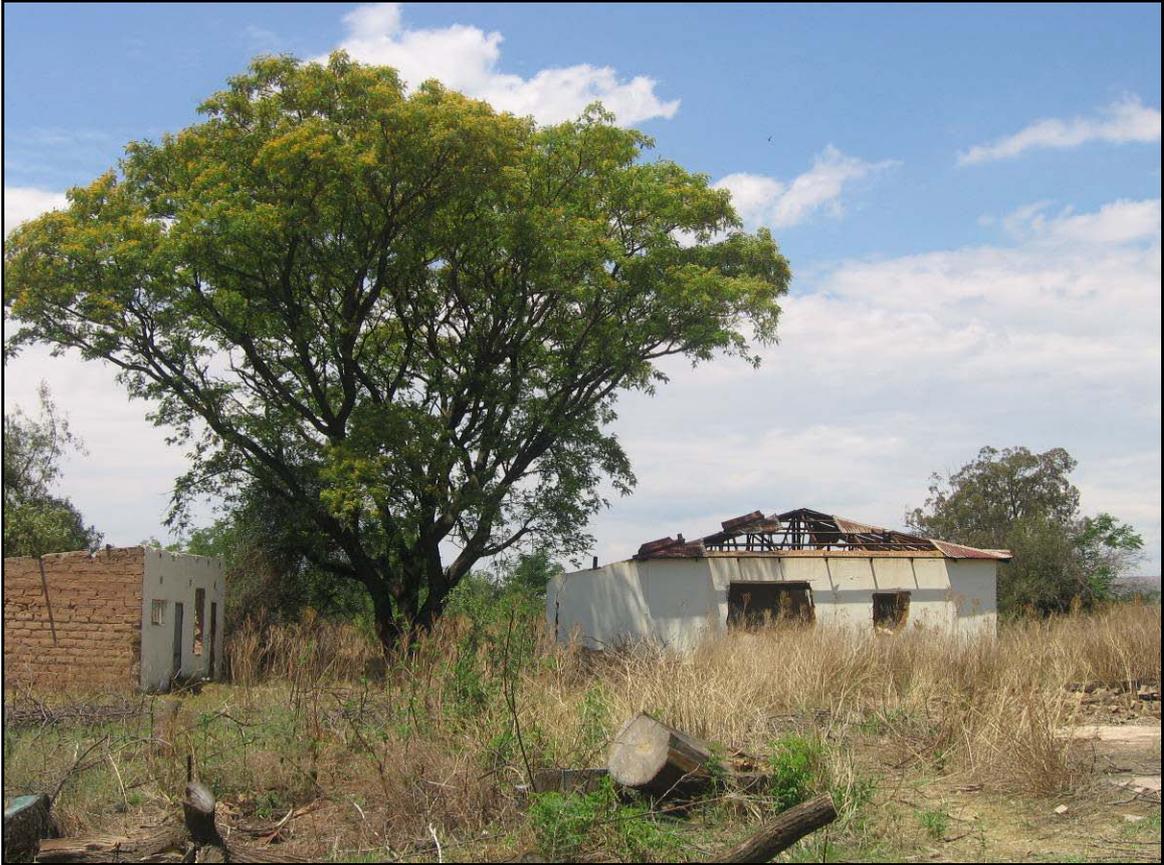
HBS-5 consists of a historic farmstead which in turn is comprised of a dwelling, milking room and tobacco shed. The milking room and tobacco shed are both constructed of cement bricks, and were probably constructed during the 1970s. The dwelling seems to be older and has a stone (“ouklip”) foundation. The roof is of corrugated iron while all the window frames are of iron. A covered veranda is situated along the eastern façade. The dwelling appears to have been constructed during the 1930s or 1940s.

Plate 17 HBS-5's dwelling is visible on the right with one of the outbuildings on the left.

The building is older than 60 years, and as a result a permit must be obtained from the relevant heritage agency. Before such a permit application may be made, the following mitigation measures must be undertaken:

- Recording of farmstead layout plan, including the farmhouse, outbuilding(s), planted trees and section of water furrow closest to farmstead.
- Recording of dwelling’s footprint.
- Photographic documentation of farmstead.
- Compilation of all recorded data in report form.
- Submission of report with permit application to relevant heritage authority.
- Only once the permit has been issued may the farmstead be demolished.

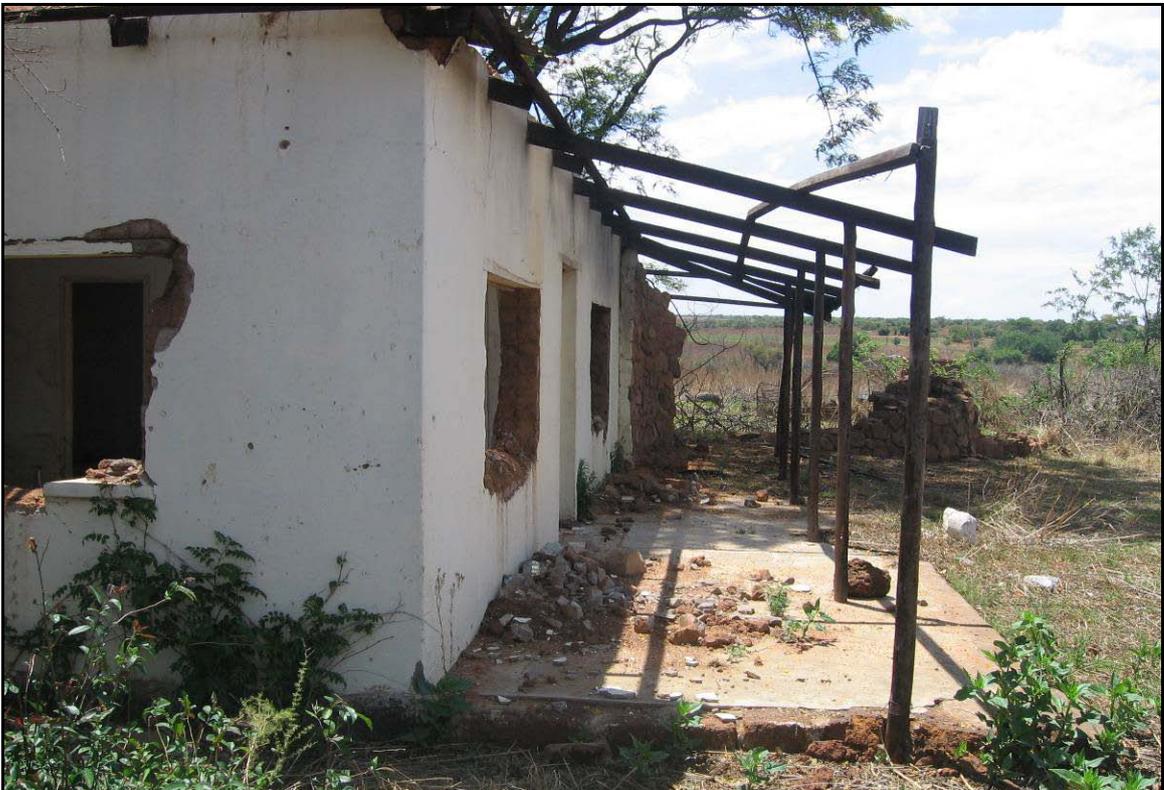
Plate 18 View along the eastern façade of the dwelling and porch area. The poor preservation of the building is clearly evident.

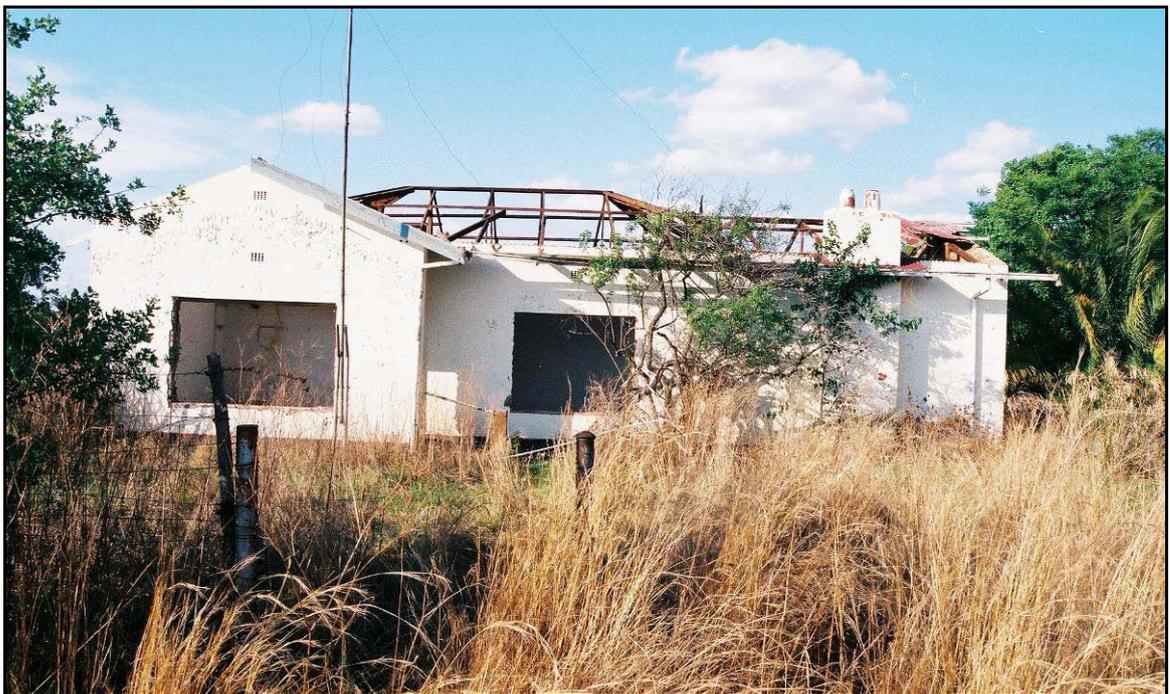
Plate 19 Front (southern) elevation of the dwelling at HBS-6.

No mitigation measures are required.

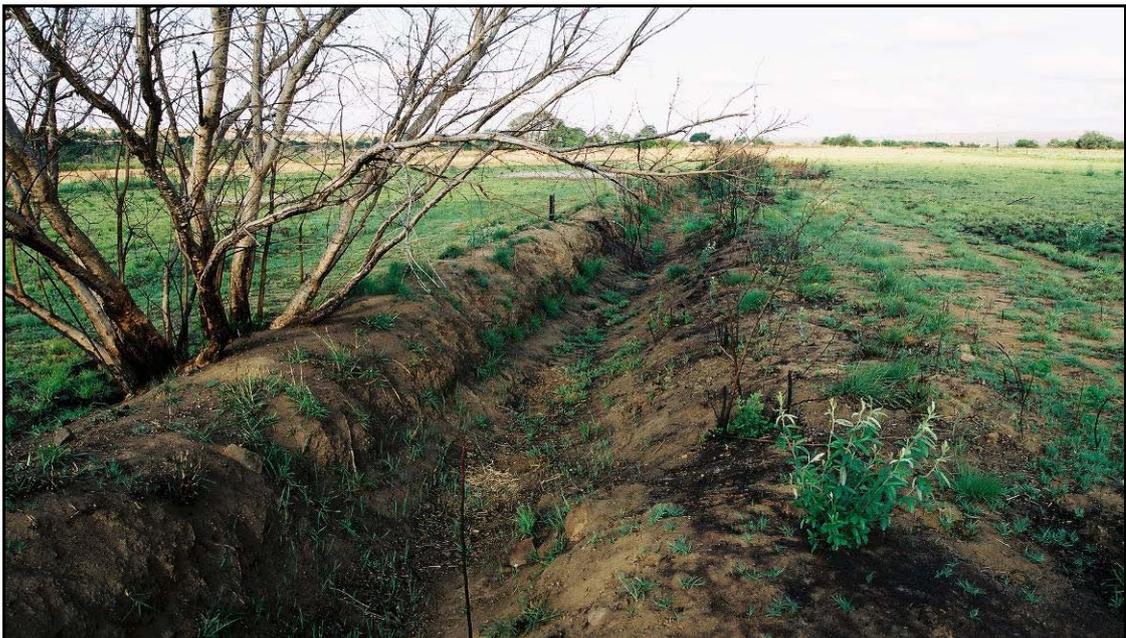
Plate 20 General view of a section of the water furrow.

The only mitigation requirement would be to document the layout of the water furrow and dams within the study area. This can be done with the available aerial photographs.
