**Phase 1 Sub-surface Investigation
Archaeological Project Report**

Old Johannesburg Fort

Central Business District
Johannesburg Municipality
Gauteng
Map reference: 2628 AA (1:50000)

24 October 2006

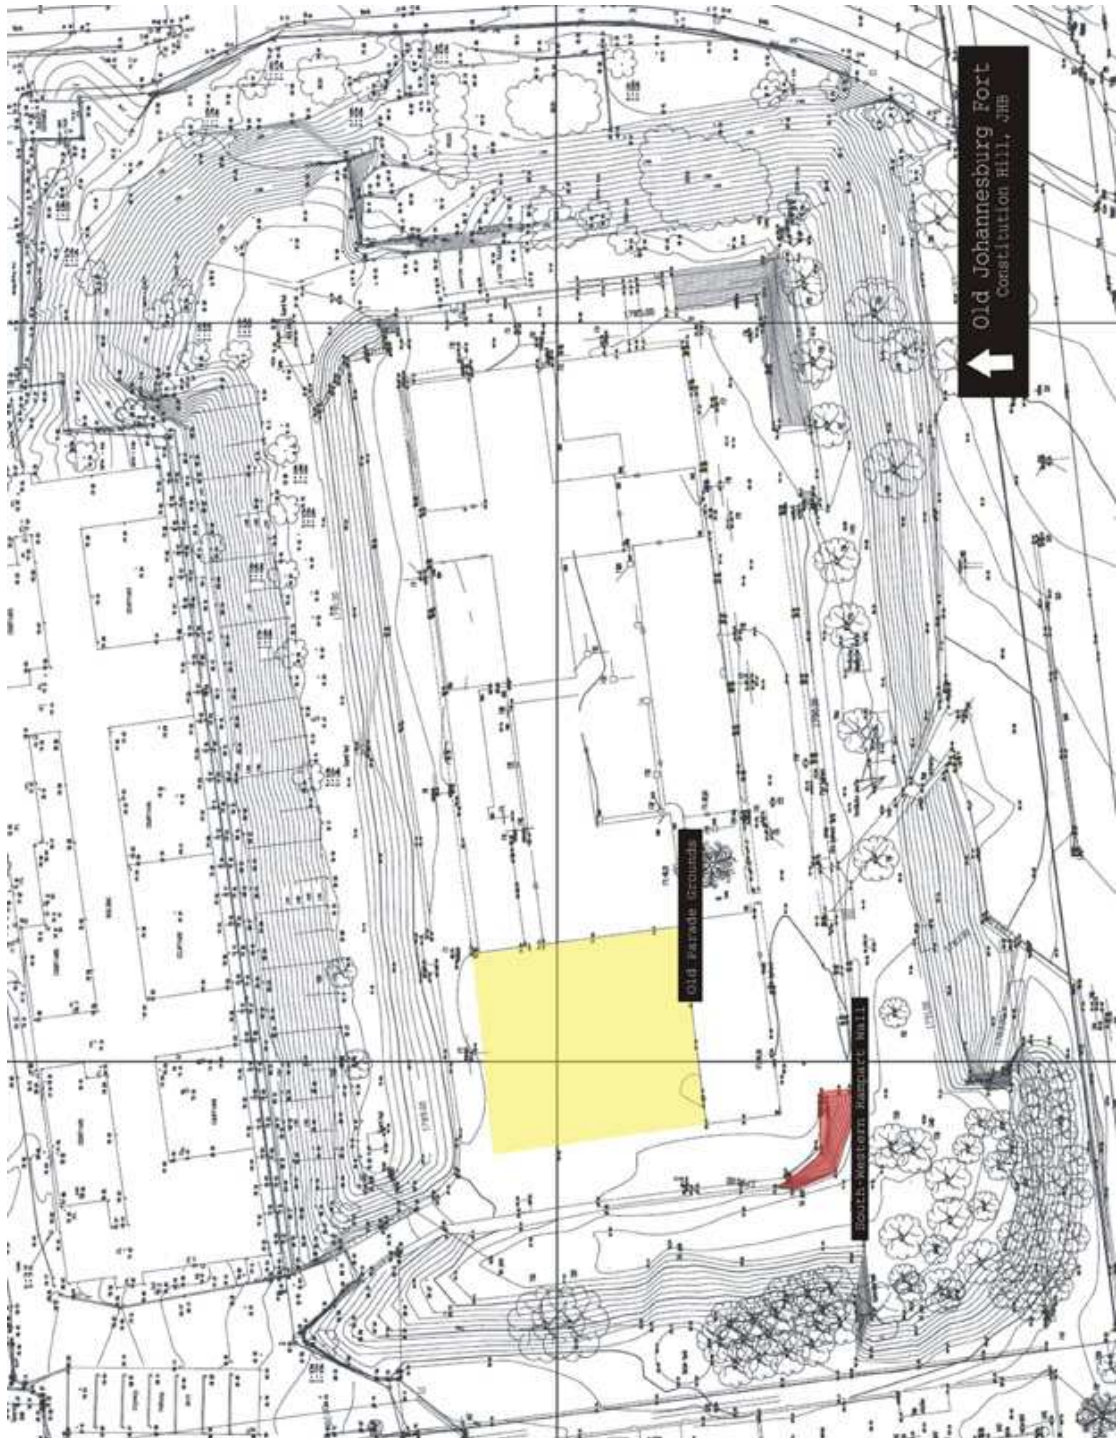
The areas under investigation are situated within the rampart walls of the Old Fort in the Johannesburg CBD (Figure 1). The Parade Ground is situated in the north-western corner of the Fort near the northern exit passage. This area is tarred and is used as a parking lot for the adjacent coffee shop and the Old Fort Museum. Excavations in this area required the removal of the tar surface in order to expose deposits and features below.

Figure 1. Areas under investigation, Old Johannesburg Fort.

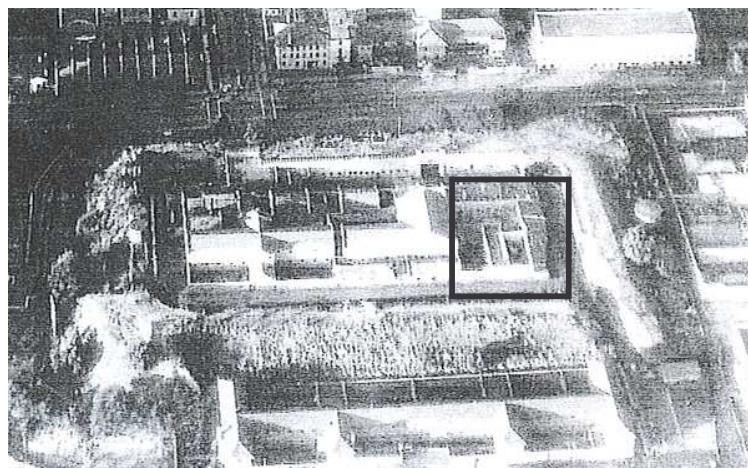
Figure 2. Historical photograph with intact padded cellblock walls.

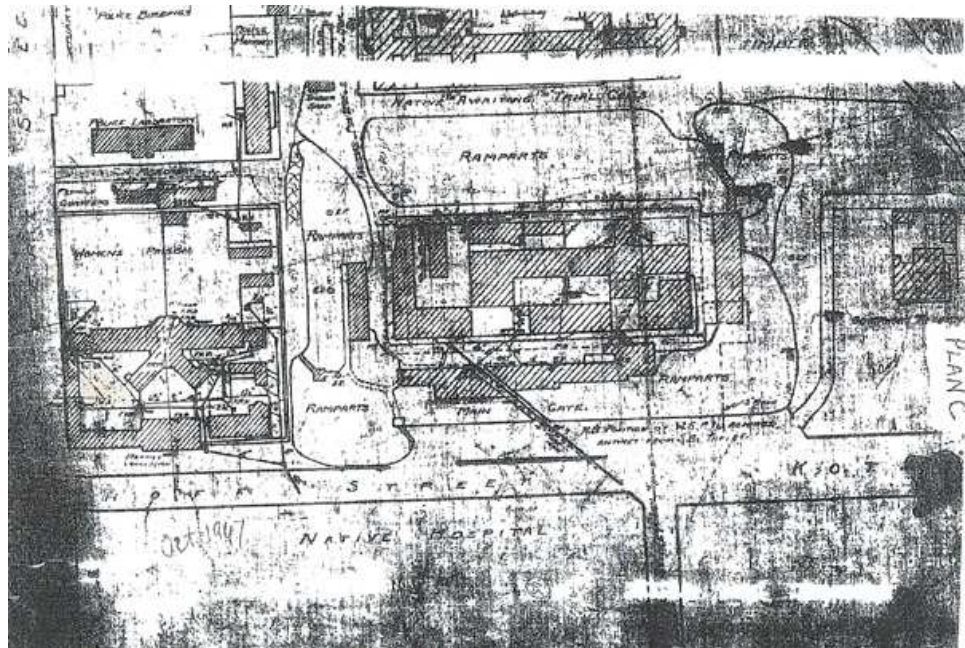
Figure 3. Historical plans of the Old Johannesburg Fort. The top plan dates to the early 1990s, and the bottom one the mid-1990s.

The circular structure, possibly the remains of a well (Figure 17) is situated between T05 and the eastern wall demarcating the parade ground. It might relate to the circular structure visible on the early 1900s plans of the fort (Figure 3). These features were documented and photographed.

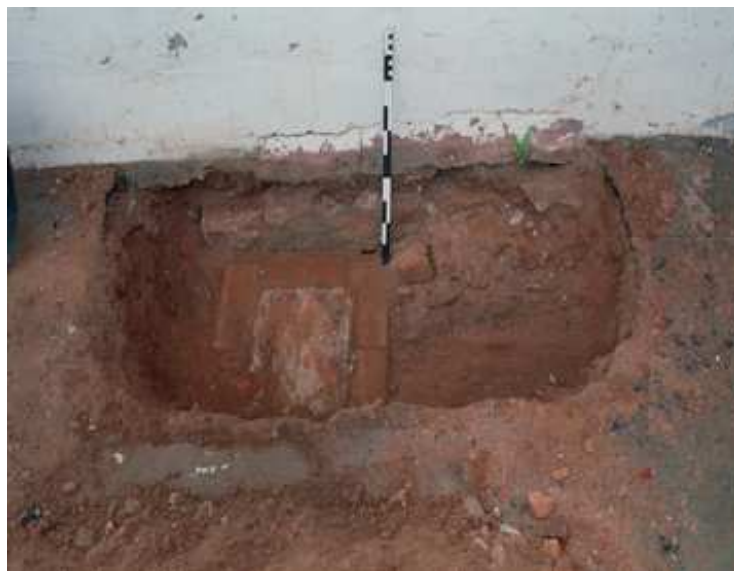
The first trench was excavated to determine the level of the damp seal (if any) in the existing walls of the fort's buildings. An east-west aligned rectangular trench measuring approximately 120cm x 50 cm was excavated next to the northern wall of the present-day coffee shop. After the tar surface was removed a 10cm spit was excavated. Soil in this spit was red in colour and its texture was coarse because of large gravel inclusions. A foundation structure was exposed at a depth of 20cm (Figure 5). This structure is made up of clay-bricks around a sandstone core. It leads directly north, away from sandstone foundation stones that form part of the foundation structure of the existing northern wall of the coffee shop.

Figure 5. Clay-brick and sandstone structure in T01.

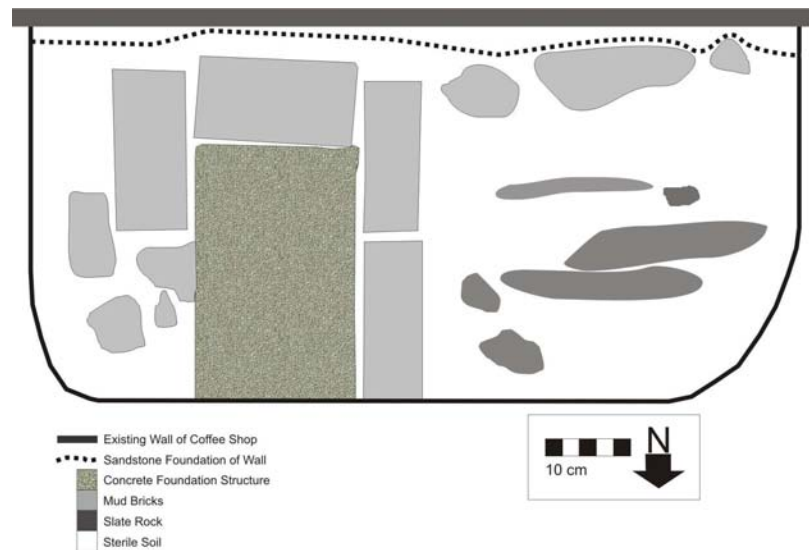
The excavation exposed a section of the foundation of the existing building, but no damp seal was identified leading to the conclusion that damp seals were not included when the building was constructed. The terminal depth of the trench, indicated by slate rocks and red rocky soil, was reached at approximately 30cm below the tar surface. The excavation was recorded, photographed and sections drawn.

Figure 6: Plan of T01, showing the foundations.

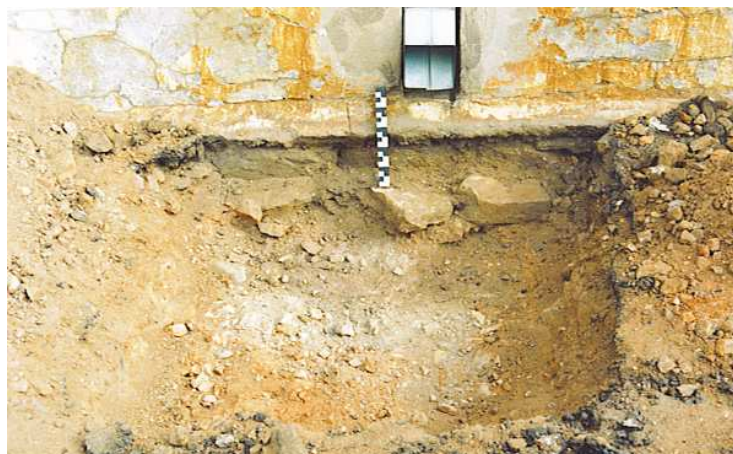
It was later decided to extend the excavation in a northern direction, following the clay-brick foundation structure. The foundation, however, disappeared immediately north of the original trench and the extension revealed only bedrock and building rubble. It was recorded and photographed and the excavation of the extension was suspended. Two smaller 50cm x 50cm trenches (**T01a** & **T01b**) were then excavated, adjacent to the wall directly east and west of T01, in order to examine the foundations in these areas, and to search for indications of damp seals. T01a revealed the sandstone foundation similar to that found in T01. No damp seals were identified and terminal depth (bedrock) was reached at 25cm. The western trench (T01b) yet again exposed the building's sandstone foundation, reinforced with concrete. A large amounts of building rubble was found in the excavation (Figure 7). These two trenches were documented and photographed.

Figure 7. Rubble and building foundation visible in the extension of T01.

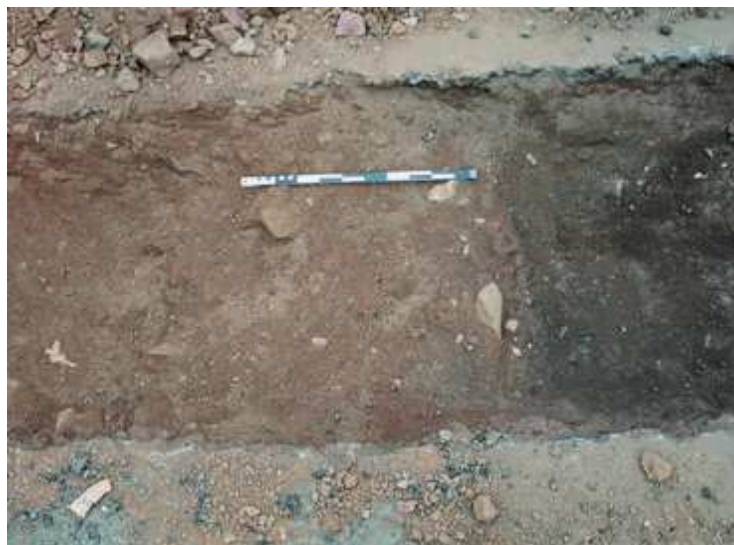
The tar surface was removed to reveal a reddish clay deposit underneath. A first layer of approximately 10cm was excavated and soil from this layer was red in colour and contained large amounts of building rubble and rocks, an indication of disturbance of deposits or features. The subsequent layers were excavated, and at a depth of approximately 20 cm large sandstone stones and clay-bricks were exposed in red coarse soil. The position of these stones and bricks corresponded with the position of the northern walls of existing buildings. Smaller stone clusters were found between the larger rocks. There was also a clear difference in colour between soil in this stone structure and soil in the trench directly south and north of it. This soil, "inside" the feature was dark brown, organic and damp. When the layer was cleaned up and brushed, it became clear that the stone structure and red soil was an intrusion into the darker brown soil. At this point it seemed that the structure was part of a wall foundation and that a trench was dug into the dark brown soil when the foundation was built (Figure 8).

Figure 8. Photograph showing the distinctive colour differences between the soil to the north and south of the stone 'foundation'.

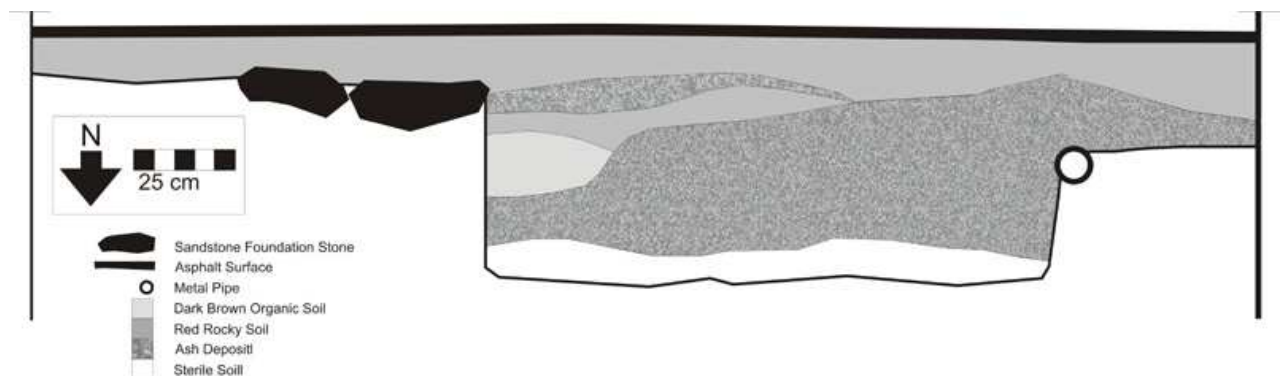
The tar surface was removed to reveal red-brown rocky soil. A first layer of ± 10 cm was then excavated. It was made up of this course red-brown soil. The next layer came down on a prominent layer of ash and charcoal that extended down to just above terminal depth. Signs of an intrusion into the ash layer appeared in the profile. This layer also revealed an iron water pipe in the western section of the trench and sandstone and clay-brick foundations in the eastern sector next to the intrusion into the ash lens. Bedrock was reached at a depth of 60cm. The sandstone and clay-brick foundation structure was then followed with a north-south orientated extension trench. This trench exposed a stone foundation structure, which included large chiseled sandstone blocks (Figure 9 & 10).

Figure 9. Profile of southern section of T03.

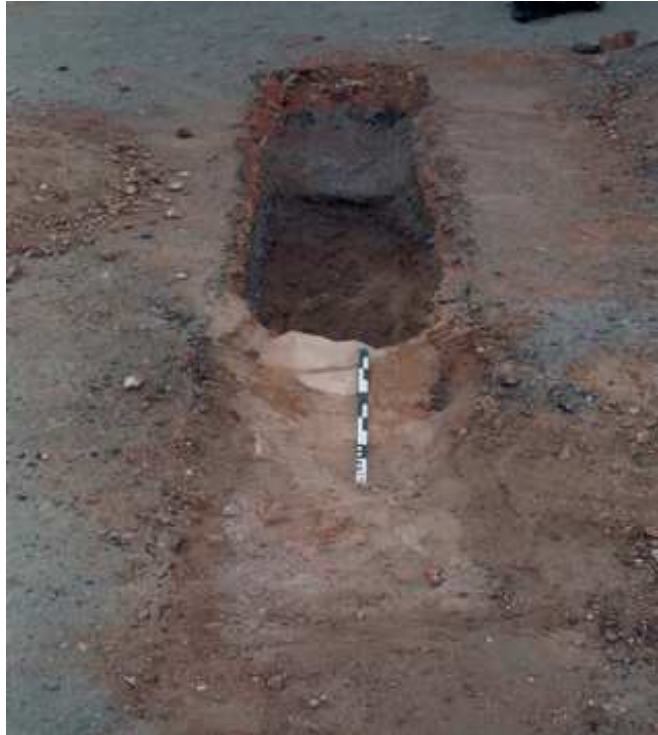
Figure 10. T03 with the stone foundation blocks in the foreground and the ashy landfill and water-pipe in the background.

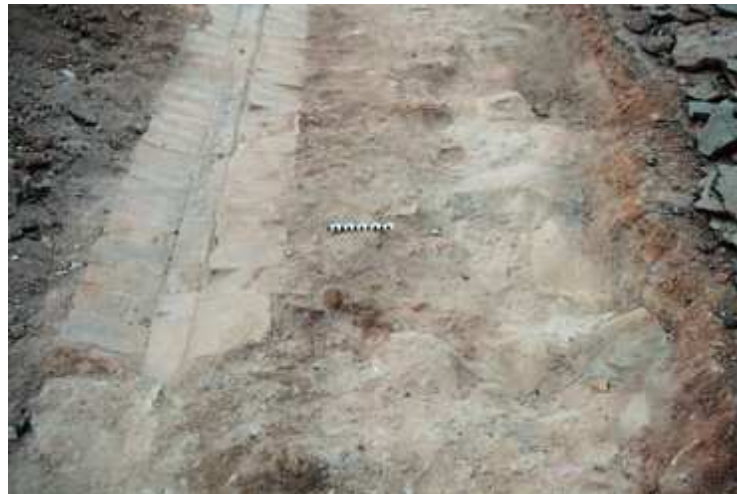
On extension of the initial trial trench, the team exposed a water furrow, built with clay-bricks, running next to the foundations (Figure 11).

Figure 11. T03 stone foundations and brick furrow.

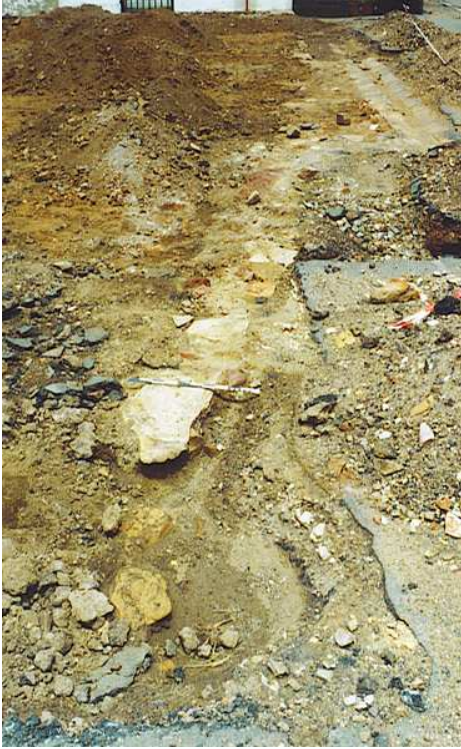
The entire southern section of foundation was then exposed. The trench was also extended to the north but the foundations, changing course in a northeastern direction, abruptly ended about 1 m north of the first T03 test-trench. It seems that the foundations were destroyed in this area (Figure 12). The trench was documented and photographed.

Figure 12. Northern extent of T03 foundation structures.

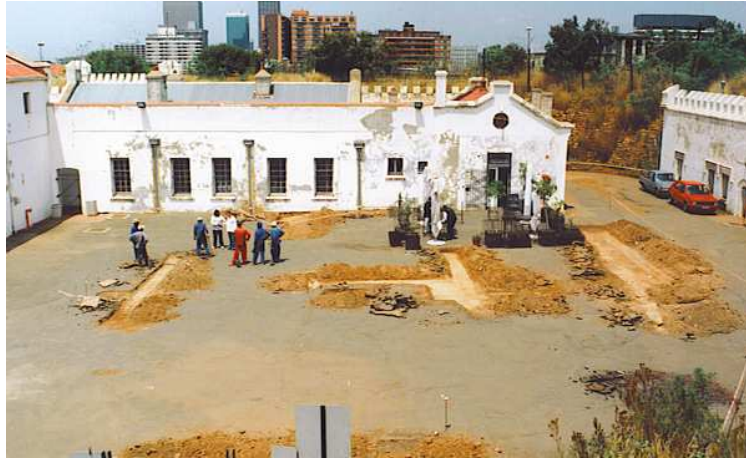
Historic sources indicate that T03 formed part of the large cellblock, which extended northwards. The archaeologists demarcated a north-south trench –T04 -for excavation in the area where the eastern wall of this structure would have stood. The tar surface was removed and a first 10cm layer was excavated through red rocky soil. This layer exposed the sandstone foundations that were later identified as the main interior wall of the cellblock. As excavations progressed, the foundations of smaller clay-brick structure extending west were exposed in the northern sector. This structure was excavated and documented. Another smaller clay-brick foundation, with adjacent cement flooring, was exposed extending southwards from the middle of the large sandstone foundations (Figure 13).

Figure 13. Excavation T04 and T05 in the central parade ground.

Excavation of this structure revealed a large section of smoothed cement floor and a cement water furrow to the south. The water furrow, orientated north-south, was exposed to the north, however it disappears to the north. It seems to have been destroyed in line with the end of the northern foundations structures in T03. In order to establish the extend of the floor exposed next to the brick foundation structure, a small trench (T04a) measuring 100cm x 50 cm was excavated in the vicinity of the exposed floors. No floor surfaces were found in this areas and it seems that the floor was destroyed along with the northern extension of the water furrow and the northern foundations in trench T03. The entire excavation was documented and photographed.

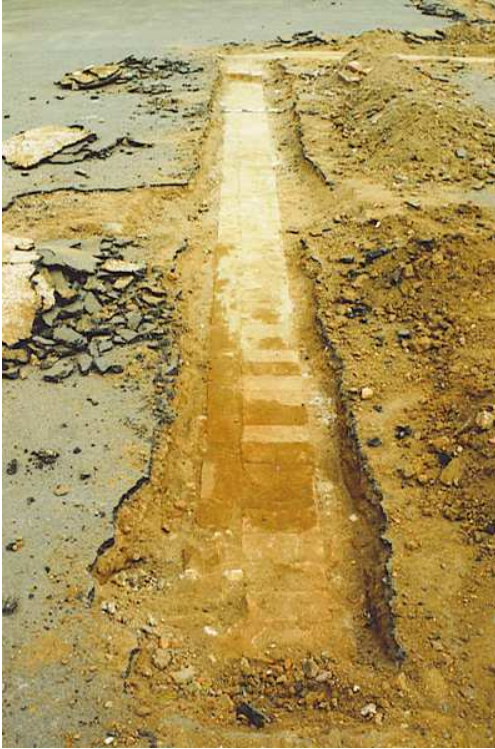
In correspondence with historical maps, a north-south trench was placed directly east of the eastern walls of the padded cell block. A wall, forming a demarcation between a courtyard and the cells, used to extend north here. The tar surface was removed and after a 10cm layer of red rocky soil was excavated, the clay-brick foundation structure of the wall under question was exposed (Figure 14).

Figure 14. Clay-brick foundation in T05.

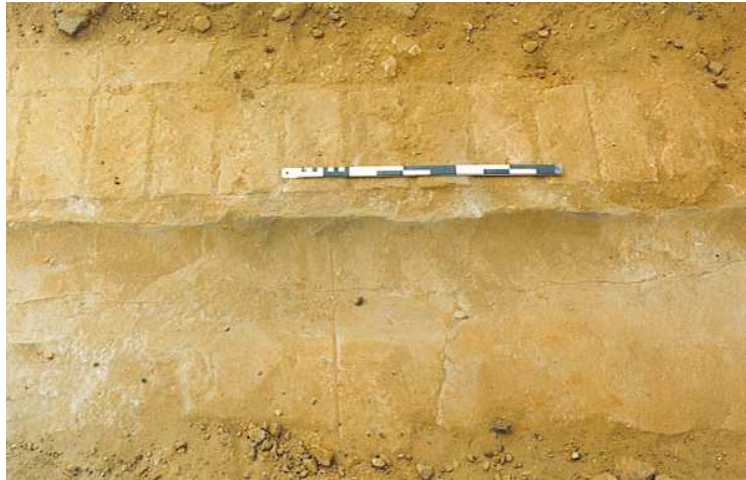
This east-west section also contained a cement water furrow right next to the foundation structure (Figure 15). The foundation also extended in a northerly direction, thus creating a U shape. In this direction the structure joined up with foundations, floors and water furrow excavated in the eastern sector of T04. The excavation was documented and photographed.

Figure 15. Water furrow found in T05.

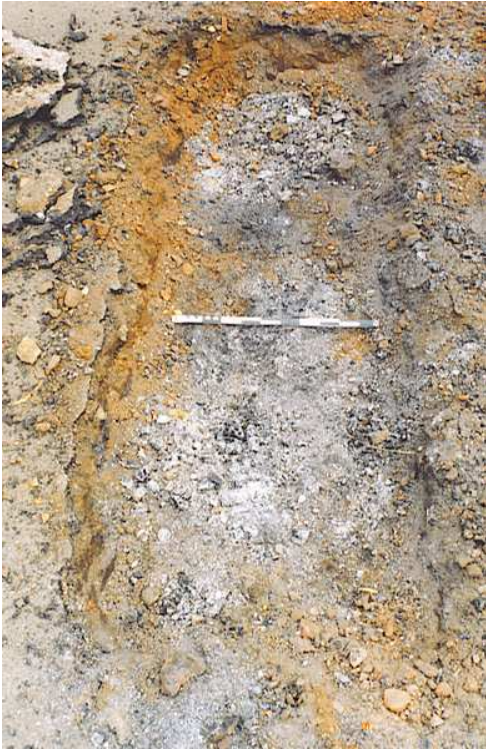
The tar surface was removed and the first 10cm layer exposed the ashy layer found in T03 (Figure 16). No foundations were found and the entire deposit in the trench was made up of this ashy soil until the terminal depth was reached at 35cm. The excavation was documented and photographed and the tar surface was partially replaced for practical and safety reasons.

Figure 16. Ashy landfill found in T06.

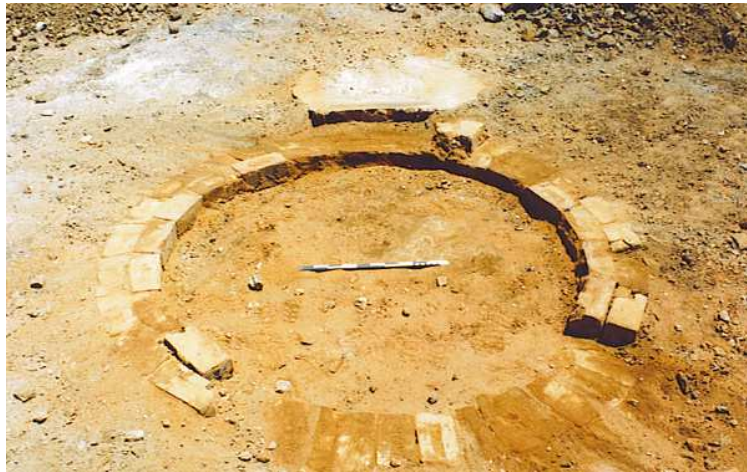
Figure 17. Circular brick feature B

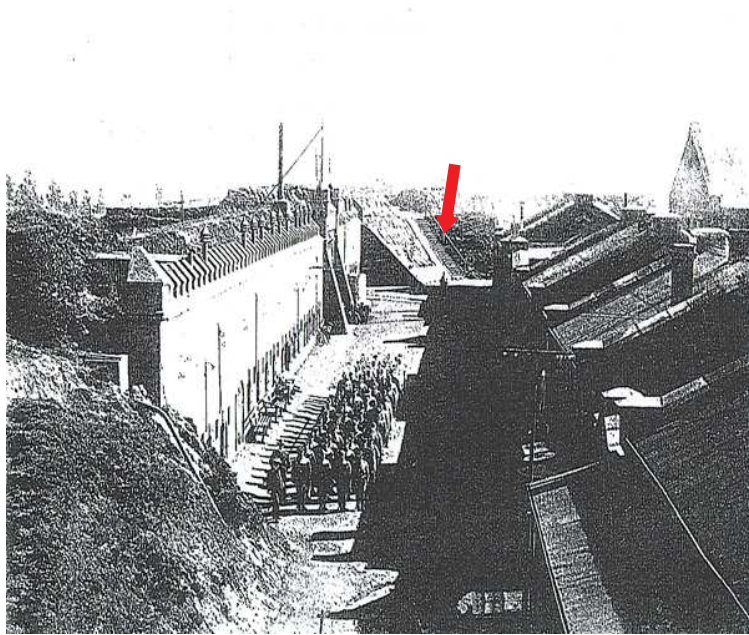
The artillery and lookout point on the southwestern rampart's top was connected to the area below by a staircase at the time of the South-African War (Figure 18). These stairs are no longer visible (Figure 19).

Figure 18. Historical photograph showing rampart steps in south-western corner.

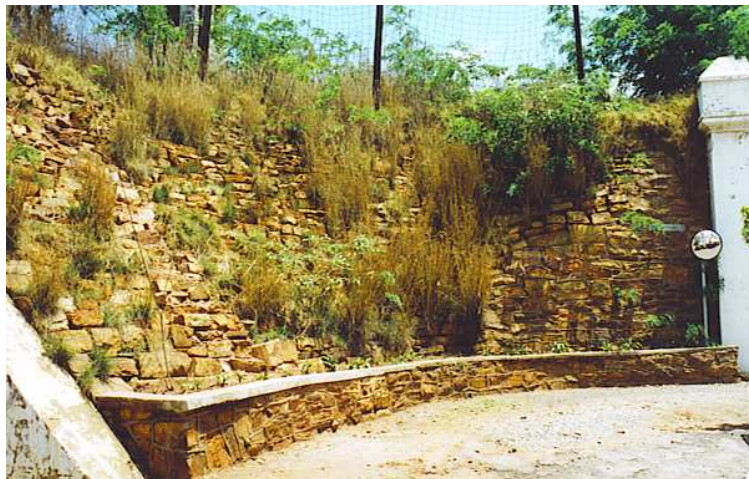
Figure 19. The south-western rampart today.

It is necessary to monitor the area in the south-western rampart where excavations were conducted. Monitoring and early intervention will ensure its continued stability. This is needed because the moving of the rocks during excavations may have weakened the structure. It is further recommended that utmost care be taken if further excavations were to be done on the ramparts in order to ensure the stability of the rampart as a whole.

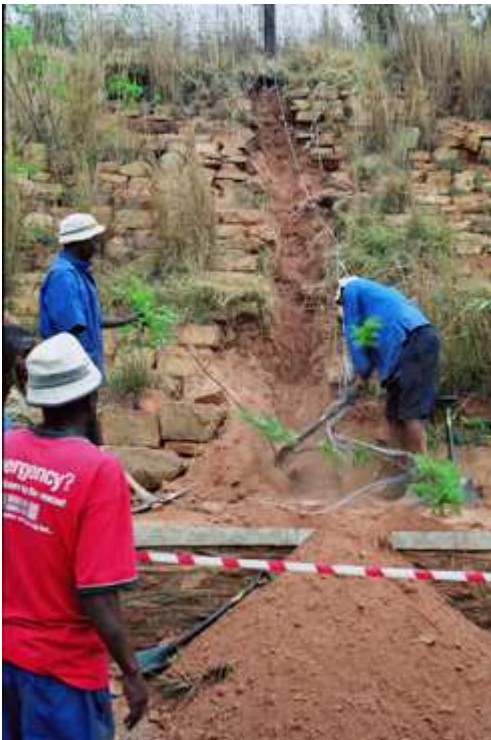
This area was excavated to determine whether this structure still existed and to uncover its remains. Packed stones forming the wall of the rampart were removed and the soil underneath excavated. The deposit below the stones consisted of fine, sandy soil of a yellow-brown colour. The trench was approximately 1m deep. No definite structures or remains of any sort were uncovered in this trench, and it was decided to extend the trench downwards and in an east-west direction at the base of the rampart. The excavation in the wall was photographed and documented (Figure 20 & 21).

Figure 20. Excavation into rampart wall (R01).

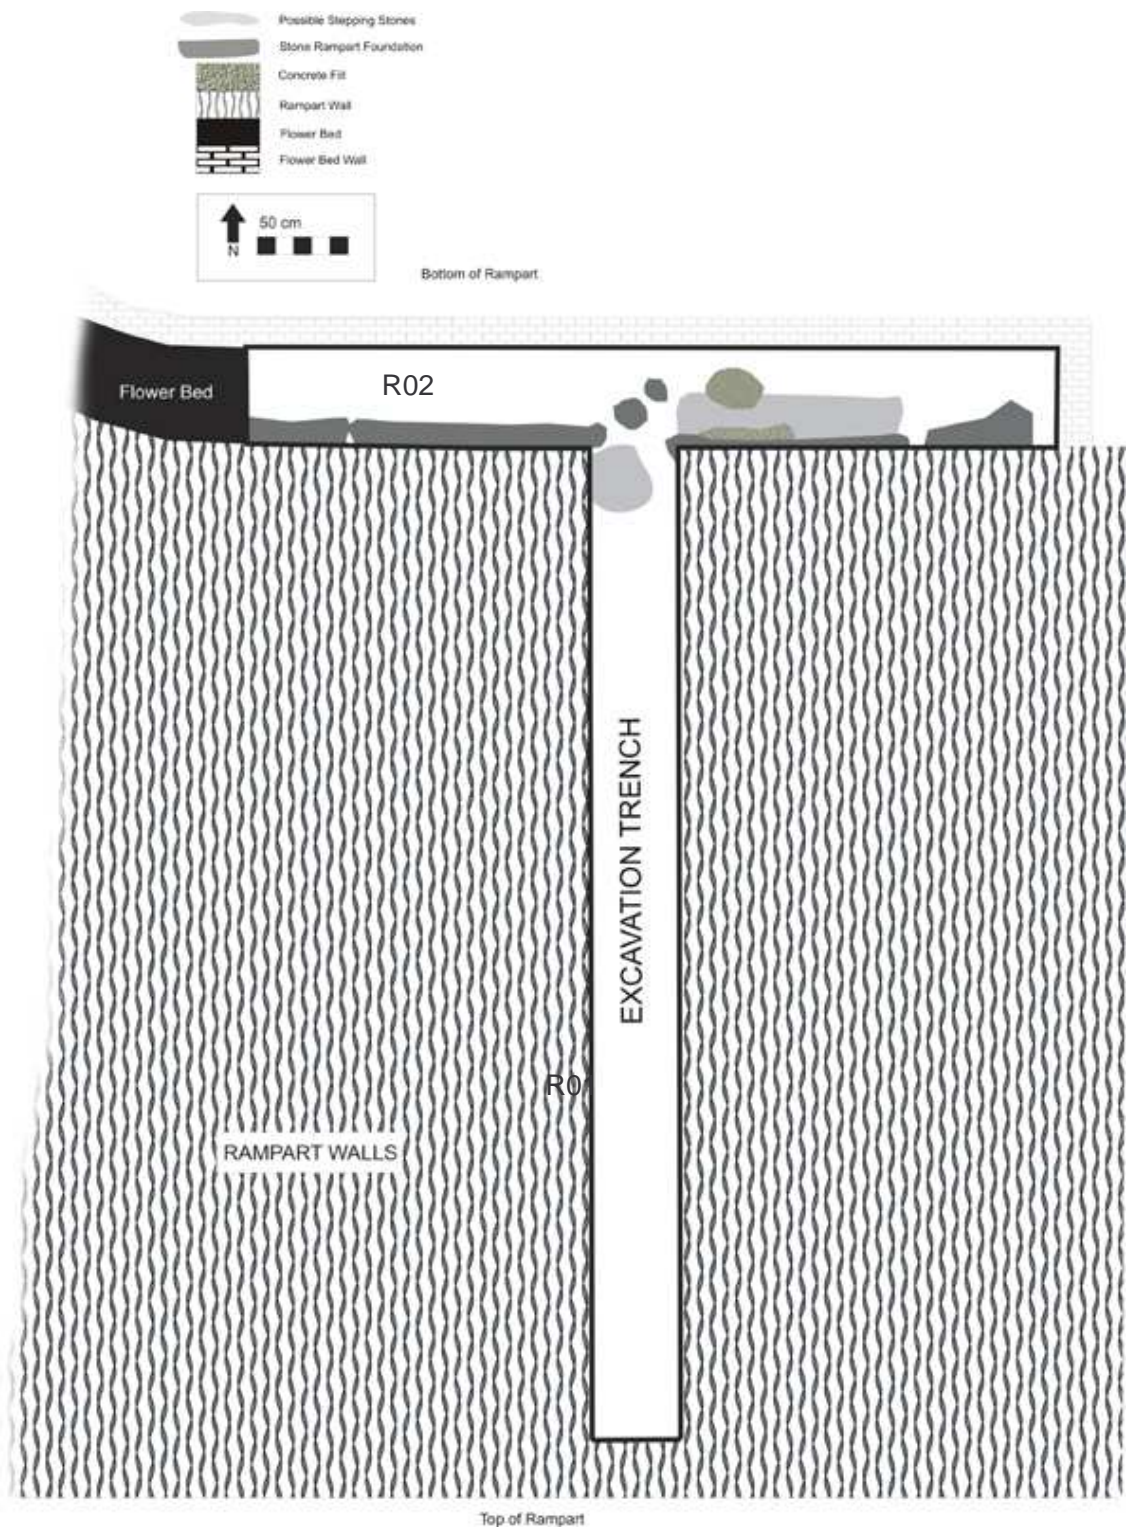
Figure 21. Plan of excavations on South-Western Rampart

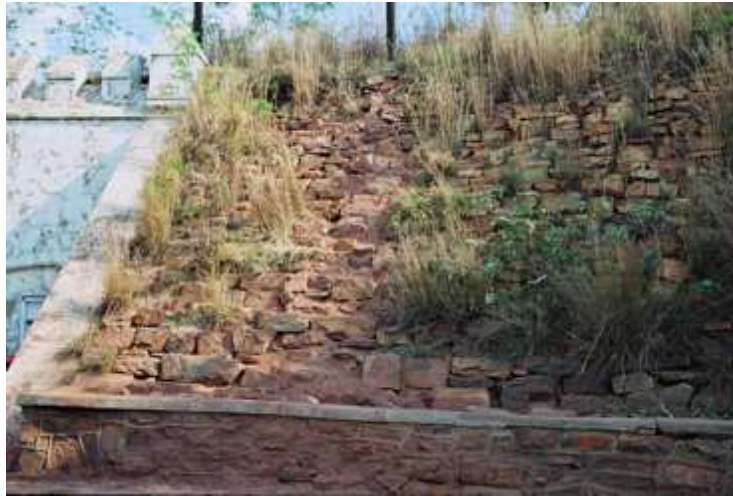
The stones were then replaced as close as possible to its original position in order to re-stabilize the rampart and to return the structure to its former appearance (Figure 22).

Figure 22. Southwestern rampart after stabilisation.

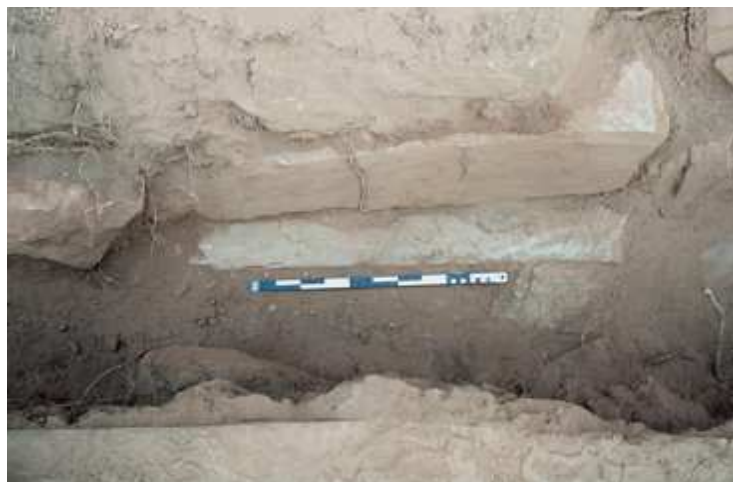
After the topsoil and soil at the base was removed the foundation structure and a possible stepping-stone, with some cement adhering, was exposed in the eastern section of the trench. The trench was excavated to the level of the foundation and the stepping-stone and these structures were photographed, documented and illustrated (Figure 23).

Figure 23. Stepping stone with cement adhering found in R02.

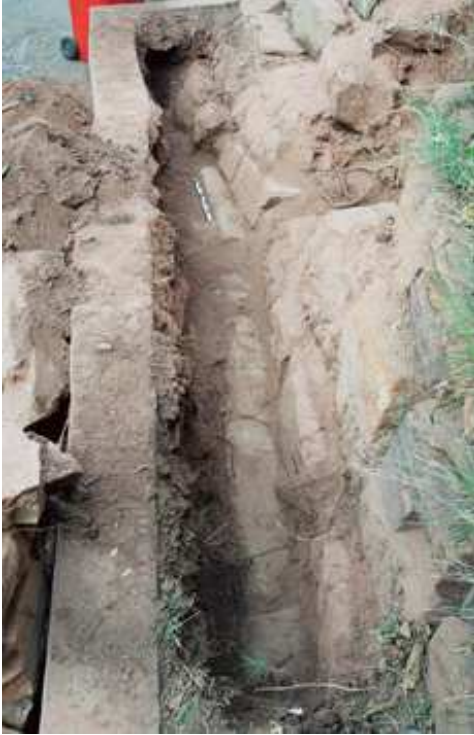
Although the flat stone in the trench closely resembles a stepping-stone it, however, is possible that this stone might be part of the foundation structure of the rampart. This question was pursued, by extending the trench, but could not conclusively be answered (Figure 24). The trench was the backfilled and stabilized.

Figure 24. R02 showing the sandstone at the base of the trench.

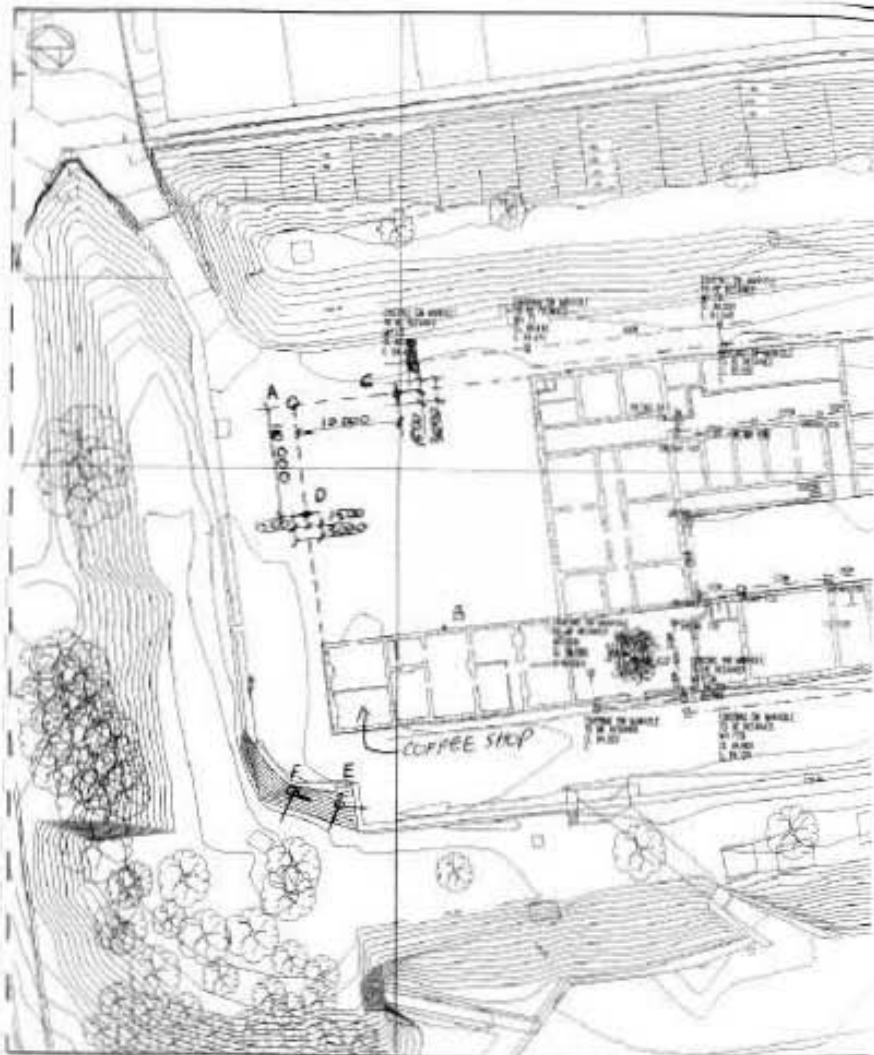
1. With reference to the attached sketch, the following methodology is proposed to carry out the exploratory trial holes on the site:
 - 1.1 Exploration for foundations
 - Mark out the imaginary line from the existing walls to meet at point A.
 - Measure back on this line for a distance of 10m each side to get points C and D.
 - Measure a line 3m long, perpendicular to the imaginary line, 1.5m each side of the line.
 - Excavate a trench approximately 600-700mm wide, 1250mm deep at C, and 1000mm deep at D.
 - Dig a 600mm square pit, 800mm deep at point B, hard up against the wall, this is to look for the damp proof course.
 - 1.2 Exploration of the Ramparts

- At points E and F, start removal of existing rock cladding about 1m wide, starting from the top of the Ramparts moving downwards until points E and F, halfway down the Ramparts have been reached.
 - Store dislodged stone where convenient for re-use.
 - Dig a slot, approximately 700mm wide into the Ramparts at E and F, about 1500mm deep (horizontally), take care to check for excavation stability during this exercise.
 - Fill in excavations and replace stone if no signs of the original material have been found.
 - If the original profile and/or steps have been found, further course of action must be decided on.
2. It is further proposed that a contingency amount of 15% of the value of the contract be allowed for which could be used for further investigation should concrete evidence be found of the foundations and rampart origins.
