Phase 1 Heritage Resource Impact Assessment
ACCESS ROAD TO ZEBETIELA ENGEN ONE-STOP COMPLEX NORTH - N1
STATEMENT WITH REGARD TO HERITAGE RESOURCES MANAGEMENT

Location - General co-ordinates: S24° 16' 53" E: 28° 59' 09"
Map reference: South Africa 1:50 000 2428 BD.

The development will involve the construction of a 6 m wide gravel road within a 15 m wide road reserve. The road will be constructed from the N11 and will run parallel to the N1 highway over a distance of approximately 3 km to the Zebetielia Engen One-Stop Complex North.

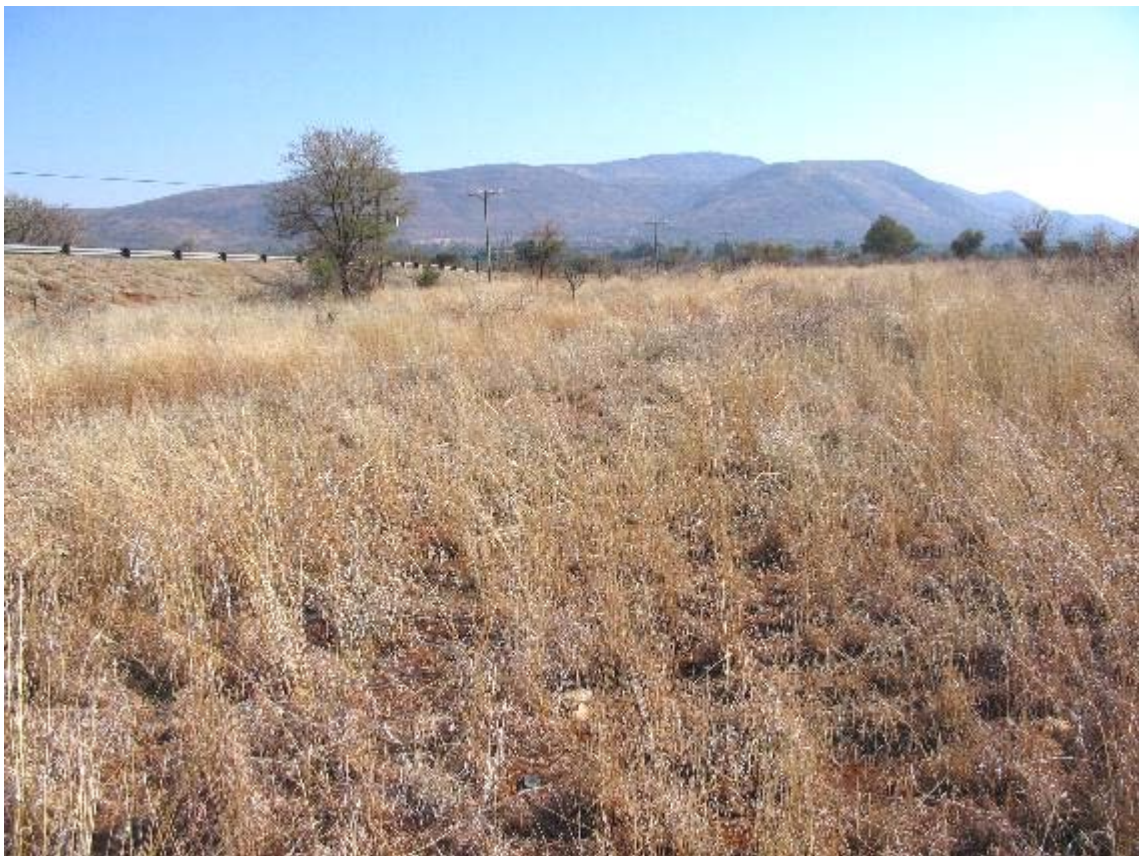
Fig 1. General view of the entry point along the N11.

The development will involve the construction of a 6 m wide gravel road within a 15 m wide road reserve. The road will be constructed from the **N11** (Fig 1) and will run parallel to the

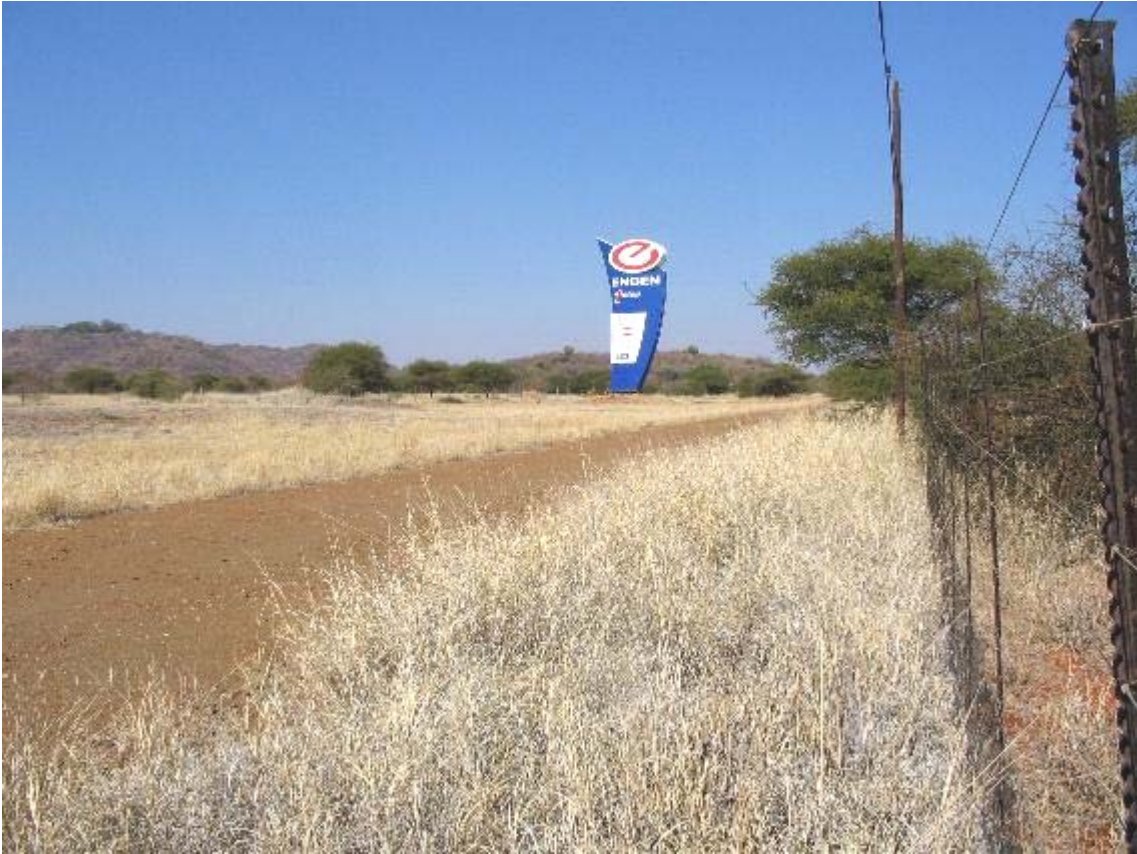
Fig 2. General view of the end point at the Engen One Stop.

N1 highway over a distance of approximately 3 km to the Zebetela Engen One-Stop Complex – North (Fig 2). The entire area had been ploughed in the recent past and is ecologically severely degraded. The terrain is now mostly overgrown by pioneer plants such as *Dichrotachys* (Fig 3) and other acacia species.

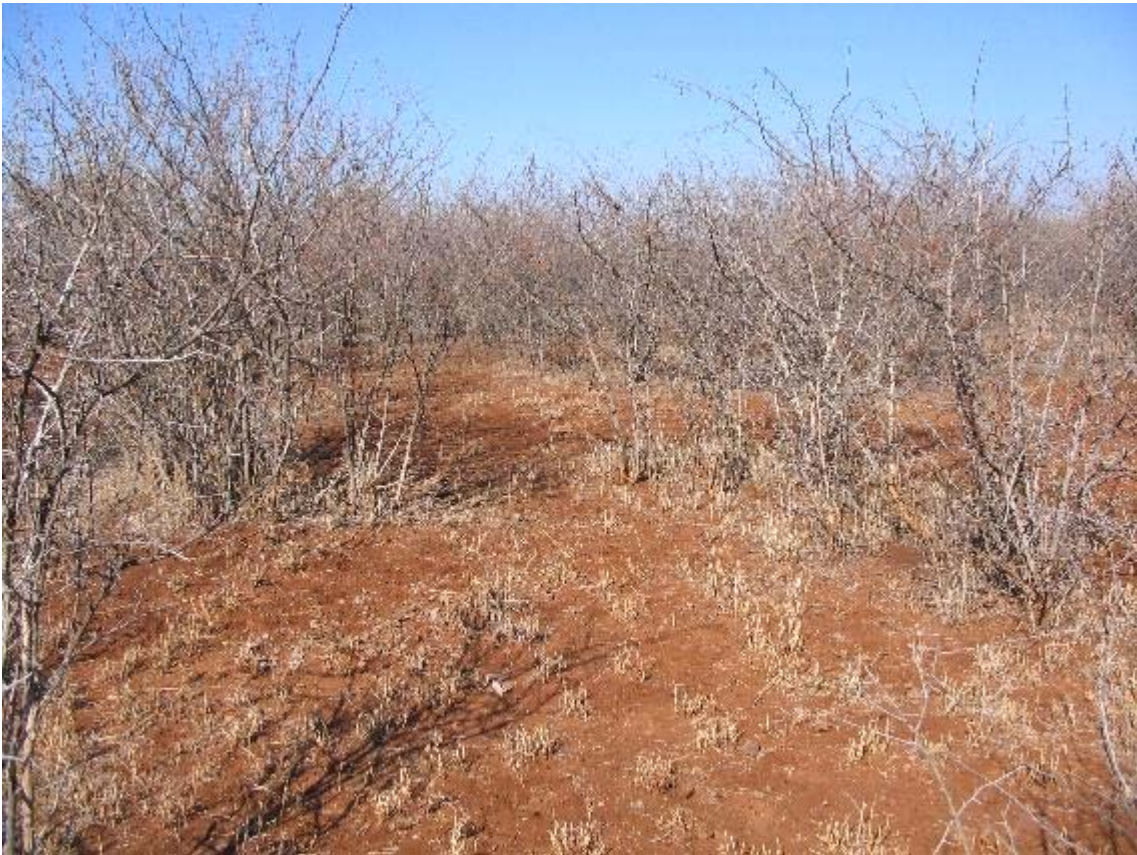
Fig 3. View of the dense vegetation in most areas.

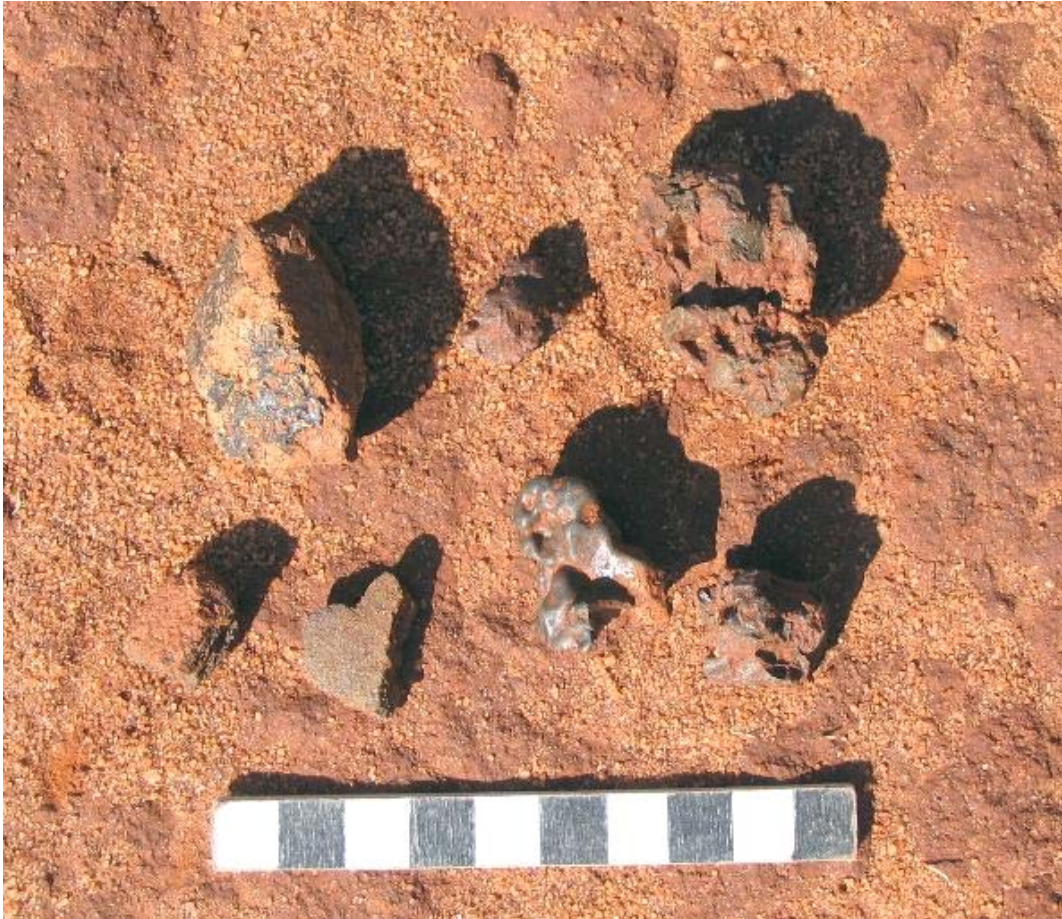
A low concentration of non-diagnostic pottery fragments was recorded at co-ordinates: S24° 17' 07.3" E28° 58' 56.8 (marked **1** on the locality map). No other signs of archaeological material or deposits were observed. A second concentration of pottery fragments, together with pieces of metal slag (Fig 4) was recorded at co-ordinates: S24° 16' 31.5" E28° 59' 28.2 (marked **2** on the locality map). Both areas recorded above have been severely disturbed by the construction of the N1 and site 2 has been extensively ploughed.

Site 1 is not regarded as significant, but site 2 may still contain adequate archaeological material to at least enable the identification of the cultural group and to place it within the cultural sequence of the area. It therefore has scientific significance. The low frequency of metal slag combined with the pottery probably represents an ironsmith activity in or very close to a pre-colonial village settlement.

Fig 4. Metal slag and potter fragments at Site 2. (Scale in cm.)

In view of the above, it is recommended that an archaeologist be present to monitor the initial earthworks for the road construction at **Site 2** in order to assess the significance of any archaeological material or deposits exposed during the process. The outcome may result in further mitigation measures being implemented.
