## **AFRICAN HERITAGE CONSULTANTS CC**

11 September 2005

### **SURVEY OF OLD COPPER MINES ON THE PROPOSED ROUTE FOR THE NEW ROAD TO SWARTKOPFONTEIN BORDER POST**

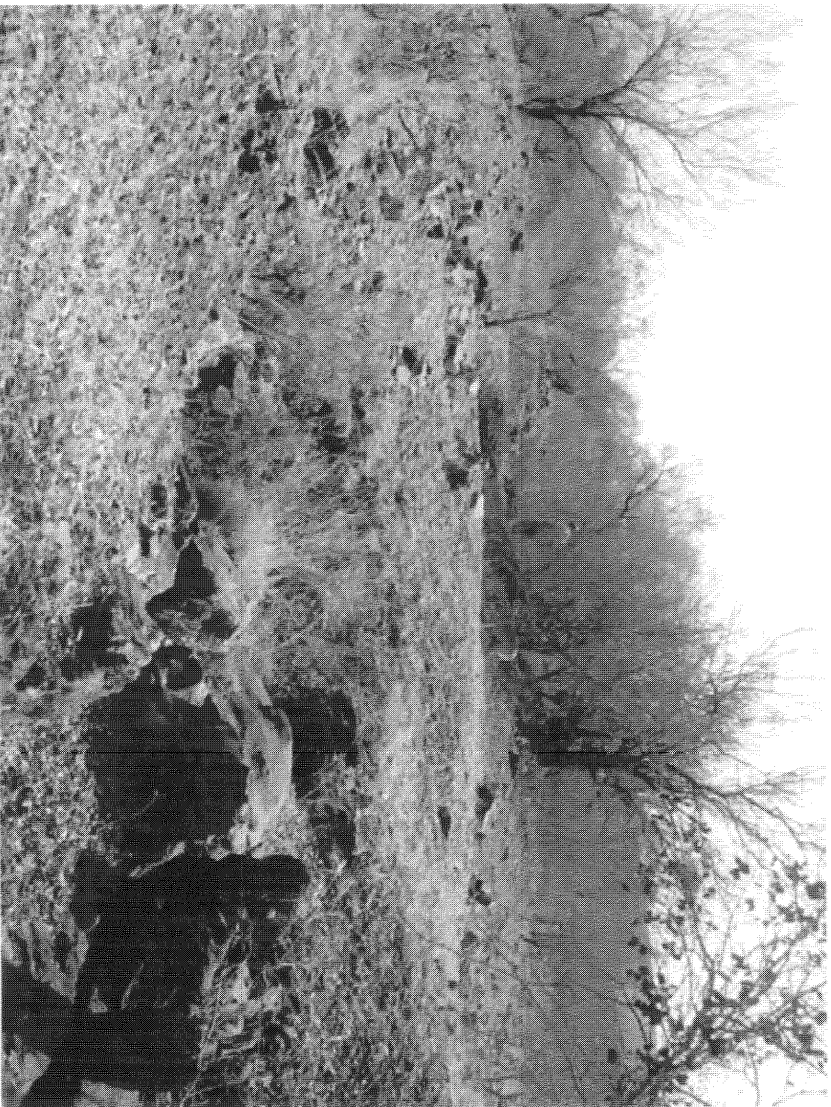
This old mine is just south of marker NW 39 and is one of the largest of the old mines. It has one open shaft, which leads underground, and another two or three shafts, which were probably closed with rubble (see photograph 1 & 2).

**No. 1 General view of ancient workings at S24° 51' 13.1" and E25° 55' 27.3"**

Depending on the costs involved there are two options.

To reroute the proposed road in a northerly direction to avoid the ancient mines,

To document, survey and excavate the mining sites, which will be destroyed by the road. Here after the South African Heritage Resources Agency (SAHRA) can issue a permit for destruction

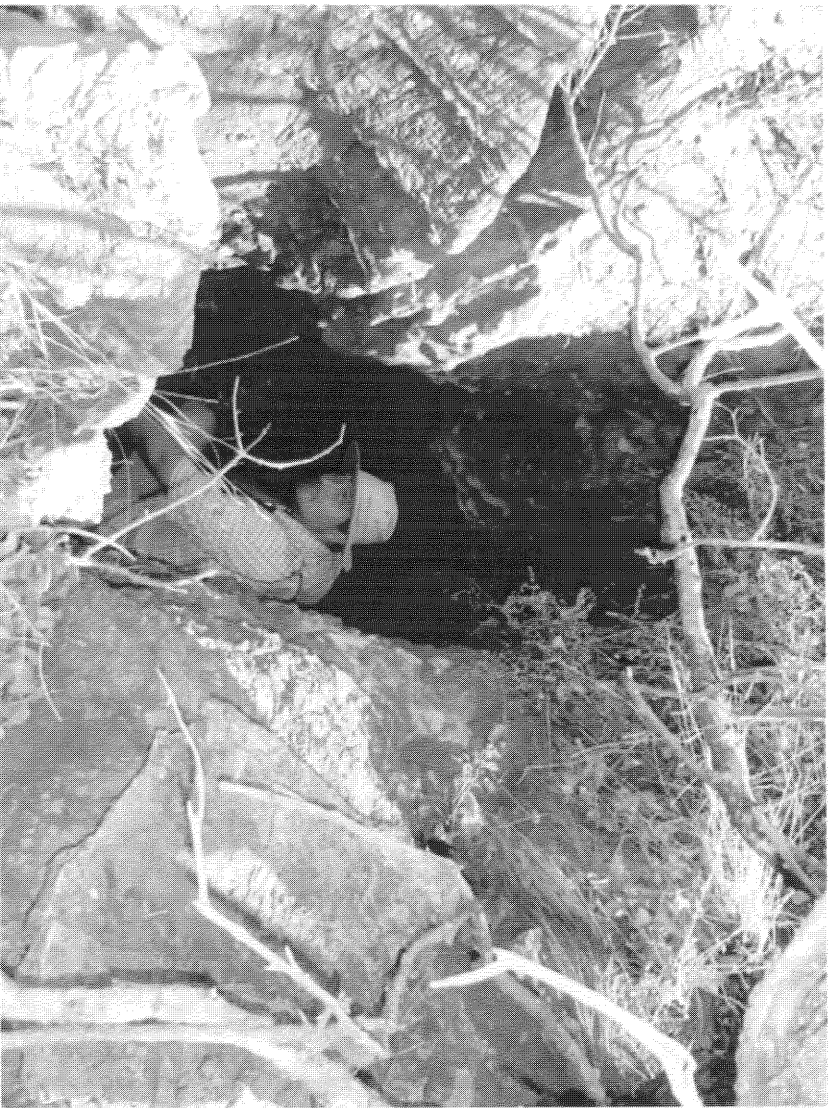
**No. 2 Shaft entrance of ancient mine**

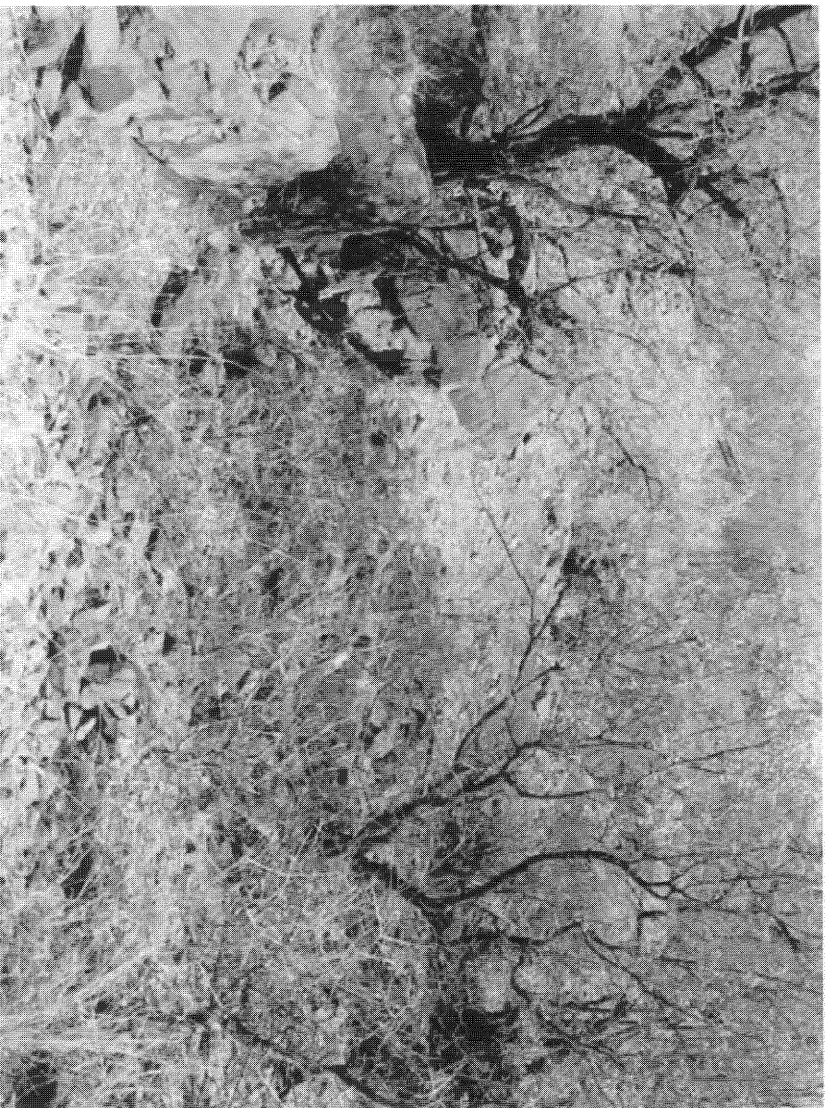
This mine is as large as the above mentioned mine. At the entrance of the one shaft are two wooden poles to prevent the entrance from collapsing (see Photograph 3 & 4). The mine is near marker NW 32.

**No. 3 General view of mine at S24° 50' 42.8" and E25° 56' 35.8"**

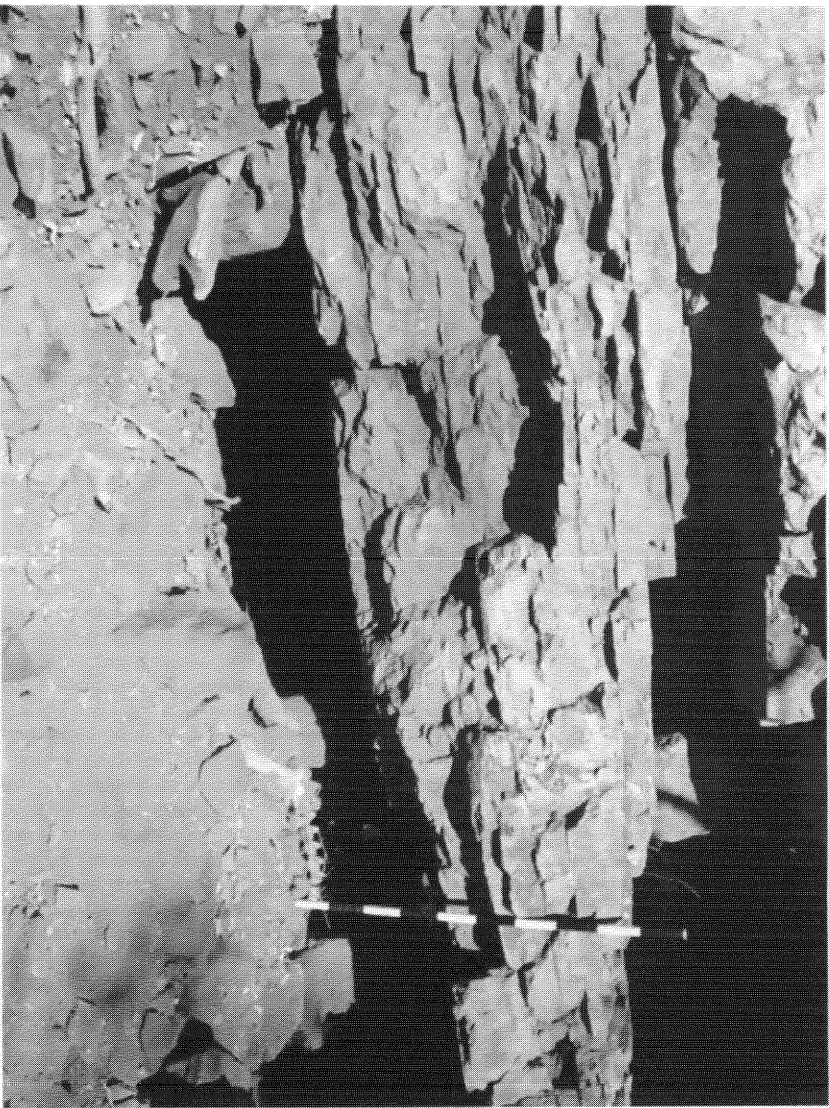
In the case of the mine discussed under 2.2 the mine was later reworked for prospecting purposes as the two wooden poles at the entrance to the mine were cut with a modern saw.

No. 4 Shaft entrance with two wooden poles supporting rock

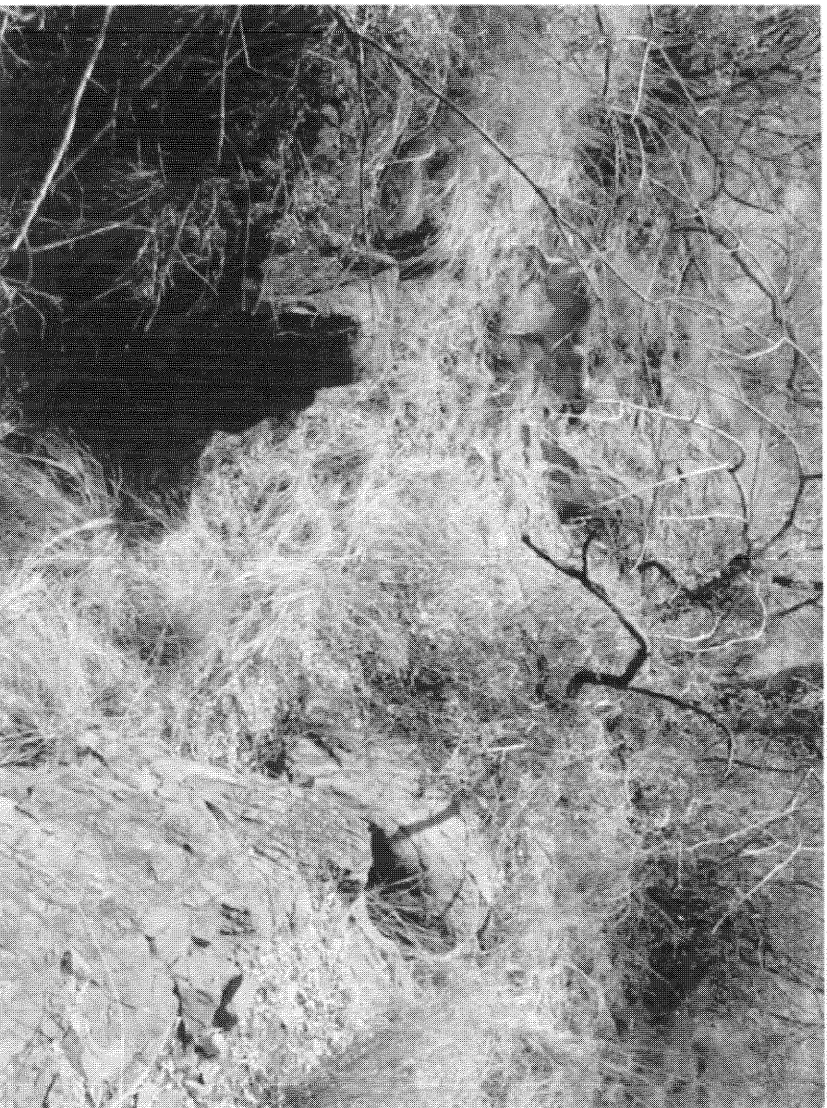
The mine at this site consists of six shallow depressions, but is not as deep as the two previous mines. The mine lies east and south of marker NW 30 (see photograph 5).

No. 5 General view of ancient working at S24° 50' 31.5" and E25° 56' 57.8"

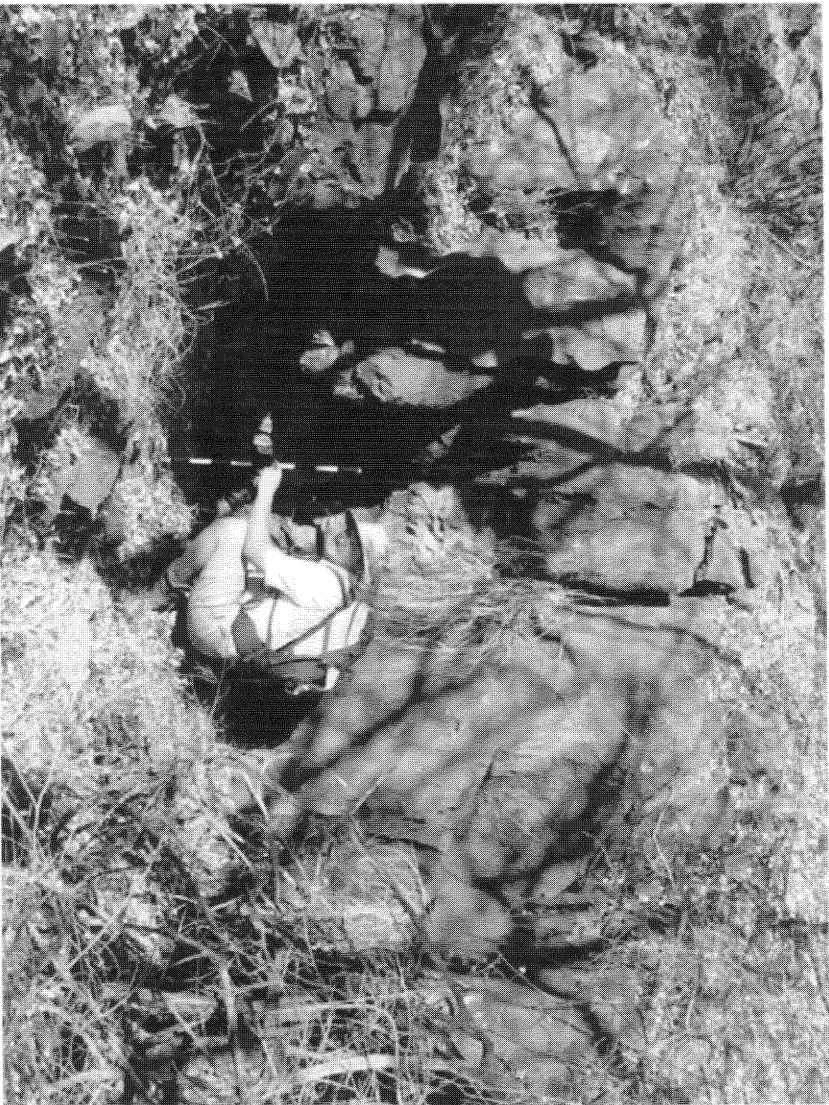
Another mine lies just south of marker NW 34 (see photograph 6).

No. 6 Entrance of ancient mine at  $S24^{\circ} 50' 51.1$  and  $E25^{\circ} 56' 16.6''$

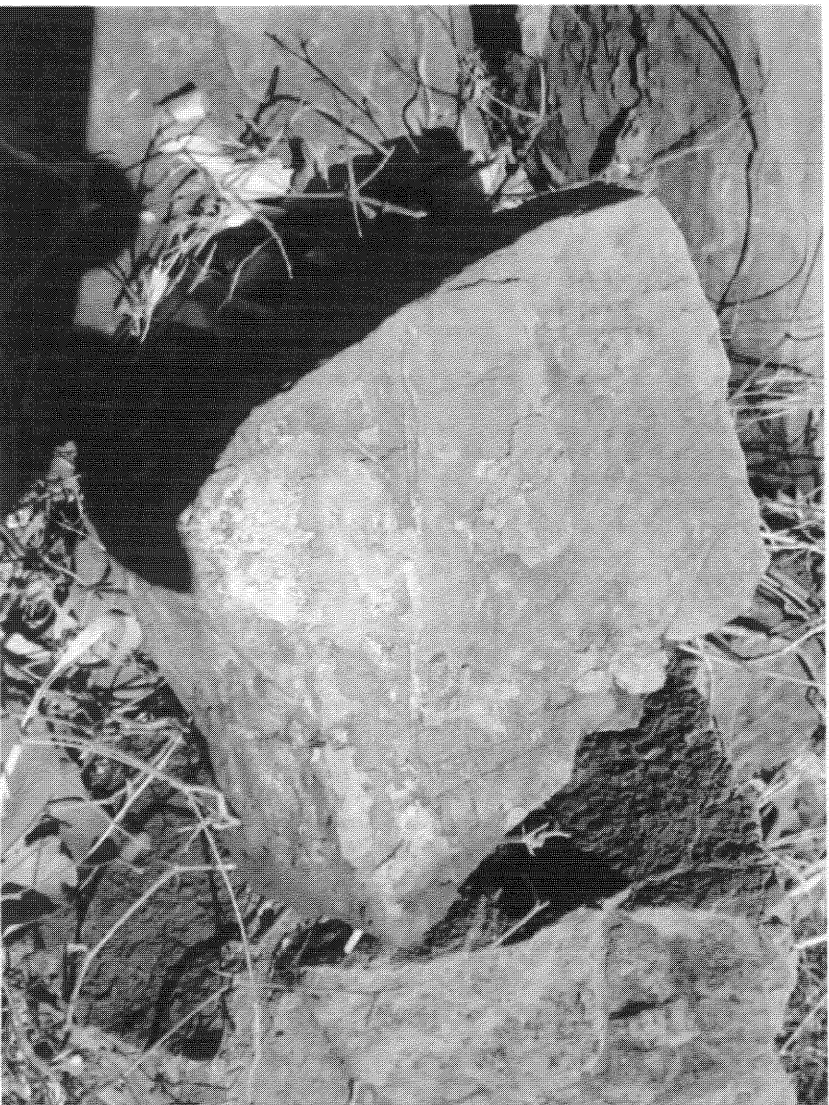
From the investigation it is clear that these mines are prehistoric or ancient copper mines. Small pieces of copper ore were found (see photograph 7), as well as two types of stone hammers (see photograph 8 & 9). The technique of mining and back filling is typical that of ancient mines. Pieces of undecorated pottery also occur on the sites. To my knowledge these mines stretch for a distance of fifteen kilometres all along the Dwarfsberg.

No. 7 Copper ore (malachite)

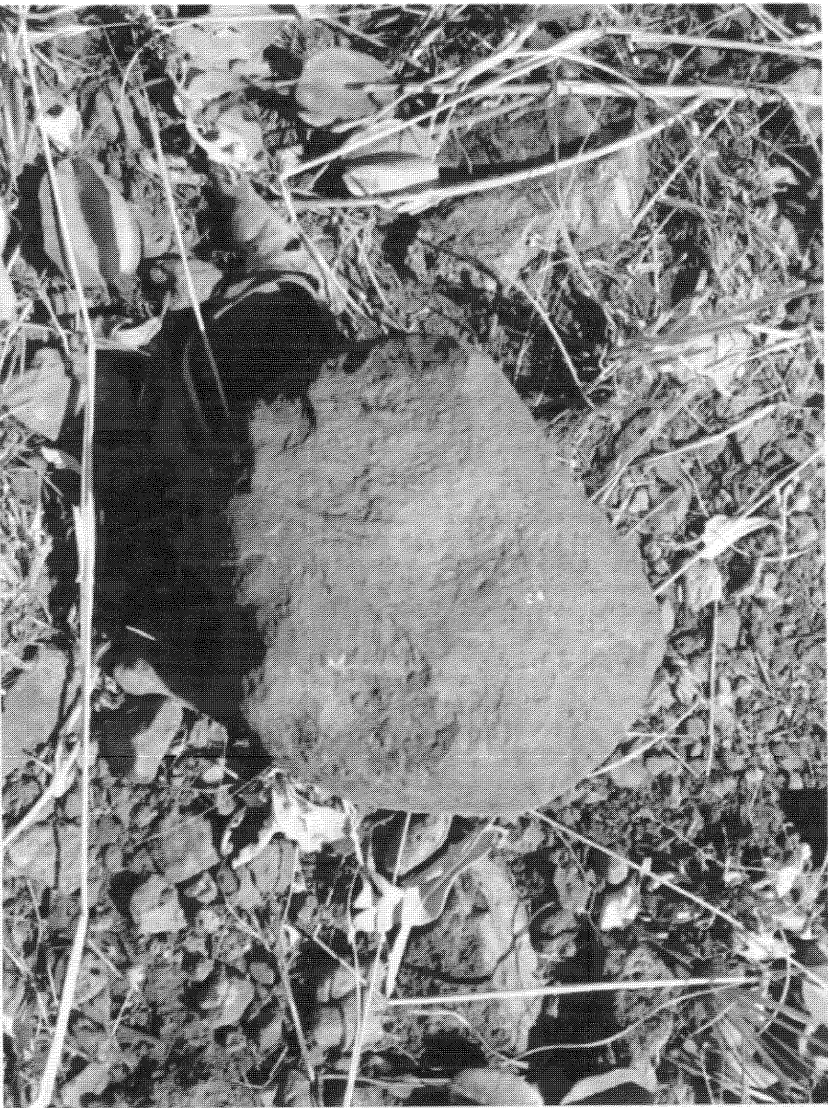
**No. 8 Stone hammer with shallow depression in the middle caused by iron chisel head**

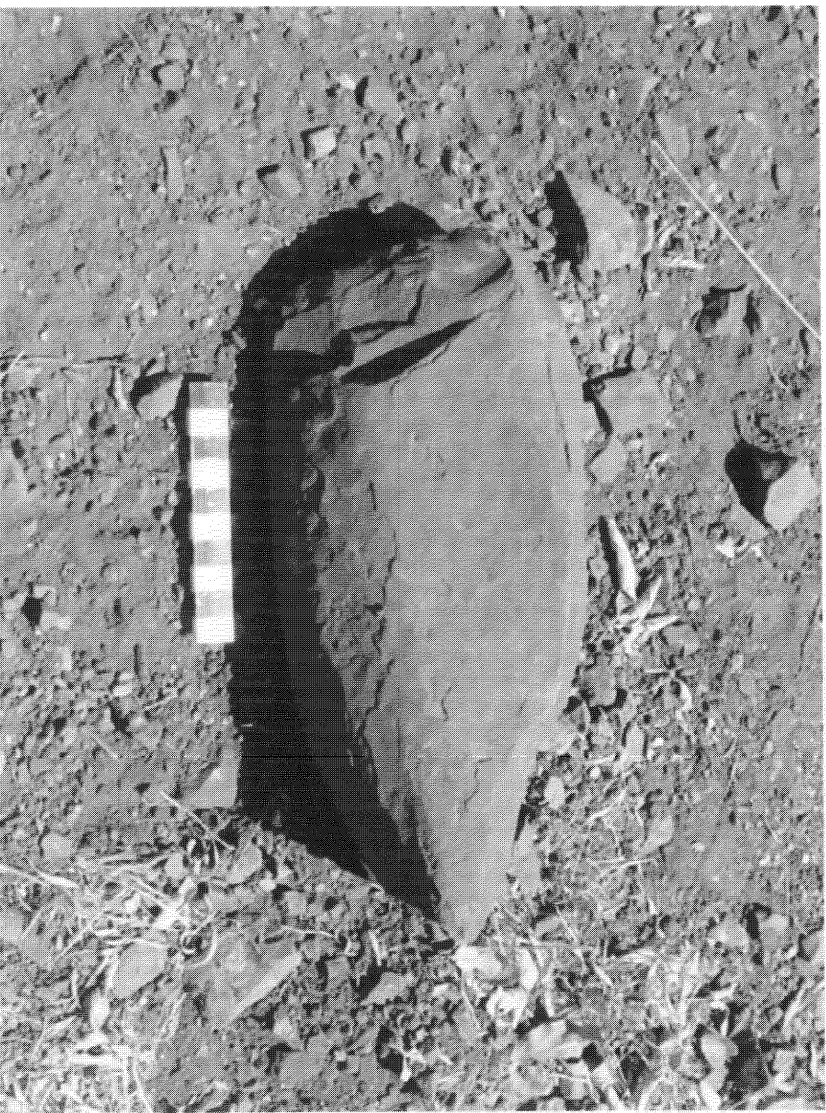
**No. 9 Stone hammer used to break rock face**
