NWANEDI-LUPHEPHE

Environmental Impact Study: Phase 2

**ARCHAEOLOGICAL
SURVEY**

NWANEDI - LUPHEPHE ENVIRONMENTAL IMPACT
STUDY: PHASE 2
ARCHAEOLOGICAL SURVEY

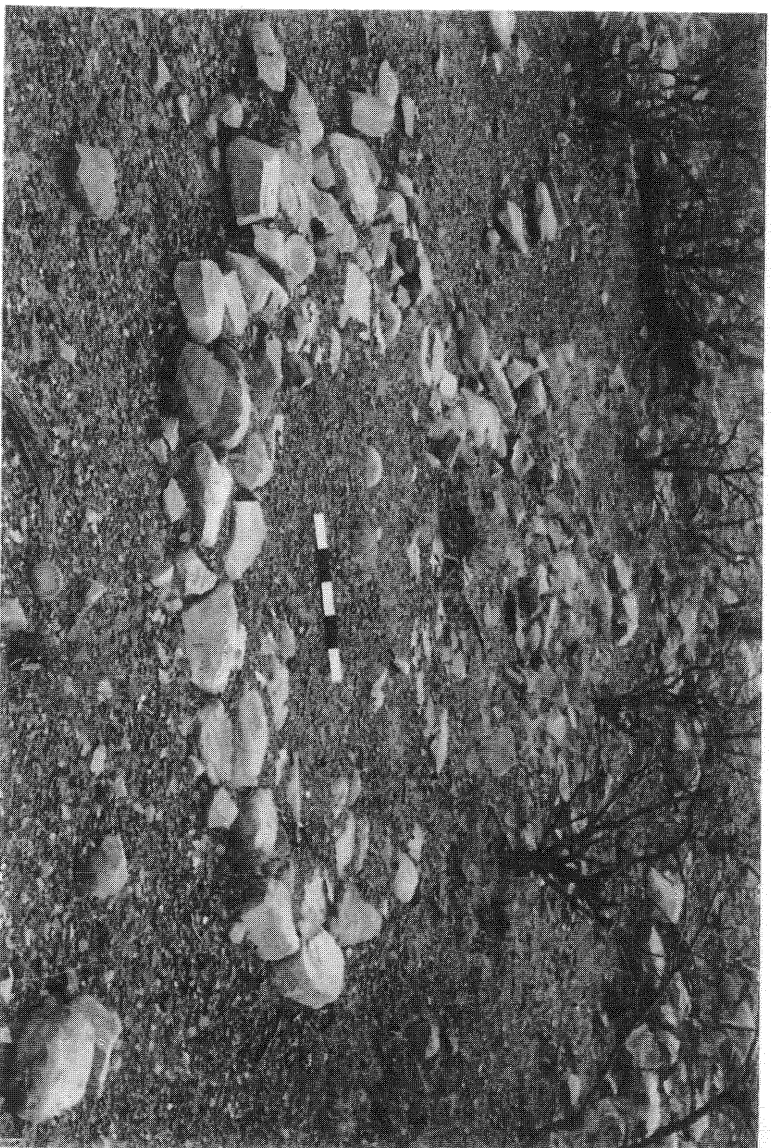
Plate 1. Circular Stone Floors

An archaeological site was found on the hill top. The site consists of a number of features such as three, possibly four, circular stone floors (*plate 1*), a banded iron stone outcrop which was probably mined in pre-colonial times (*plate 2*), collapsed stone walling forming terraces (*plate 3*), and numerous fragments of pottery (*plate 4*). A spindle whorl (*plate 5*) was also found. Excavations will certainly reveal more settlement deposits. The southern foot of the hill also contains archaeological remains.

The pottery is fragmented, but nevertheless could tentatively be identified as two separate traditions namely Moloko (13th - 15th century Sotho-Tswana) and Khami (15th - 16th century Zimbabwe [Shona]). This is a historically significant site and may not be damaged.

Significance: High.

Recommendation: *That the reservoirs be placed on an unobtrusive place on the northern side of the hill and that the pipeline be routed accordingly.*

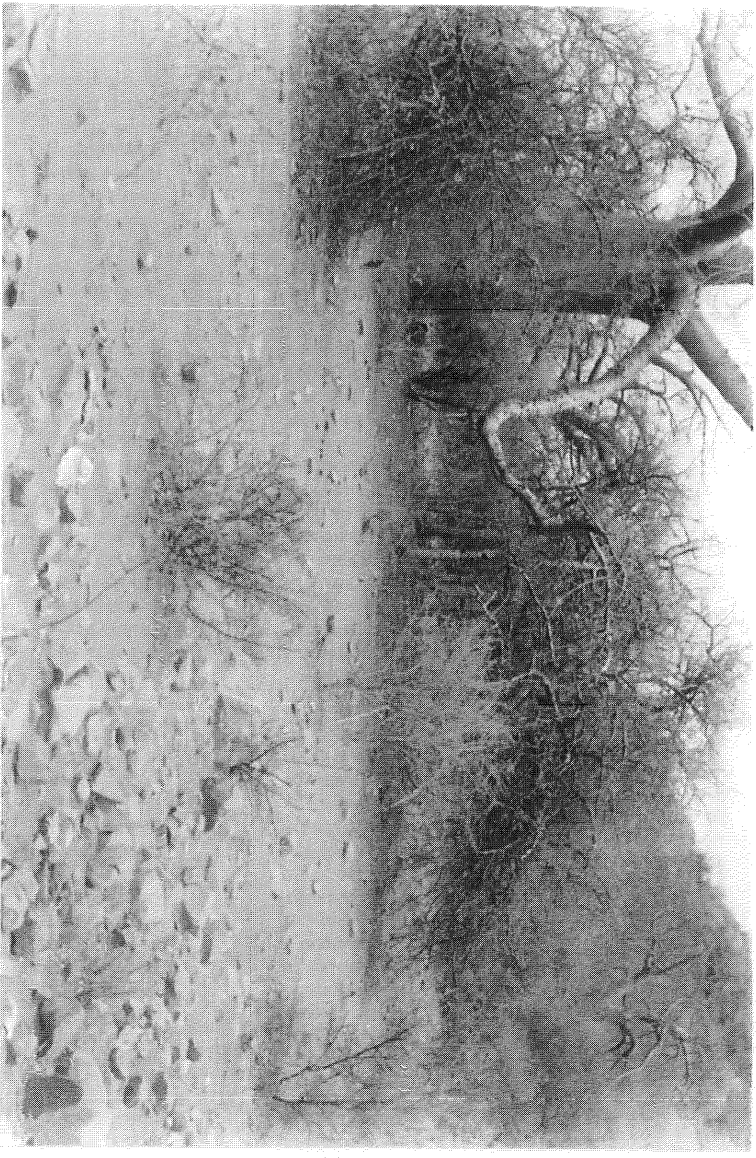
Plate 6. General View of Hill Top

An archaeological site was found on the plateau of the hill where natural terracing occurs (*plate 6*). This site produced pottery as well as slag (*plate 7*) from metalworking activities. The pottery (*plate 8*) is classed as Khami (15th - 17th century) and Letaba (Venda) traditions.

Significance: High.

Recommendation: *That the reservoir be placed at the furthestmost eastern side of the hill.*

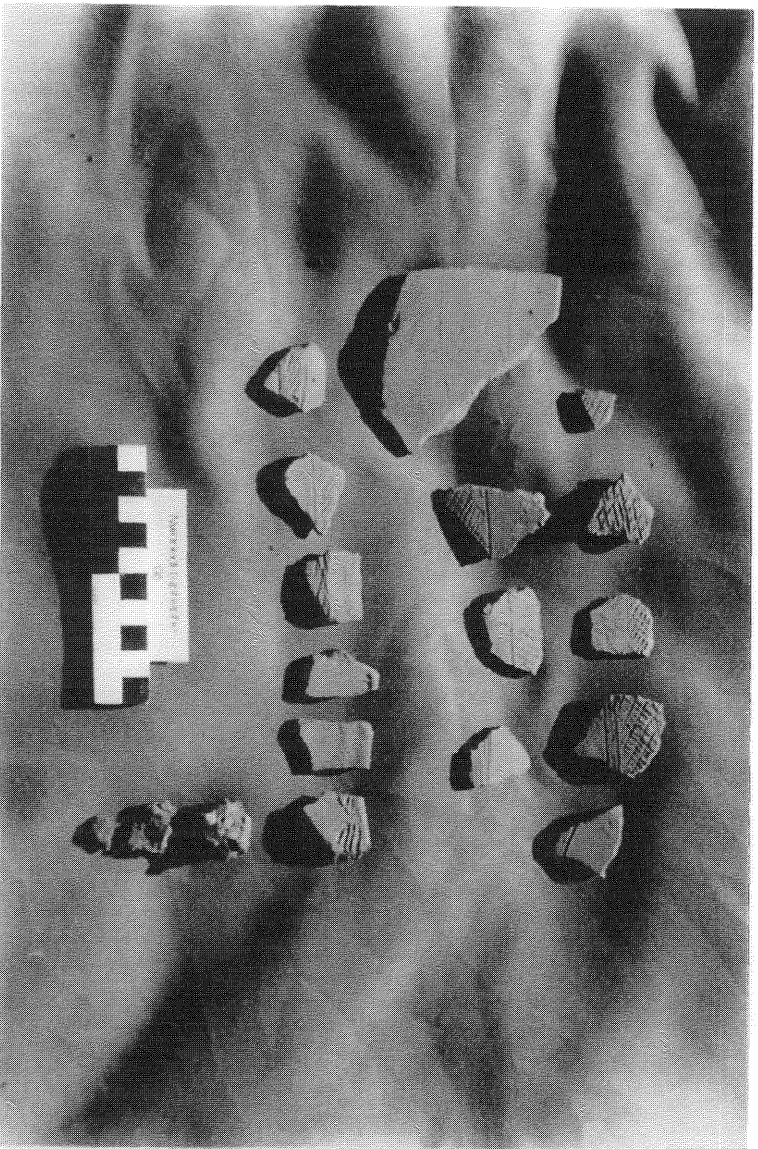
Plate 9. Pottery Fragments

An archaeological site was located next to the road that will be intersected by the pipeline. The site extends up the slope to an elevated flattened area which has been ploughed. Cultural remains found include pottery, metalworking slag, hut debris and grinding stones. Three different pottery traditions (*plate 9*) were tentatively identified, namely Eiland (11th - 13th century), Moloko (13th - 15th century), and Khami (15th - 17th century). This site has been degraded to a large extent and it seems that the only part still intact is the section where the pipeline will pass through.

Because of the interaction and overlapping between the different traditions, this site may be of significance in understanding the pre-colonial history of the region.

Significance: High.

Recommendation: *This site must be mitigated with the aim of a possible Phase 2 excavation. It is recommended that the archaeologist be allowed time to inspect and record the deposit when the trench is excavated. Should a significant deposit be found, a standard excavation must be commissioned by the developer.*

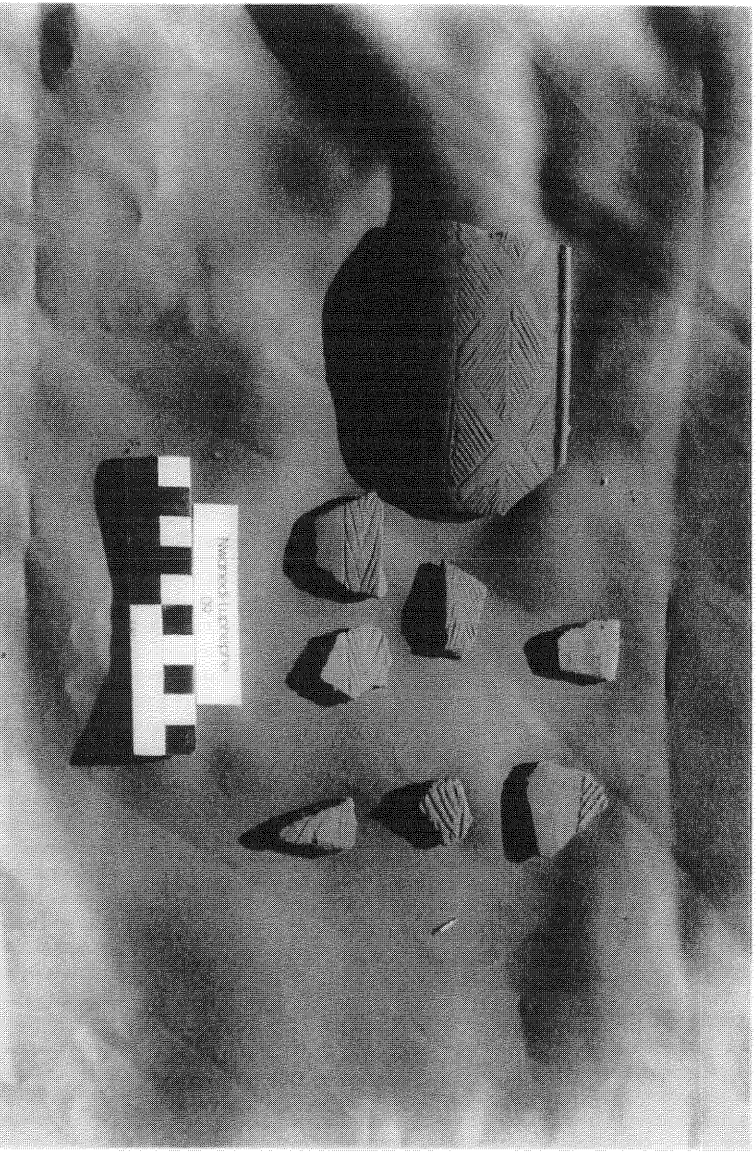
Plate 10. Pottery Fragments

An archaeological site was located immediately west of the Tshivongweni Township. Cultural remains consist of pottery, middens and hut debris. The pottery tradition (*plate 10*) found here is Khami (15th - 17th century). This site is significant as it probably represents a commoner settlement of the Khami (Zimbabwe) culture.

Significance: High.

Recommendation: *That this site be avoided during construction of the pipeline and not be damaged.*

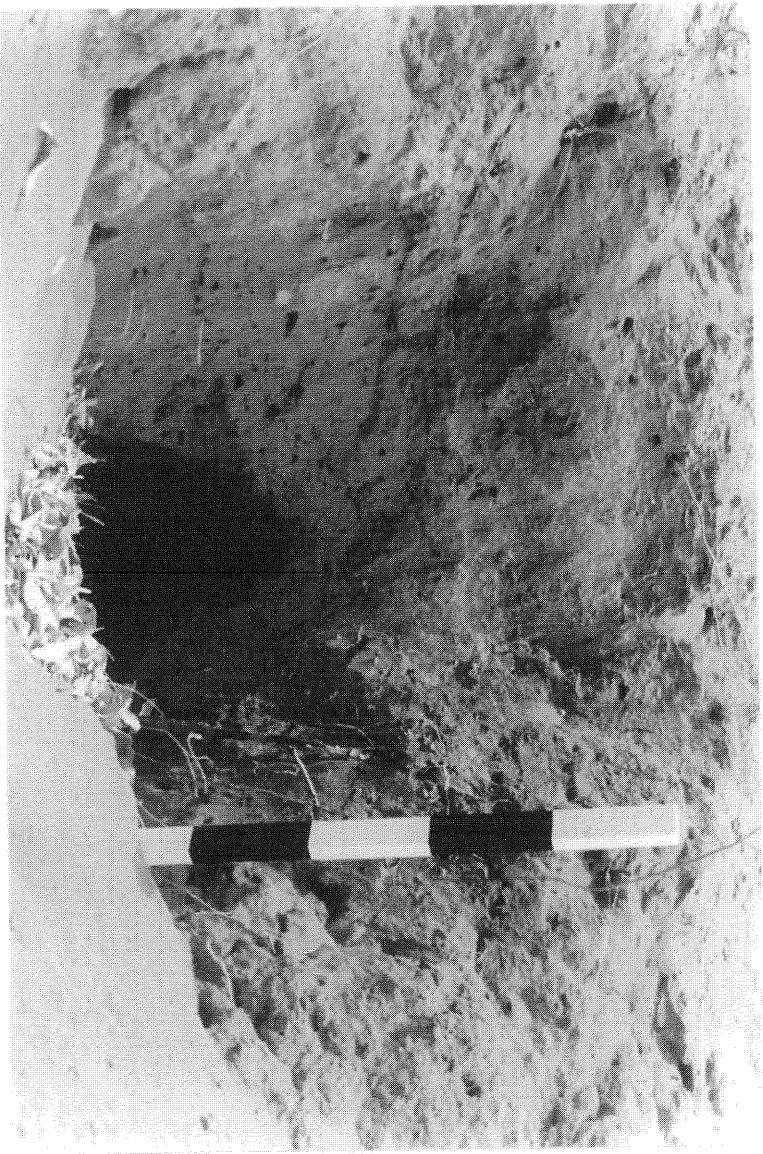
Plate 11. Ash Deposit

An archaeological site was found on the southern slope of Tshivongweni hill. It is in the process of being eroded. The site contains dung and ash deposits, and pottery. A charcoal sample was taken from one of the ash deposits and delivered to the CSIR for C₁₄ dating (plate 11). The pottery (plate 12) has both Khami and Letaba characteristics.

Recommendation: This site is probably higher up the slope than the proposed location of the reservoir, but action should nevertheless be taken not to disturb it.

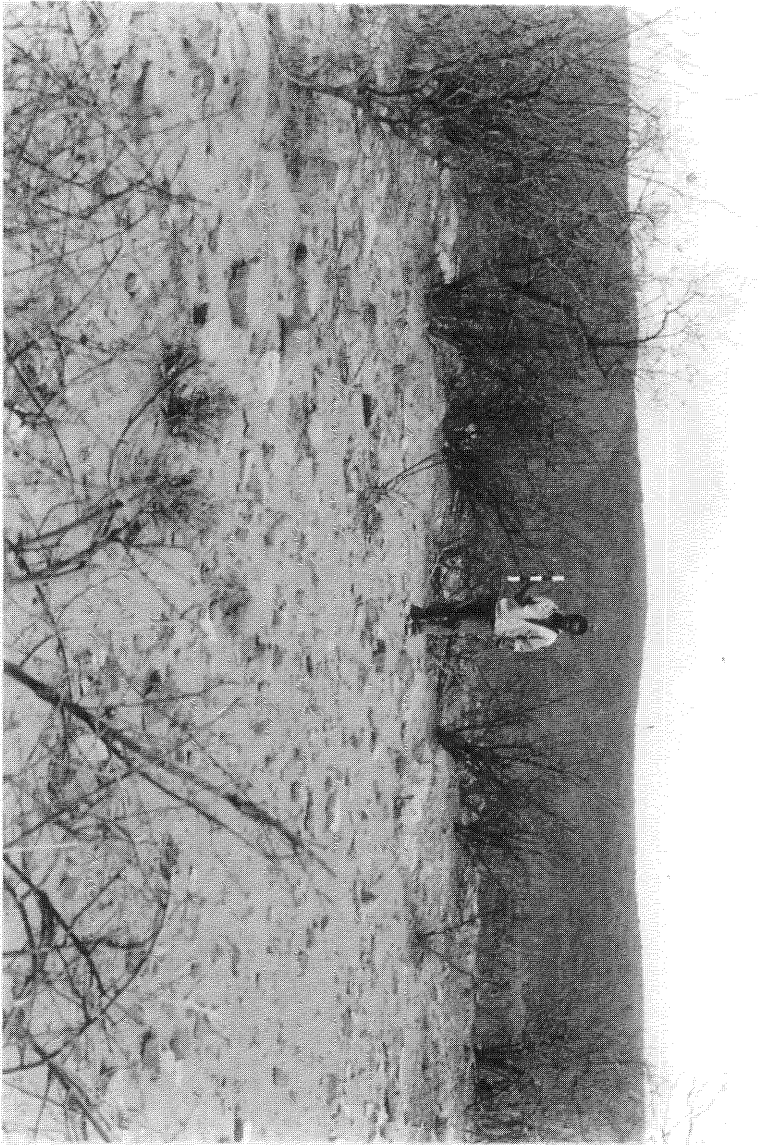
Plate 13. The Hill Top

The proposed reservoir is located on the plateau (*plate 13*) where a few potsherds were found. The pottery (*plate 14*) has Khami characteristics but due to the low density of remains, the site is not regarded as significant.

Significance: Low.

Recommendation: *That the reservoir be placed on the eastern side of the hill.*

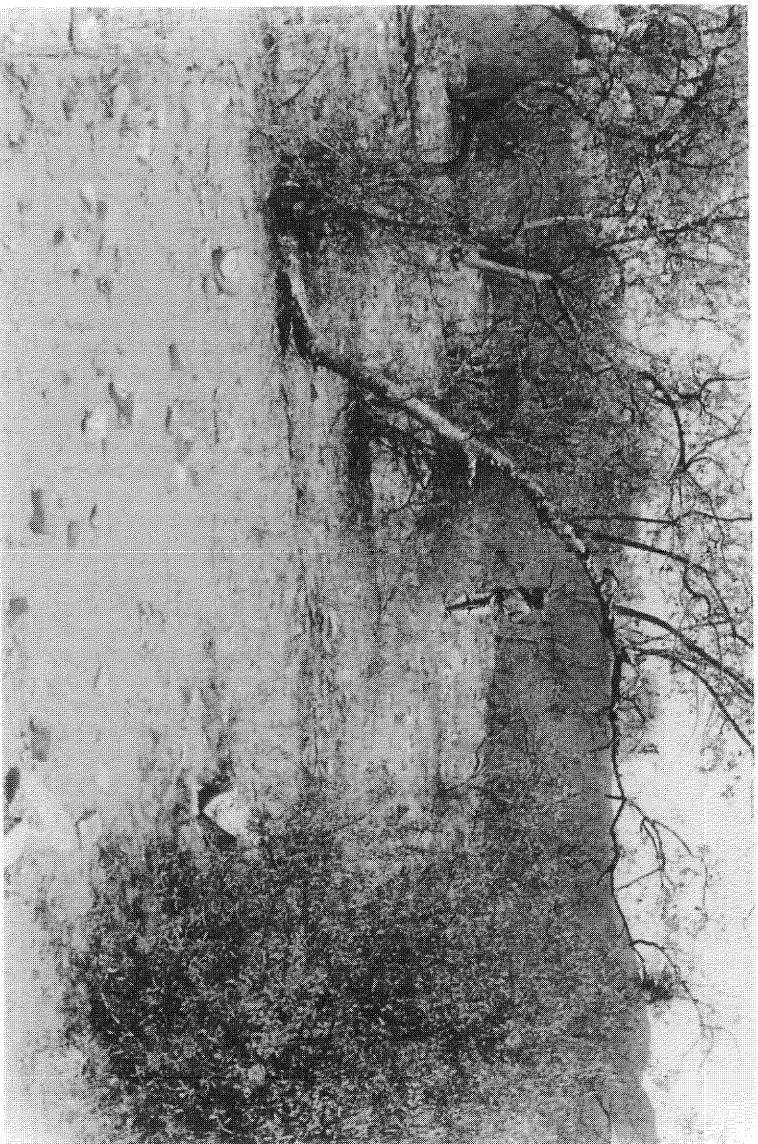
Plate 15. The Hill Top

An extensive archaeological site is located on the plateau (*plate 15*) which dates from relatively recently to the 15th/16th century. A cattle enclosure could be identified (*plate 16*) and remains of stone-walling occurs (*plate 17*). The pottery falls within the Khami (15th - 17th century) and Letaba (Venda) traditions (*plates 18 & 19*) The northern part where the older deposits seem to occur, has been eroded.

Significance: High.

Recommendations: *That the reservoir be placed on the extreme north-western side of the plateau.*

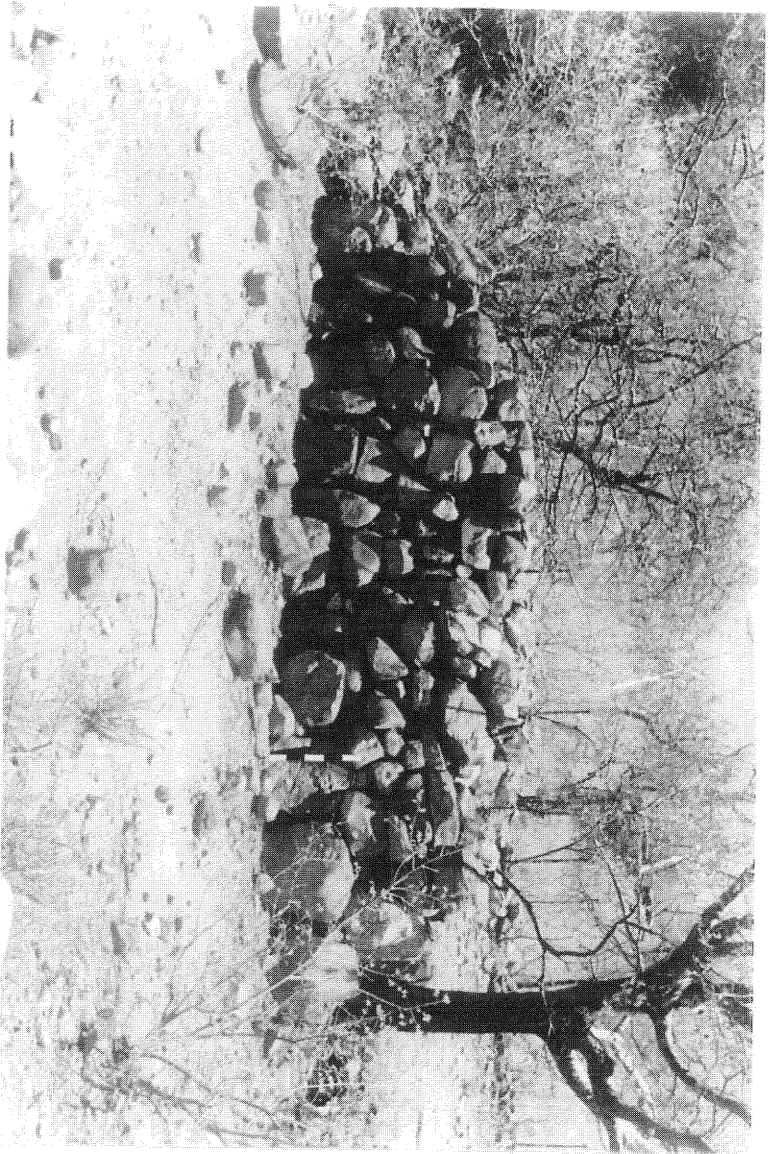
Plate 20. Remains of Stone-walling

The remains of stone-walling (plate 20) is located here and although the ruin was built within living memory, it should not be damaged, but left as part of the heritage of that area.

Significance: Low.

Recommendation: *That the reservoir not be placed in the immediate vicinity of the stone wall and that the pipeline should follow a route within a safe distance.*
