AFRICAN HERITAGE CONSULTANTS CC

30 NOVEMBER 2005

CULTURAL HERITAGE RESOURCES IMPACT ASSESSMENT OF PORTION 5 OF DONKERPOORT 406 KR MODIMOLE

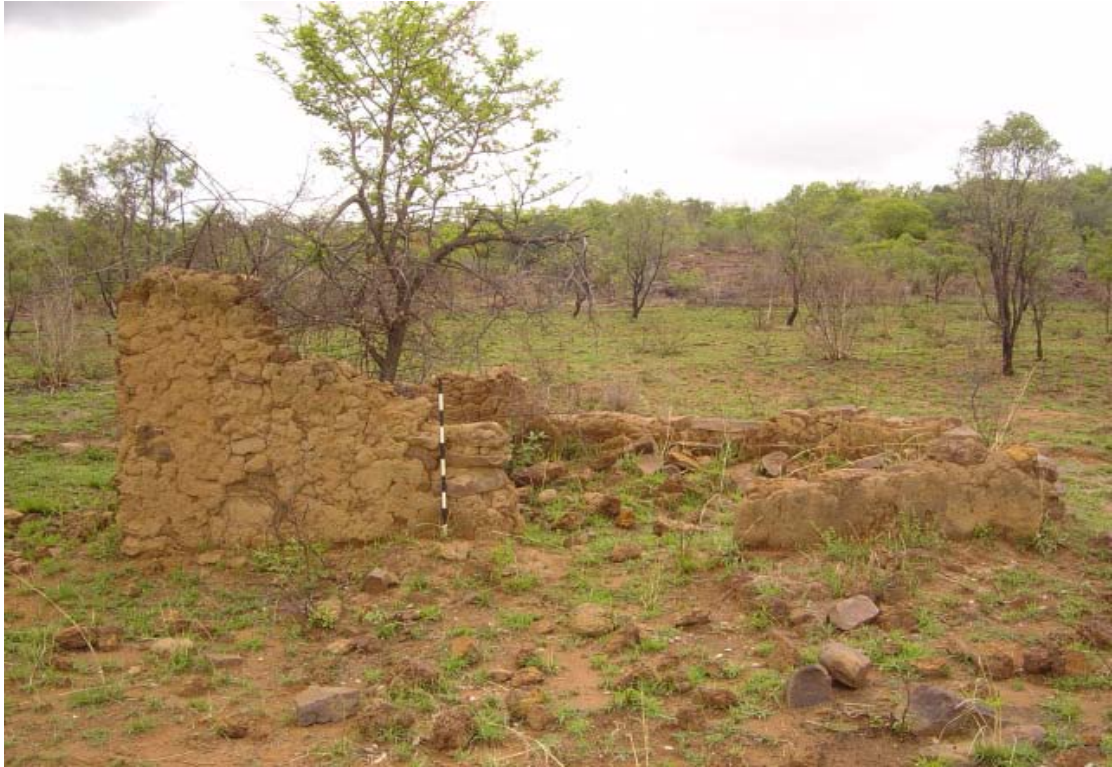
No. 1 Remains of farm workers house

When the farm was sold in 2001 all the farm workers left the farm. Remains of farm worker houses were found at the following localities:

S24° 39' 11.3"	E28° 20' 08.5"
S24° 39' 26.2"	E28° 19' 44.6" (see photograph 1)
S24° 39' 33.3"	E28° 19' 43.4"

These remains are all relative young and thus do not fall under the protection of the National Heritage Resources Act No. 25 of 1999.

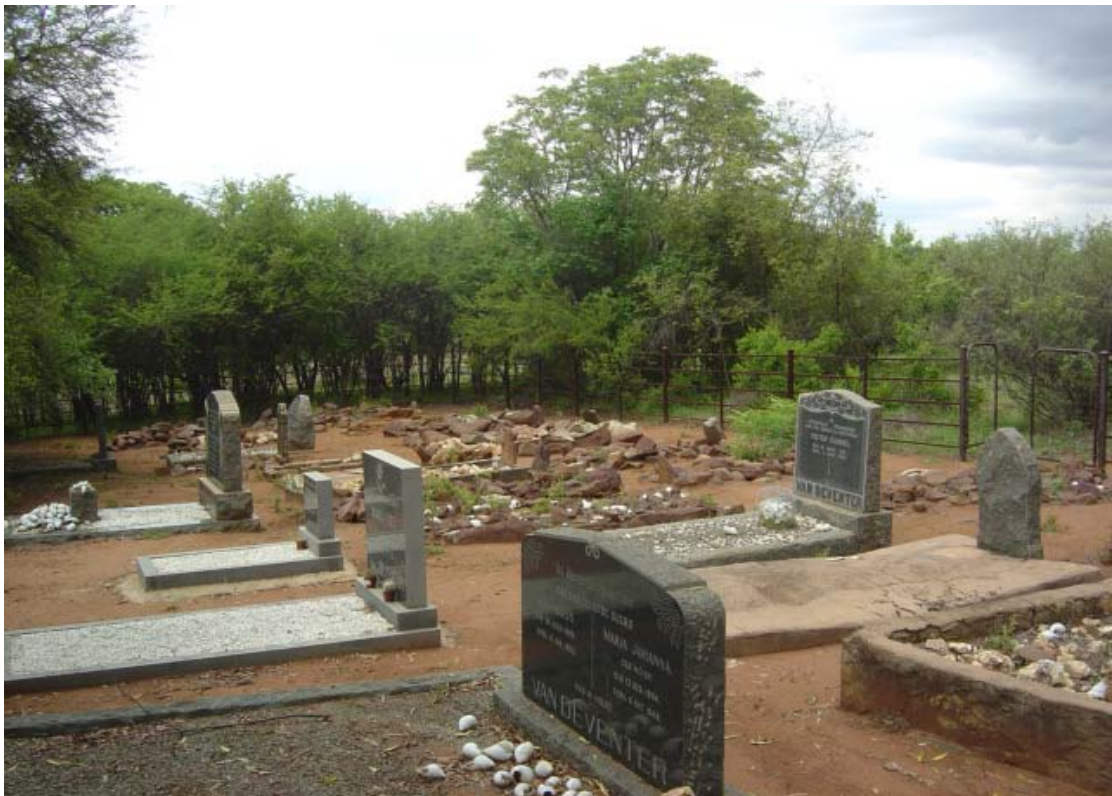
No. 2 Cemetery

The Van der Venter cemetery is situated at S24° 39' 37.4" and E28° 19' 22.9". In total there are thirty-three graves in the cemetery of which 50% are unmarked. The oldest marked graves date back to 1921. Some of the unmarked graves may be even older. The cemetery is fenced off and well maintained (see photograph 2).

The cemetery and the small farmhouse are both older than sixty years and thus protected by the National Heritage Resources Act No. 25 of 1999. Art. 34 (1) and 36 (1).

Both the cemetery and the small farmhouse should be protected and be included in the new development as a heritage feature.

It is recommended that the cemetery and the small farmhouse be properly recorded, documented and protected as heritage features in the new development. A proper heritage management plan must be compiled and implemented to safeguard the two heritage sites.

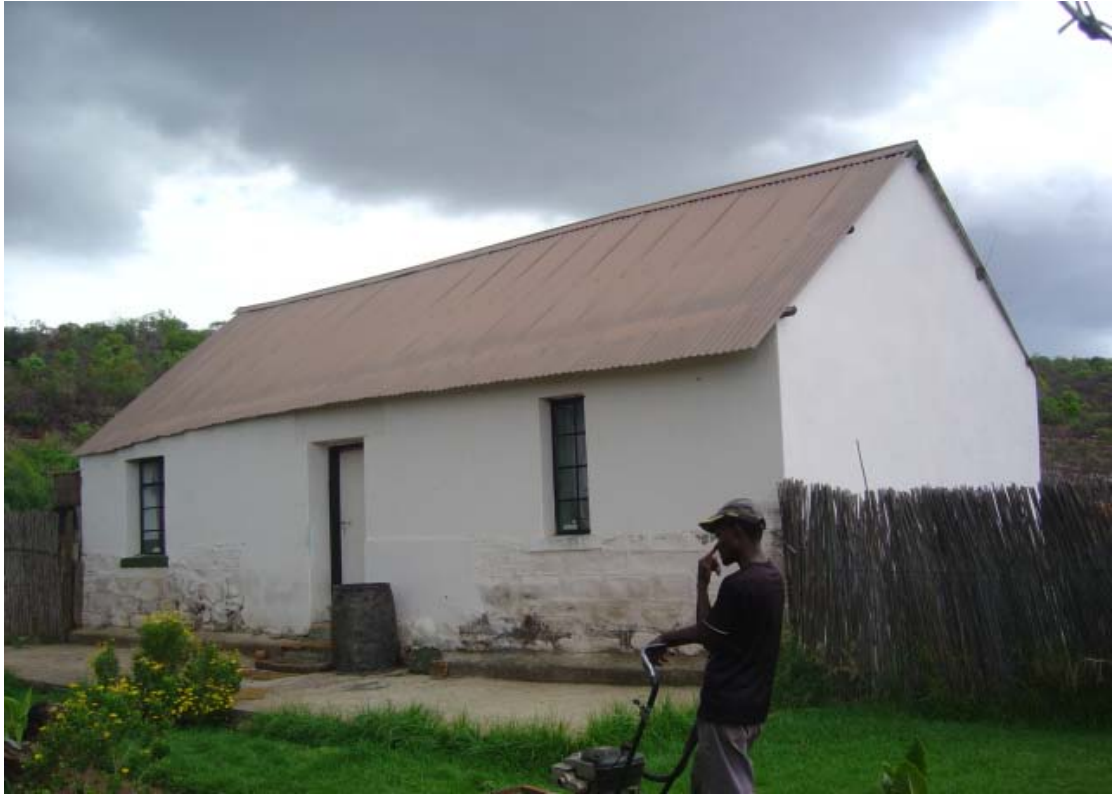
No. 3 Small original farmhouse

A small stone and brick house is situated at S24° 39' 36.2" and E28° 19' 20.1". The foundations and a portion of the walls are built with local sandstone and the rest of the walls and gables with bricks. The roof is of corrugated iron. The horizontal roof beams were hand cut and date to the beginning of the 20th century. The building is a

typical three-roomed pioneer farmhouse. The building is still in a good condition (see photographs 3 and 4).
