PHASE 1
ARCHAEOLOGICAL IMPACT
ASSESSMENT

PROPOSED ESKOM OVERHEAD POWER LINE
*PALMIETFONTEIN, GA-MOTHIBA,
MATHIBASKRAAL*
Polokwane: Northern Province

Frans Roodt
November 2001

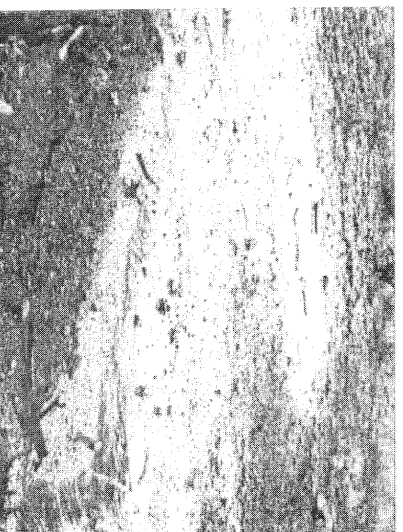
Figure 4. Communal grinding stone, site 3

SITE 3 Co-ordinates: S24°02'05.2" E29°33'46.2"

This site contains communal grinding stones related to the ruins above.

The historical sites (2, 3, 4, & 5) with the communal grinding areas and graves as well as site 6 are regarded as significant. The Power Line will pass the actual ruins, but one must bear in mind that these previously dwelling place will contain graves, even though they may not be marked. Human remains must be treated with sensitivity.

When excavating postholes, care must be taken should any signs of human activity be exposed. The communal grinding area must be avoided at all cost and planning must ensure that the power line spans over these places.

1. That no posts be erected within 10 meters of the communal grinding places.
2. That an archaeologist be allowed to inspect the positions of postholes at the areas generally identified as historical sites, i.e. Sites 2, 3, 4, 5, 6,

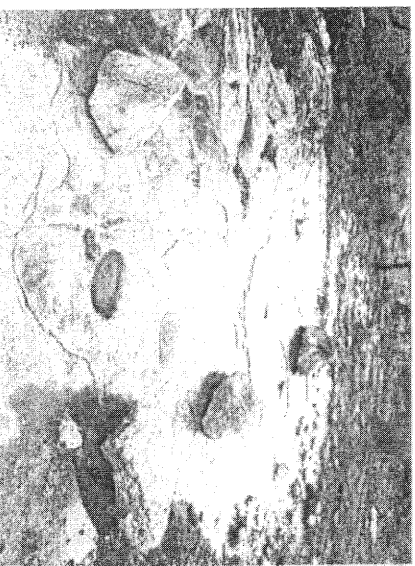
SITE 4 Co-ordinates: S24°02'06.4" E29°33'47.3"

This site contains communal grinding stones related to the ruins below.

Figure 6. Communal grinding stone, site 4
