**FOLLOW-UP REPORT**

**CULTURAL HERITAGE ASSESSMENT OF THE SOUTHDOWNS IRENE  
COUNTRY ESTATE, IRENE, CENTURION**

**FP Coetzee  
The Archaeology Contracts Unit  
University of South Africa  
PO Box 392  
Pretoria  
0003**

January 2007

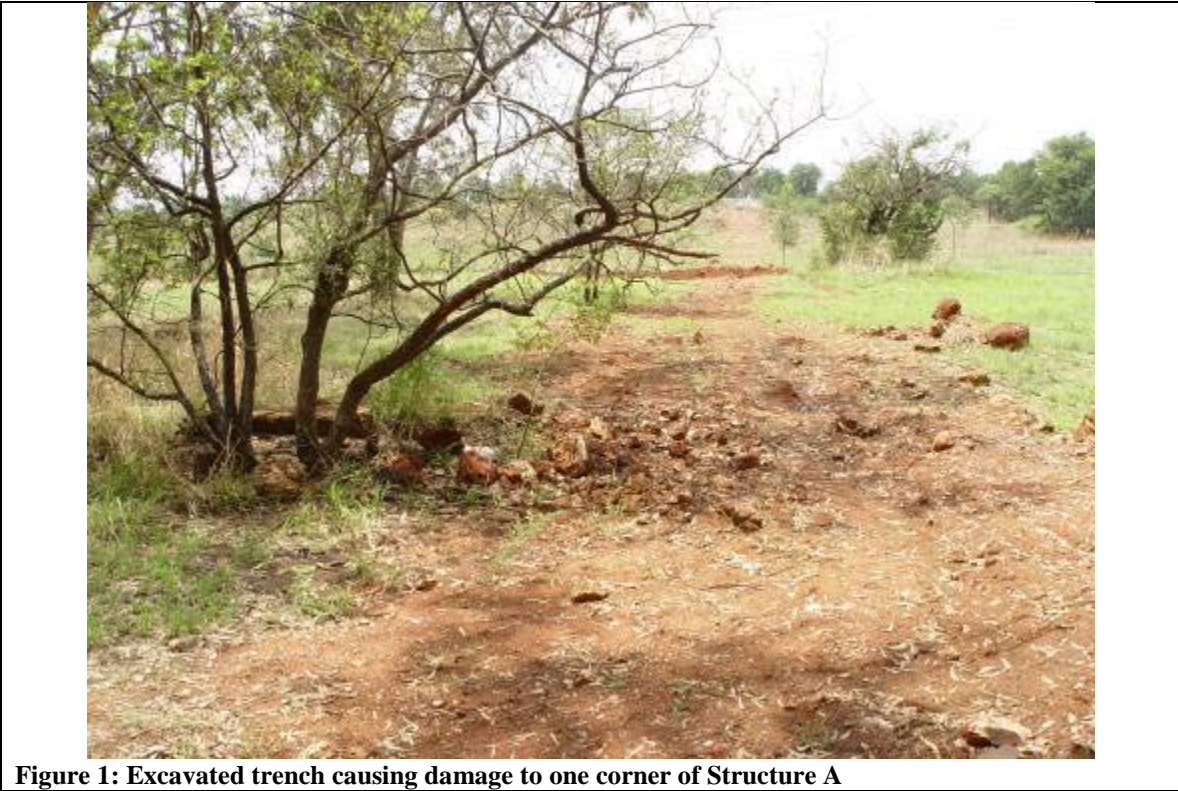
- A trench was excavated and back-filled for an electrical cable to service the borehole pump (Figure 1). The trench cuts through the site (see Map 2) and caused damage to the north-western corner of the foundation of the dining room (structure A). The trench also went through foundations of the office building (structure O) (Figure 2).

**Figure 1: Excavated trench causing damage to one corner of Structure A**

- The trench for the electrical cable providing power to the borehole is stable. Any further rehabilitation of the damaged structures must be conducted in consultation with the archaeologist.

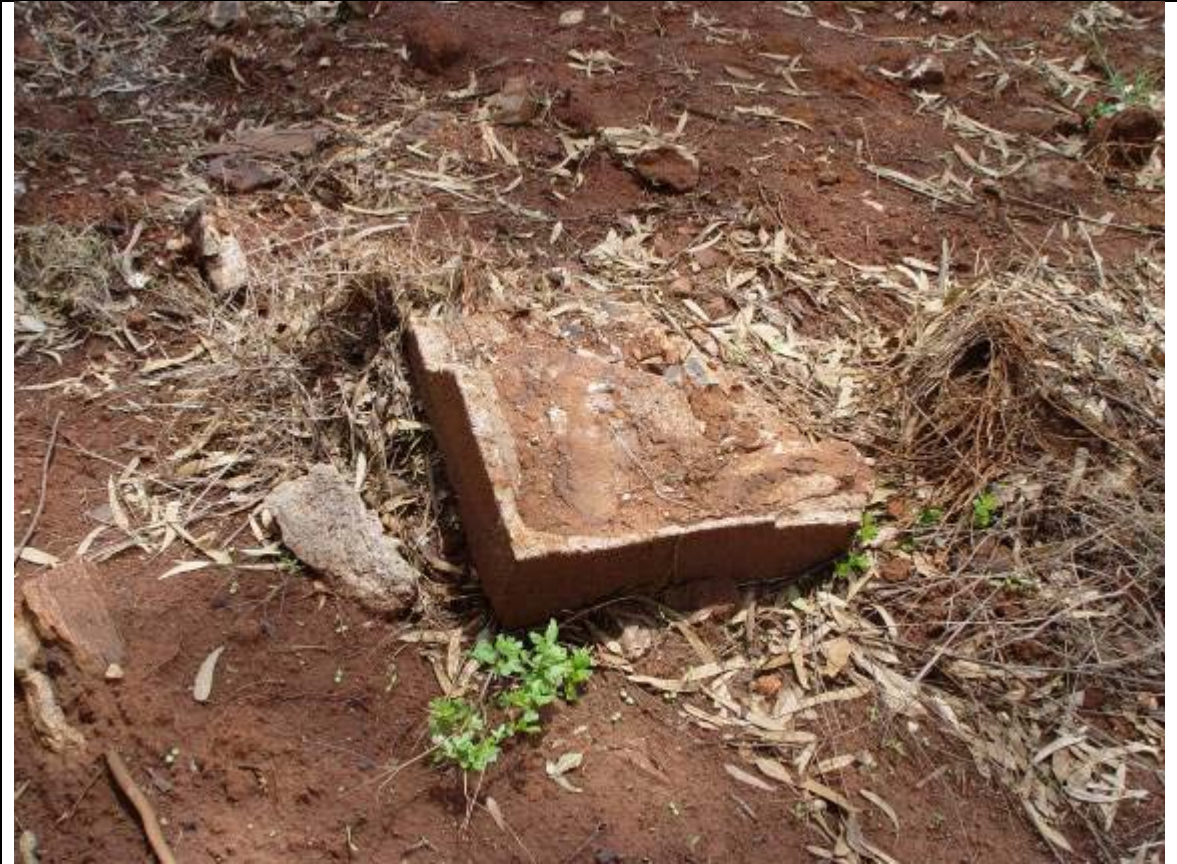
**Figure 2: Damaged caused by the trench to Structure O**

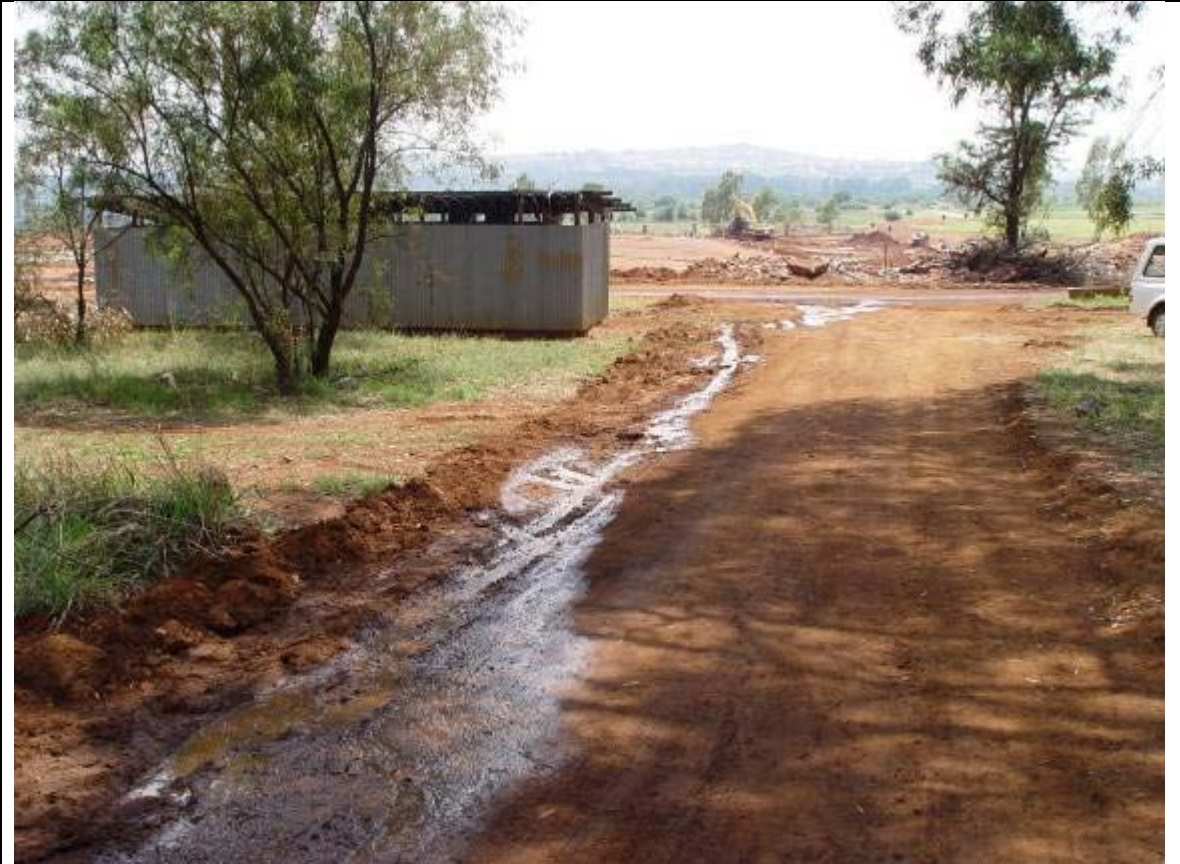
- The eastern fence was removed. This coupled with the fact that a tap was erected close to the borehole increased traffic on the site. A new access road was scraped which proved easy access to the tap (Figure 3).
- A large hole was recorded in the north-eastern corner of the site. The pipe for storm water drainage is still visible (Figure 4). Notwithstanding the severe damage to the area, no damaged was caused to any heritage structures.
- An additional access road was scraped along the eastern periphery of the site (Figure 5). Notwithstanding the surface damage to possible deposits, no damaged was caused to any heritage structures.

**Figure 3: Access road to the borehole and tap**

- The large hole associated with the storm water drainage pipeline will be closed off and rehabilitated.
- The tap that has been installed will be closed off.

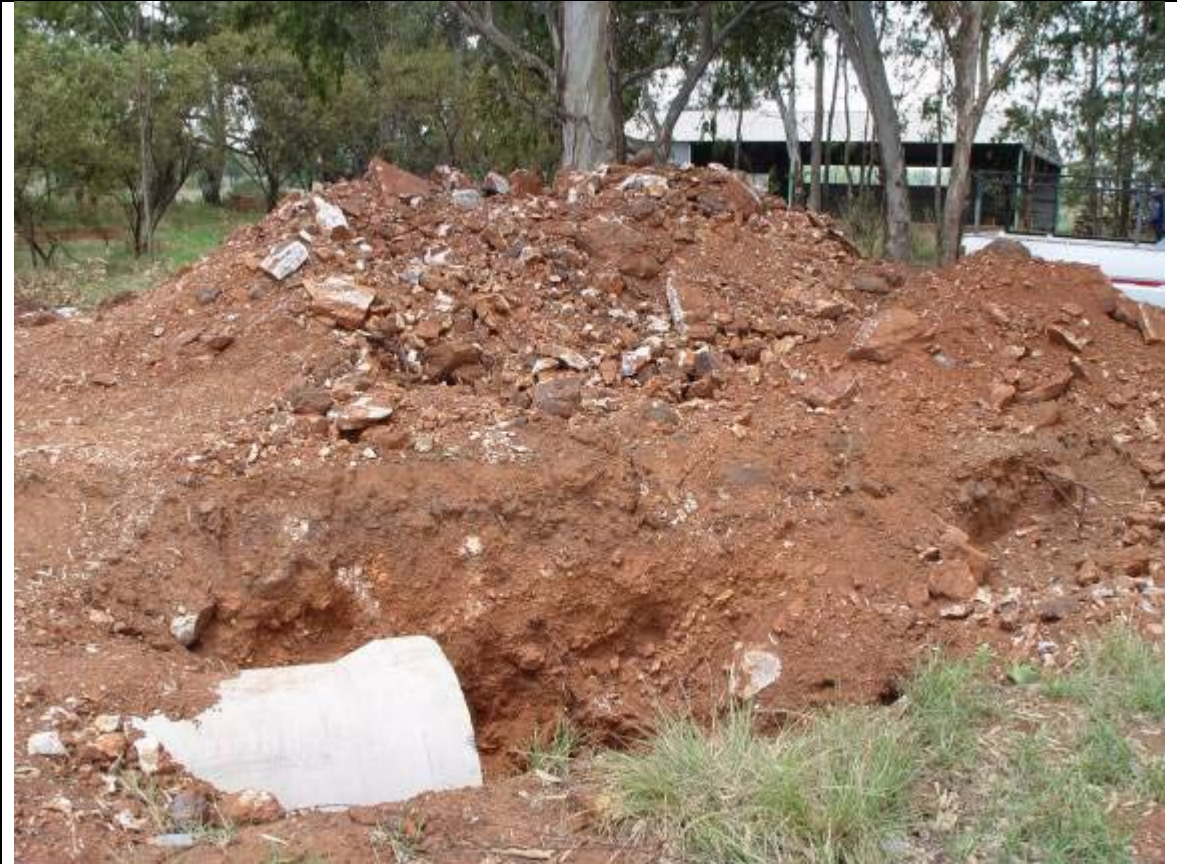
**Figure 4: Large hole for storm water drainage**

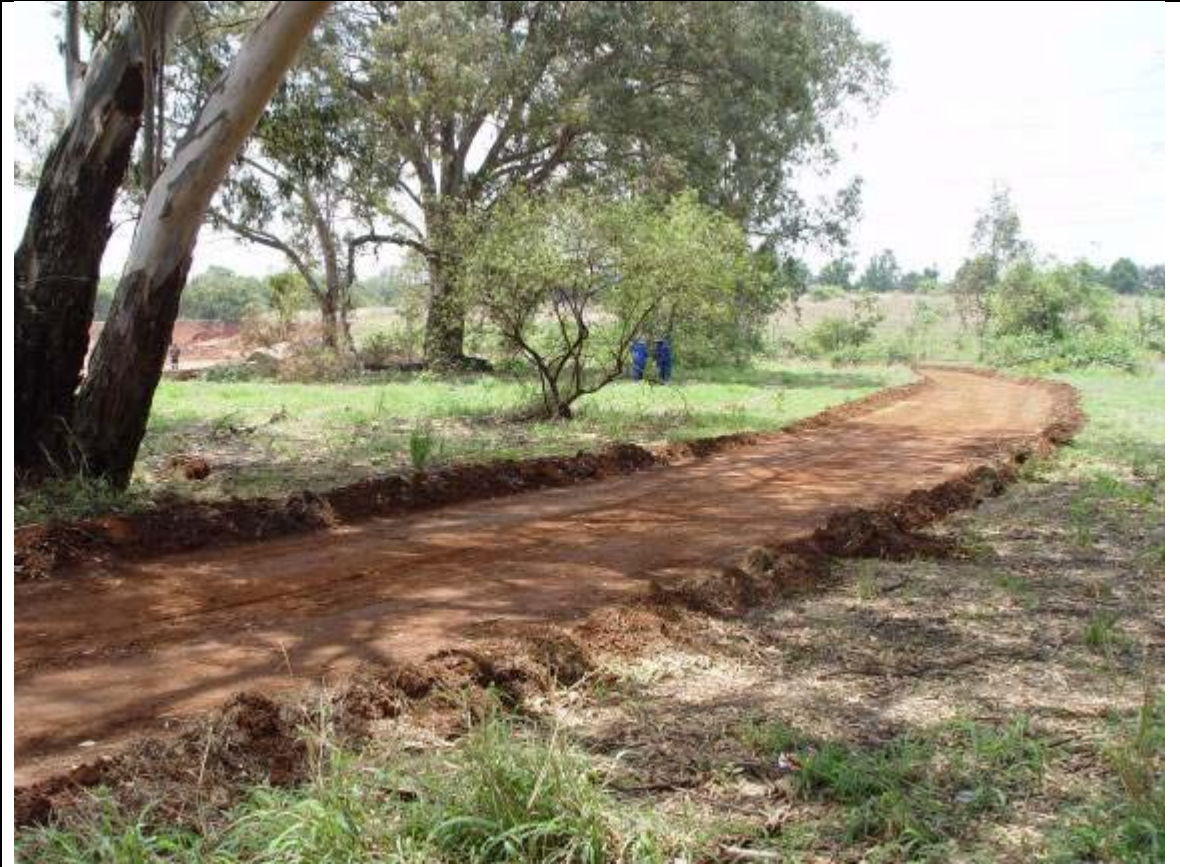
**Figure 5: New access road**

- The new road along the eastern periphery will not be used further and the surface rehabilitated.
- The reservoir will be moved behind the main shed (used by the Voortrekker Commando). An additional reservoir is also planned, which will also be erected in the new location.

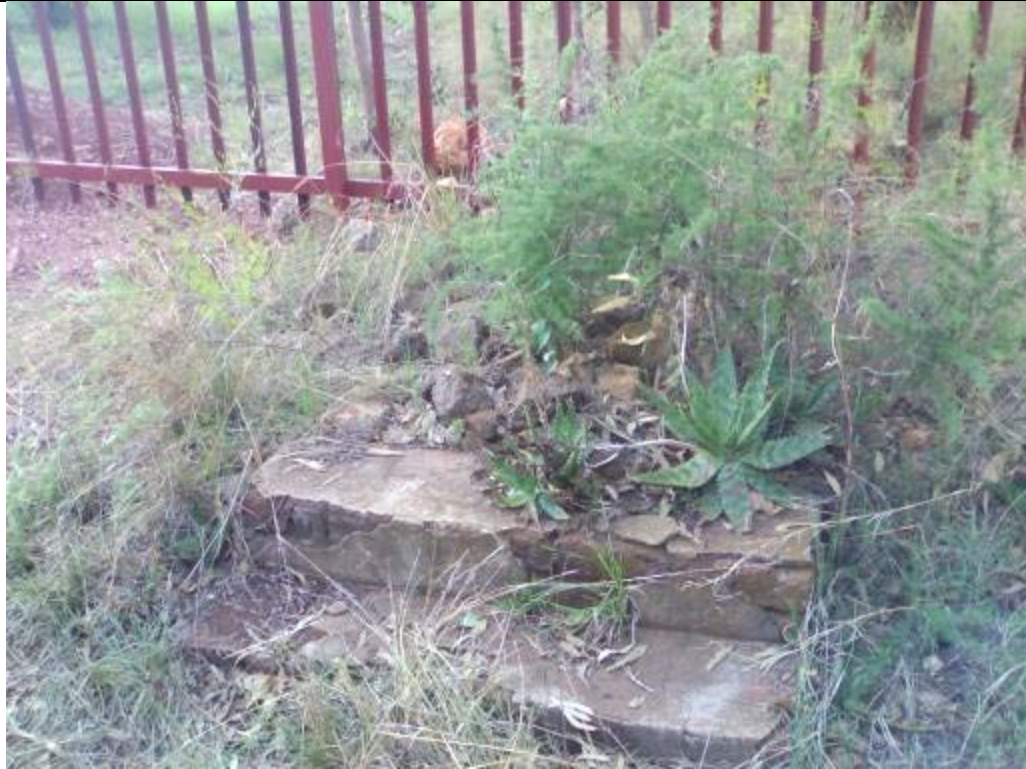
- An extensive palisade fence was erected in the middle of the site. The supporting poles were cemented in place, with the result that foundations of several structures were damaged (Figure 6). In several places foundation stones were moved to make way for the palisade sections.
- An area was levelled and a large circular reservoir constructed on the site (Figure 7). Additional pipelines will then provide irrigation to the various sports fields of the new school.

**Figure 6: Damage caused by fence**

- The eastern section of the original fence (which prohibits access to the area) will be restored to prevent further activities on the site.
- The palisade fence will be removed. However, the main poles that have been cemented in place will only be cut off above ground level. They will not be removed as this will cause further damage to some of the structures.

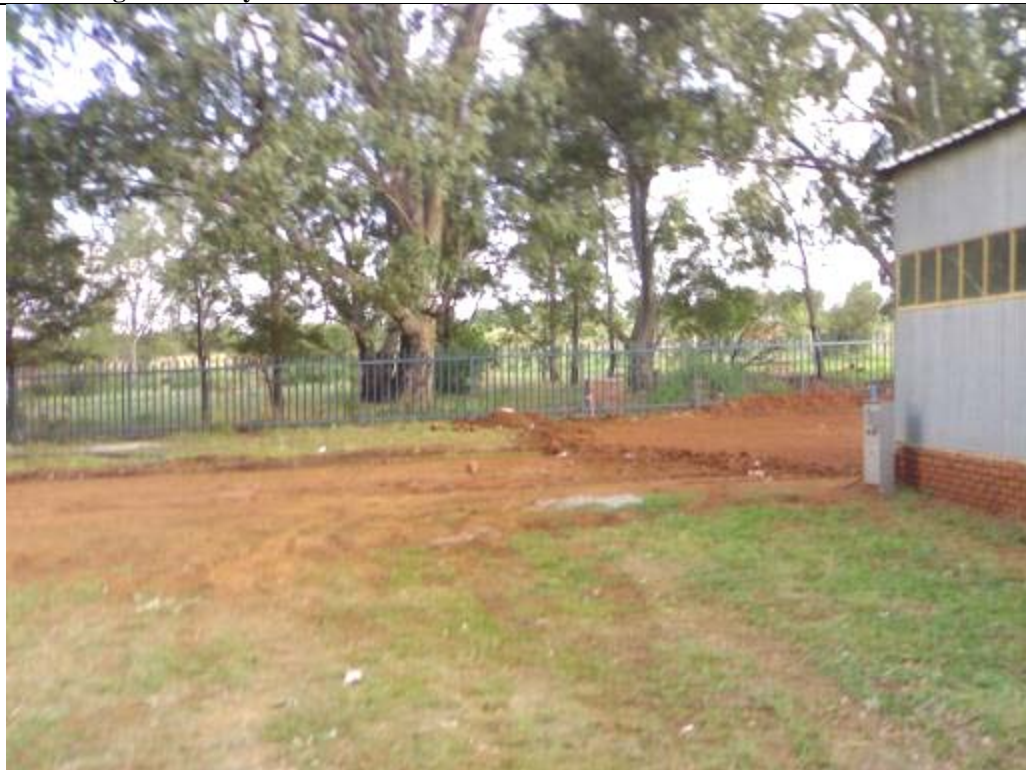
**Figure 7: Cleared area for the construction of the reservoir**
