PHASE 1 HERITAGE RESOURCES SCOPING REPORT

BAKONE SUBSTATION & POWERLINE POLOKWANE LIMPOPO

Frans Roodt
November 2007

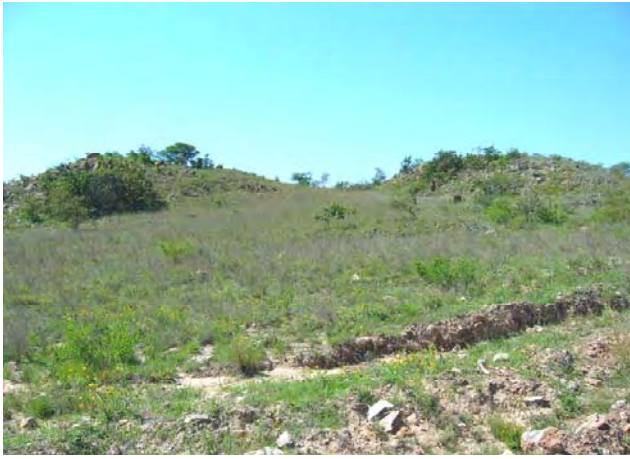
Fig 1. Proposed area for new substation at the foot of a small hill.

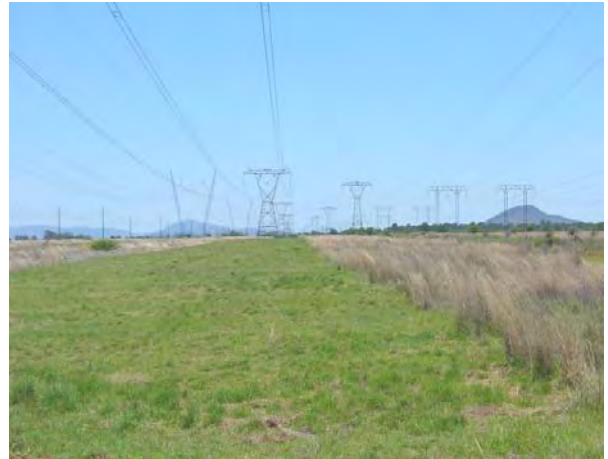
Fig 2. Existing power lines.

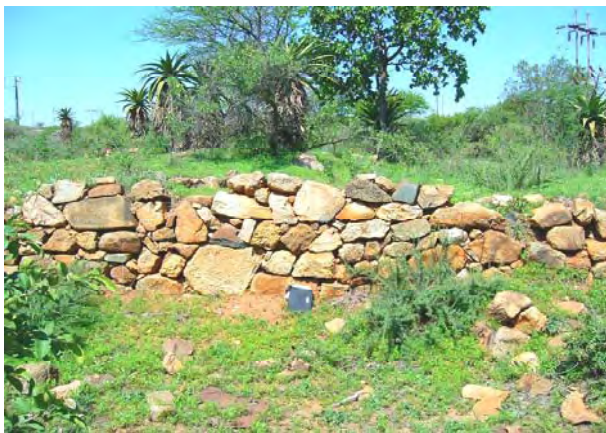
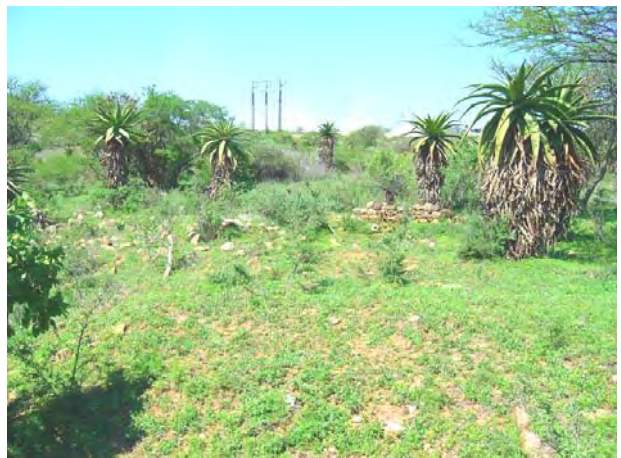
One recent historical stone built structure was noted along the route. It is situated close to the proposed area for the new substation. The walls are thick and rectangular; it could possibly be the remains of an old farm building or farm worker's dwelling (1 on locality map).

Fig 3. Historical stonewall at Site 1.

Fig 4. Wider view of the stone structures – Site 1.

The recent historical site (Site 1) is rated as low in significance. The power line should however span over it with no pylon placed on top of the remains. No further action would then be required.

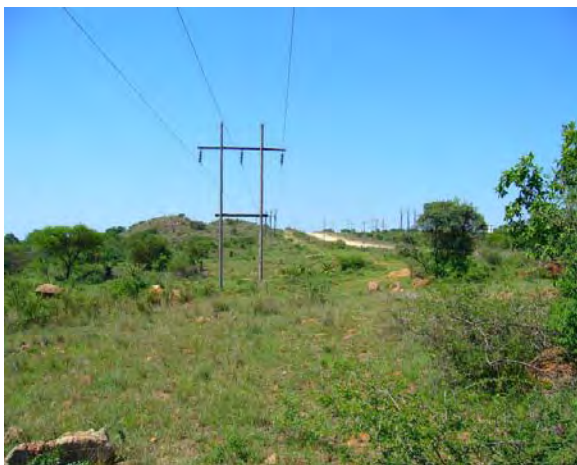
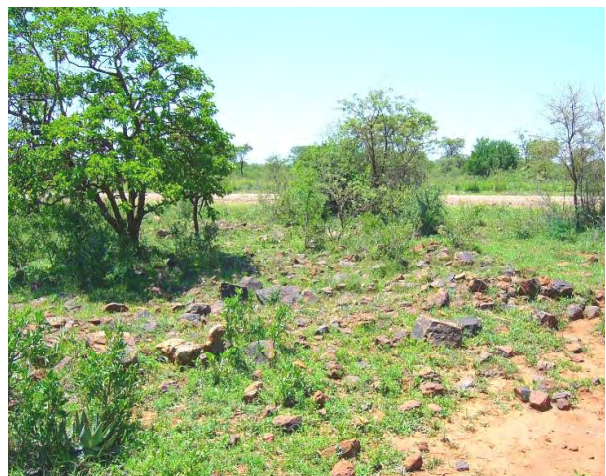
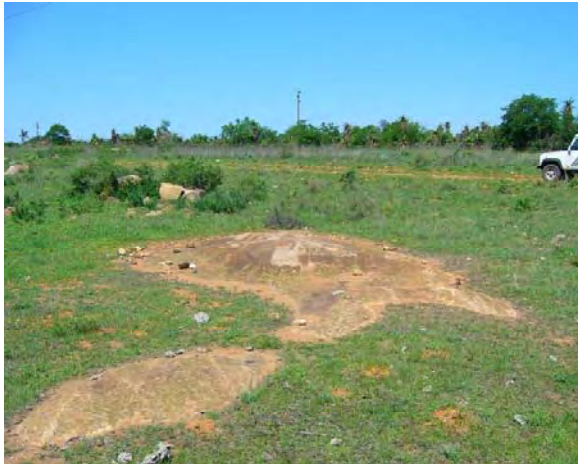
This site is situated close to the recent historical site and opposite the brickyard; it has been severely disturbed in the past and very little walling remains. The stones from which the mentioned historical structure had been built were probably robbed from here. The site has two large flat rocks that contain shallow communal grinders, they are however not visible on a photo.

Significance: low.

Fig 5. View of Iron Age Site 2.

Fig 6. Iron Age Site 2, Stone Walled Site.

Fig 7. Large Rock with communal grinders at Site 2.

The Late Iron Age stonewalled sites (Sites 2 – 5) form part of the *Badfontein*-type walling that occurs on the Pietersburg plateau. These date from the 17th – 19th century AD and were inhabited by Koni and Ndebele speakers. The significance of these sites is rated as low because of their poor state of preservation. Monitoring of earthwork is required where power pylons are placed and constructed.

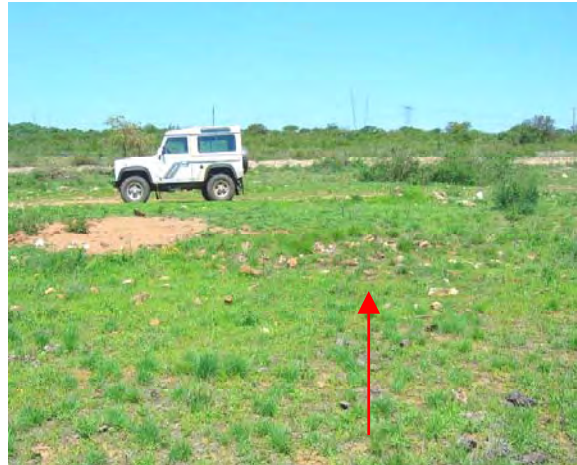
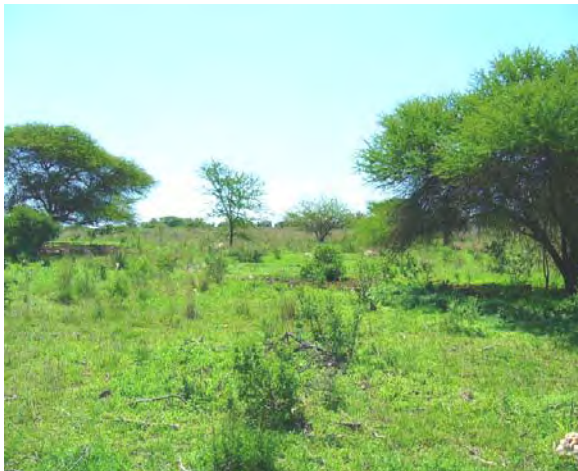
This site is another stone walled complex and it is as severely disturbed as the previous site.

Significance: low.

Fig 8. Iron Age Site 3, note wall.

Fig 9. Iron Age Site 3, most walling not visible.

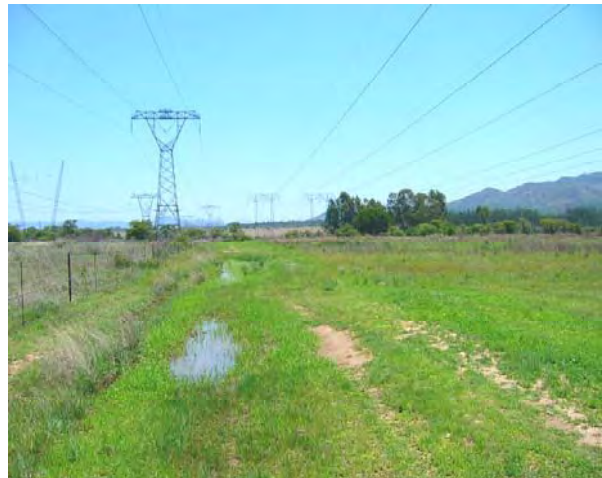
This site is situated next to the river underneath existing power lines. There is no stonewalling, and only a small scattering of non-diagnostic pottery fragments, and possible hut rubble was noted. The area has been under cultivation in the past.

Significance: low.

Fig 10. Iron Age Site 6.

Site 6, which only contains fragmented remains, is probably either an *Eiland* (10th – 13th century AD) or an *Icon* (14th – 16th century AD) archaeological site. It is also rated as low because of its destruction and only requires monitoring should a power pylon be placed directly on it.
