ARCHAEOLOGICAL IMPACT ASSESSMENT REPORT

LEVUVHU RIVER GOVERNMENT WATER SCHEME

NAVAMBE TO VALDESIA PIPELINE BORROW PITS

NOVEMBER 2007

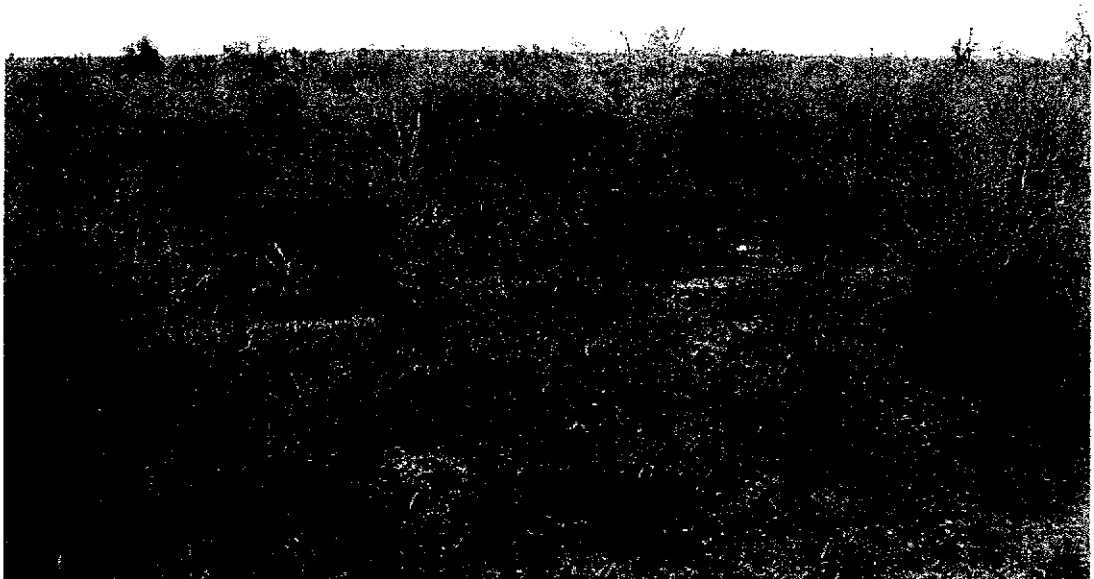
6.1 Borrow Pit A

The area has many Marula trees and the natural plant growth, as evident in surrounding areas, is absent.

Limit excavations exist on the site, no archaeological material was found in the excavated soil.

Old agricultural land, no archaeological material was observed.

A borrow pit can be excavated at Locality A without any danger of damage to the cultural heritage.

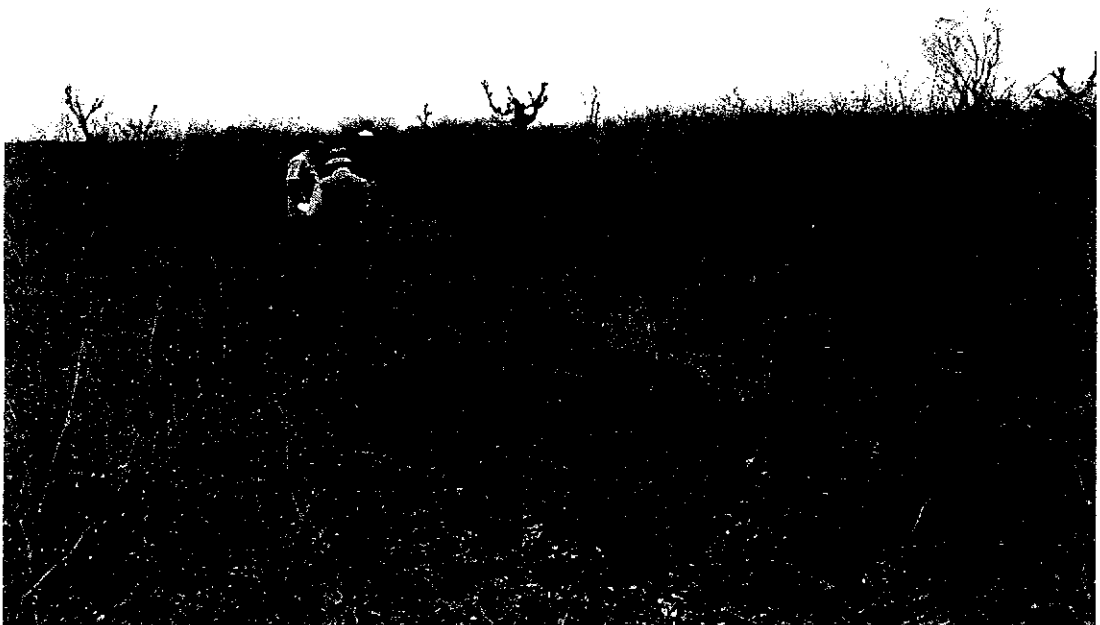
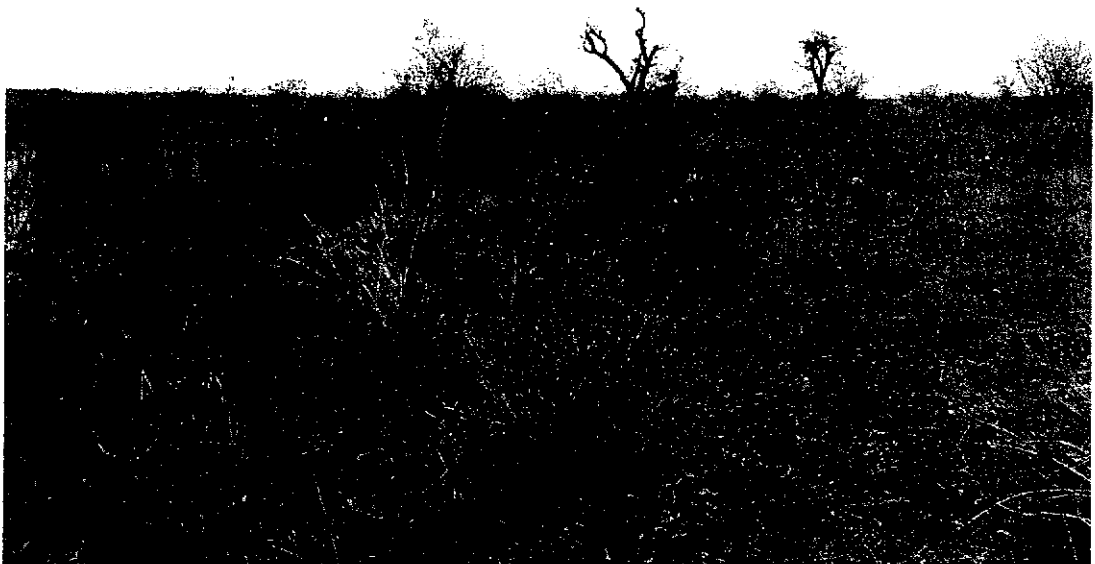
6.2 Borrow Pit B

The natural plant growth of this area is absent on the site allocated for a borrow pit. Marula trees do, however, occur.

Old agricultural land, no archaeological material was observed.

A borrow pit can be excavated at Locality B without endangerment of the cultural heritage.

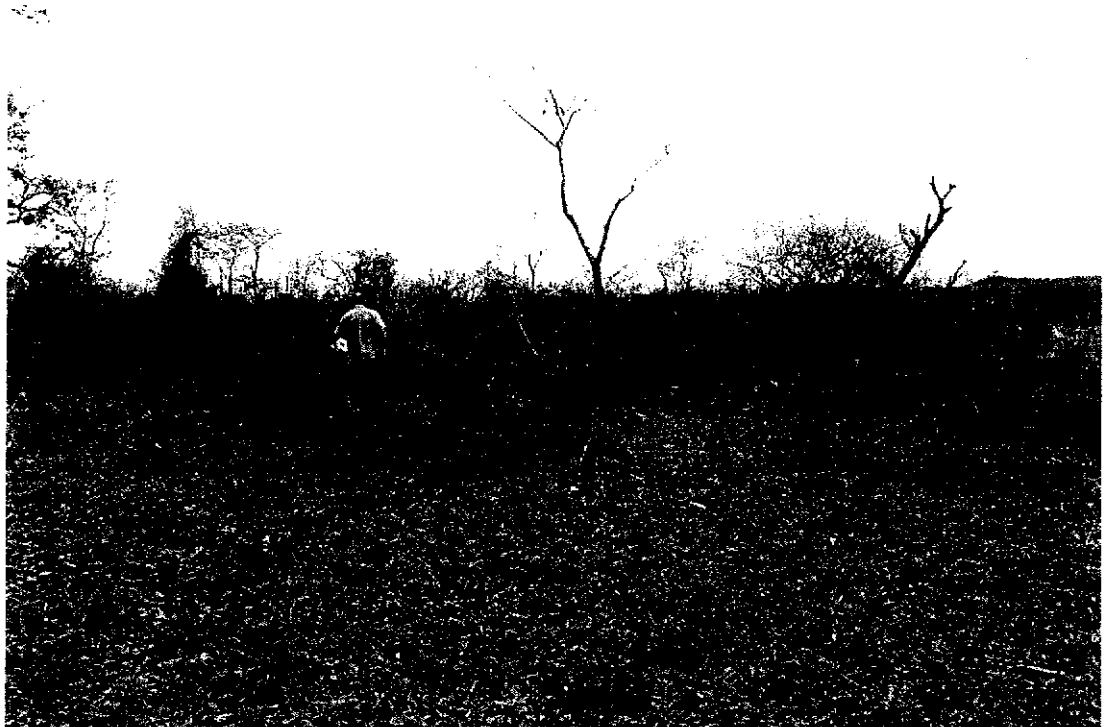
6.3 Borrow Pit C

The natural plant growth of this area is absent on the site allocated for a borrow pit. Marula trees do, however, occur.

Old agricultural land, no archaeological material was observed.

A borrow pit can be excavated at Locality C without endangerment of the cultural heritage.

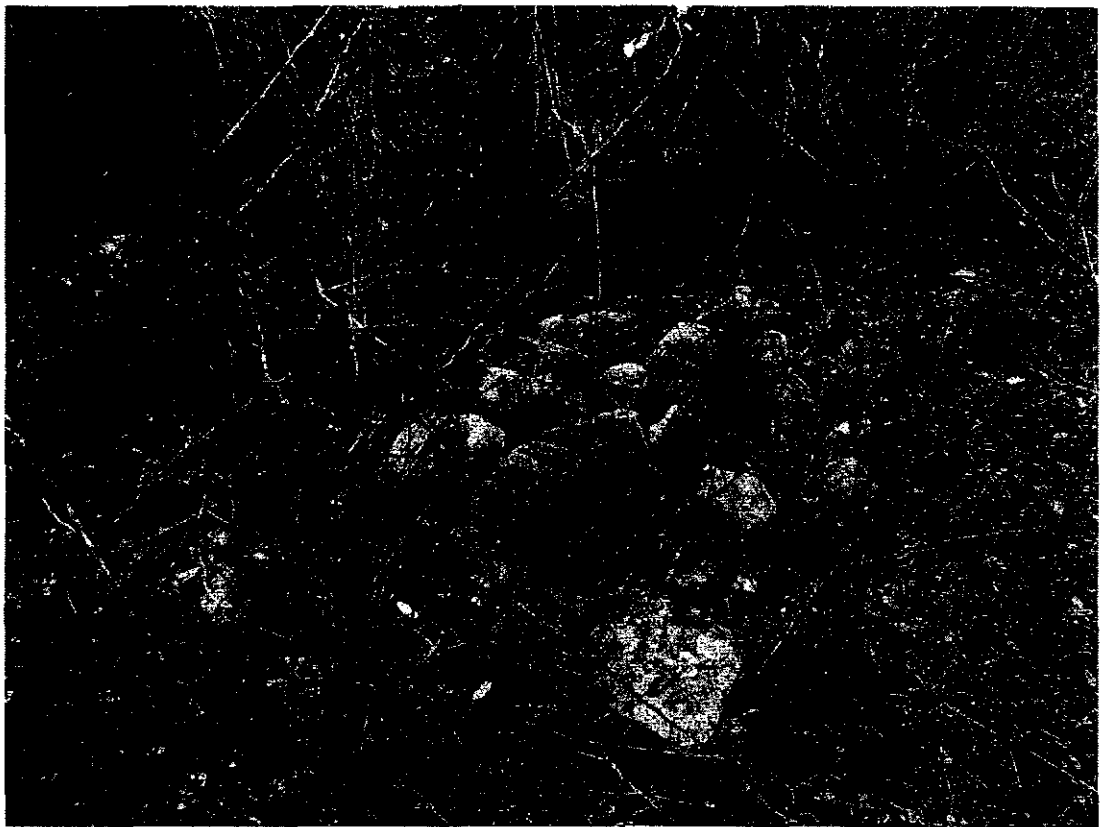
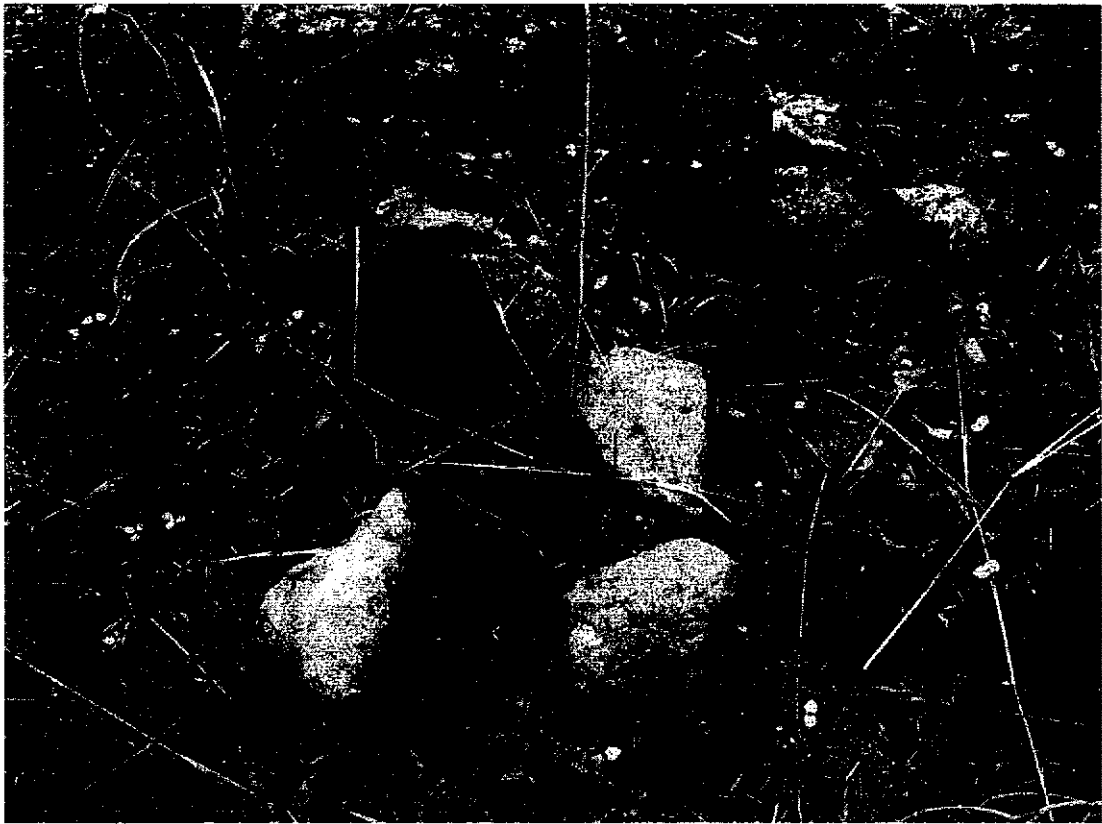
6.4 Borrow Pit D

The site allocated for Borrow Pit D is a rocky outcrop, a potential area for cultural activity.

During the examination of the rocky outcrop packed stone structures were found. They are roughly circular in form. The stone structures are possible graves (see definition in 4.3).

Comparable structures were found in various parts of Venda during previous research projects. On further examination of these structures they proved to be graves.

Good examples of these structures are at S23° 07.525 and E30° 22.451.

The rocky outcrop should be voided as several potential graves are present in this area.

Should work be done in this area, Phase 2 archaeological work would need to commence to excavate and translocate the graves prior to any borrow pit excavation.

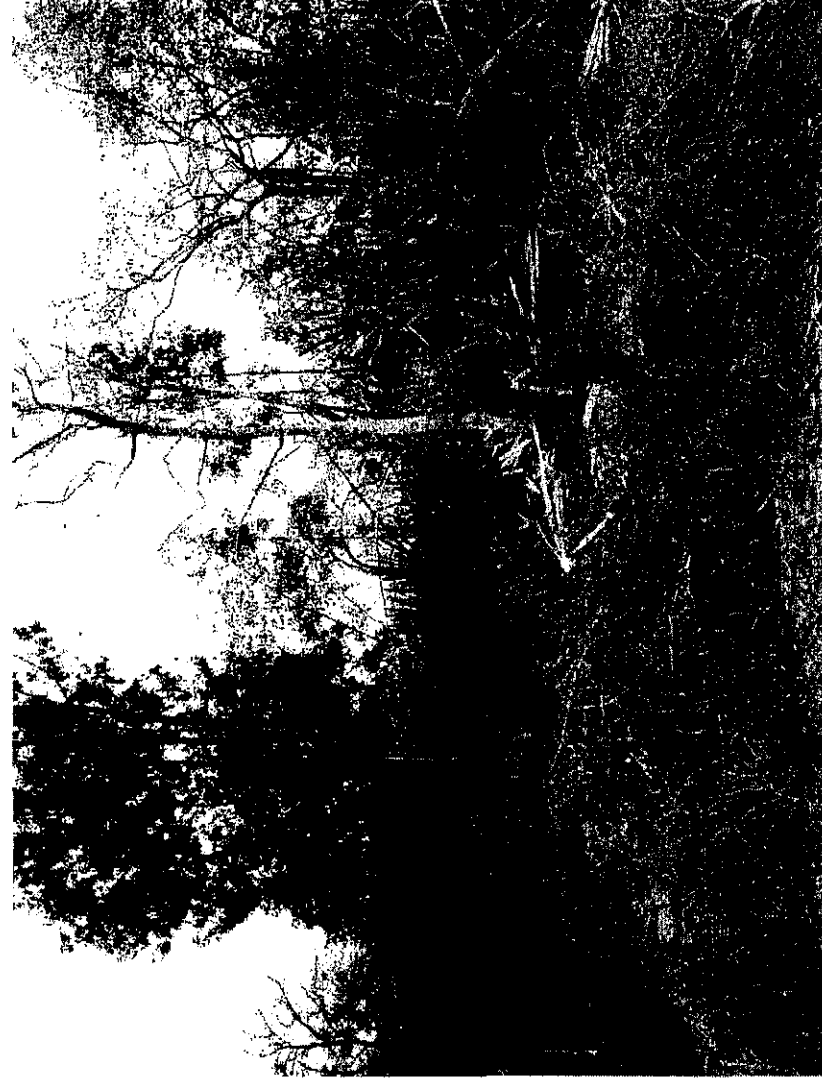
6.5 Borrow Pit E

Sisal plants, Bluegum trees and Sicklebush indicate former habitation and disturbance of the natural habitat.

Pieces of three cement floors were found. No other building material was present. The cement floors could have been part of corrugated iron or pole and dagha buildings.

Work can proceed. Care should, however, be taken if large quantities of porcelain are unearthed. An archaeologist should be informed and consulted.

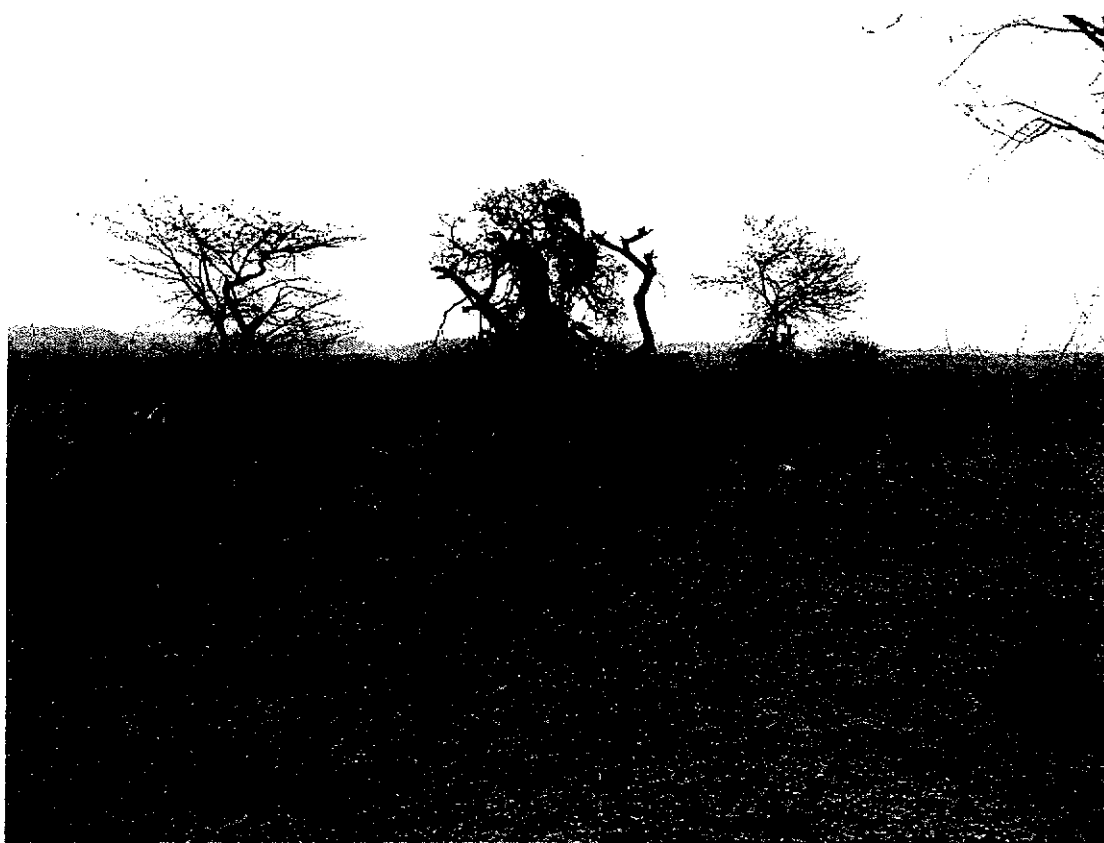
6.7 Borrow Pit G

Excavations exist on the site. No cultural remains were present in the excavated soil.

The natural habitat of this area is extensively disturbed by intensive utilisation for cattle farming and the erection of structures for cattle farming.

Damage on the site renders it useless for any archaeological research, even if archaeological sites were present.

Excavation of the borrow pit can proceed.
