Cultural Heritage Survey of the proposed Thaba Lesodi Golf and Game Estate
Development, Modimolle Local Municipality, Waterberg District, Limpopo Province

December 2006

DRAFT REPORT

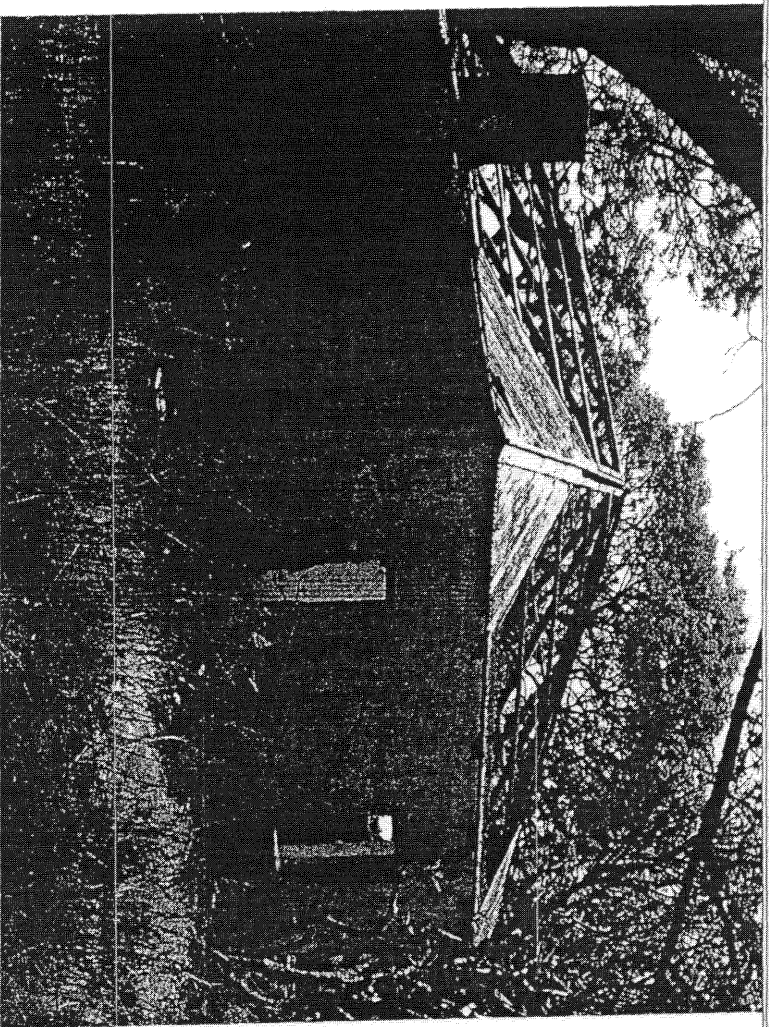
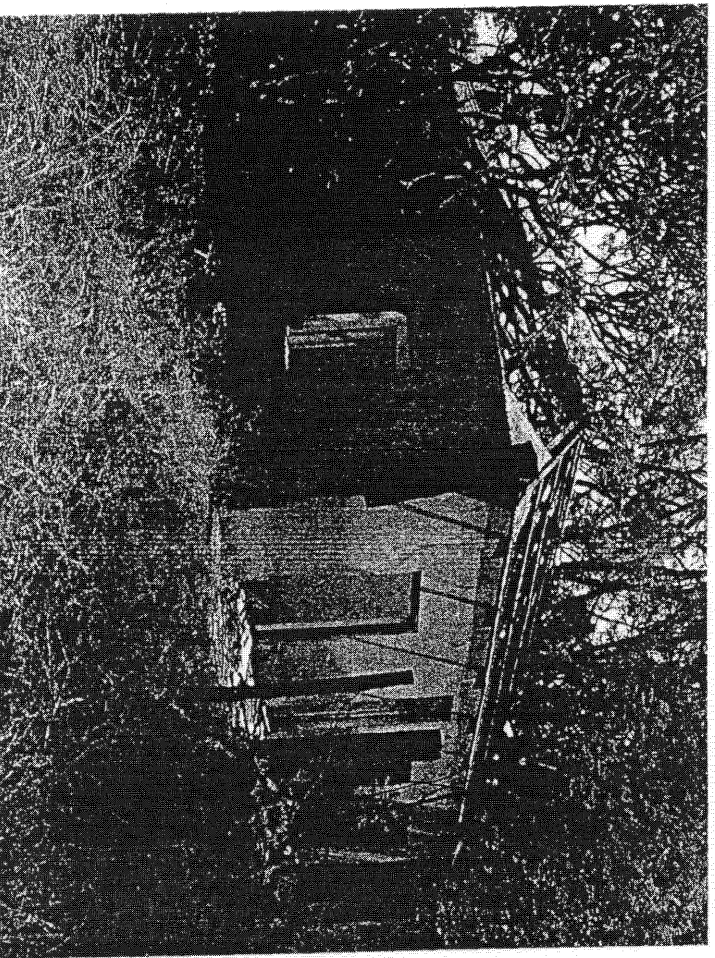
The site consists of an abandoned farm homestead in a fairly dilapidated state (Figures 1 & 2).

Dilapidated and damaged
No midden recorded

Figure 1: Remains of farm homestead.

Figure 2: The northern aspect of the house with the remains of a veranda.

G. RECOMMENDED MITIGATION			
<ul style="list-style-type: none"> • Phase 2 investigation • Surveying and documentation of the structure 			
H. APPLICABLE LEGISLATION AND LEGAL REQUIREMENTS			
<ul style="list-style-type: none"> • National Heritage Resources Act (Act no. 25 of 1999) • Permit from SAHRA for destruction

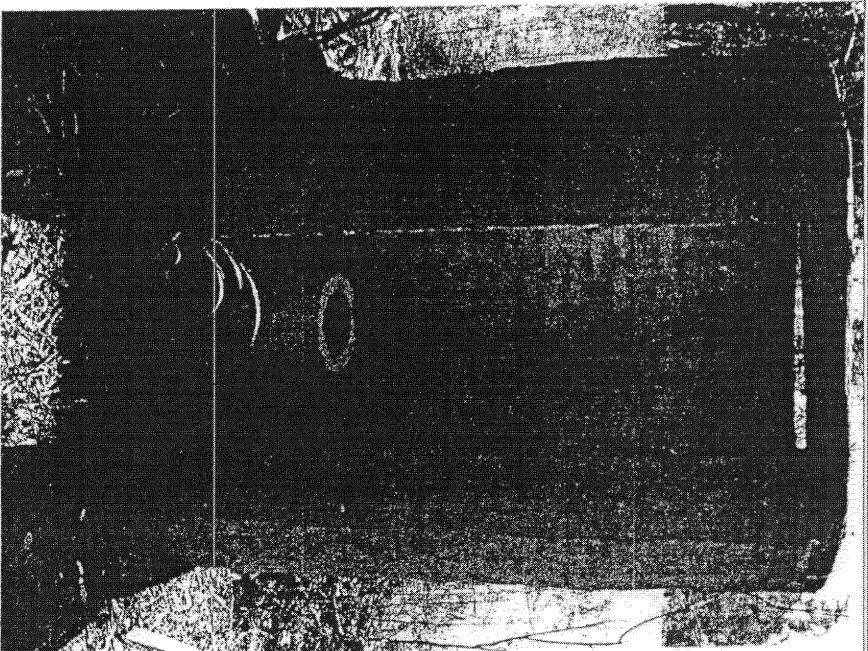
- a boiler with a tiled furnace opening;
- a bathroom tiled with white-and-green geometric design ceramic tiles, shower, and porcelain fittings;
- an outdoor toilet (Figure 3)
- scullery and Kitchen
- living room
- 3 bedrooms

Figure 3: The outdoor ablutions.

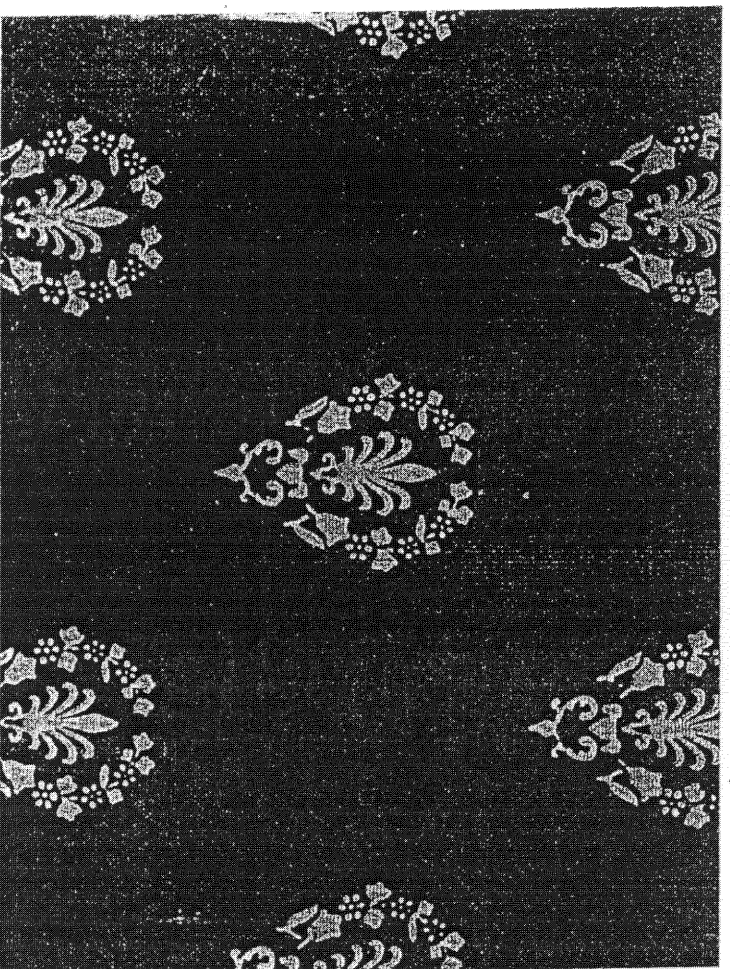
Further elements that were recorded include the cement floors, rhino board ceilings, the wall paper used in the main living rooms (Figure 4), pine roof trusses, and bricks produced from

Figure 4: An example of the wallpaper used.

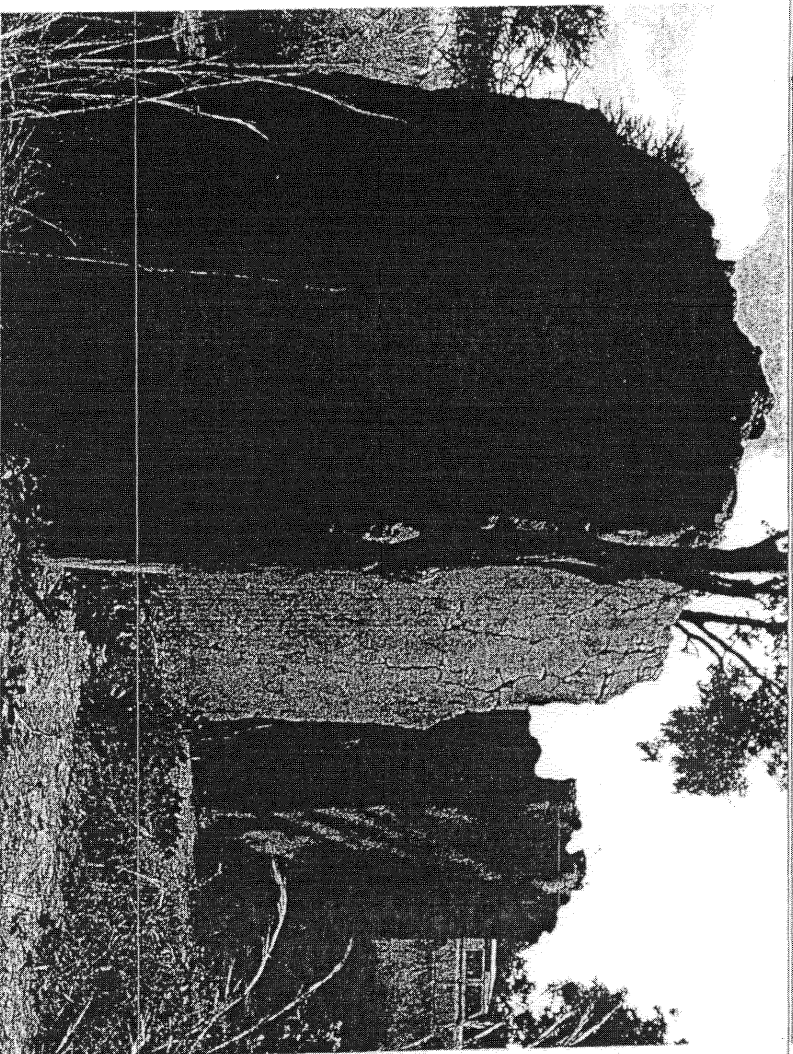
The site consists of a rectangular clay-walled structure with two rooms of 10 x 5 and 15 x 40. Wooden forked poles were used to strengthen the walls and a possible veranda (Figure 5). From the decaying structure it is evident that a foundation of stone was laid first, after which large-sized daggha bricks were used in the construction, the walls were then covered with a daggha layer. A stone layer on top of the walls served as a basis for the roof construction.

B3. CONDITION OF SITE		Dilapidated and damaged		
Integrity of deposits/structures.		No midden recorded		
C. SPHERE OF SIGNIFICANCE		High	Medium	Low
International				✓
National				✓
Provincial				✓
Local				✓
Specific community				✓

Figure 5: Remains of a clay-walled structure.

G. RECOMMENDED MITIGATION				
<ul style="list-style-type: none"> • Sufficiently recorded, no further action required. 				
H. APPLICABLE LEGISLATION AND LEGAL REQUIREMENTS				
<ul style="list-style-type: none"> • None

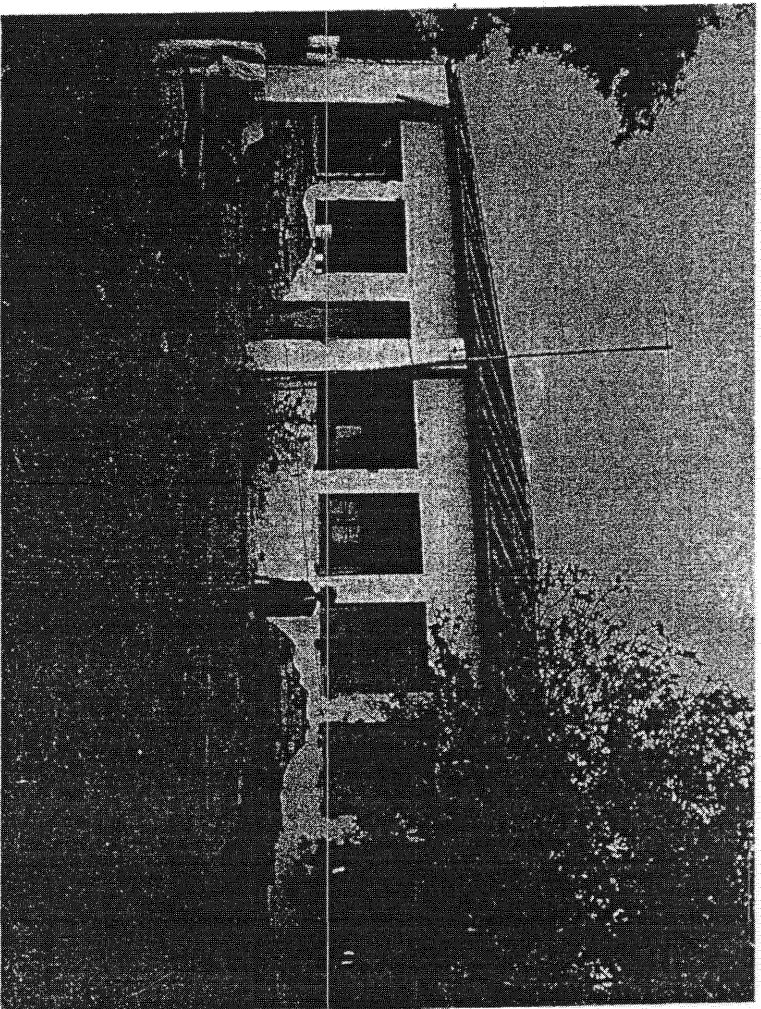
B2. REGIONAL CONTEXT			
Other similar sites in the regional landscape.			✓
B3. CONDITION OF SITE			
Integrity of deposits/structures.		Main structure intact and stable	
		Not well maintained

Figure 6: The main house.

G. RECOMMENDED MITIGATION			
<ul style="list-style-type: none"> Phase 2 investigation

- Surveying and documentation
- National Heritage Resources Act (Act no. 25 of 1999)
- Permit from SAHRA for destruction

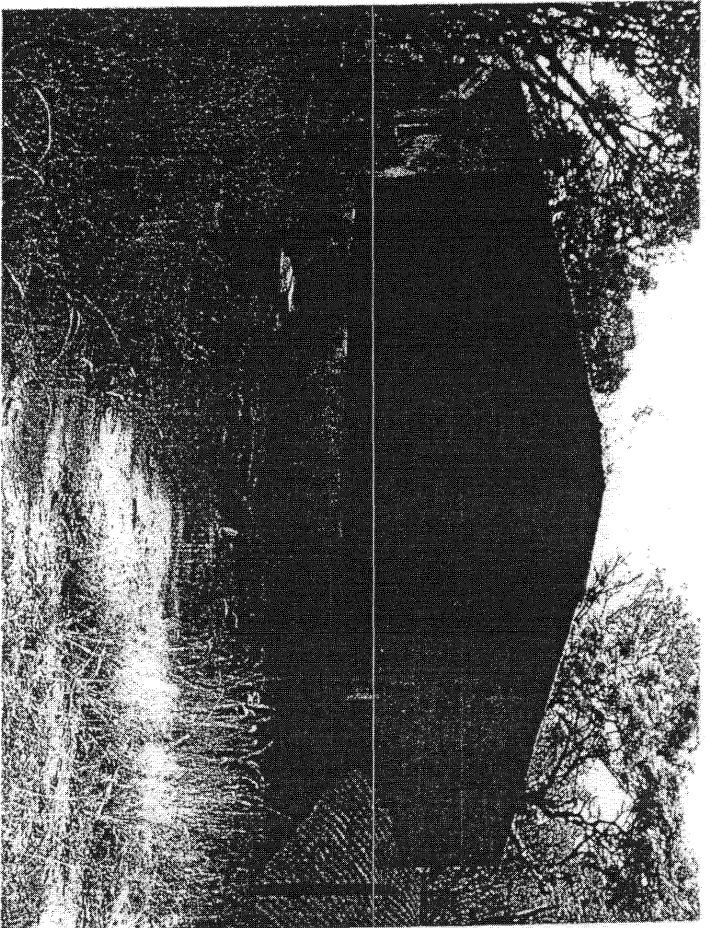
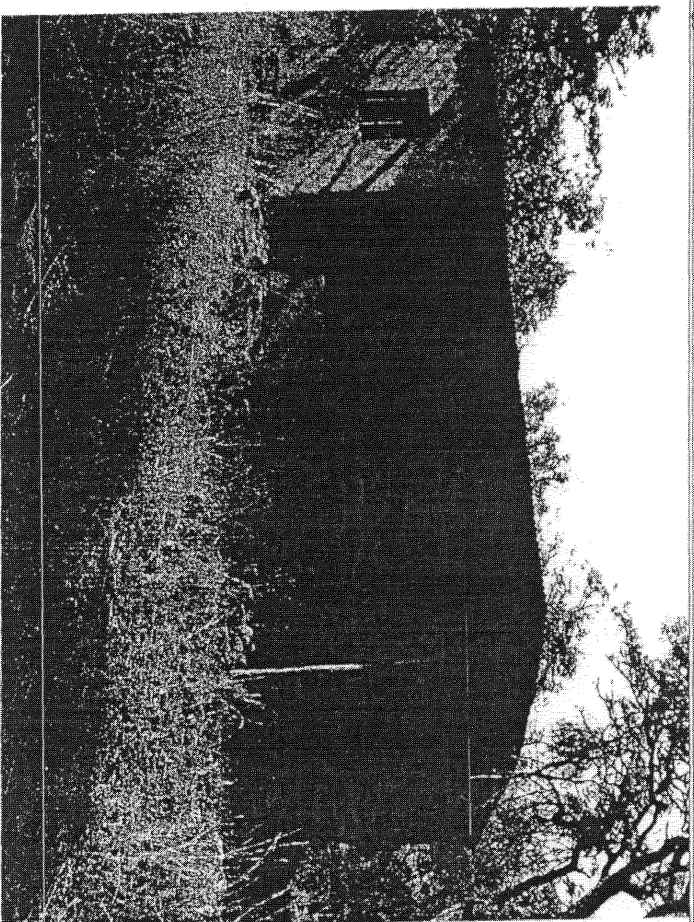
The site consists of two cement and brick-walled, corrugated iron roof houses, probably used as farm worker accommodation (Figures 7 & 8). Both structures (with dimensions: 5m x 10m; 7m x 4m respectively) have two rooms with a veranda. The remains of fencing for poultry and household goods, such as enamel bowls, and rusted farm implements are evident in the vicinity of the structures.

Rarity Value			
It possesses unique, uncommon, rare or endangered aspects of South Africa's natural or cultural heritage.			√
Representative Value			
It is importance in demonstrating the principle characteristics of a particular class of South Africa's natural or cultural places or objects.		√	
B2. REGIONAL CONTEXT			
Other similar sites in the regional landscape.		√	
B3. CONDITION OF SITE			
Integrity of deposits/structures.		Structures stable but abandoned No middens recorded

Figure 7: House with veranda.

Figure 8: House with veranda.

Peripheral	
Destruction	
Uncertain	✓
G. RECOMMENDED MITIGATION	
<ul style="list-style-type: none"> • Sufficiently recorded, no further action required. 	
H. APPLICABLE LEGISLATION AND LEGAL REQUIREMENTS	
<ul style="list-style-type: none"> • None 	
I. PHOTOGRAPHS

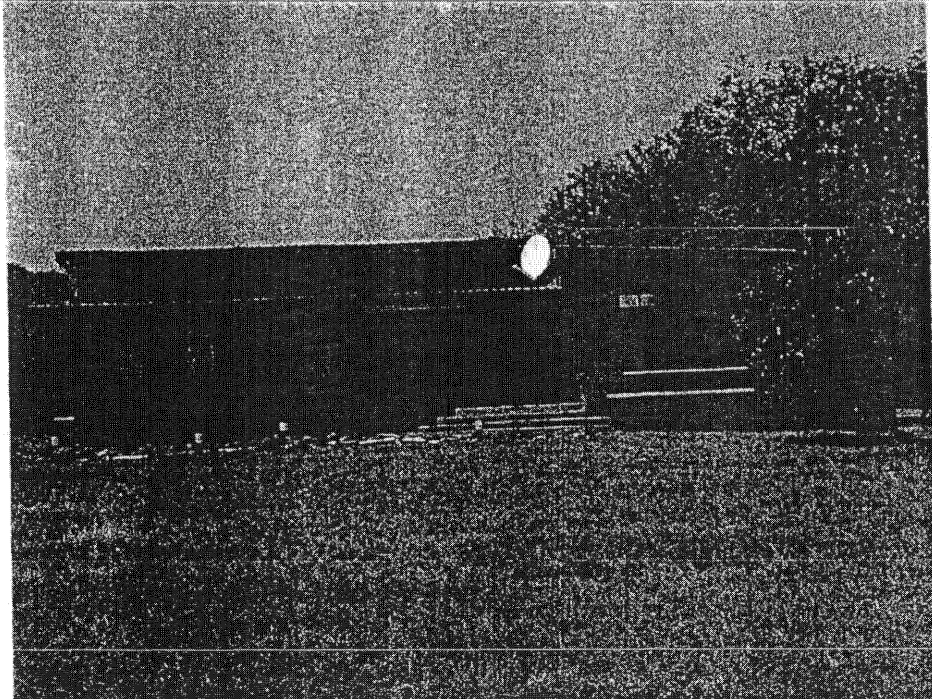
Figure 9: Recently constructed house.

G. RECOMMENDED MITIGATION						
<ul style="list-style-type: none"> Sufficiently recorded, no further action required. 						
H. APPLICABLE LEGISLATION AND LEGAL REQUIREMENTS						
<ul style="list-style-type: none"> None

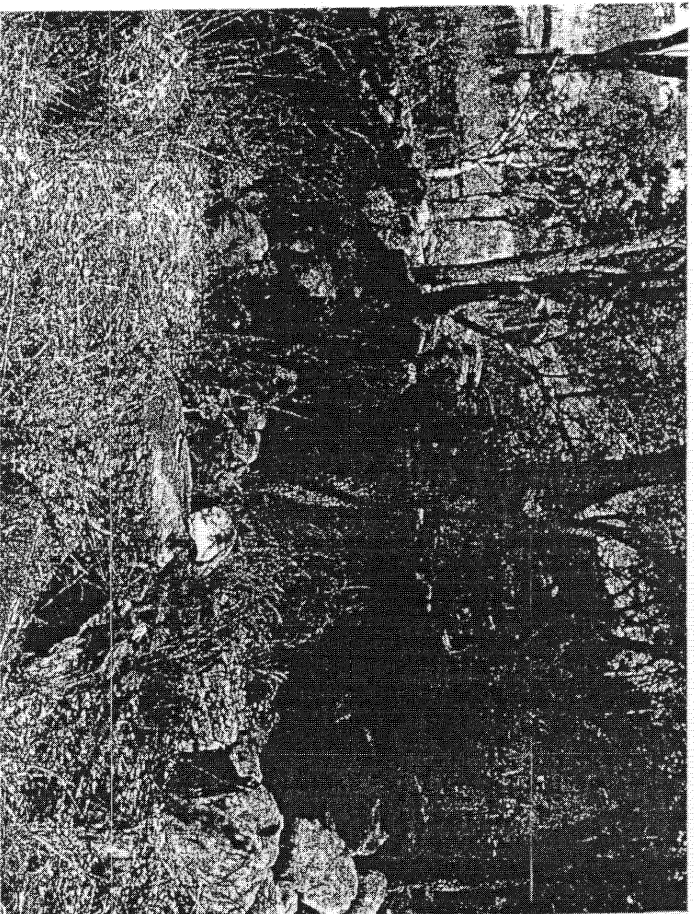
The site consists of two attached stone-walled enclosures and the foundation of a two-roomed rectangular house, situated at the foot of a sandstone ridge. The house also had an open veranda and probably served as accommodation to earlier farm workers. Only the stone foundations remain. No midden was recorded.

B3. CONDITION OF SITE		
Integrity of deposits/structures.	House: Foundations only Enclosures: Stable	
C. SPHERE OF SIGNIFICANCE	High	Medium
International		√
National		√
Provincial		√
Local		√
Specific community		√

Figure 10: A stone-walled enclosure.

G. RECOMMENDED MITIGATION		
<ul style="list-style-type: none"> Sufficiently recorded, no further action required. 		
H. APPLICABLE LEGISLATION AND LEGAL REQUIREMENTS		
<ul style="list-style-type: none"> None

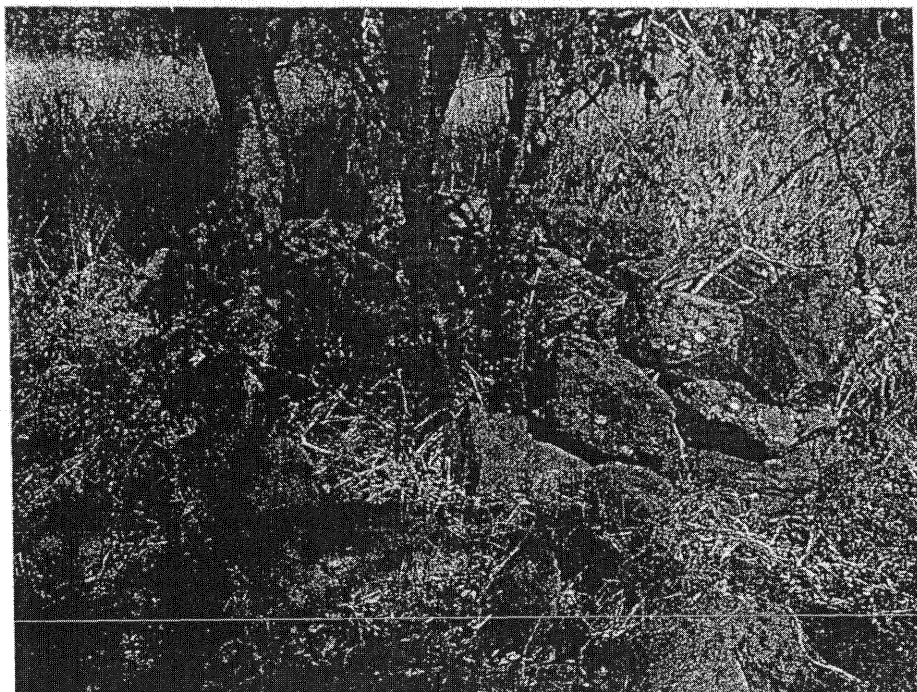
The site consists of a small roughly built circular stone-walled enclosure (3 meters in diameter) clearly intended for holding livestock (Figure 11). In the immediate vicinity some fragments of ceramics, glass, iron household goods such as a three-legged pot and wire confirm a relatively recent occupation. Although several dispersed chunks of brick rubble were recorded, no foundations could be identified.

Other similar sites in the regional landscape.						✓
B3. CONDITION OF SITE						
Integrity of deposits/structures.				Stable		
C. SPHERE OF SIGNIFICANCE						
			High	Medium		Low
International						✓
National						✓
Provincial						✓
Local						✓
Specific community						✓

Figure 11: Stone-walled enclosure.

G. RECOMMENDED MITIGATION						
<ul style="list-style-type: none"> • Sufficiently recorded, no further action required 						
H. APPLICABLE LEGISLATION AND LEGAL REQUIREMENTS						
<ul style="list-style-type: none"> • None

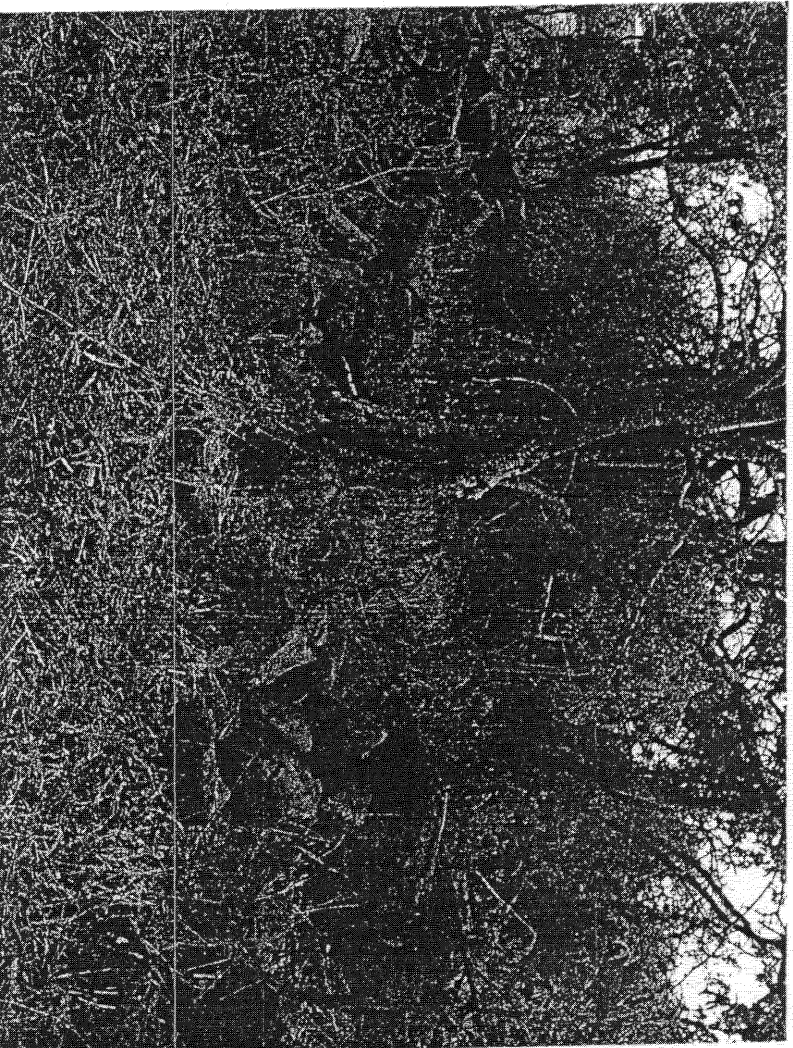
The site consists of two attached circular stone-walled enclosures (10 meters and 5 meters in diameter respectively) (Figure 12). Adjacent to these enclosures is the foundations of a house which probably consisted of two or three rooms. Several pieces of cultural material and some midden deposits were noted.

Integrity of deposits/structures.		Houses: Foundations only		
		Enclosures: Stable		
C. SPHERE OF SIGNIFICANCE		High	Medium	Low
International				✓
National				✓
Provincial				✓
Local				✓
Specific community				✓

Figure 12: The large stone-walled enclosure.

G. RECOMMENDED MITIGATION				
<ul style="list-style-type: none"> Sufficiently recorded, no further action required 				
H. APPLICABLE LEGISLATION AND LEGAL REQUIREMENTS				
<ul style="list-style-type: none"> None

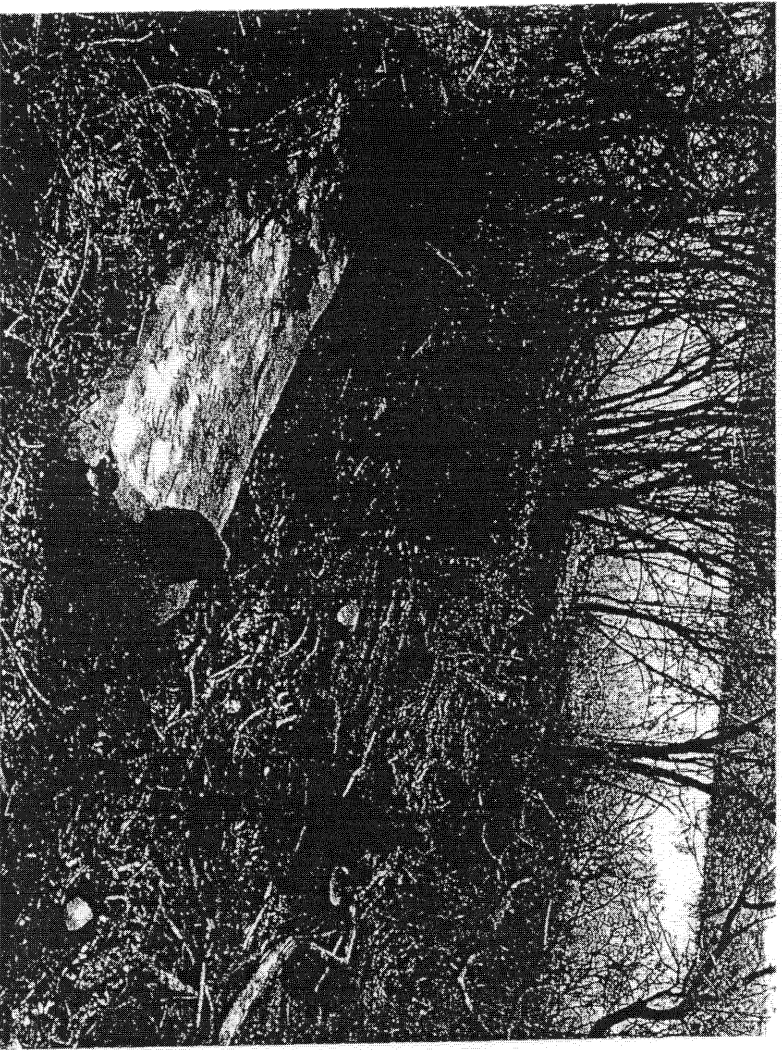
Figure 13

The site consists of an enclosed cemetery that is situated within an old agricultural field and is demarcated by a circular grove of trees. The cemetery comprises six graves that could be determined with certainty. Damaged caused by an uprooted tree resulted in much damage in the area which may have obscured the remains of other possible graves.

Generally Protected C [Low significance, no further action]	
E. GENERAL STATEMENT OF SITE SIGNIFICANCE	
Low	
Medium	
High	✓
F. RATING OF POTENTIAL IMPACT OF DEVELOPMENT	
None	✓
Peripheral	
Destruction	
Uncertain	
G. RECOMMENDED MITIGATION	
<ul style="list-style-type: none"> • Phase 2 investigation • Social consultation • Permanently fenced 	
H. APPLICABLE LEGISLATION AND LEGAL REQUIREMENTS	
<ul style="list-style-type: none"> • National Heritage Resources Act (Act no. 25 of 1999) • Human Tissue Act (Act 65 of 1983 as amended). • Removal of Graves and Dead Bodies Ordinance (Ordinance no. 7 of 1925) • Ordinance on Excavations (Ordinance no. 12 of 1980) • Local and regional provisions, laws and by-laws • Permit from SAHRA (if exhumation and reburial is to be considered) 	
II. PHOTOGRAPHS

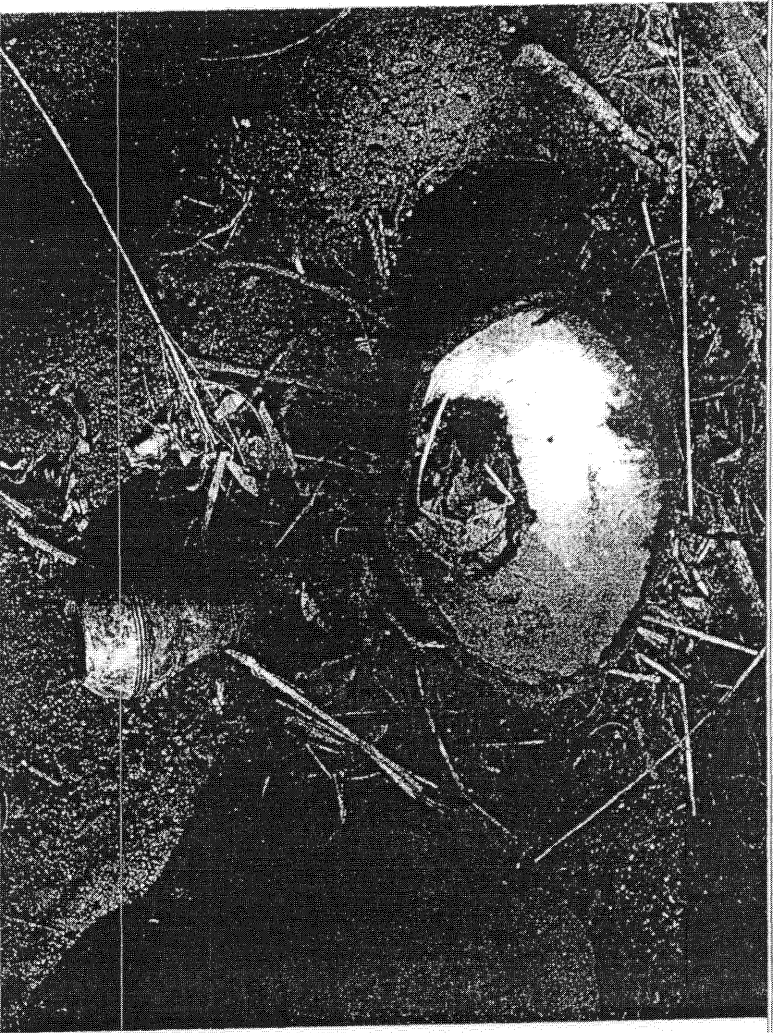
Figure 14: Grave offerings

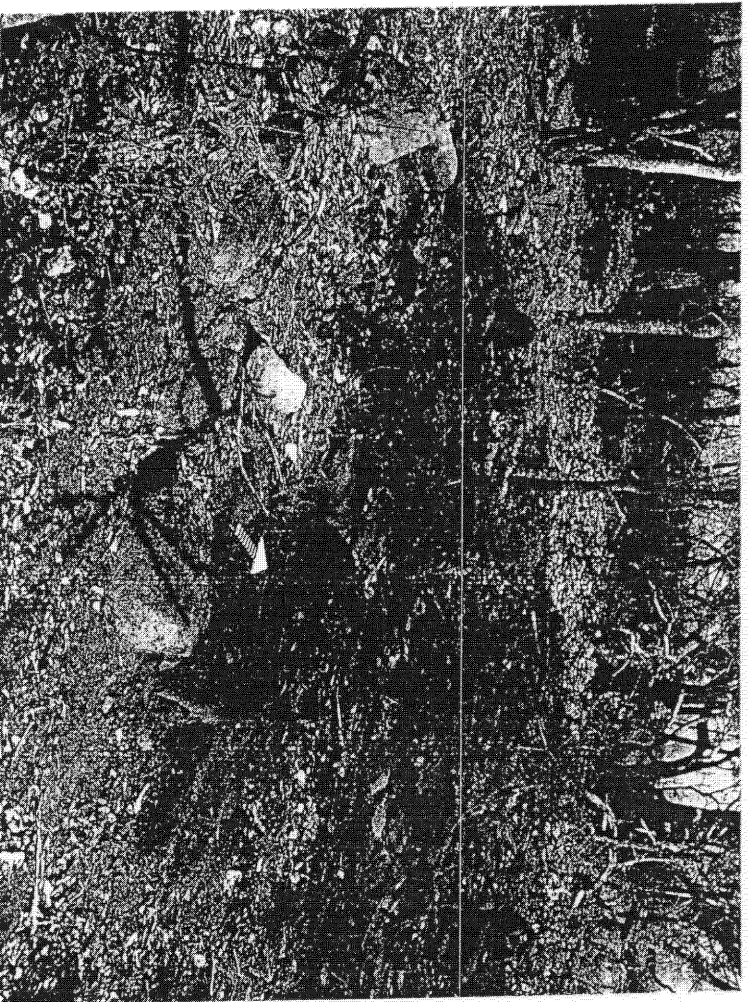
Figure 15

The site is a cemetery, situated amongst a grove of trees, and consists of 5 graves demarcated by large packed stones (although one is paved with stones). All the graves have an east-west orientation with the headstones on the western side (Figure 15). On of the graves seems to be of a juvenile judging from its size. Four graves are positioned along a row, and a smaller one lies above the third grave. The only grave offerings observed are pieces of porcelain.

B2. REGIONAL CONTEXT					
Other similar sites in the regional landscape.					✓
B3. CONDITION OF SITE					
Integrity of deposits/structures.		Cemetery: Stable

G. RECOMMENDED MITIGATION					
<ul style="list-style-type: none"> • Phase 2 investigation • Social consultation

<ul style="list-style-type: none"> • Permanently fenced
<p>H. APPLICABLE LEGISLATION AND LEGAL REQUIREMENTS</p> <ul style="list-style-type: none"> • National Heritage Resources Act (Act no. 25 of 1999) • Human Tissue Act (Act 65 of 1983 as amended). • Removal of Graves and Dead Bodies Ordinance (Ordinance no. 7 of 1925) • Ordinance on Excavations (Ordinance no. 12 of 1980) • Local and regional provisions, laws and by-laws • Permit from SAHRA

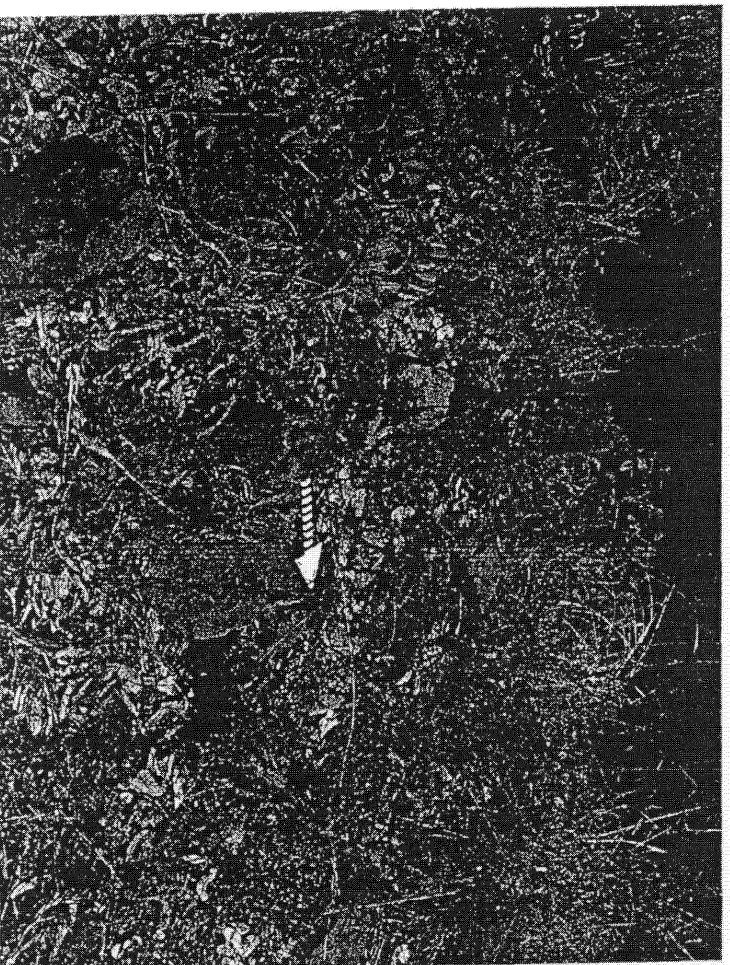
Figure 16

Tourism Value		
It has significance through its contribution towards the promotion of a local sociocultural identity and can be developed as tourist destination.		✓
Rarity Value		
It possesses unique, uncommon, rare or endangered aspects of South Africa's natural or cultural heritage.		✓
Representative Value		
It is importance in demonstrating the principle characteristics of a particular class of South Africa's natural or cultural places or objects.	✓	
B2. REGIONAL CONTEXT		
Other similar sites in the regional landscape.		✓
B3. CONDITION OF SITE		
Integrity of deposits/structures.	Cemetery: Stable

High	✓
F. RATING OF POTENTIAL IMPACT OF DEVELOPMENT	
None	✓
Peripheral	
Destruction	
Uncertain	
G. RECOMMENDED MITIGATION	
<ul style="list-style-type: none"> • Phase 2 investigation • Social consultation • Permanently fenced 	
H. APPLICABLE LEGISLATION AND LEGAL REQUIREMENTS	
<ul style="list-style-type: none"> • National Heritage Resources Act (Act no. 25 of 1999) • Human Tissue Act (Act 65 of 1983 as amended). • Removal of Graves and Dead Bodies Ordinance (Ordinance no. 7 of 1925) • Ordinance on Excavations (Ordinance no. 12 of 1980) • Local and regional provisions, laws and by-laws • Permit from SAHRA

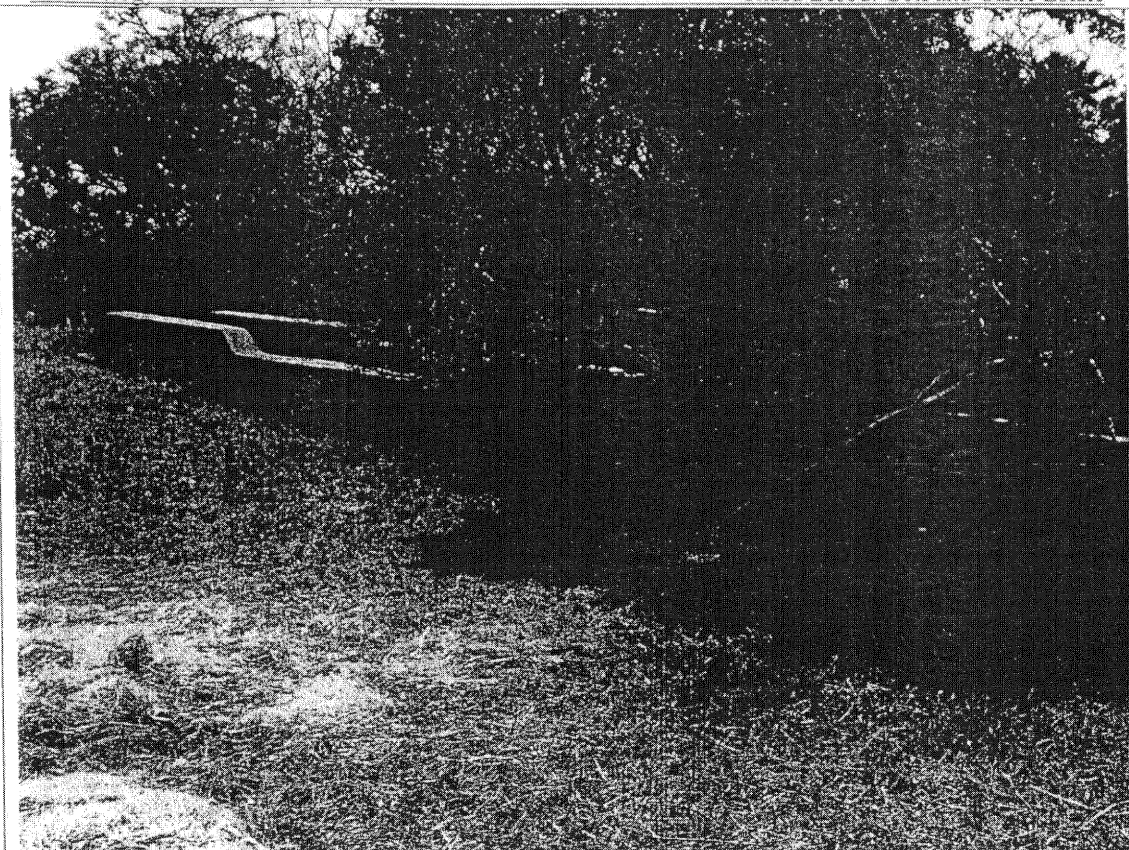
Figure 17: Cattle dip

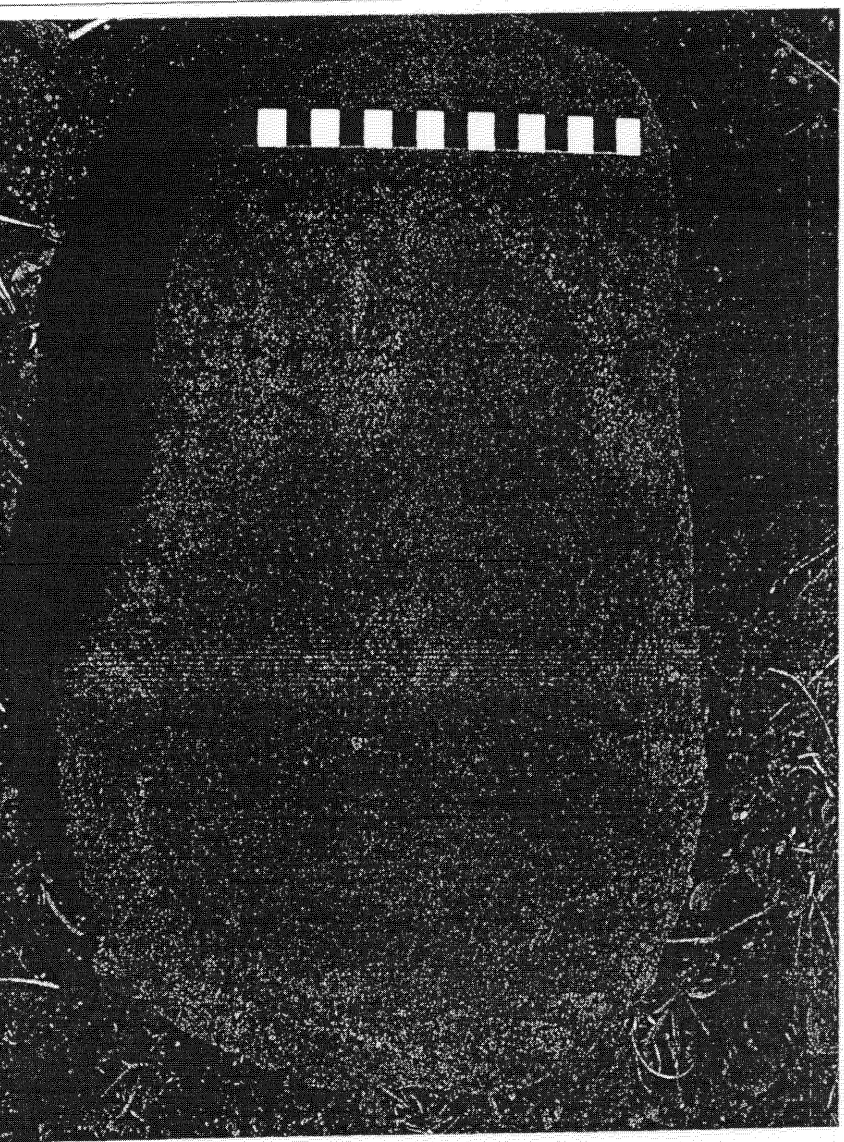
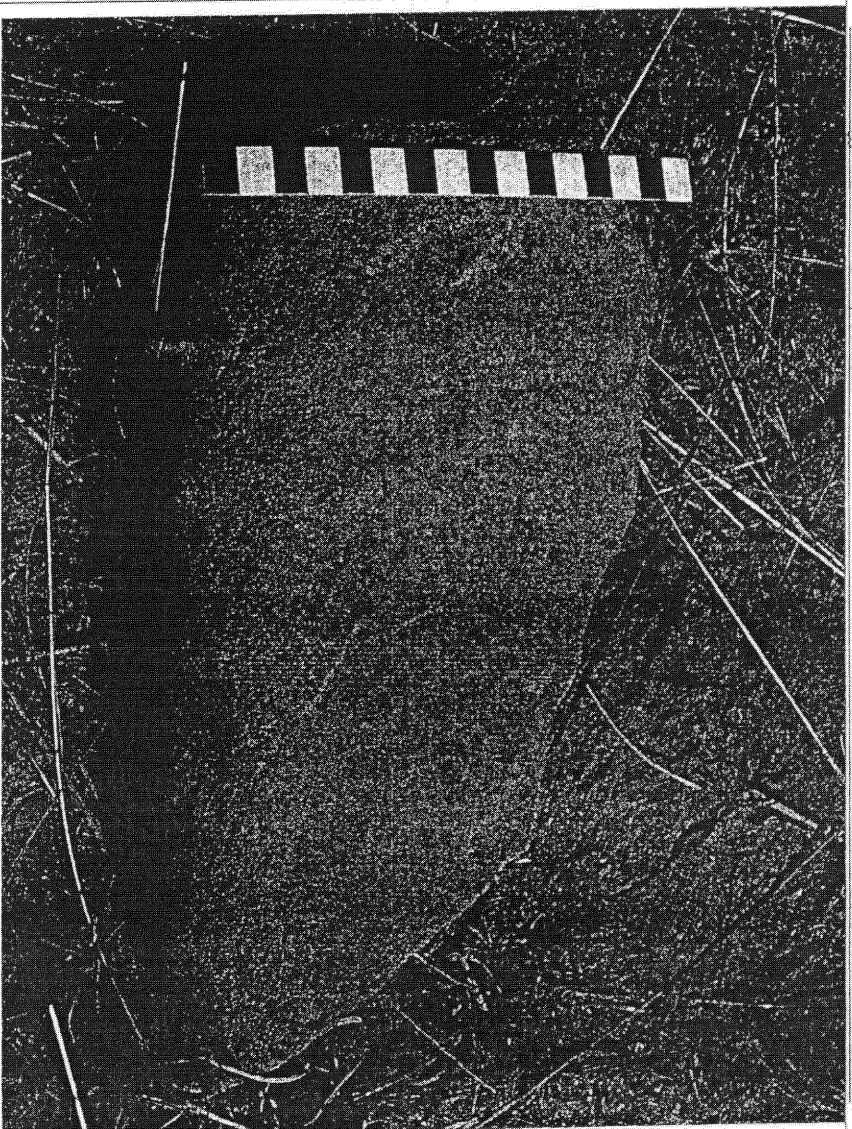
Both lower grinding stones are well used (one has been broken), each with a large grinding area which usually indicates it was used to grind large grained cereal (ie. maize).

B2. REGIONAL CONTEXT			
Other similar sites in the regional landscape.			√
B3. CONDITION OF SITE			
Integrity of deposits/structures.	Stable, but without context

Figure 18: Lower grinding stone

Figure 19: Lower grinding stone (broken)

H. RECOMMENDED MITIGATION

- National Heritage Resources Act (Act no. 25 of 1999)
- Permit from SAHRA
