**THE SOUTH AFRICAN HERITAGE RESOURCES AUTHORITY (SAHRA)
FULLESHOWARD AND DE LANGE
(PHD) DOUGLAS COLLIERY**

Results of a Phase II Heritage Impact Assessment Study:

**AN INVESTIGATION OF A HISTORICAL SANDSTONE FARMSTEAD AND
OUTBUILDINGS ON THE BANKS OF THE OLIFANTS RIVER ON THE FARM
KLEYNKOPJE 1518 WITHIN THE BOUNDARIES OF DOUGLAS COLLIERY IN
THE MPUMALANGA PROVINCE OF SOUTH AFRICA**

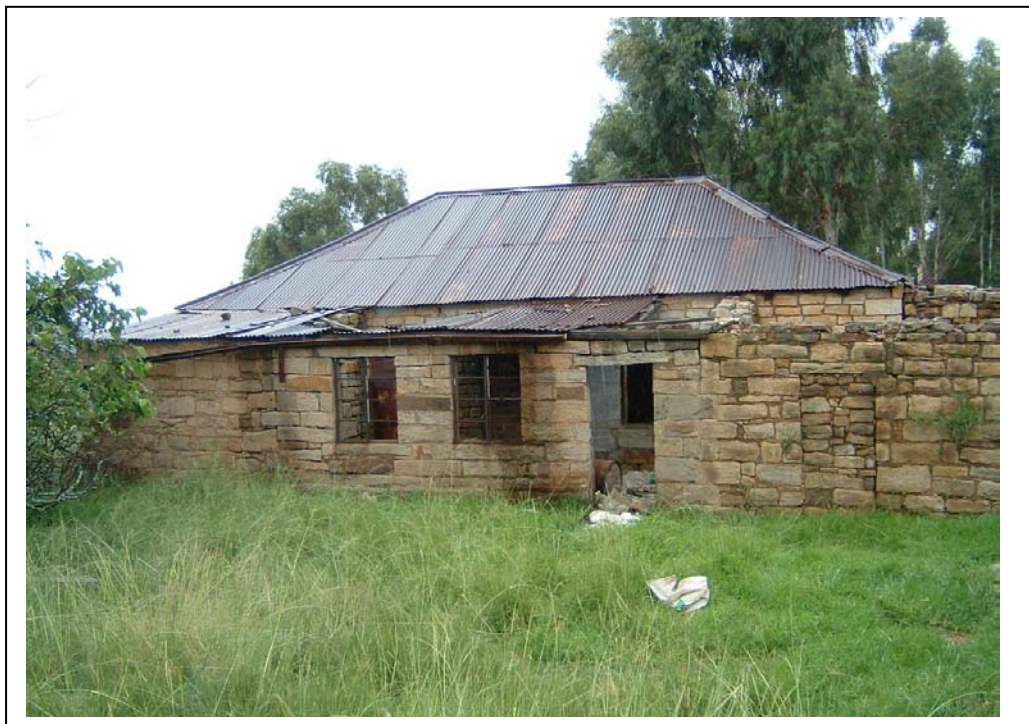
Figure 6- The farmstead in Site SCH01 consists of a rectangular core structure build with sandstone. Note the extensions (lean-to's) constructed on at least two sides of the house. This is the 'normal way' through which the core of the farmstead was extended over time. This farmstead is associated with a shed and with a graveyard.

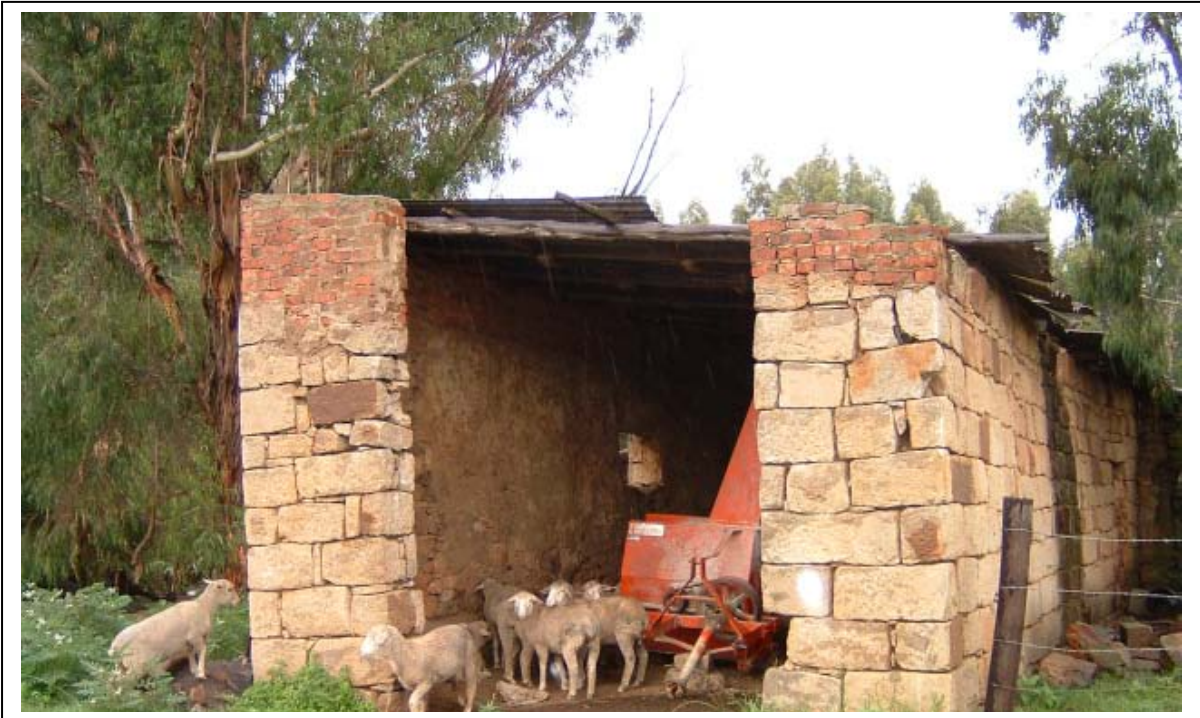
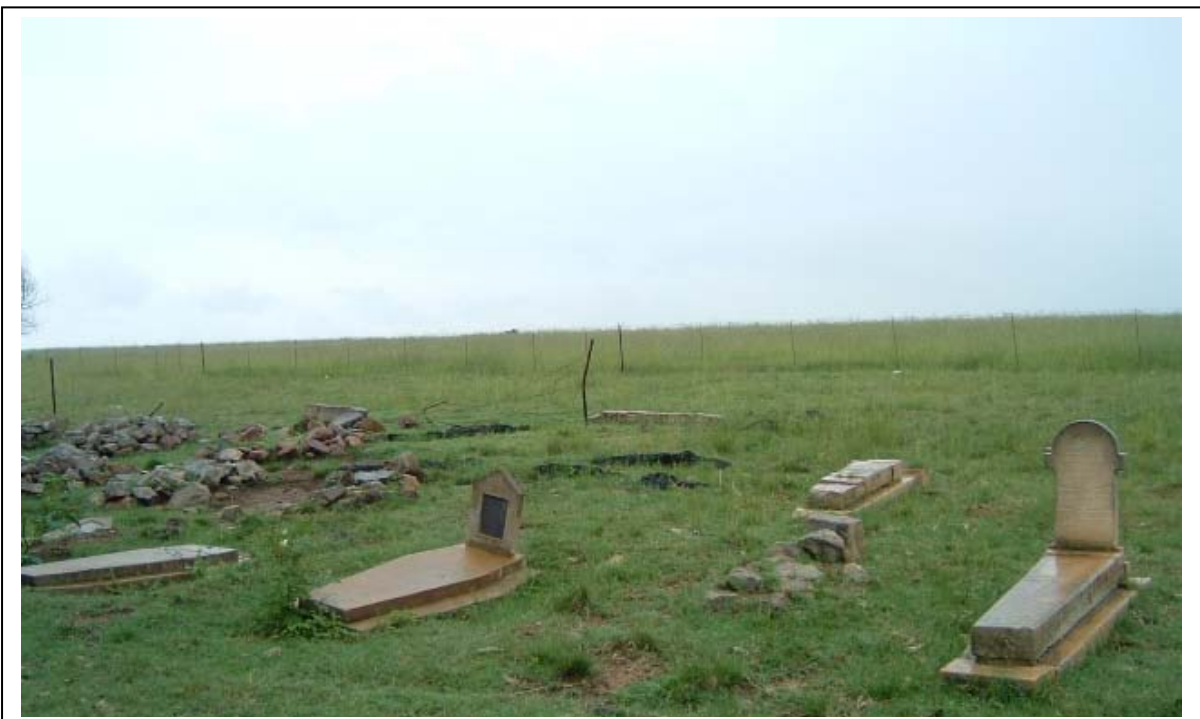
Figures 7 & 8- The shed associated with farm homestead SCH01. This structure is currently used as a store and to shelter sheep (above). A historical graveyard is located in close proximity to the shed and farmstead (below).

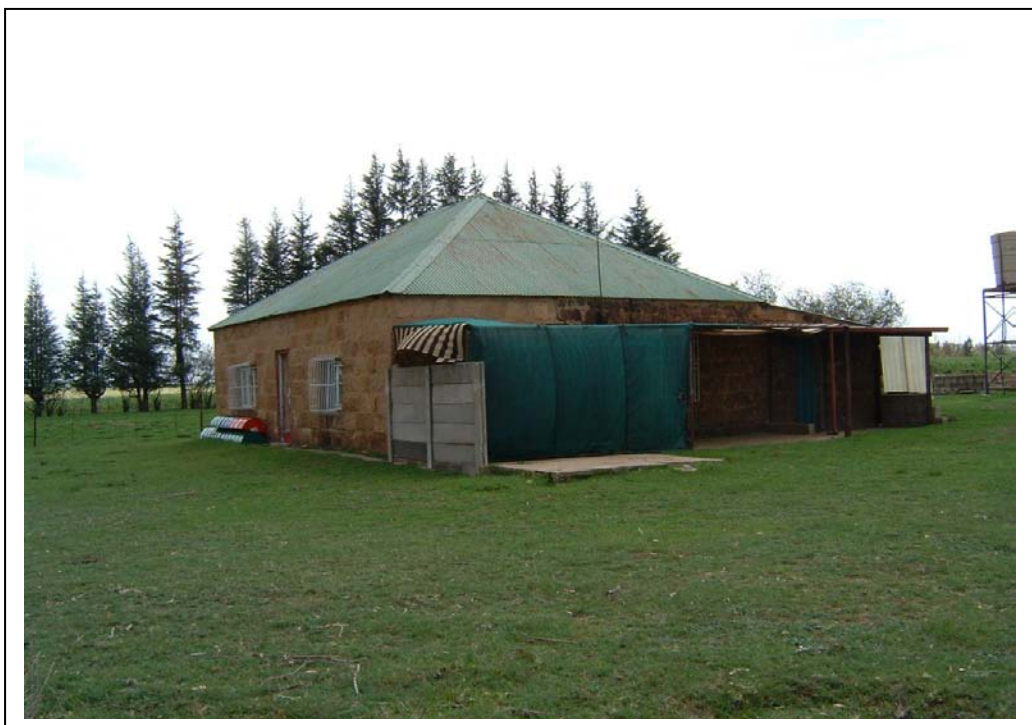
Site SCH02 incorporates a farmstead, a shed with a kraal attached to it and a rondavel. This farmstead was built with sandstone and is covered with a pitched corrugated iron roof (currently painted green). The lean-to on the houses' right hand side has been added later and was built with sandstone and ferricrete (Figure 9).

Figure 9- The farmstead in Site SCH02 was built with sandstone while the lean-to was also constructed with ferricrete.

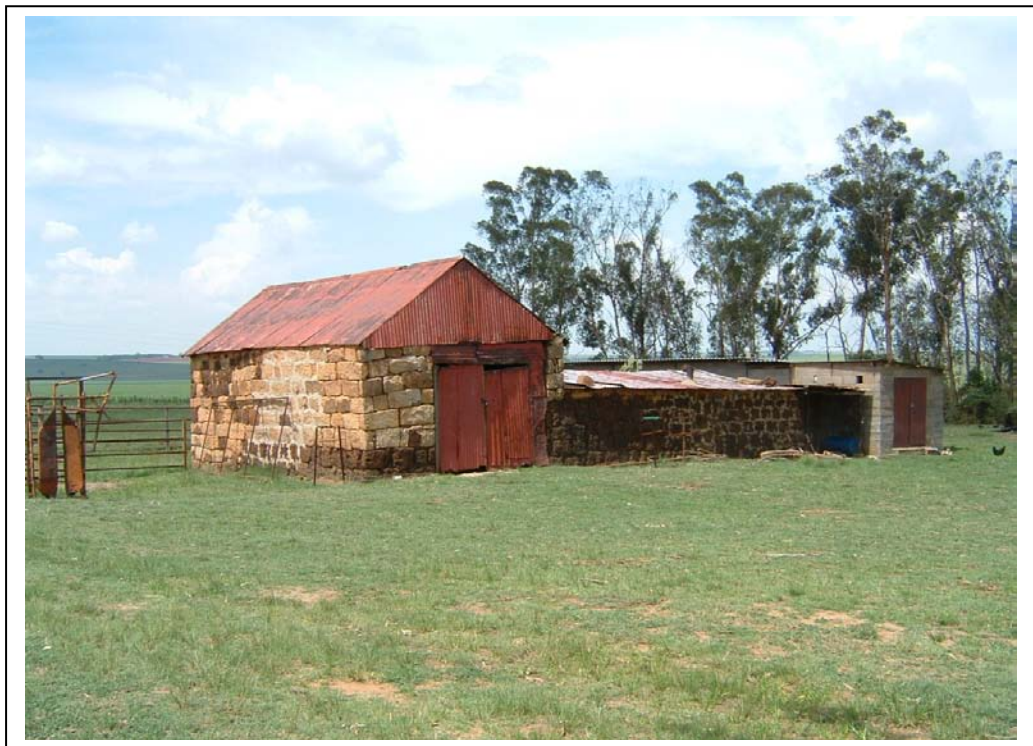
Figure 10- The shed associated with Site SCH02. This structure was built with sandstone and ferricrete while its roof is covered with a pitched corrugated iron roof (painted red).

The shed is linked to a square courtyard which was constructed with ferricrete and which served as a kraal (for sheep). The kraal may have been added some time after the shed was constructed. The cement brick structure to the right is another (still later) addition to the shed.

The shed was probably used for wagons or coaches. Note the single large door at one of the gable ends (below).

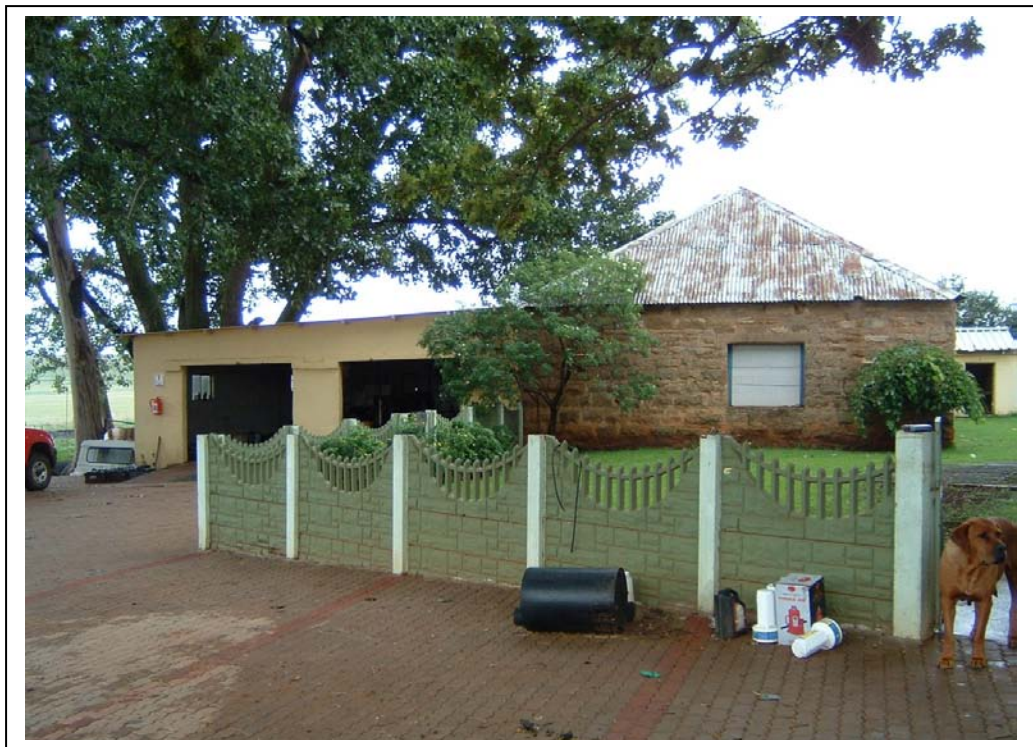
This structure comprises a farmstead that has become incorporated in a modern farm complex. This rectangular structure was built with sandstone and with a pitched corrugated iron roof. Currently it is being utilized as a store. It is situated next to the modern farmhouse (not visible in the photograph) and is linked with a garage (below).

Figure 11- A historical farmstead that has been incorporated in a modern working farm complex where it is being used as a store (above).

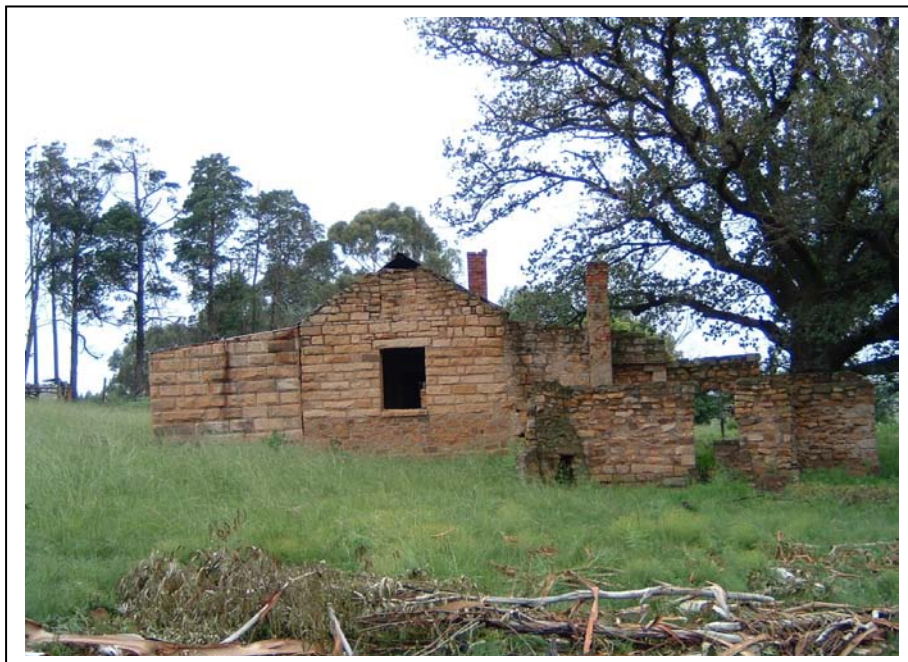
This farm homestead is located directly to the east of Road 38 running from the N4 in the north to Hendrina in the south. It is situated on a reef and overlooks a valley beyond (to the south) of the farm homestead. This house was built with sandstone and with a pitched corrugated iron roof. It is probably the largest or second largest farmstead that the author has observed in the Witbank-Middelburg area.

Two large Oak trees are standing next to the farmstead. The farm homestead is also associated with a Blue Gum plantation that is currently being chopped down (Figure 12).

Figure 12- The excellently preserved remains of a sandstone farmstead associated with Site SCH04. Note the large (historical) Oak tree next to the house. The house has been extended several times from its original core, mainly by means of lean-to's (above).

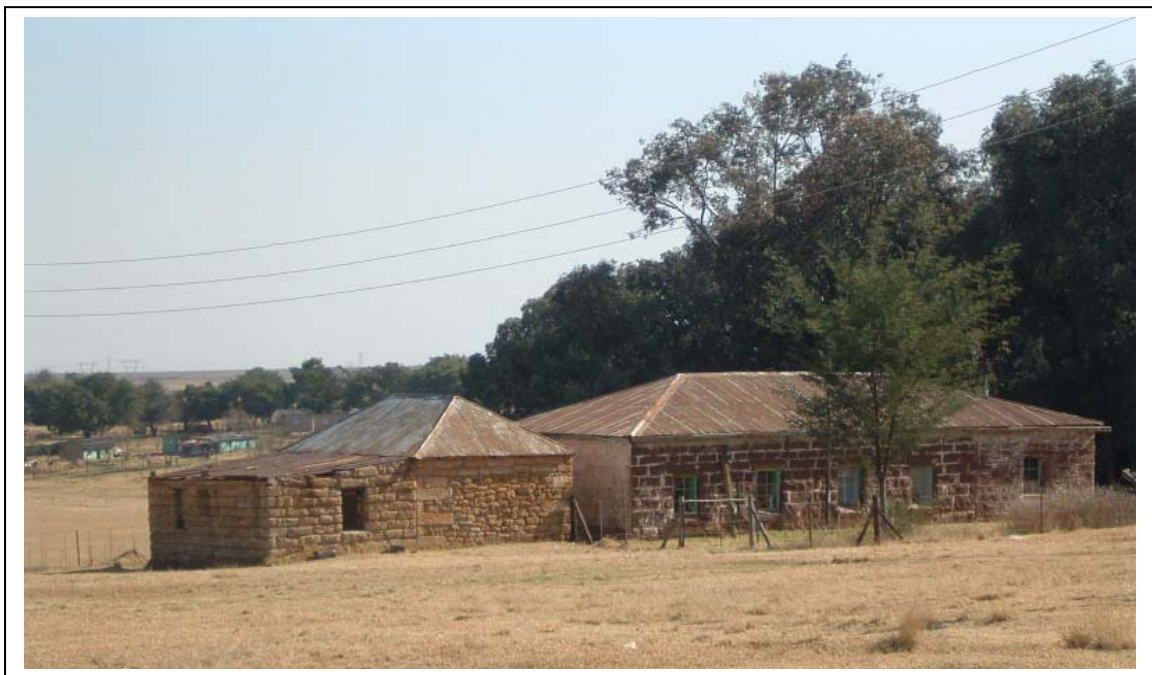
The two farmsteads are located next to each other. Whilst one of the dwellings was built with sandstone, the second was built with ferricrete (Figure 13). Both these structures are occupied by farm workers and are still in a relatively good condition.

Figure 13- A sandstone and a ferricrete house next to each other (above). Note the lean-to constructed against the square structure. The entire ferricrete house was built with dressed ferricrete, which was shaped in a standard size so that it could be laid in level layers. The mortar between the layers was whitewashed. The two houses are also associated with a historical graveyard.

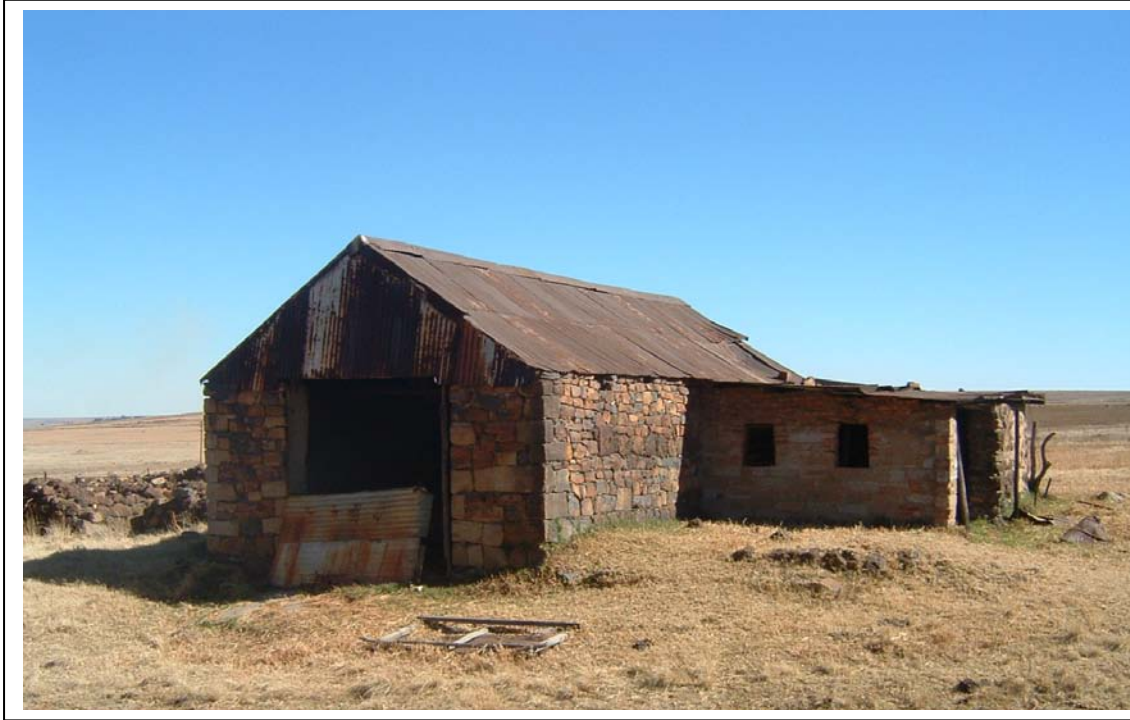
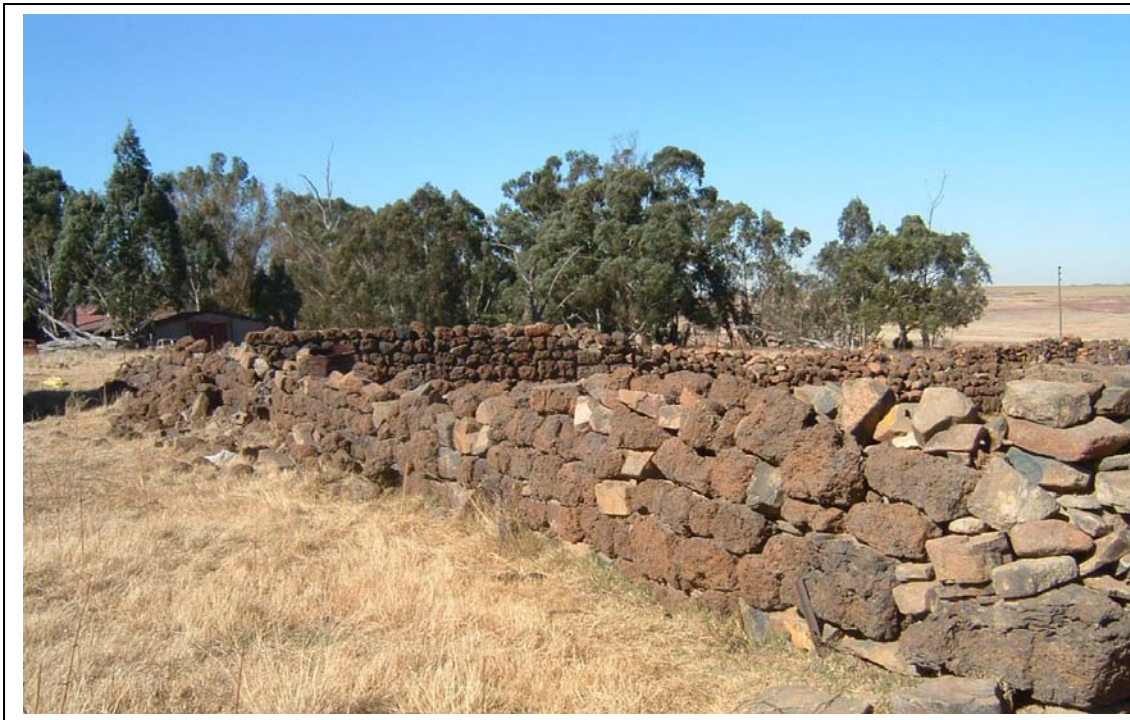
The shed is a square structure built with a solid foundation consisting of dolerite stone. The walls of the shed were constructed with dolerite, sandstone and ferricrete. Sandstone was used for quoining while undressed dolerite and ferricrete served as the bulk of the material in the walls of the shed. The walls were wedged with small pieces of stone. Sand mixed with another substance was used as mortar ('cement').

The kraal complex that is associated with the shed has a square ground plan and is composed of at least three different kraals. The three kraals of varying sizes are linked together. The building material used in this structure consists of undressed ferricrete and dolerite. A part of the wall of the kraal complex that is still standing reaches a height of 2m.

Figures 14 & 15- Shed constructed with sandstone, ferricrete and dolerite (above). Kraal complex with several enclosures that were built with undressed dolerite and ferricrete (below).
