COBUS DREYER

26 OCTOBER 2006

**FIRST PHASE ARCHAEOLOGICAL AND CULTURAL HERITAGE
ASSESSMENT OF THE PROPOSED RESIDENTIAL
DEVELOPMENTS AT THE FARM BOSCHPUNT 2218,
KROONSTAD, FREE STATE**

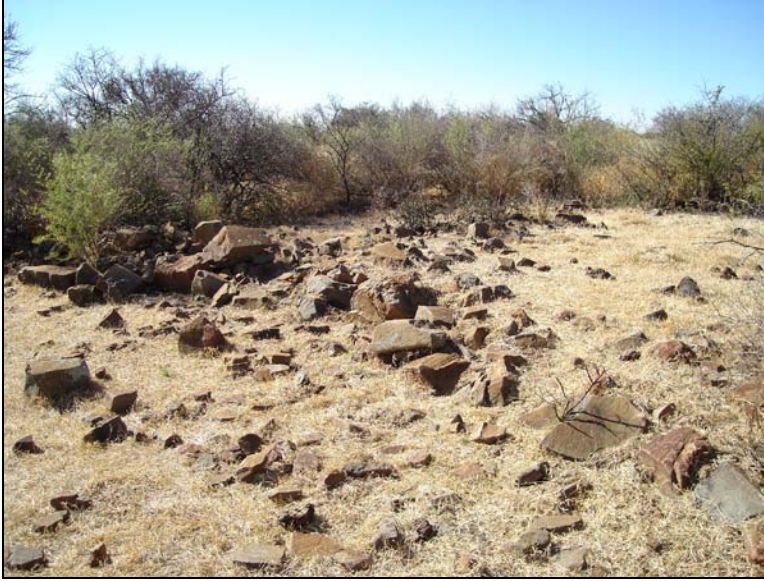
Fig.1 Stone-walled enclosures above the old farmhouse.

number of Later Iron Age stone-walls (Figs.7-14). The walls are mostly in a poor and rundown state of preservation (Figs.10-14), while others show evidence of heavy wall-robbing (Figs.1-4). Despite the wall-robbing, the settlement pattern is still recognisable.

I recommend that further planning and development of the site could continue, provided that the stone-walled areas and ash heaps are avoided.

Care should also be taken to avoid damage to any of the walls or to destroy ash heaps during the installation of services and the building of roads. The removal of stones from the walls should strictly be prohibited.

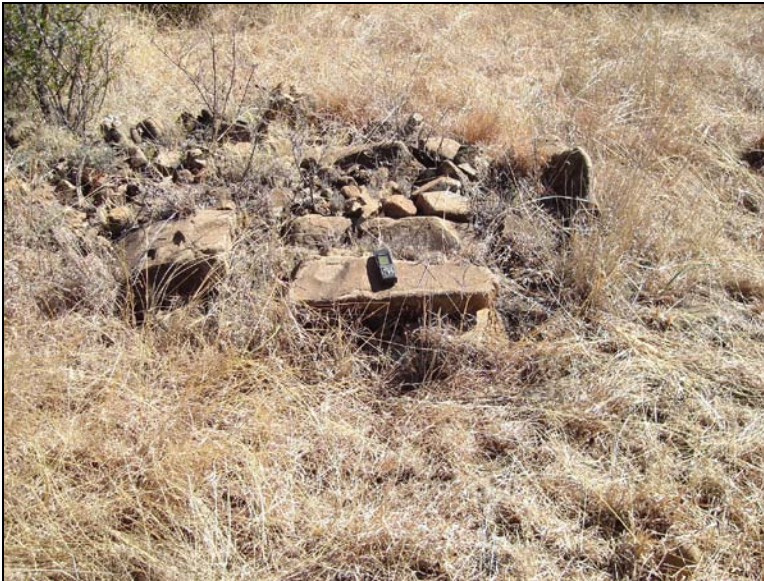
Fig.7 Stone-wall at Point B.

There is a thick grass stand all over the site (Figs.6-14) and no pottery or any other cultural material was visible on the surface.

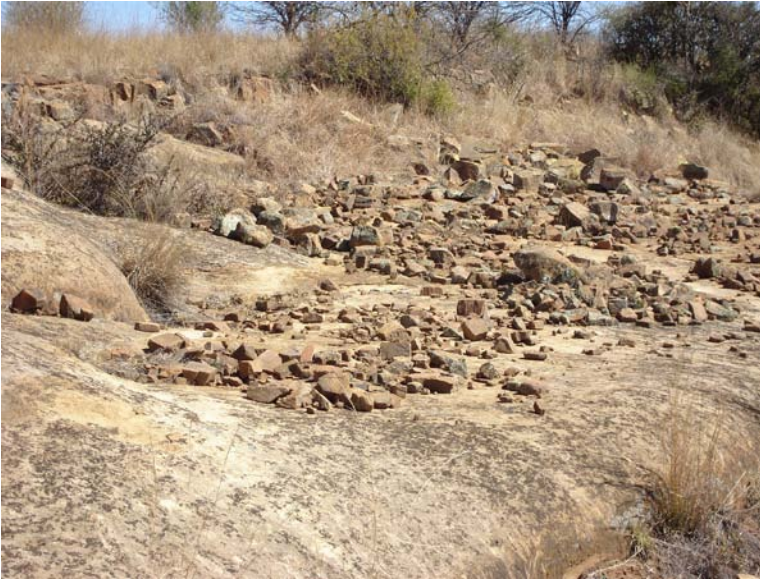
Fig.17 An ancient quarry where Later Iron Age building material had been removed.

A quarry where stones were removed for the building of the ancient walls was found at the site (Fig.17).
