ARCHAEOLOGICAL AND CULTURAL HISTORICAL ASSESSMENT OF THE PROPOSED UPGRADING OF THE ROAD (R59) BETWEEN PARYS & N1, FREE STATE

INVESTIGATION

The borrow pits and road adjustments for the proposed upgrading of the R59 road between Parys and the N1 main road, Free State (Map1), was inspected on 6 September 2005 in the company of Dr Johan du Preez of Cebo Environmental Consultants, Bloemfontein.

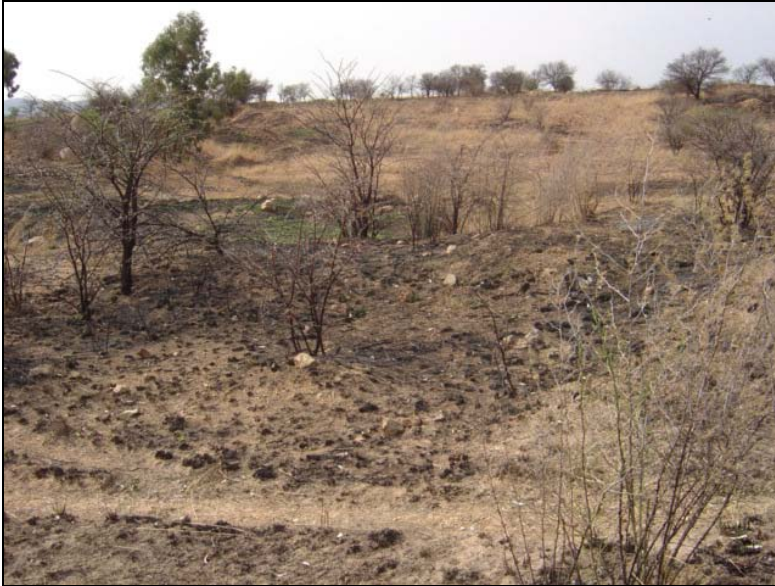
Existing borrow pit (Figs.1&2).
 Surface damaged during previous road building.
 Grass cover on surface.

Fig.1 BP 19. Existing borrow pit at Feesgronde on the outskirts of Parys.

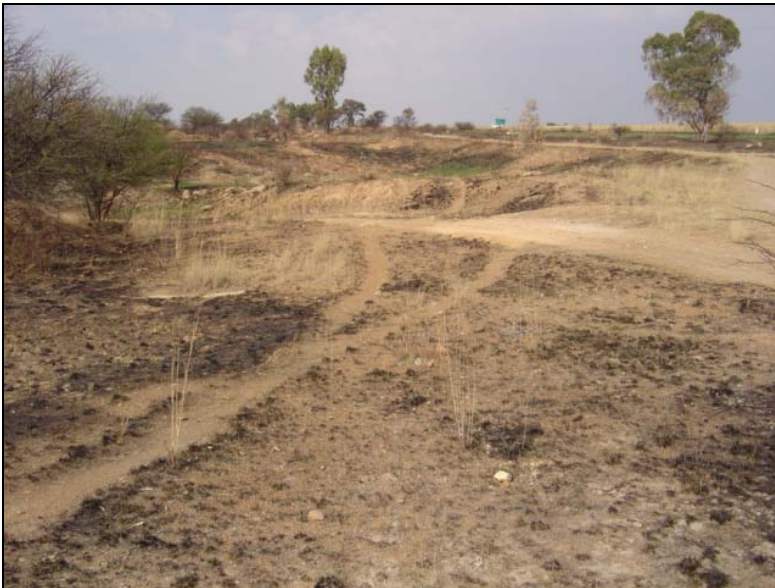
Fig.2 BP 19. Existing borrow pit at Feesgronde, Parys.

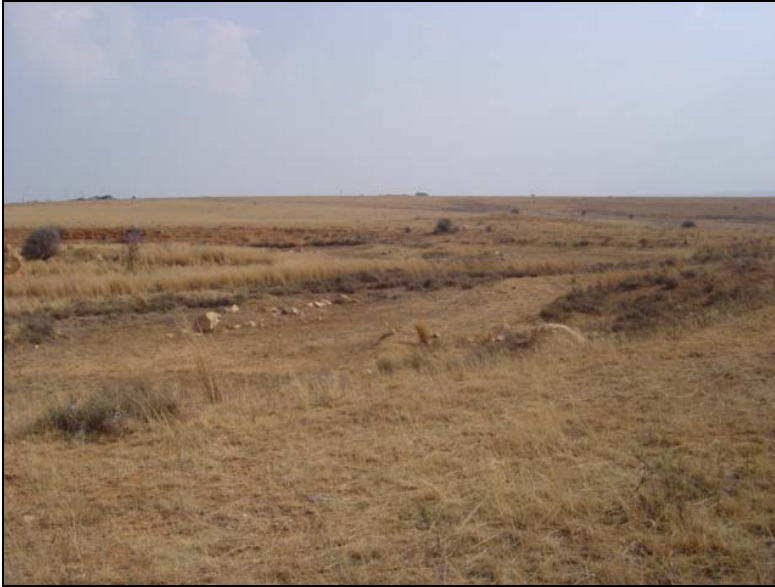
26°52'39"S. 027°34'21"E. Altitude 1525m.
 Existing borrow pit (Figs.3&4).
 Surface damaged during previous road building.
 Grass cover on surface.

Fig.3 Borrow Pit 26/62 Abel 52, Parys.

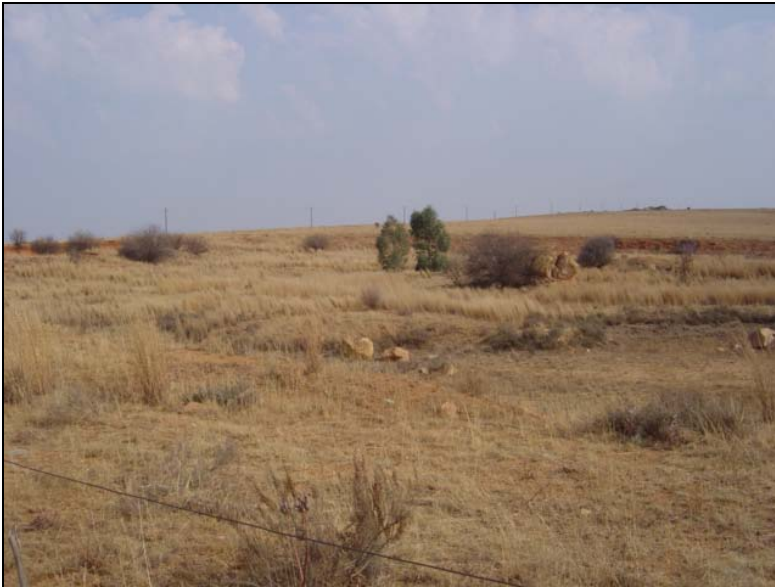
Fig.4 Borrow Pit 26/62 Abel 52, Parys.

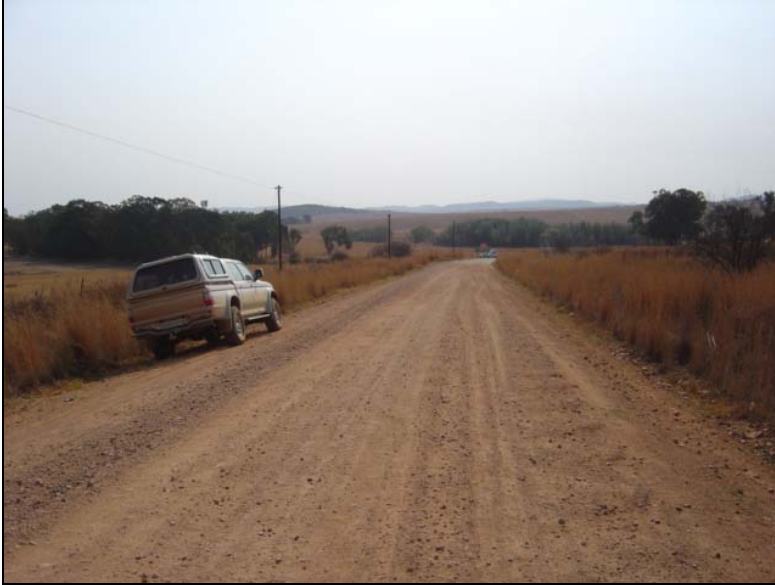
26°52'26"S. 027°34'03"E. Altitude 1494m.
 Existing interchange (Fig.5).
 Grass cover on both sides of gravel road. There is an abundance of Aloe species.
 Grave 26°52'27"S. 027°33'59"E. Altitude 1486m (Fig.6).
 Heap of stones 26°52'25"S. 027°33'56"E. Altitude 1482m (Fig.7).

Fig.5 Wolwehoek road intersection with R59 near Parys.

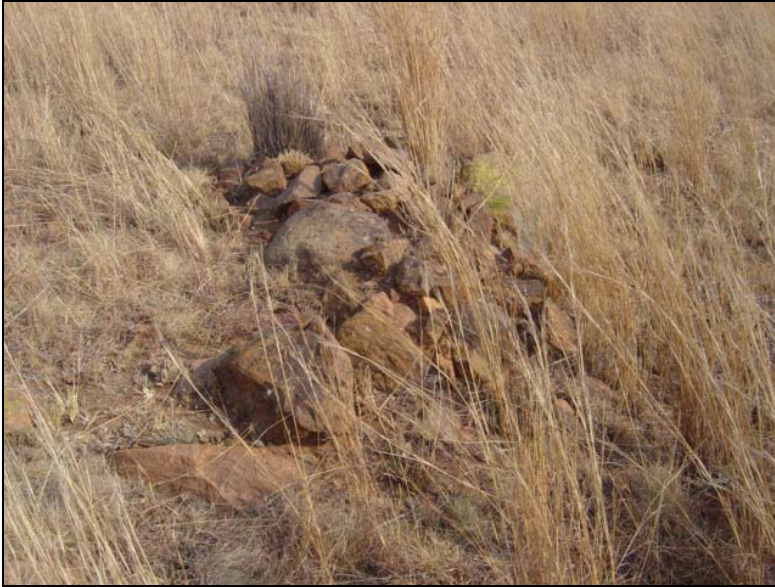
As indicated, a grave and heap of stones (which is possibly also a grave), near the Wolwehoek turn-off and about 25 graves were discovered at Ladiesfontein.

Fig.7 Heap of stones at the Wolwehoek intersection with R59, Parys.

The grave and heap of stones near the Wolwehoek turn-off and the graves at Ladiesfontein, should be avoided. I recommend that these features should be fenced off and should be brought to the attention of the labourers and operators at the site. Care should be taken not to disturb or damage the graves in any way, especially during the construction phase of the road building.

It is recommended that the road alterations should be planned to by-pass the stone structures. Care should be taken to limit the disturbance of the environment near these features.

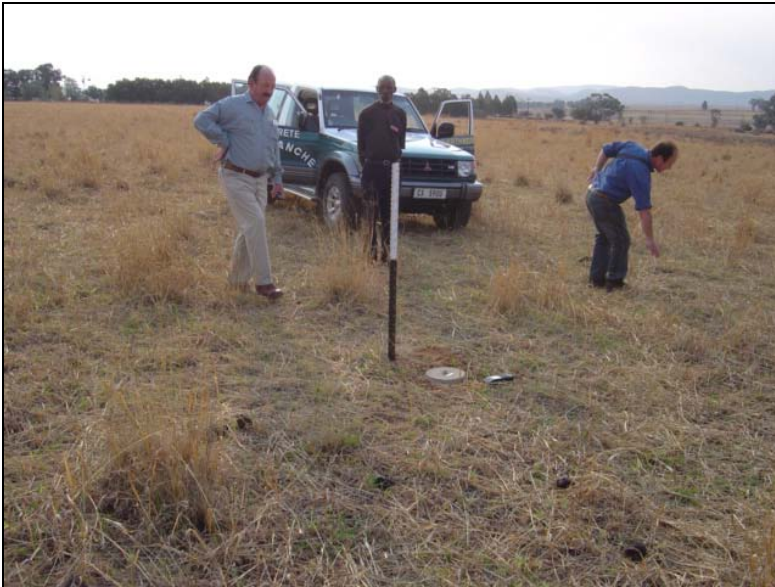
26°52'59"S. 027°31'25"E. Altitude 1444m (Map 3 2627DC).
 New borrow pit (Figs.9-10).
 Soil surface covered with cultivated grazing.

Fig.8 BP22/00 Proposed borrow pit at Boomplaas, Parys.

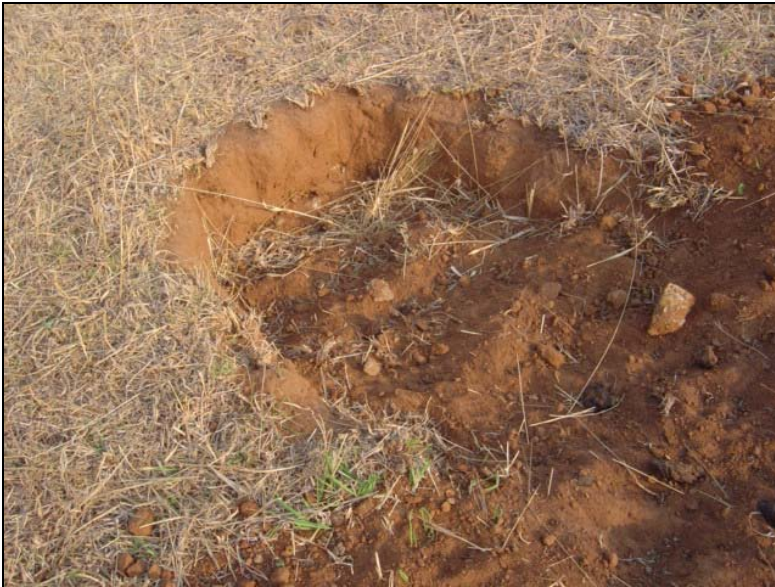
Fig.9 Test pit shows sandy soil at BP2B on Boomplaas, Parys.

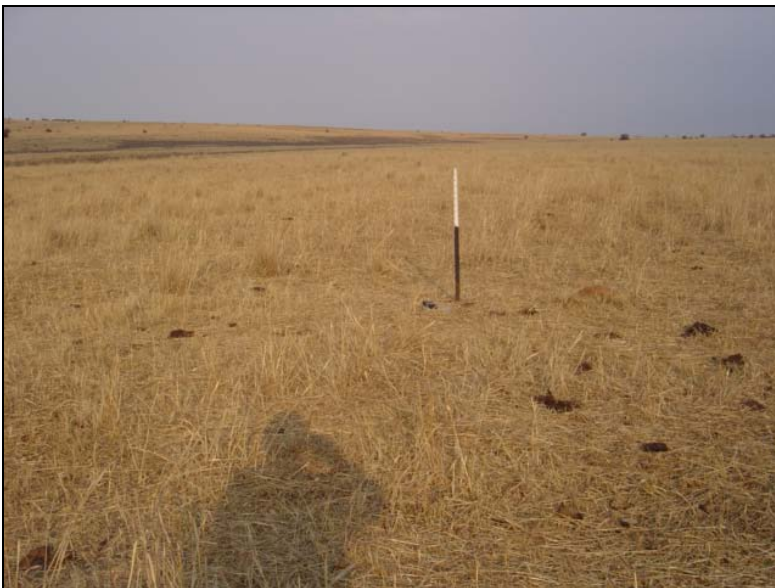
26°52'59"S. 027°31'25"E. Altitude 1444m (Figs.9-10).

Fig.10 BP2B Proposed borrow pit at Boomplaas, Parys.

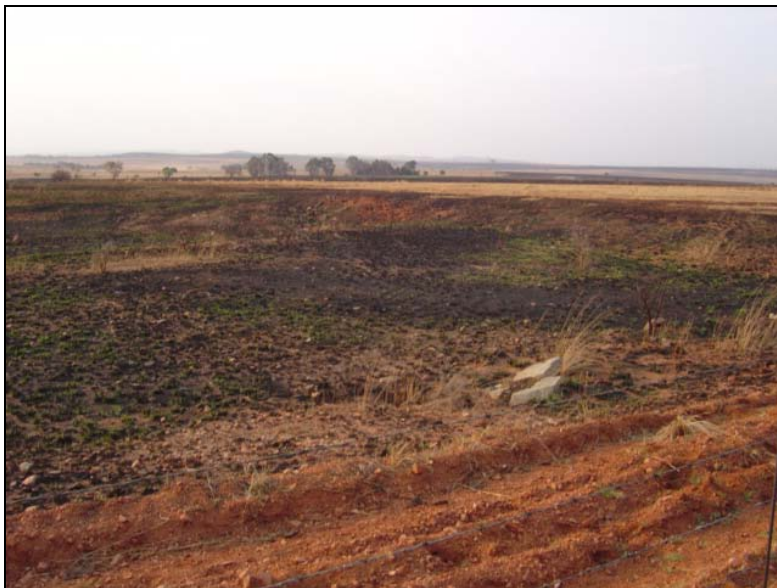
26°51'28"S. 027°36'32"E. Altitude 1483m (Map 5 2627DC).
 Existing borrow pit (Figs.11-12).
 Surface damaged during previous road building.
 Grass cover on surface.

Fig.11 BP 31/00 Ladiesfontein, Parys.

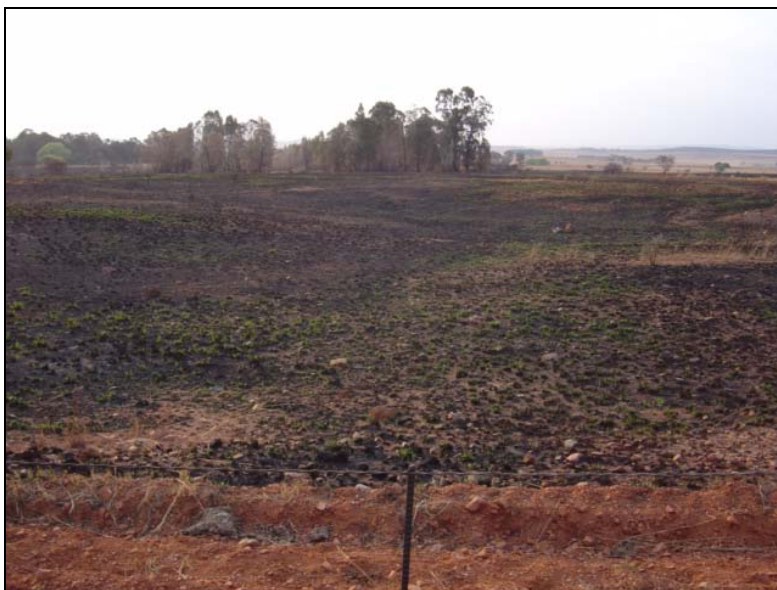
Fig.12 BP 31/00 Ladiesfontein, Parys.

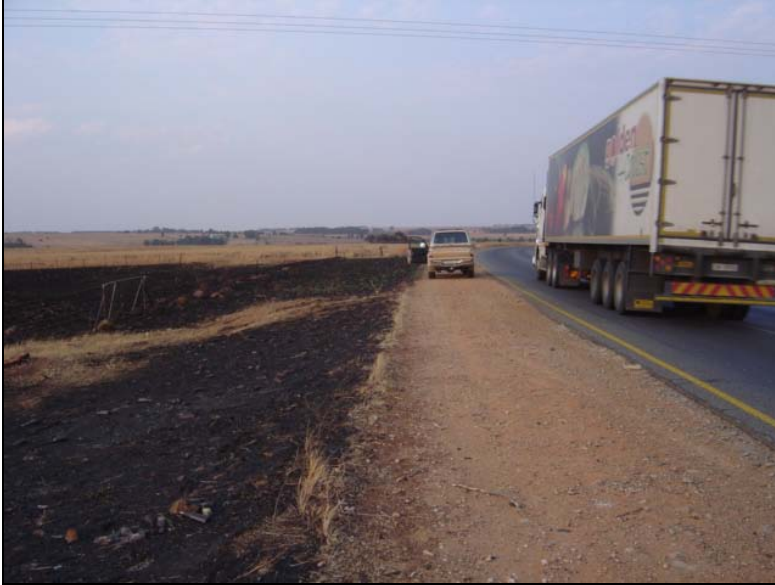
26°51'03"S. 027°37'20"E. Altitude 1483m (Map 5 2627DC).
 Extension of existing road (Fig.13).
 Grass cover on both sides of gravel road.
 About 25 graves next to road 26°51'04"S. 027°37'18"E. Altitude 1480m (Fig.14).

Fig.13 Extension of the left lane at Ladiesfontein, Parys.

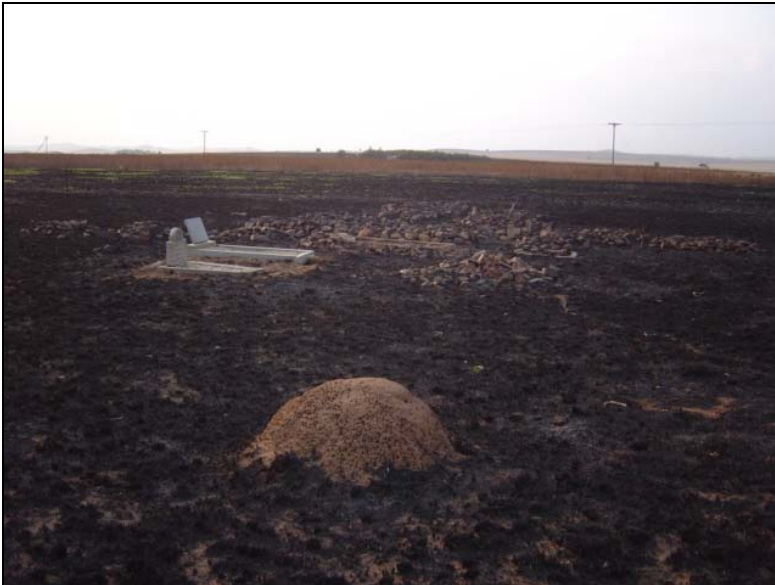
Fig.14 Graves near the proposed alterations at Ladiesfontein, Parys.

Mitigation measures will therefore, only be needed in the case of the graves as described above.

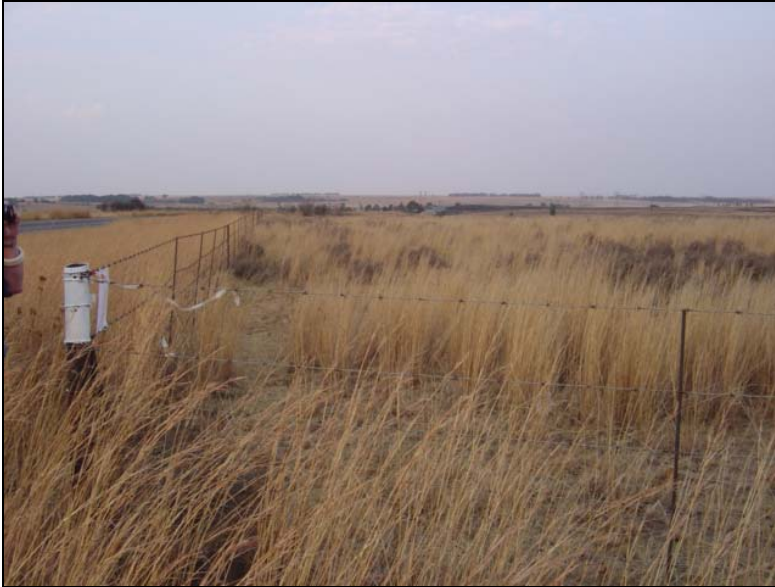
26°51'03"S. 027°37'22"E. Altitude 1463m (Map 5 2627DC)..
 Existing borrow pit (Figs.15-16).
 Surface partly damaged during previous road building.
 Grass cover on surface.

Fig.15 BP32/64 on Klein Smaldeel, Parys.

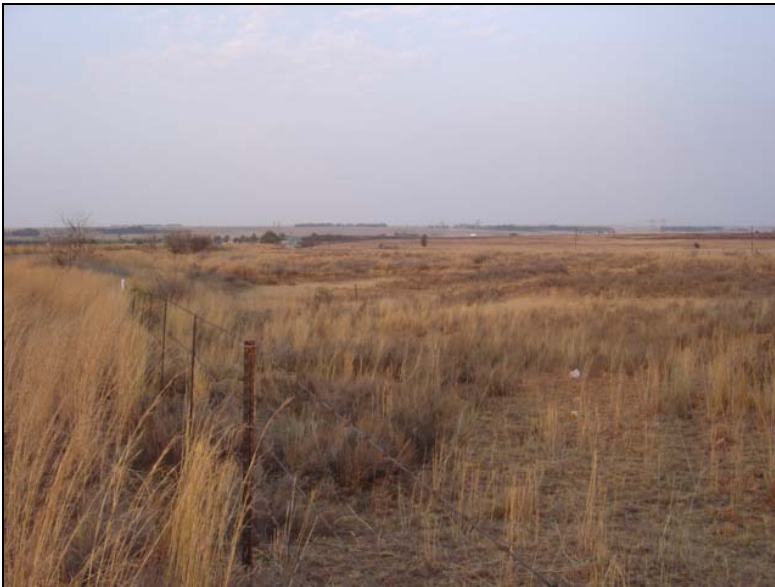
26°51'00"S. 027°37'34"E. Altitude 1458m (Map 5 2627DC).

Fig.16 Existing borrow pit P56/50 in the eastern corner of Klein Smaldeel, Parys.
