# **COBUS DREYER**

20 JUNE 2005

## **ARCHAEOLOGICAL ASSESSMENT OF THE PROPOSED UPGRADING OF THE R57 ROAD (P9/2) BETWEEN REITZ & PETRUS STEYN, FREE STATE**

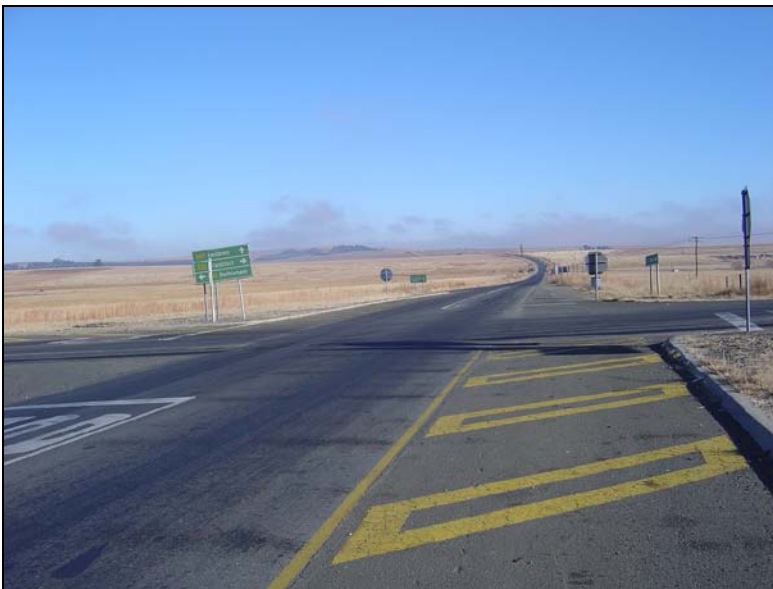
**MAIN ROAD CROSSING TO REITZ / BETHLEHEM / FRANKFORT /  
HEILBRON** 27°46'40"S. 028°24'49"E. Altitude 1615m (Fig.1).

Fig.1 The main crossing on the R57 from Reitz to Bethlehem, Frankfort and Heilbron. The photograph was taken facing towards Petrus Steyn.

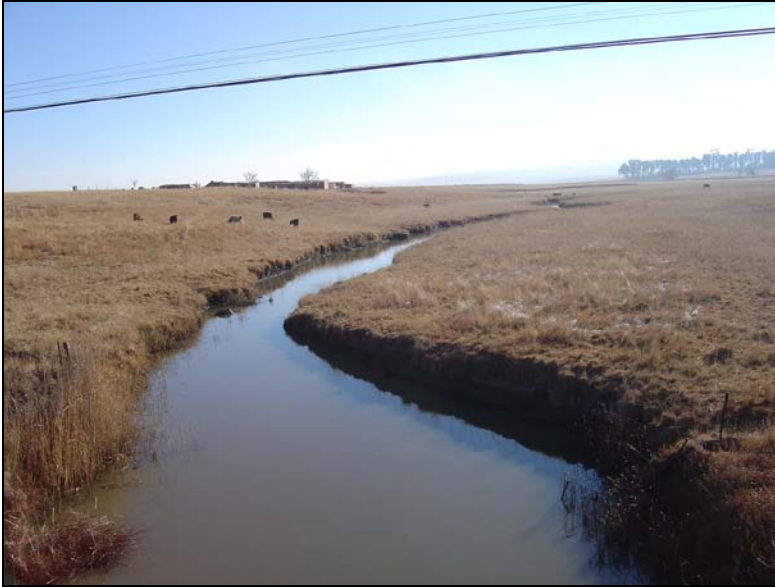
**LANGESPRUIT BRIDGE** 27°46'24"S. 028°24'22"E. Altitude 1603m  
(Figs.2&3).

Fig.2 From the bridge at Langespruit on the R57.

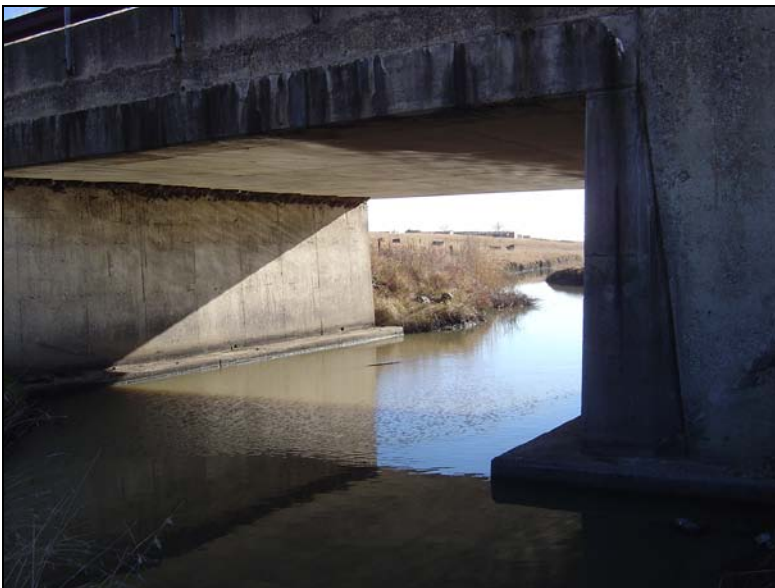
Fig.3 The bridge at Langespruit on the R57.

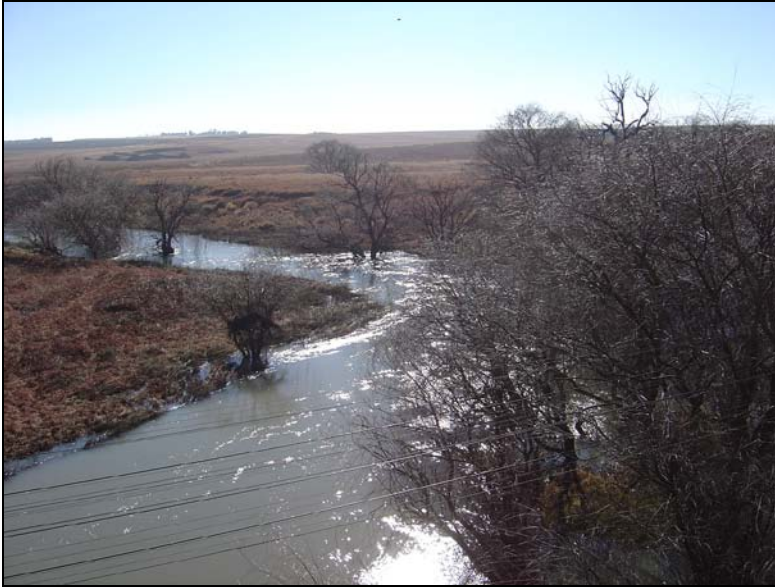
Fig.4 Liebenbergsvleispruit on the R57 between Reitz and Petrus Steyn.

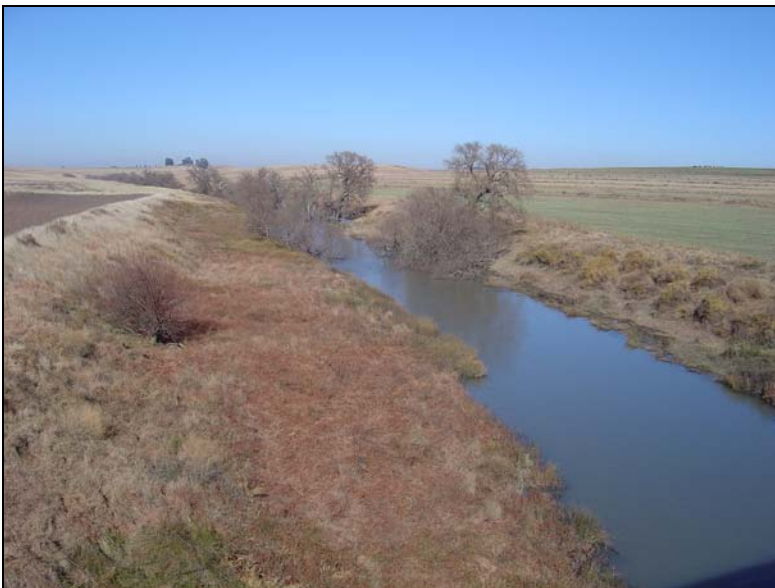
Fig.5 Liebenbergsvleispruit on the R57 between Reitz and Petrus Steyn.

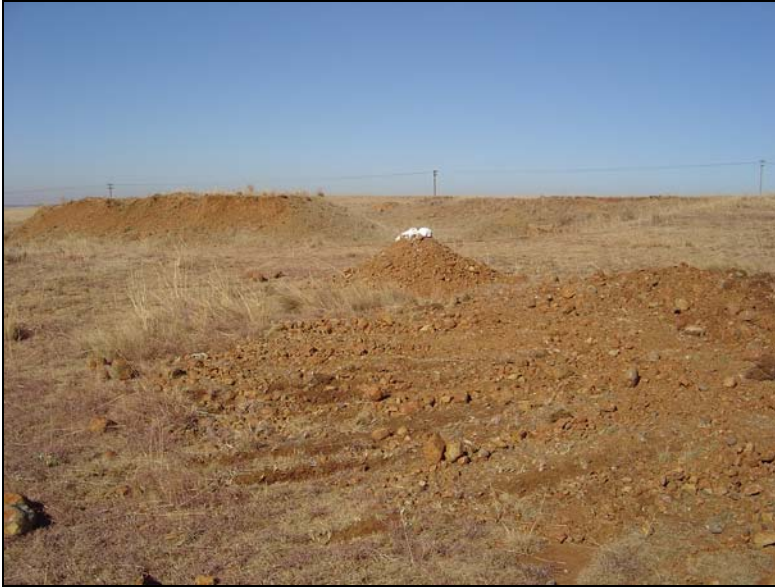
Fig.6 BP2 (Existing borrow pit) at Waterval 796.

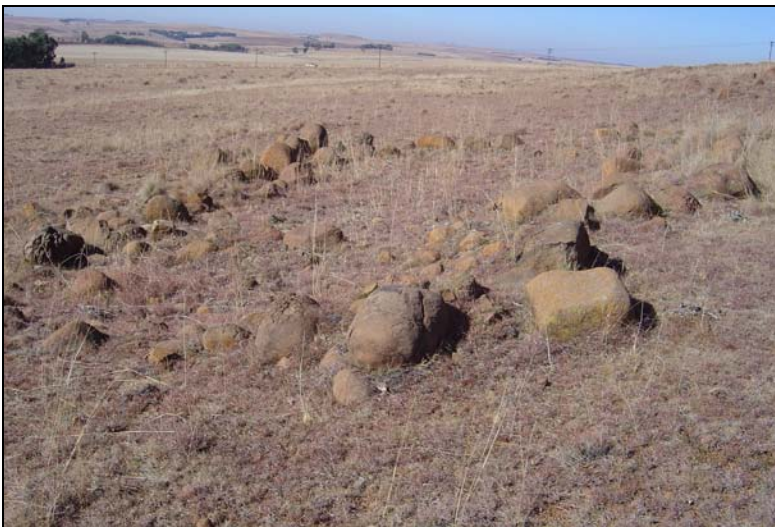
Fig.7 Remains of a rectangular stone structure at Waterval 796.

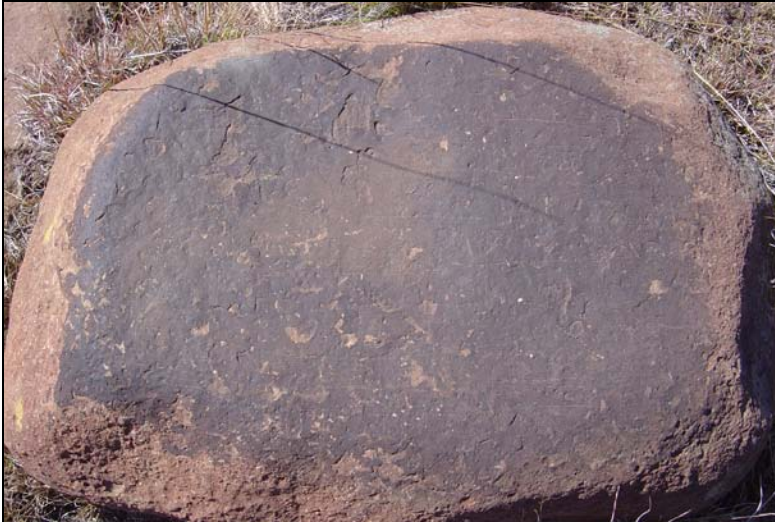
At BP2 on the farm Waterval 796 some boulders contained vague remains of etchings resembling graffiti or engravings (Figs.8&9), but they were actually quite illegible and could not be connected to any group or origin.

Fig.8 Boulder with vague etchings at Waterval 796.

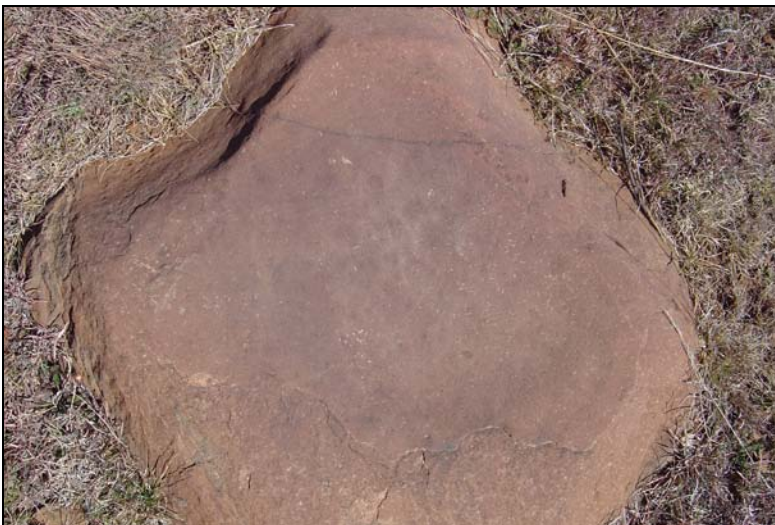
Fig.9 Another boulder with vague etchings at Waterval 796.

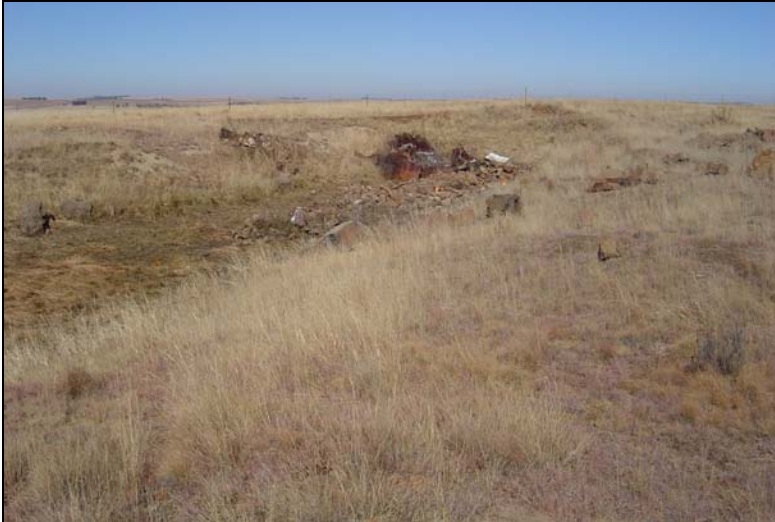
Fig.10 BP3 (Existing) to be extended.

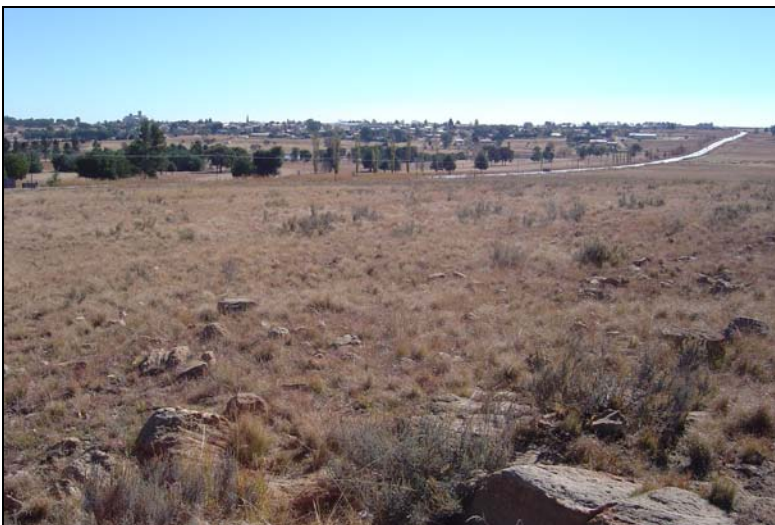
It was only in the case of BP5 on the outskirts of Petrus Steyn (Fig.11) where the remains of a Late Iron Age stone-walled settlement have been found (Fig.16). In this case the edge of the borrow pit will also be very near the boundary fence.

Fig.11 View from BP5 facing towards Petrus Steyn.

It is recommended that a borrow pit should be selected elsewhere or that the extent of the pit should be planned to by-pass the ash heaps in the area. It is recommended that the disturbance should be limited near the ash heaps.

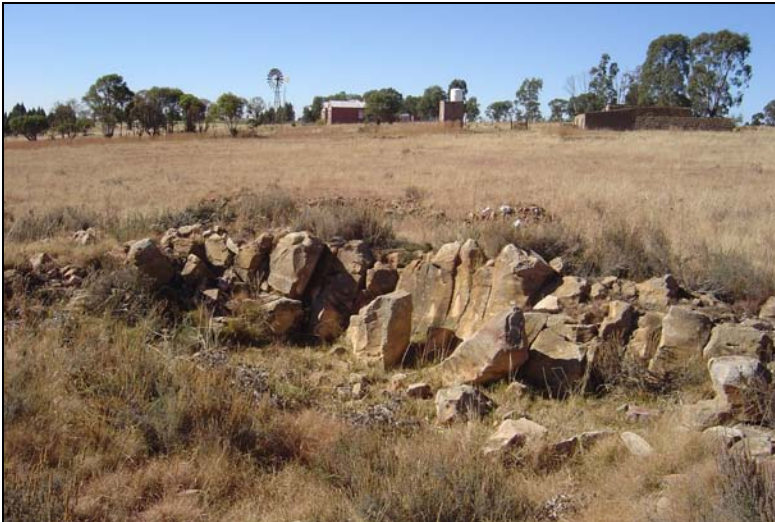
Fig.12 Existing sandstone quarry at BP5 near Petrus Steyn.

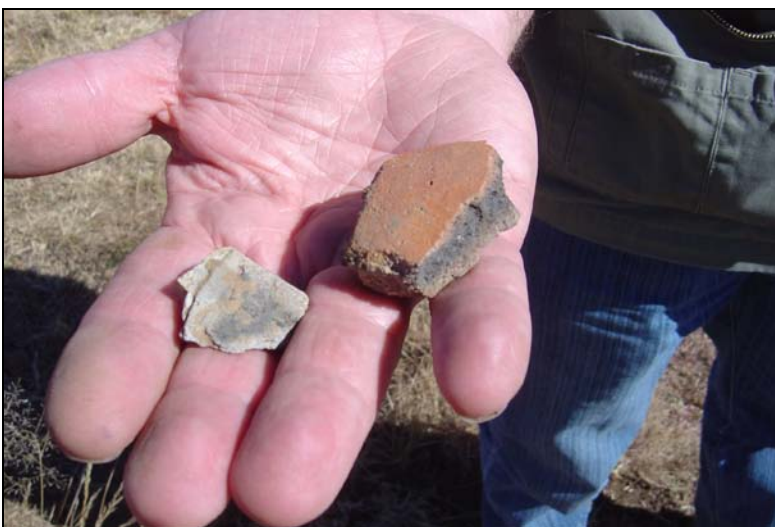
The cultural material occurred in the form of potsherds and porcelain on an ash heap at BP5 (27°39'39"S. 028°08'30"E. Altitude 1715m.) (Figs.13&14).

Although no stone-walling was found in the case of BP5, it will be important to investigate the origin of the potsherds on the ash heap. If people were living there in the past, it could be possible that there may be graves at the site or in the vicinity.

Fig.13 Potsherd and stone flake from the ash heap at BP5 near Petrus Steyn.

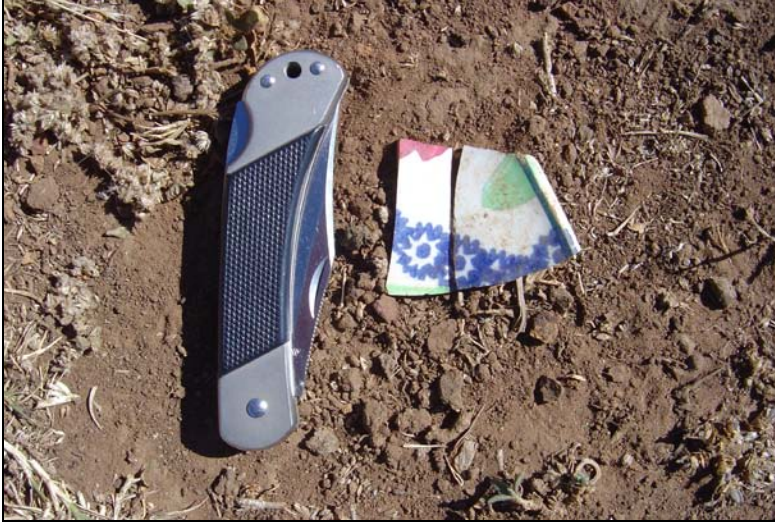
The porcelain fragments are been identified as sponge ware, which had been known to be very popular amongst European women in the former British colonies. Sponge ware decorated crockery had been manufactured at Staffordshire, England, for distribution in the different British colonies, including

Fig.14 Sponge ware decorated crockery from BP5, Petrus Steyn.

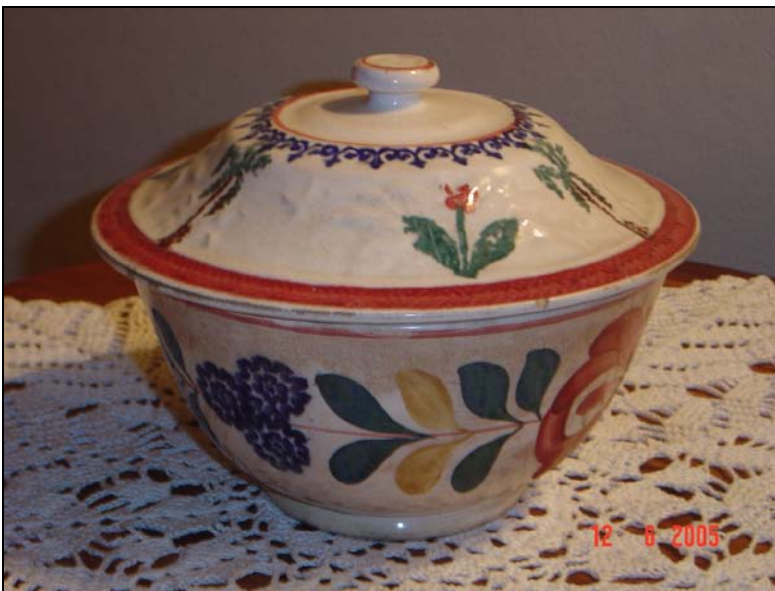
South Africa. The fragments from BP5 could therefore, date from a period well before the Anglo-Boer War (Trehaven 1996, Dreyer 2001) (Fig.15).

Fig.15 A sponge ware bowl with lid. Sponge ware decorated crockery, manufactured at Staffordshire, England, for sole distribution in South Africa. This specimen dates from pre-Anglo Boer War times. (J. Dreyer Private Collection).

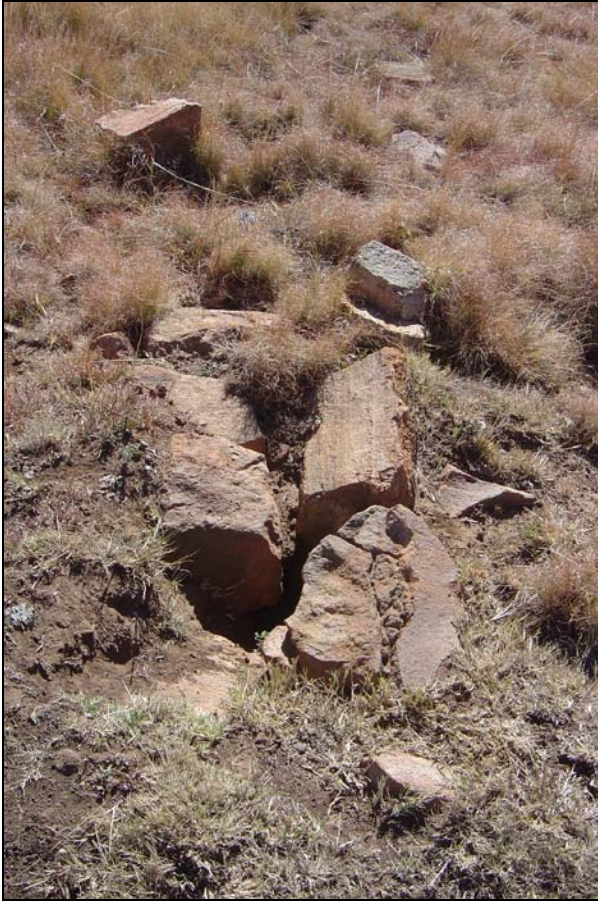
Fig.16 Base of a stonewall at BP5 near Petrus Steyn.

Concerning the areas for the proposed developments, mitigation measures will only be needed in the case of the BP5 at Petrus Steyn.
