PHASE 1 HERITAGE IMPACT ASSESSMENT

**PROPOSED LEFAPHA HOUSING DEVELOPMENT
SITUATED ON THE REMAINING EXTENT OF THE FARM LEITRIM 926,
METSIMAHOLO LOCAL MUNICIPALITY, FREE STATE PROVINCE.**

Compiled by: P.D. Birkholtz & H.N. James
Date: 15 February 2008

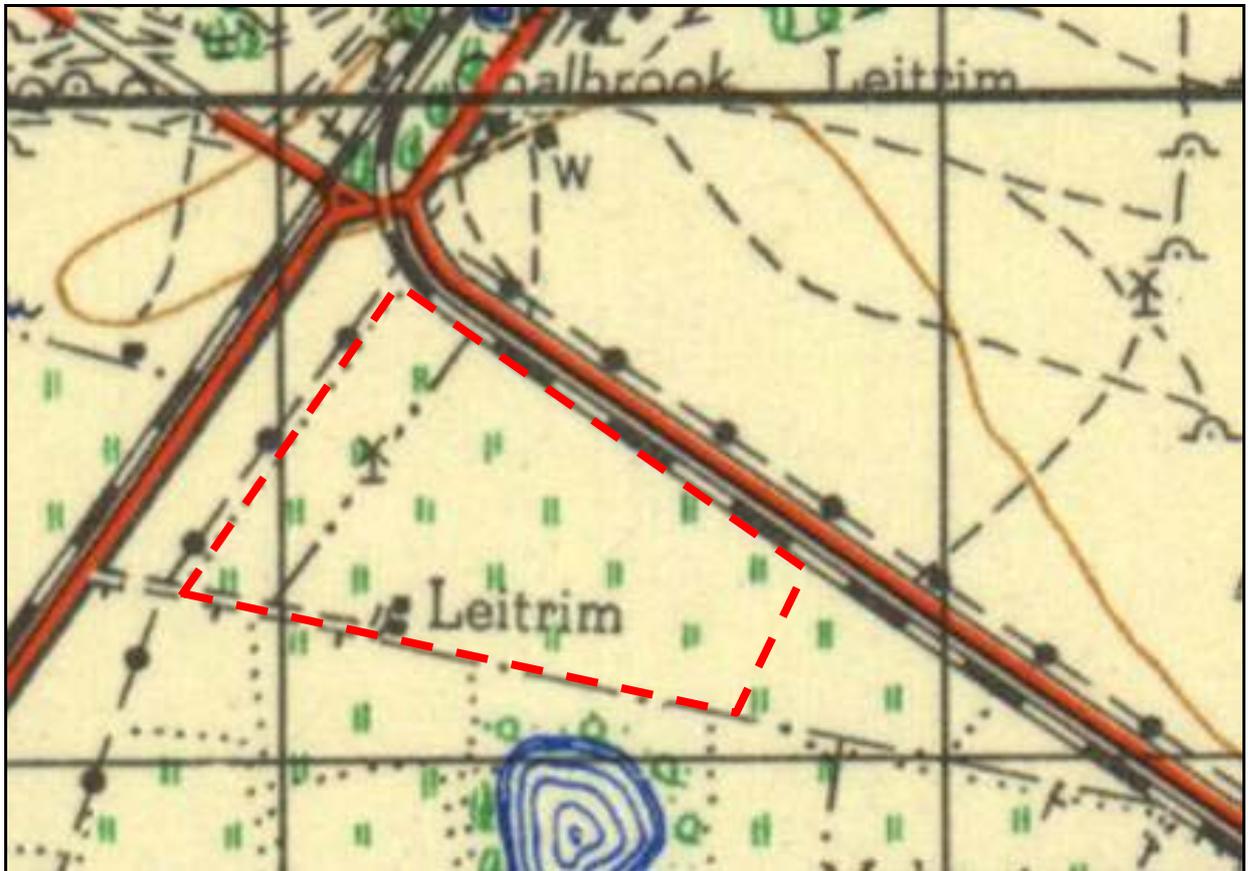
Figure 1 First edition of the 2627DD topographical sheet.

Figure 1 below depicts an enlarged section of the First Edition of the 2627DD Topographical Sheet. The aerial photography and actual survey work took place during 1948. The map was compiled in 1949 and drawn by the Trigonometrical Survey Office in 1953. It was printed by the Union of South Africa's Government Printer in 1954.

- Two buildings are depicted on the southern boundary of the farm. The southernmost of the two is depicted in exactly the same locality as a farm dwelling still found on site (see Site 1 below).
- At the time when the map was compiled (i.e. 1940s), agricultural activities took place across the entire study area.

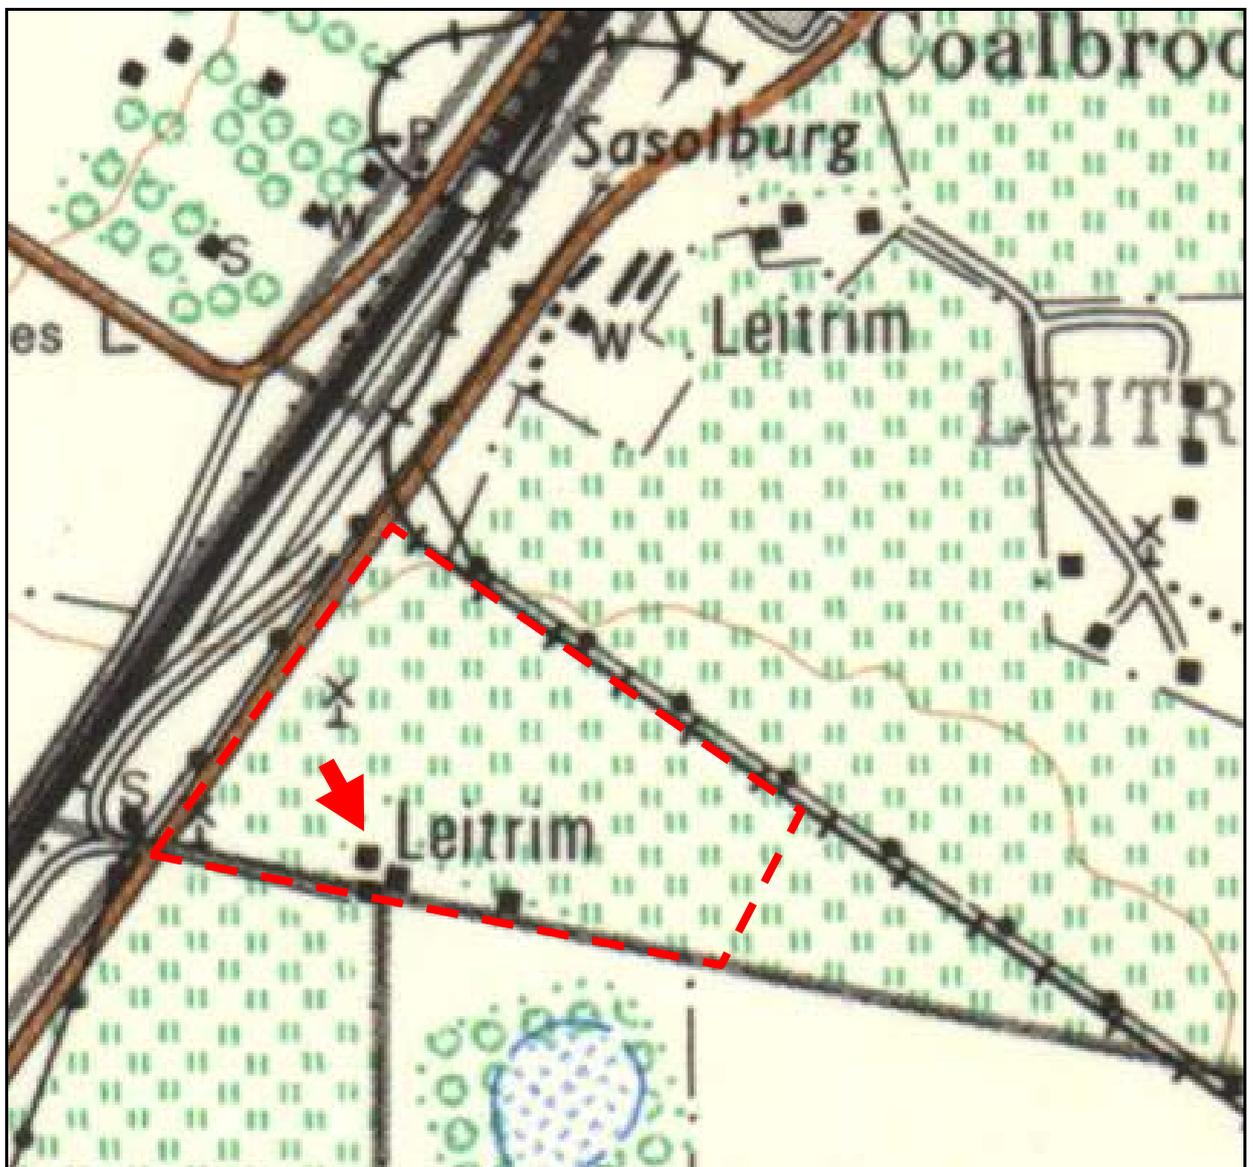
Figure 2 Second edition of the 2627DD topographical sheet.

Figure 2 below depicts an enlarged section of the Second Edition of the 2627DD Topographical Sheet. The map was printed by the Government Printer in 1979.

- A cluster containing four buildings is depicted on the southern boundary of the farm. The building believed to be Site 1 is indicated with an arrow on the associated map.
- At the time when the map was compiled (i.e. 1970s), agricultural activities still took place across the entire study area.

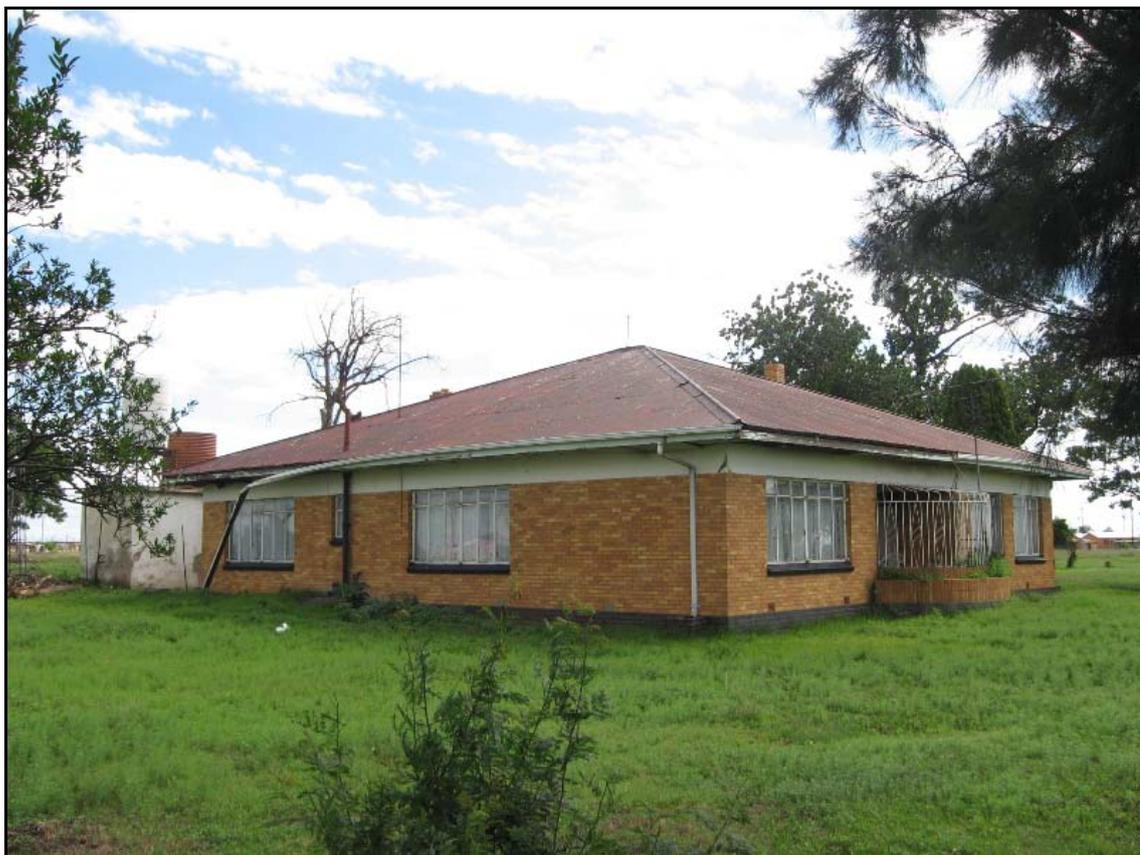
Plate 3 General view of the farm dwelling.

The site consists of a historic farm dwelling which is situated against the southern boundary of the proposed development site a short distance east of the road from Coalbrook (S70).

The building dates to the period between 1940 and 1950. The exact date of construction is unknown as it is a farm building and no architectural drawings exist, but a relative date for the building may mean that it is older than 60 years. It is not a typical vernacular farm dwelling (constructed with stone or plastered clay brick) but an example of a dwelling type of similar style and executed within the architectural vocabulary that was common in urban areas at the time.

Structurally it is a solid building and contains several typical stylistic elements of the period (1935-1950) and some elements of the Art Deco style (1920-1935). No name for this period or style exists, but it has a distinct character of which the use of yellow face bricks is the most significant element.

- Recording: measuring the floor plan, elevations and details.
- Drafting measured drawings (1:100scale).
- Photographic recording with descriptions using standard architectural vocabulary
- Compiling the drawings, photographic recordings and descriptions into a report.
- Submission of the report to the SAHRA to acquire a destruction permit.

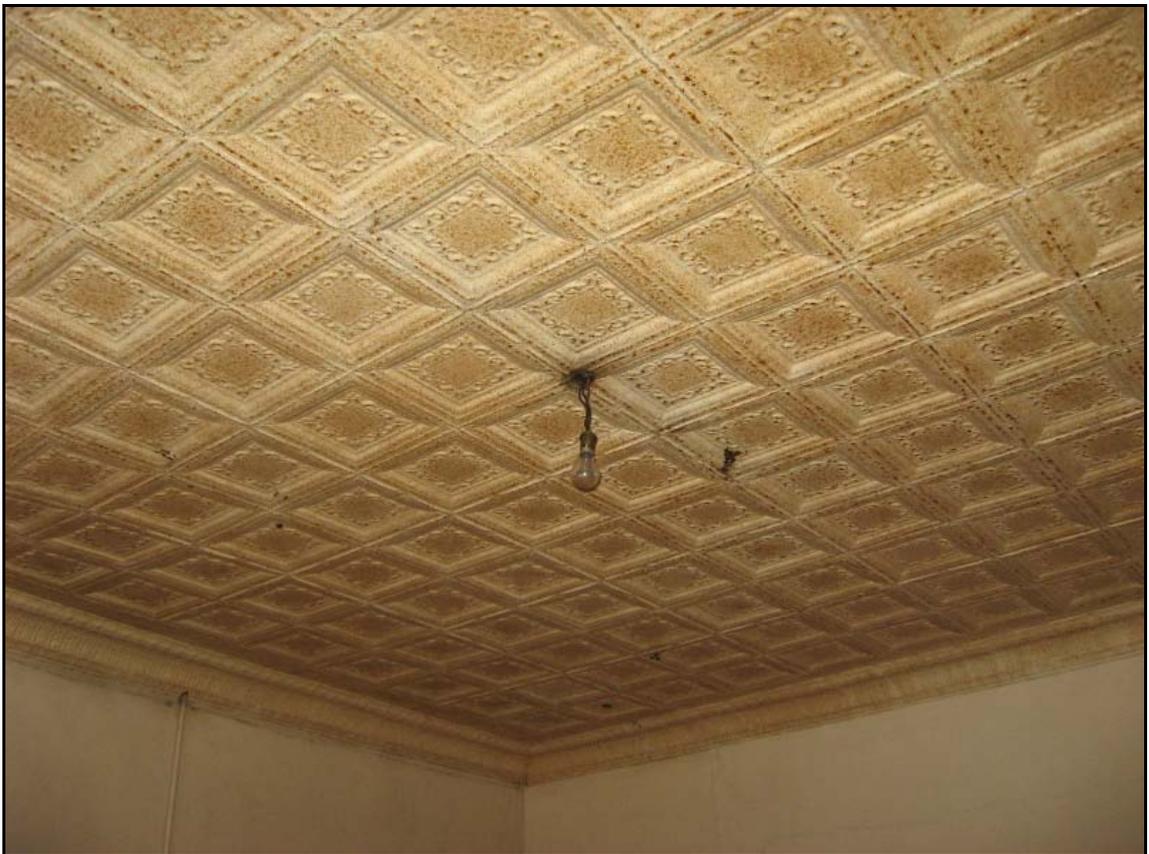
Plate 6 Pressed ceilings of farm dwelling.

An exceptional detail in the building is the occurrence of pressed metal ceilings. These ceilings were common from the 1920s and earlier but not used this late into the 20th century. All the other features are typical of the period and the style such as timber floors, wooden frame front door, wide un-bevelled timber skirting and architraves and Art Deco type interior doors.

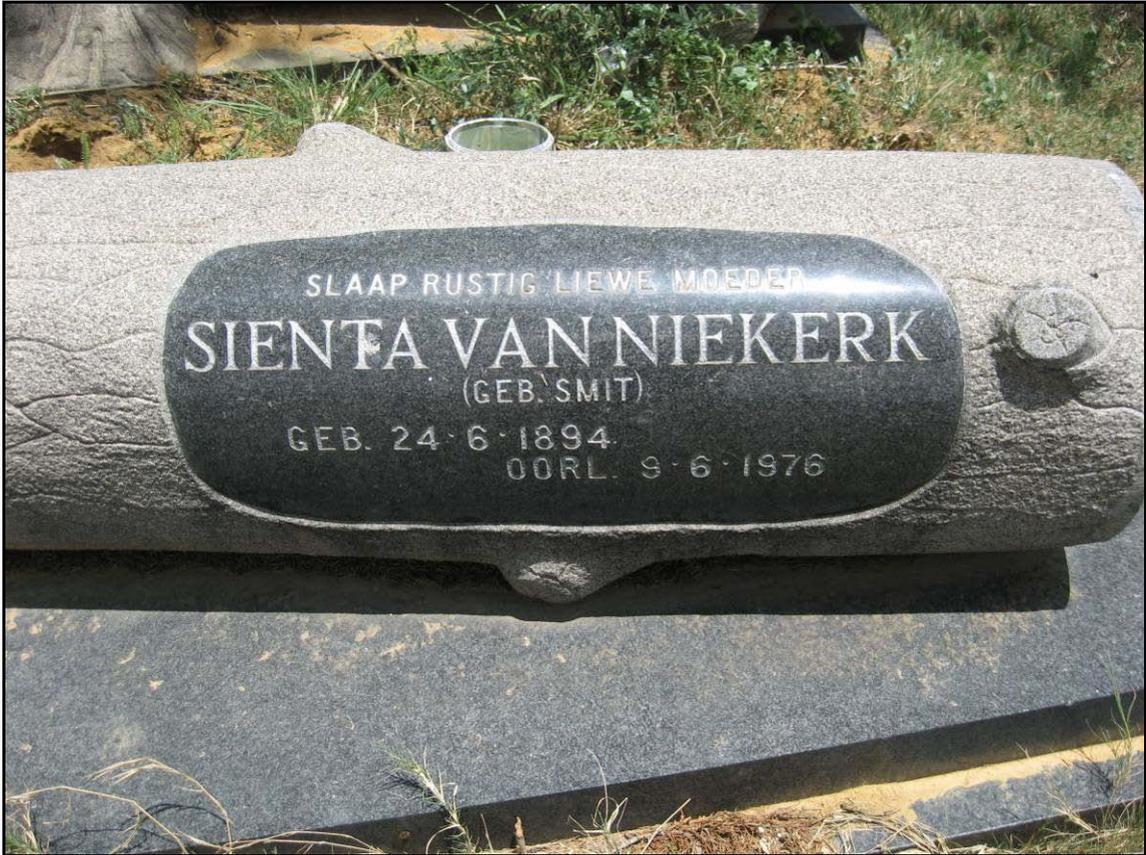
Plate 10 Close-up view of head stone on Sienta Van Niekerk's grave.

SLAAP RUSTIG LIEWE MOEDER
SIENTA VAN NIEKERK
(GEB. SMIT)
GEB. 24-6-1894
OORL. 9-6-1976

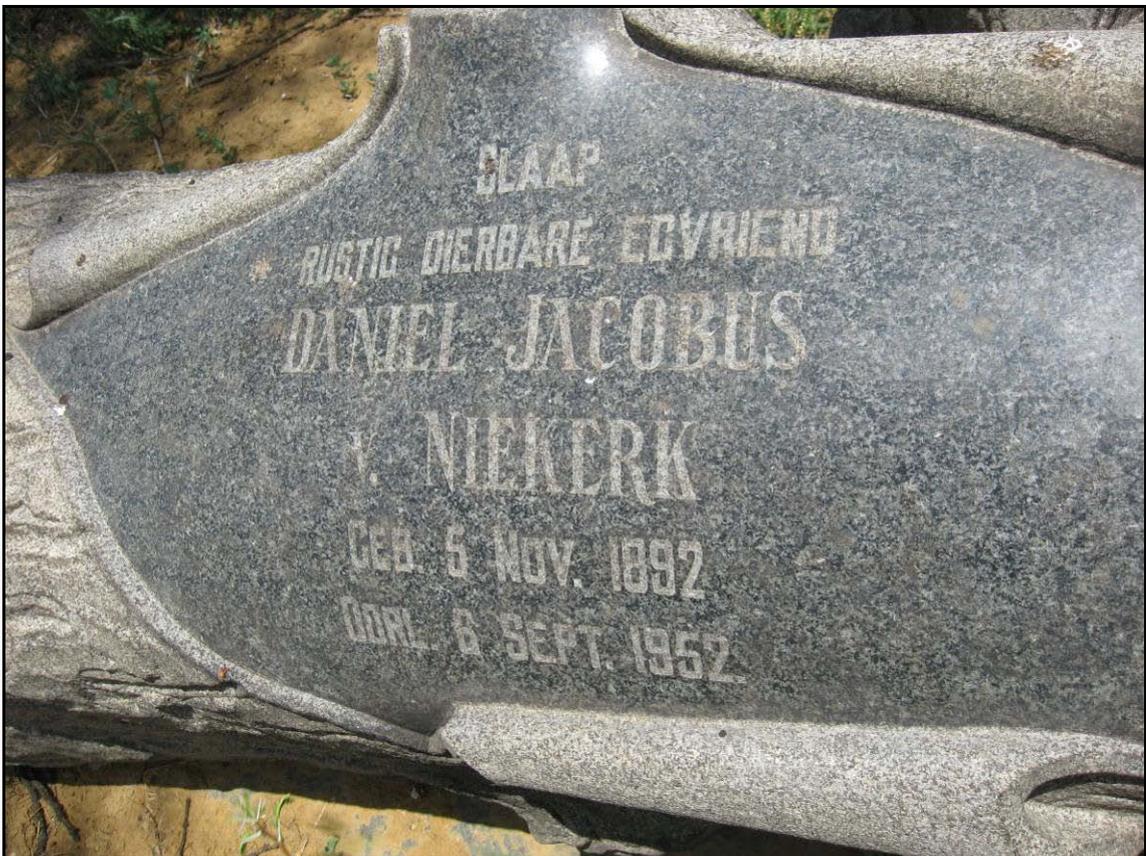
Plate 11 Close-up view of head stone on Daniel Jacobus Van Niekerk's grave.

SLAAP RUSTIG DIERBARE EGVRIED
DANIEL JACOBUS V. NIEKERK
GEB. 5 NOV. 1892
OORL. 6 SEPT. 1952
