20 MAY 2008

# ARCHAEOLOGICAL AND CULTURAL HERITAGE ASSESSMENT OF THE PROPOSED LEISURE RESIDENTIAL DEVELOPMENTS AT ANNEX ELDERSLEA "A" 433, WEPENER, FREE STATE

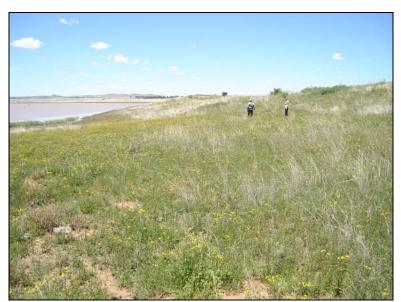
A dense vegetation cover hampered the investigation (Fig.1).

Fig.1 View across the site at the farm Annex Elderslea "A" 433, Wepener.

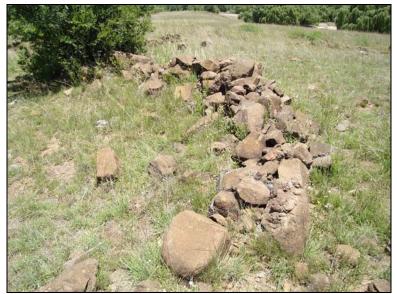
Fig.4 Stone-wall at Annex Elderslea "A" 433, Wepener.

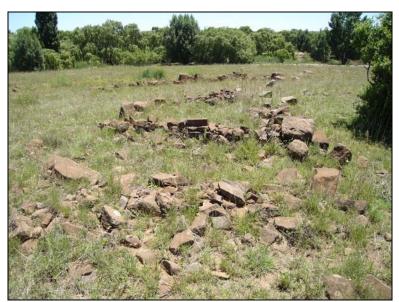
Several individual stone structures (Fig.7) and clusters of low stone walls (Fig.5) were found in the area. Some of the walls have been heavily robbed (Fig.14).

Fig.5 Cluster of stone-walls at Annex Elderslea "A" 433, Wepener.

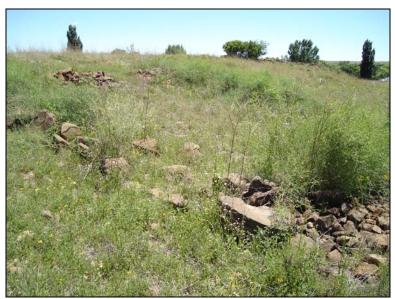
Fig.7 Circular stone-wall at Annex Elderslea "A" 433, Wepener.

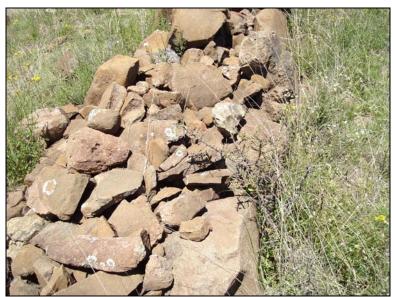
The lower grinding stone together with the construction method visible in the stone-walls (Fig.9) indicate erection and by early Black people.

Fig.9 Detail of the construction of a stone-wall at Annex Elderslea "A" 433, Wepener.

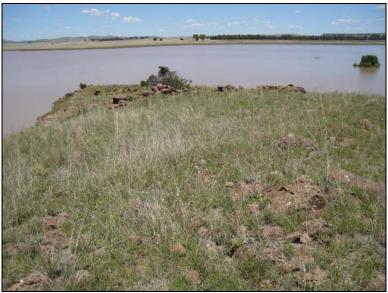
Fig.10 Stone-walls on the water edge at Annex Elderslea "A" 433, Wepener.

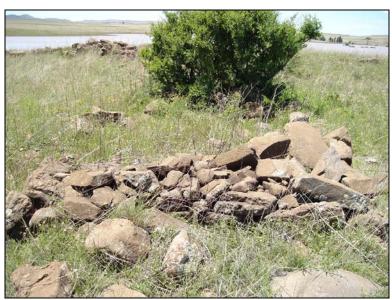
Fig.11 Stone-walls at Annex Elderslea "A" 433, Wepener.

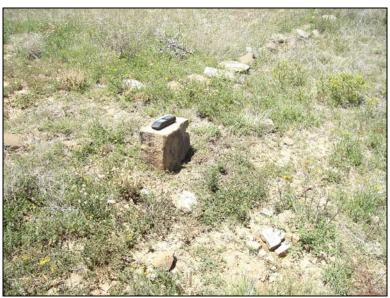
Fig.13 Rectangular stone-wall foundation at Annex Elderslea "A" 433, Wepener.

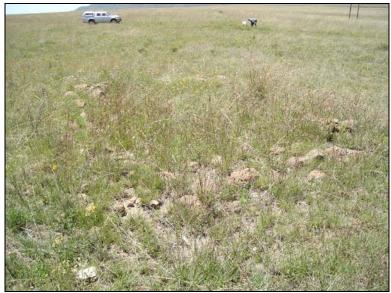
The structures are either circular or half-circular and rectangular (Fig.14).

Fig.14 Heavy stone robbing is visible at some walls at Annex Elderslea "A" 433, Wepener.

I recommend that further planning and development of the proposed residential developments could proceed, but that care should be taken to avoid the stone walls in the site layout.

It is also stressed that care should be taken not to destroy or damage the walls during the building phase.

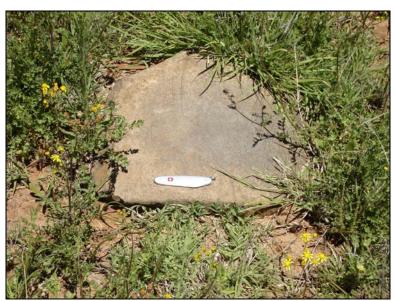
A single flat lower grinding stone (Fig.15) was found amongst the stone-walls.

Fig.15 Lower grinding stone at Annex Elderslea "A" 433, Wepener.
