PHASE I ARCHAEOLOGICAL SURVEY REPORT AND ASSESSMENT OF THE  
AREA DESIGNATED AS THE MANDELA MUSEUM AT MVEZO IN THE EASTERN  
CAPE, SOUTH AFRICA (Site 3128DC1)

MH Schoeman  
Curator: Historical Anthropology  
Albany Museum  
Somerset street  
Grahamstown  
6139  
Tel: (046) 622-2312  
e-mail: a.schoeman@ru.ac.za  
July 2000

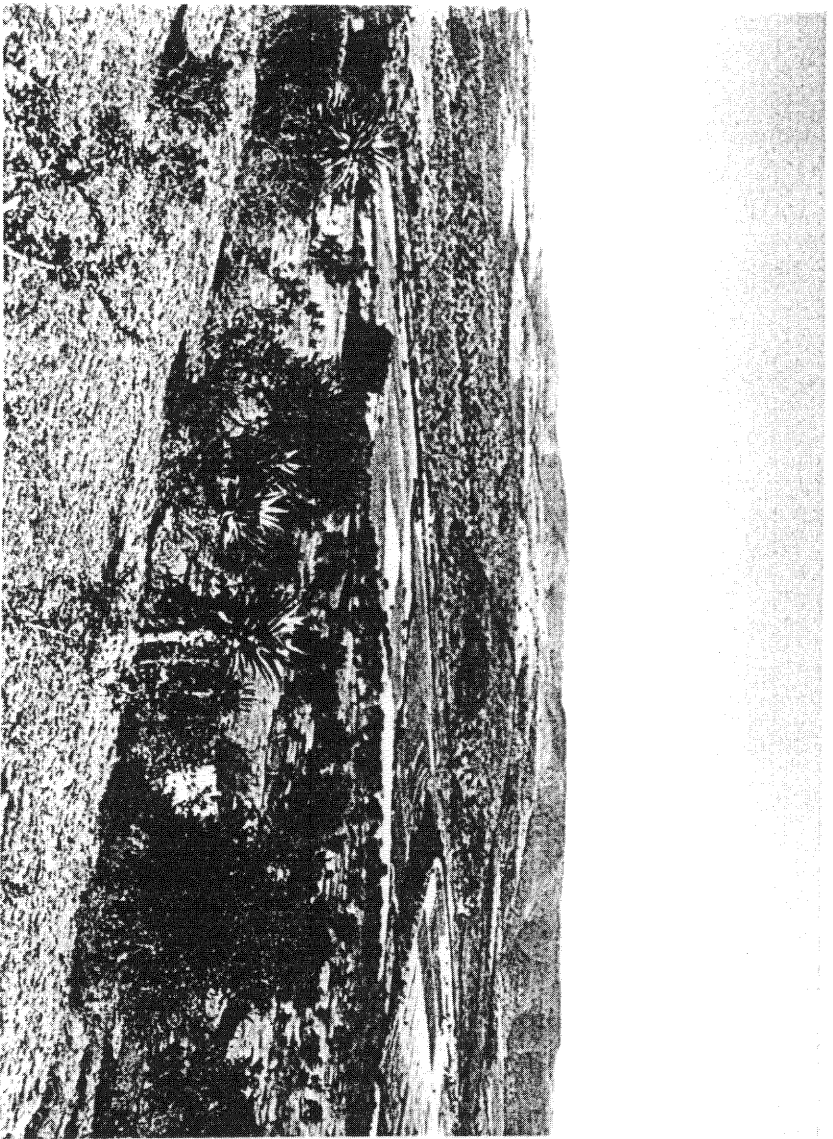
Figure 1 Photograph showing view of Occupation Areas within the fenced area at Mvezo.

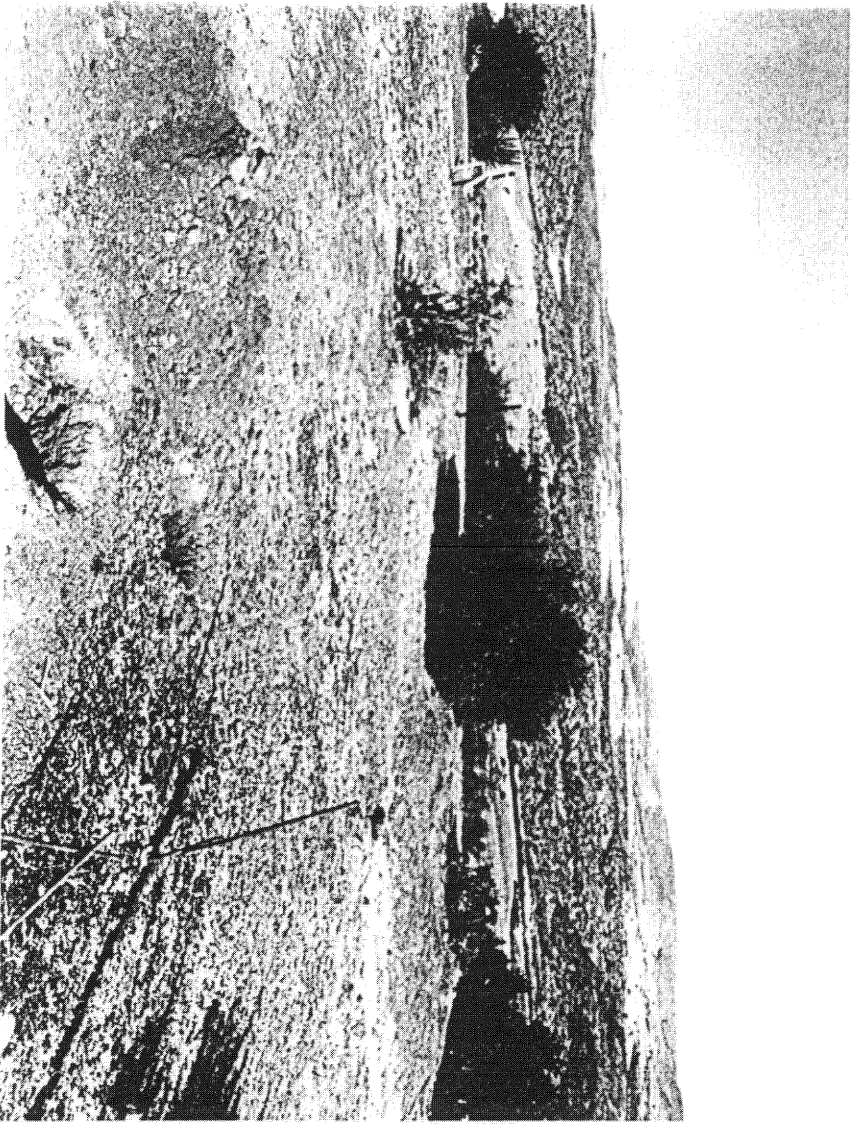
House remains A1 is the least visible in Occupation Area A. It consists of a low mound with no visible wall remains. Of note is that this area is associated with a low flat stone (Fig. 3). When the survey was undertaken there was an Upper Grindstone placed on it, however the smoothed areas do not resemble that of traditional grindstones (see Fig. 22), but is rather similar to stones found on Iron Age sites on which spears have been sharpened. This implies that the stone might have been part of the male assembly area, which suggests that the A1 remains predate the settlement at Occupation Area A, as a building would not have marked this area. A square shallow hole has recently been excavated into this mound.

Figure 3 Photograph of house remains A1 associated with a large flat stone.

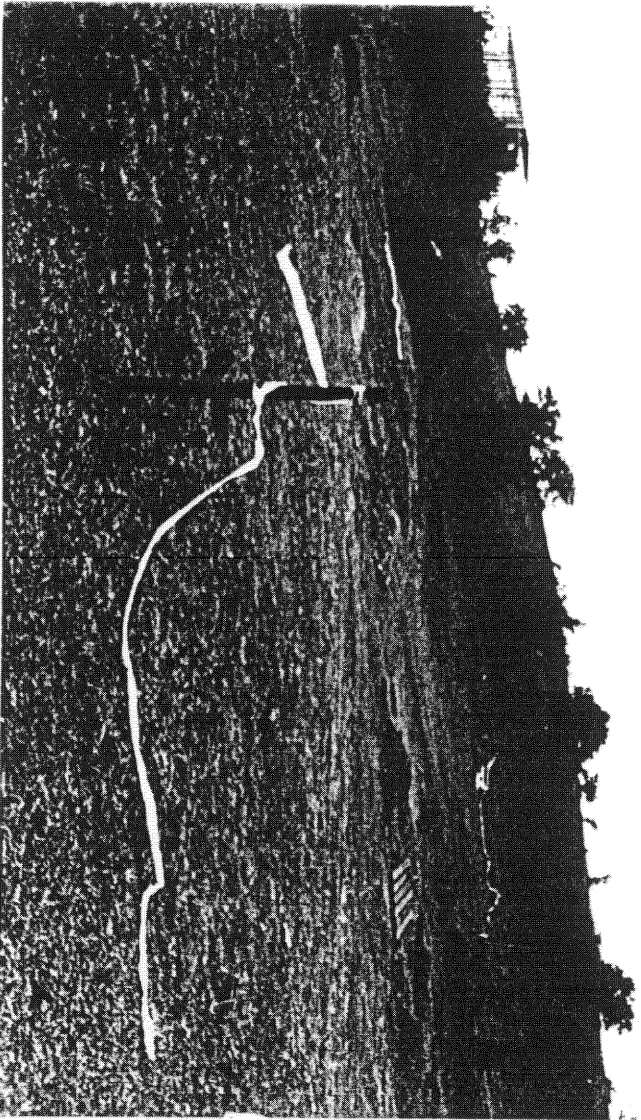
House remains A2 has clearly visible individual clay box bricks from a collapsed wall. House remains A3 and A4 are also clearly visible (Fig. 4). The up slope side of A4 was excavated into the hill, with the down slope side raised. A3 consists of a raised mound. House A5 was built on a stone foundation that is visible at the base (Fig. 5). The stones in the foundation have been cut. Clay box brick walls were built on top of the stone layer. The individual clay box bricks are still visible.

Figure 4 Photograph of house remains A3 and A4.

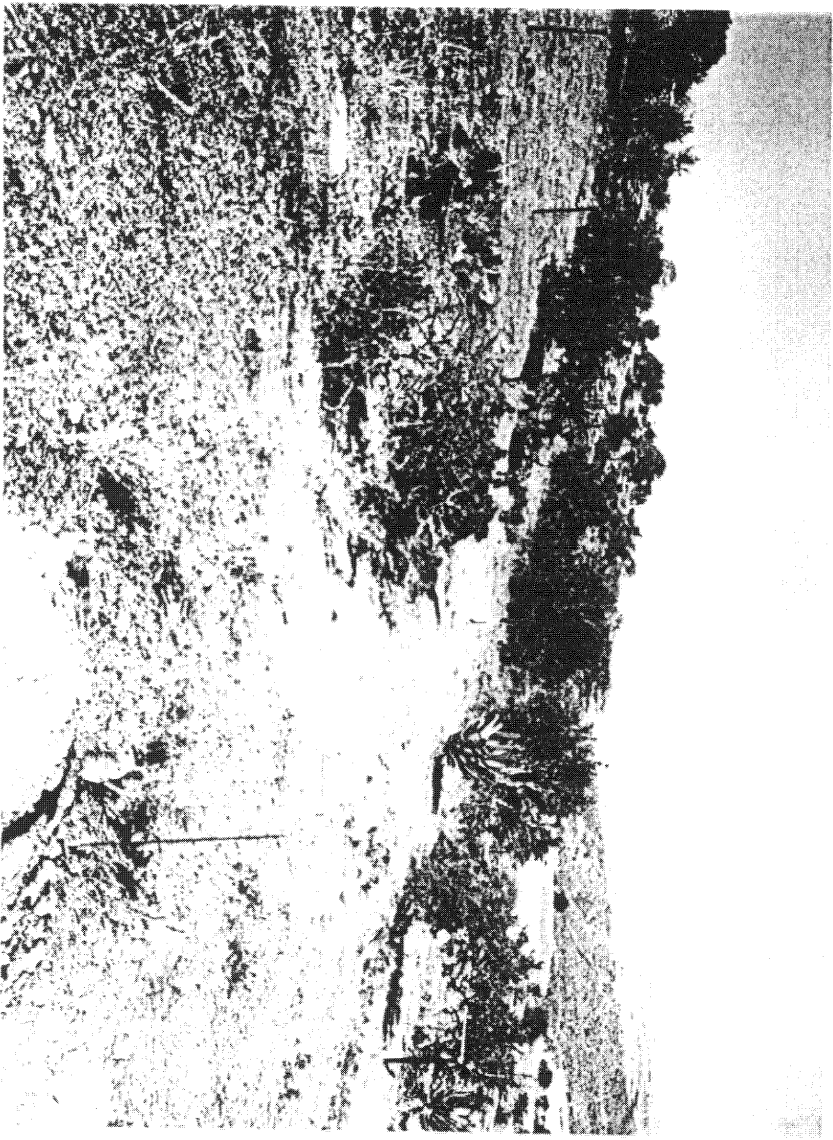
The house platform at A6 was formed through excavation at the up slope side into the hill. The down slope side has been built up. The base for this consists of uncut stone (Fig. 6). The up slope areas of A7 and A8 were also cut into the hill. The mound at A9 is smaller than that of the house remains (Fig. 7). It consists of a raised mound ridge with a more shallow centre. A smaller mound is associated with it. The nature of this collapse and placement in the occupation area suggests that it was a granary.

Figure 6 Photograph of house platform A6.

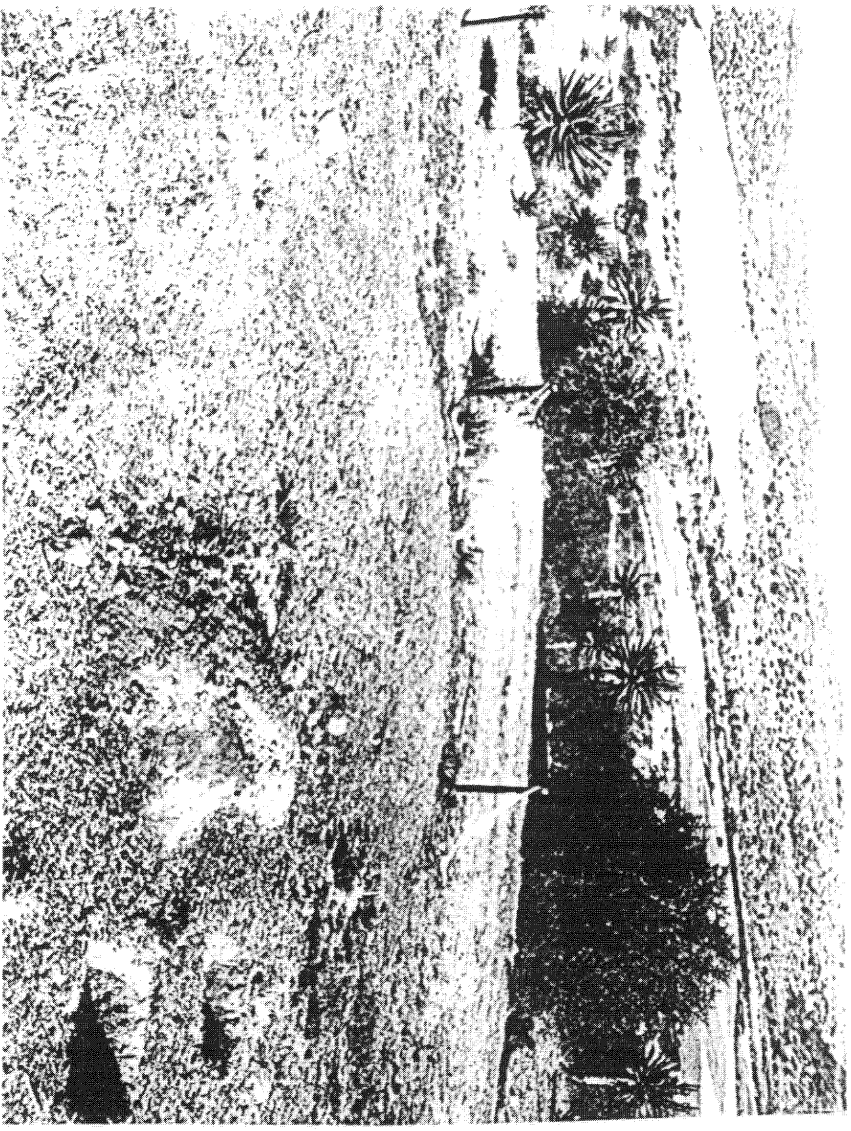
Figure 7 Photograph of the A9 granary mound.

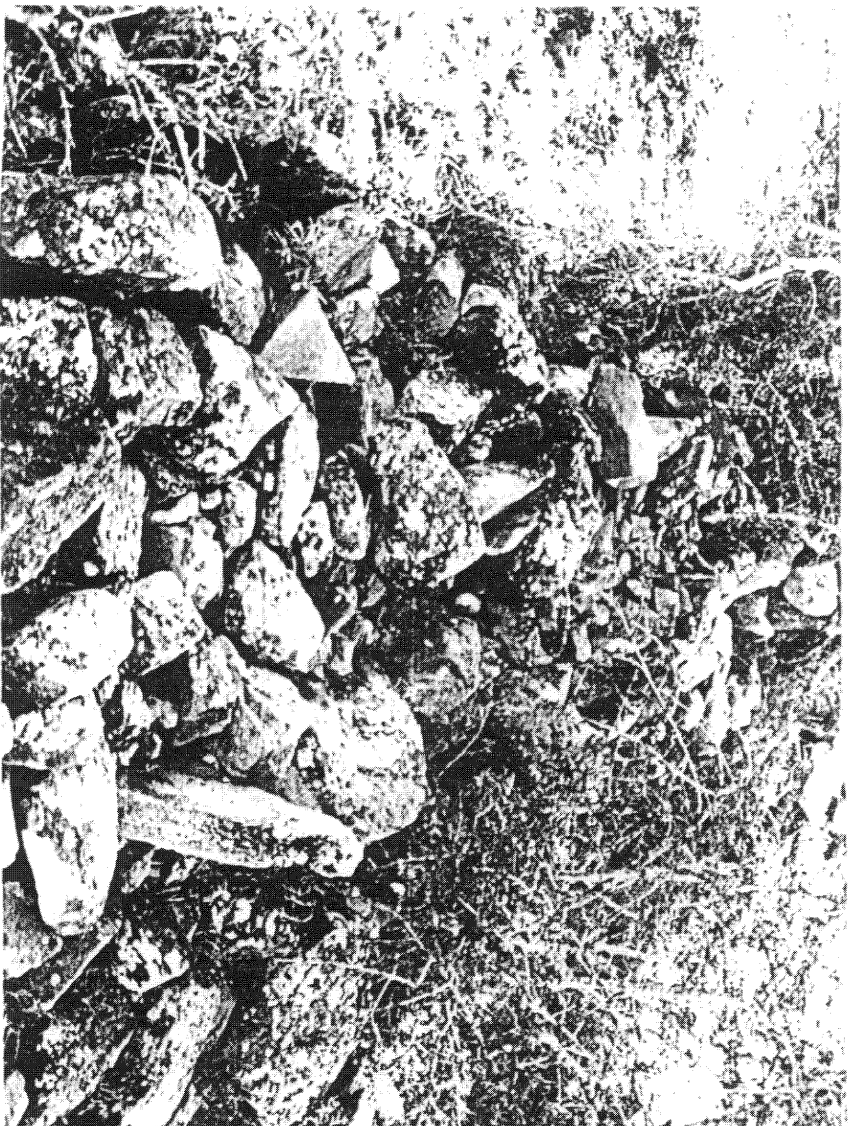
(Fig. 9). The oral information suggests that this was the tobacco garden. If this is correct it implies that tobacco occupied a very important role in the homestead as this is the only visible stone wall on the site and would have required a large amount of energy to construct. It is more likely, however that this was the kraal. This is indicated by the time and energy spend in construction as well as by the location immediately down slope from the rondawels.

Figure 9 Photograph of stone enclosure wall.

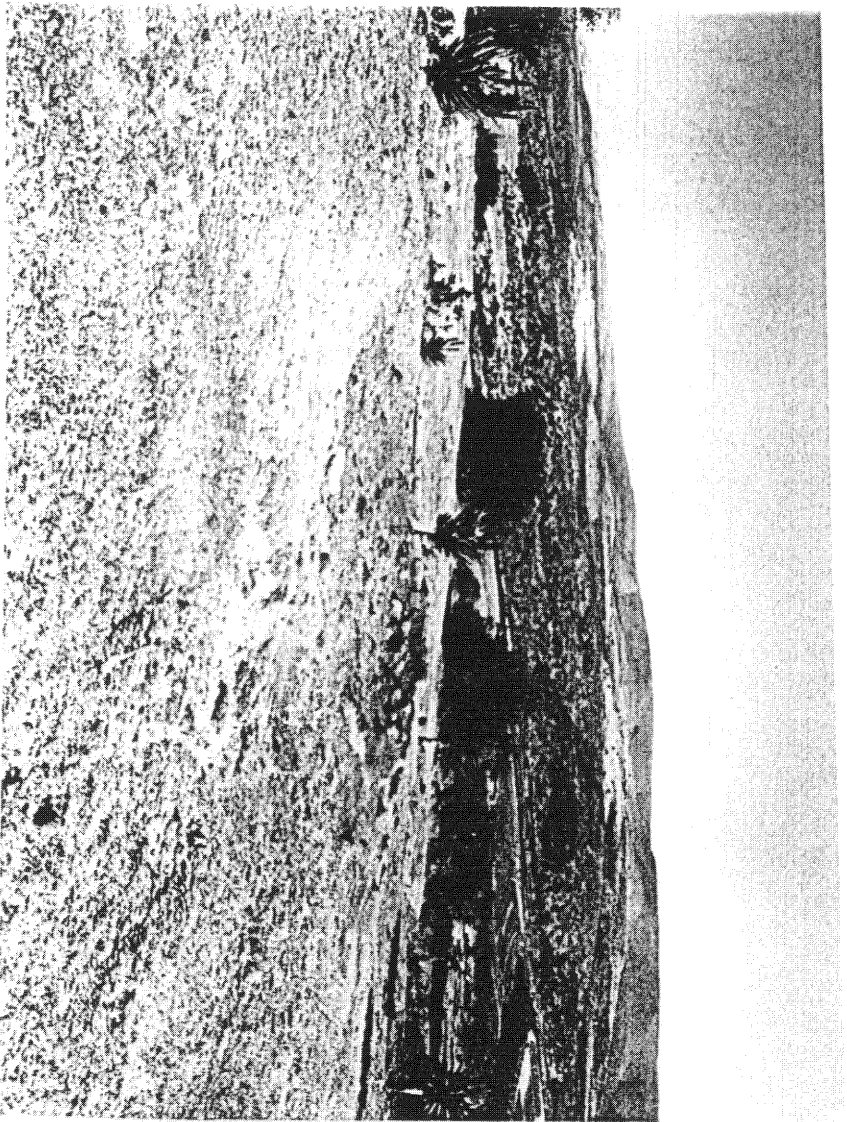
Figure 12 Photograph of B4 house remains with a broken lower grindstone.

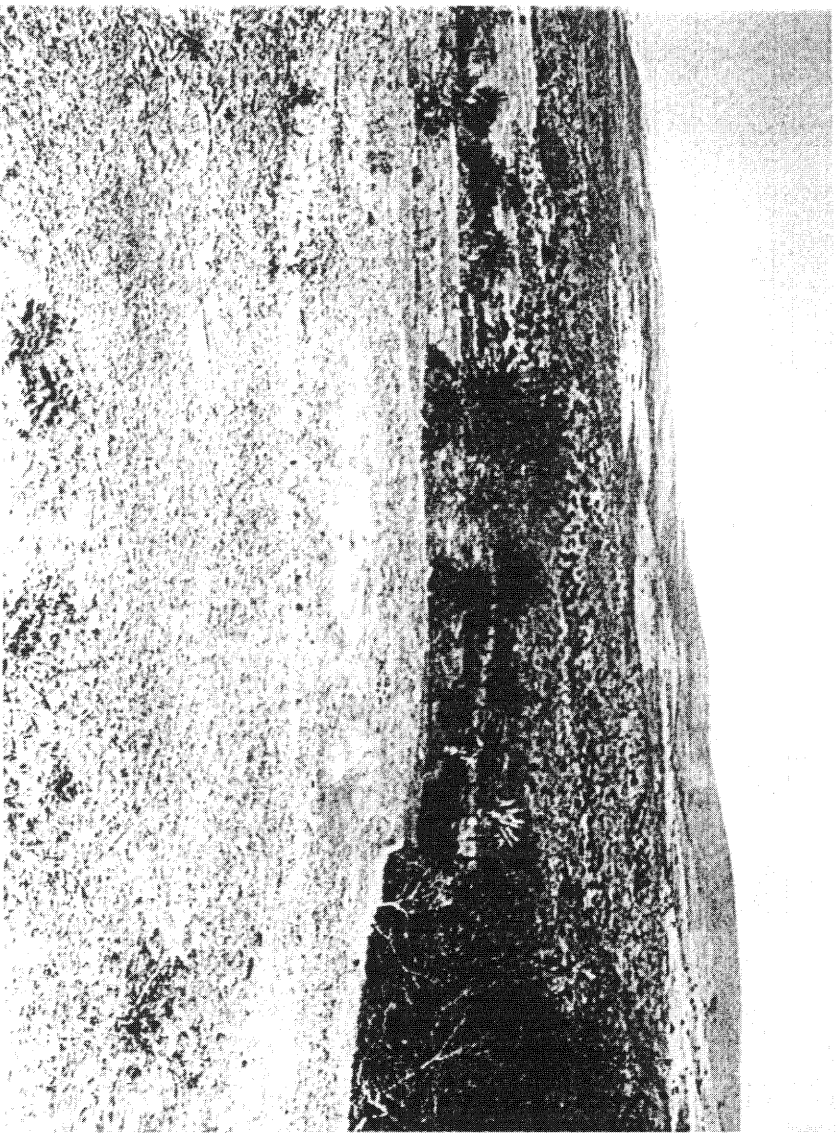
House platform C1 (Fig. 14) consists of a flat topped circular mound with some visible dakha walling on the outside. However, no stone foundation is evident. A ring of unworked stone surrounds the mound, set approximately 1 metre from it on the inside (Fig. 15).

Figure 14 Photograph of house platform C1.

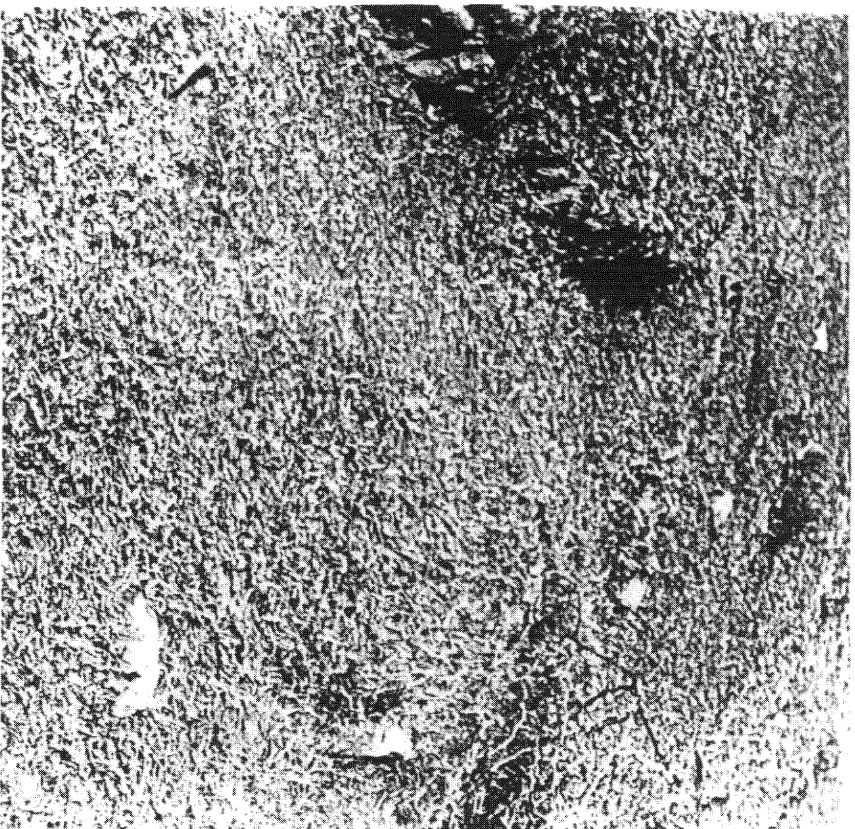
Figure 15 Photograph of platform and stone ring associated with C1.

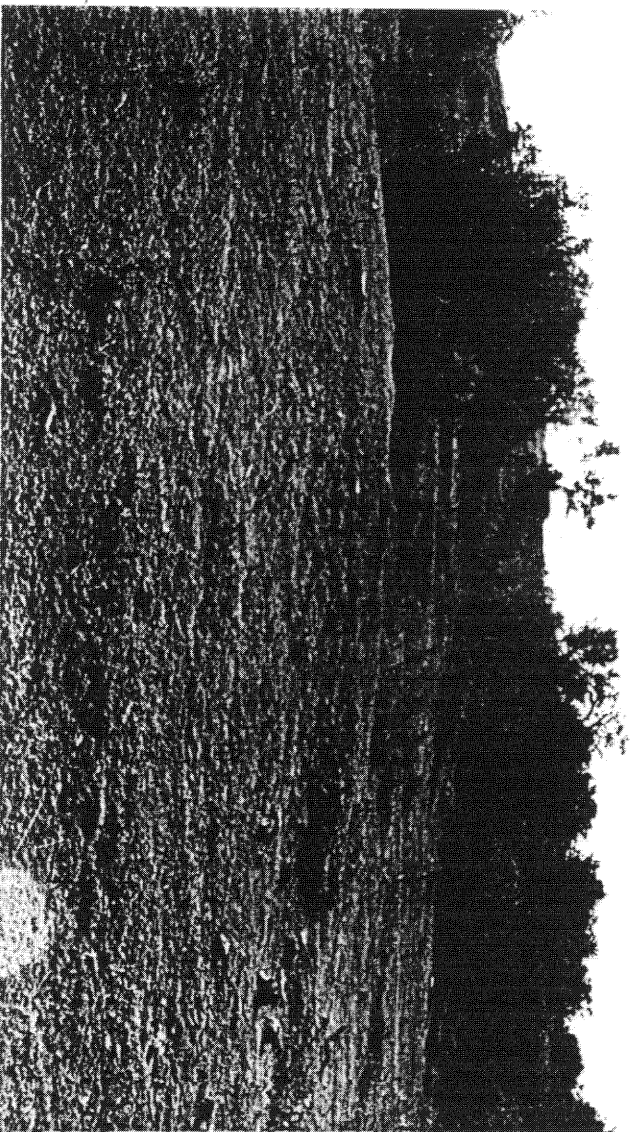
Figure 20 Photograph of terrace detail at Occupation Area C viewed from down slope

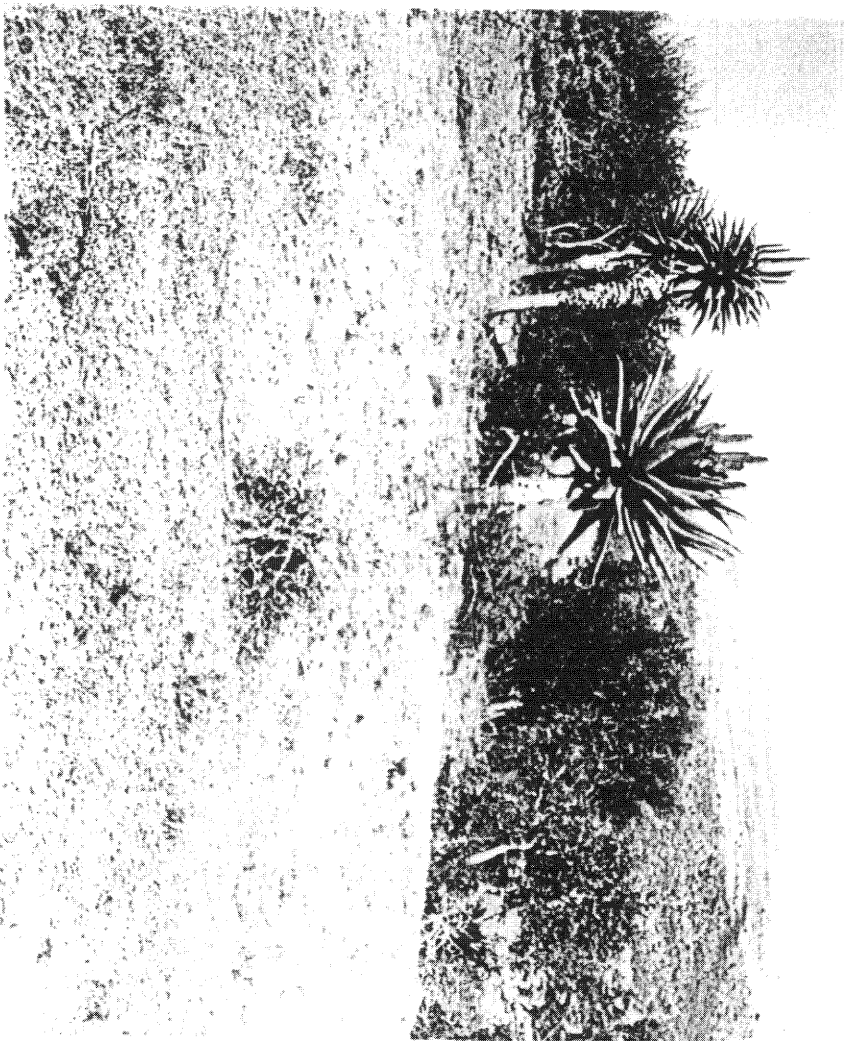
Occupation Area D is located directly above the slope that separates the lower part of the site (Occupation Area C) from the rest of the site. The remains of only one house were found in this area. These remains are not easily visible, forming a very low flat mound (Fig. 20). There are no visible wall remains associated. The remains of a broken lower grindstone in area D further strengthen the possibility that the area was in fact an occupation area.

Figure 21 Photograph of low flat mound in Occupation Area D.

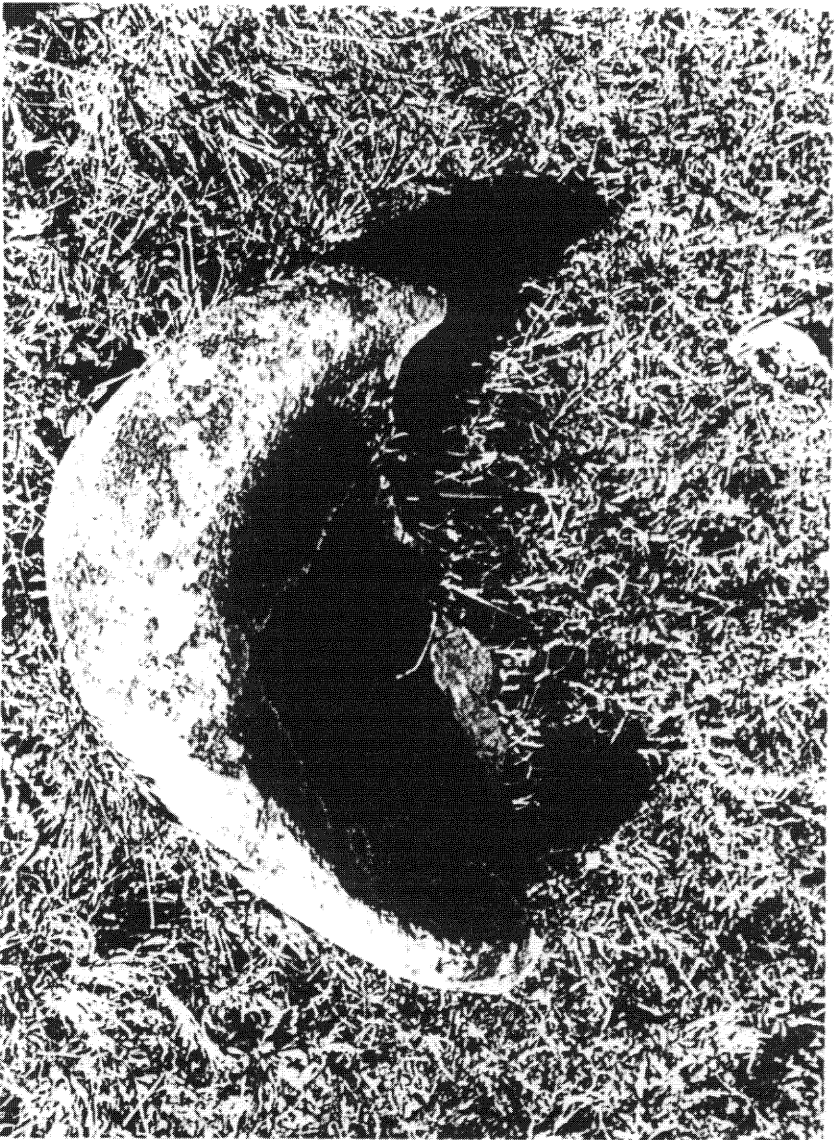
Figure 22 Photograph of broken lower grindstone from Occupation Area D.

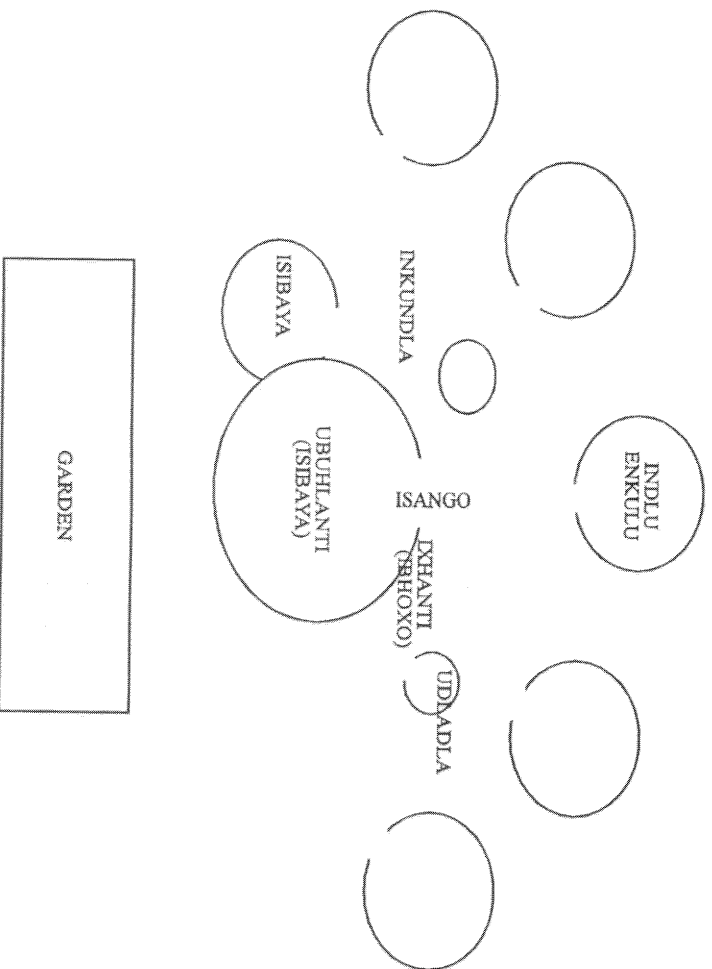
The main wife's house was in the highest position above the kraal and her store-hut and the houses and store-huts of the other wives were arranged on either side. The kraal would be found in the conceptual centre of the homestead. Between the kraal and the houses there would be an area (*inkundla*) where guests are received, where functions and *imbizo* are held and at the places of *inkosi* court-cases are heard. On the other side in the area between the kraal and houses there would be a granary (*udlala*). The domestic garden would be located down slope from the homestead (Shaw and van Warmelo 1972) (Fig. 23).

Figure 23 Drawing of the spatial layout of a Thembu homestead redrawn from Shaw and Van Warmelo (1972).
