HERITAGE IMPACT ASSESSMENT

DR 01392 Cape Winelands

Langeberg – Cape Winelands District Municipality, Western Cape

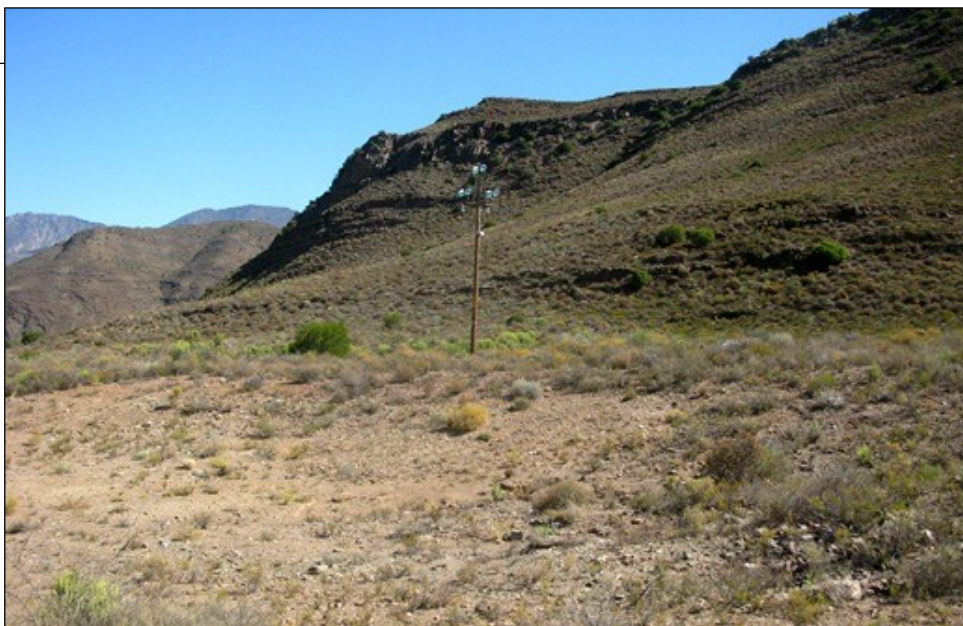
Figure 2: View south-westwards across the existing borrow pit (Almond 2013: 5)

Proposal is for an extension of an existing borrow pit DR1392/3.3/L/10/A/R22 located along the unsealed DR1392 road approximately 13 km northwest of Montagu, Western Cape. The source of wearing course gravel is located within an existing borrow. Grass, shrubs and trees within and surround the borrow pit. The site is situated on the gentle east-facing footslopes of a low mountain range (Geewelkrans area south of the Waboomberge Range) on Portion 2 of Montagu Farm No.87 (Middel Voetpad) in private ownership of Wilem Gerhardus Beetge. Borrow pit co-ordinates are 33° 41' 12.2" S, 20° 03' 33.9" E

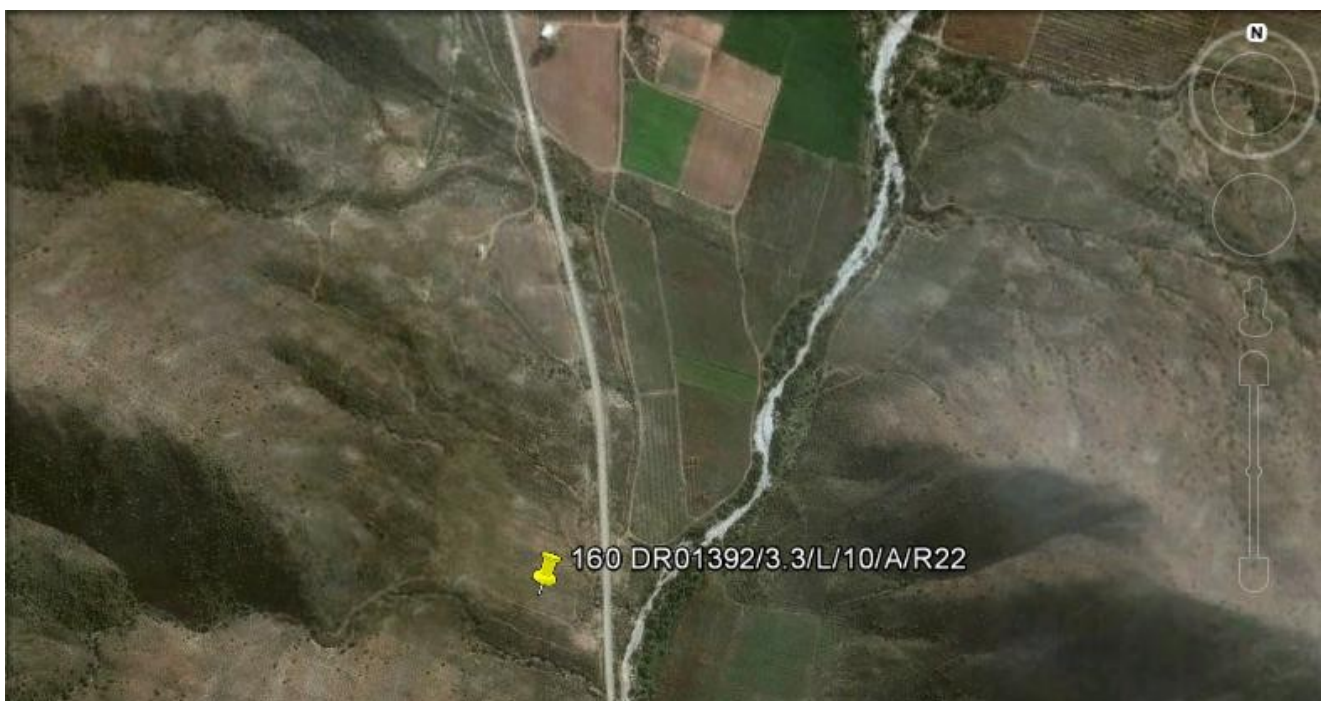
Figure 4: Aerial view of potential borrow pit (Google earth image, February 2013) 3
