HERITAGE IMPACT ASSESSMENT

29 October 2012

DR 01252 Caledon

Overberg District Municipality, Western Cape

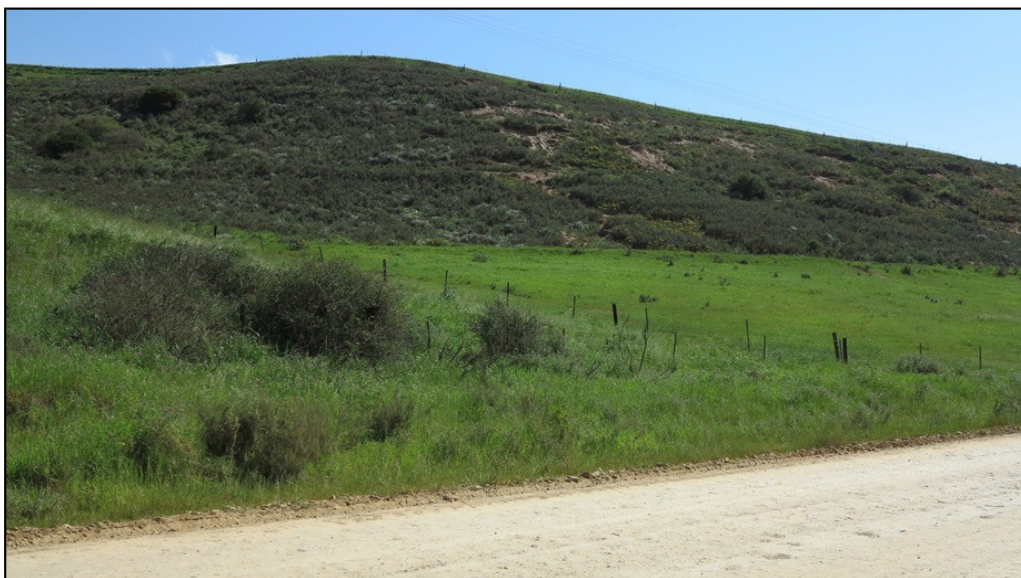
Figure 2: At km 10.50 View towards the west of the proposed borrow pit in the area covered by grass (Tusenius 2012: 7)

It is proposed to expand an existing borrow pit at DR01252/10.5/R/30 south east of Caledon, Western Cape. The site is located in a wheat field extending from a depleted borrow pit on the right hand side of the road for a distance of approximately 30m into an abandoned wheat field. Surrounding context is characterised by Agriculture and wheat cultivation. The site lies on the farm Dunghye Park 528 in private ownership of Mr M Eksteen. Borrow pits coordinates are 34°19'22.15"S 19°31'19.89"E

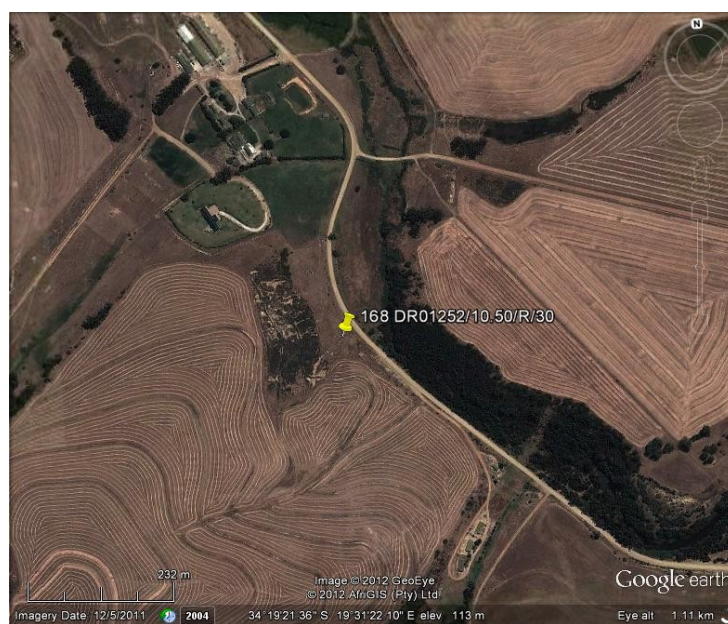
Figure 4: At km 10.50 aerial view of existing borrow pit and expropriation area (Google earth image, October 2012)

Summary of borrow pit	
	at km 10.50
Expropriation area	2 609 m ²
Maximum depth	2 m
Material description	Rock shale
Proposed usage after rehabilitation	farm dam
Volume of material to be sourced	2806 m ³
