**ARCHAEOLOGICAL IMPACT ASSESSMENT
OF THE PROPOSED EXTENSION OF A BORROW PIT ON
THE REQUEST 547, CALEDON, OVERBERG DISTRICT,
WESTERN CAPE**

(Assessment conducted under Section 38 (8) of the National Heritage Resources Act as part
of a Heritage Impact Assessment)

OCTOBER 2012

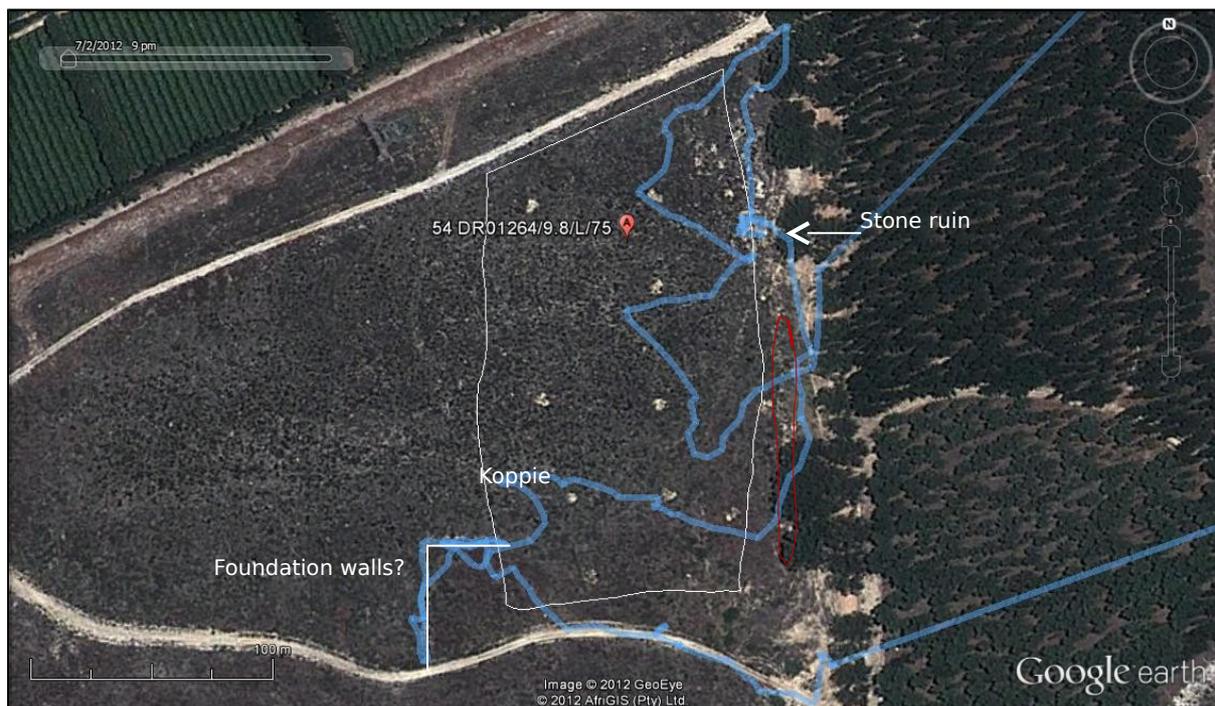
Figure 2: Google earth image showing the proposed borrow pit 54, the position of the stone ruin, possible foundation walls and the tracks of the field survey. The DR01264, the eastern boundary of the affected area, is obscured by trees in this image. The area outlined in red indicates the approximate position of the previously quarried road reserve. Please note that the straight blue lines do not indicate survey tracks.

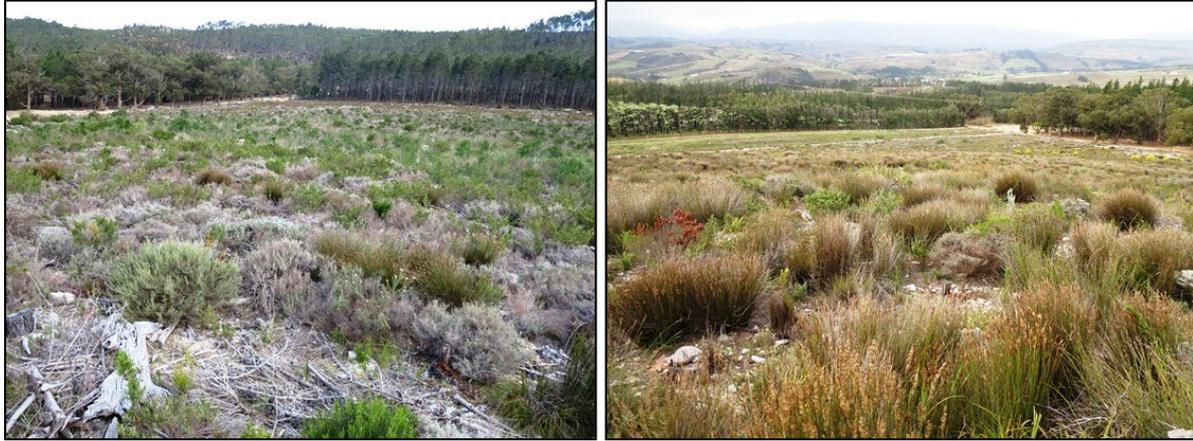
Figures 3 and 4: View from the koppie towards the southeast; view from the koppie downslope towards the northeast.

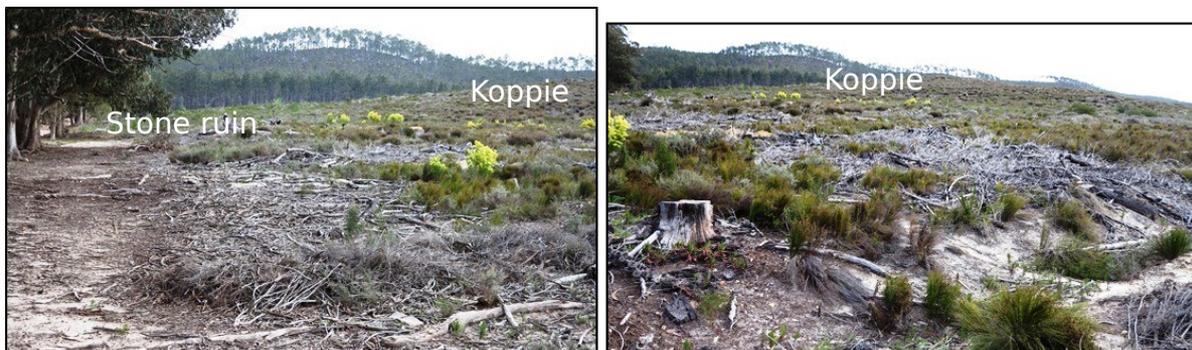
Figures 5 and 6: View from the northeast corner towards the south showing the position of the stone ruin and koppie. The previously excavated road reserve lies beyond the ruin, further to the south; view towards the southwest.

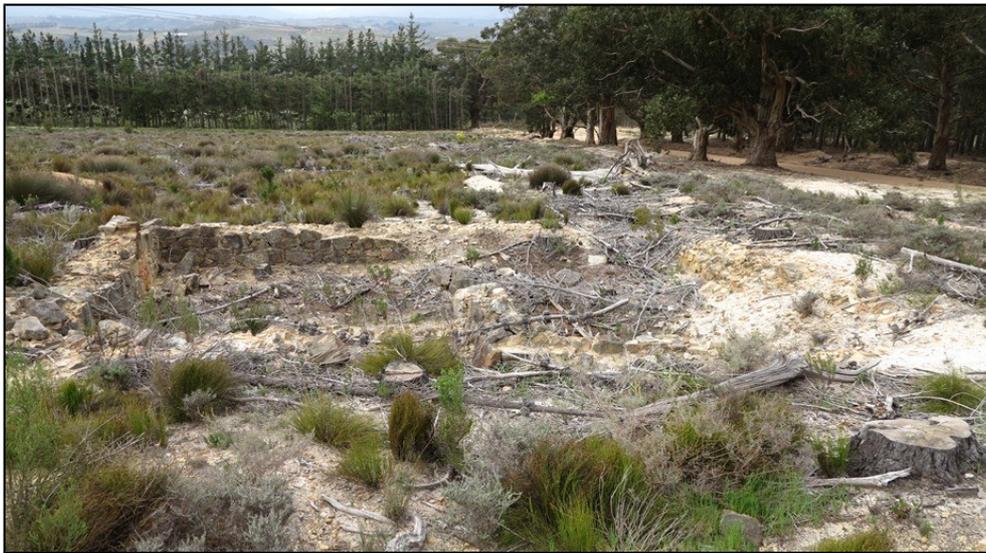
The stone ruin is in fact quite a substantial, rectangular, largely sub-surface structure with thick, mainly intact walls, possibly foundations (Figures 7 to 12). The north and south walls are approximately 11m in length and the eastern and western walls are approximately 8.5m and 7.5m respectively. The wall on the eastern side is not as well preserved as the others. The walls consist of sandstone blocks on the inside and outside, with an infill of smaller stones (Figures 9 and 12). The random rubble stone building method is not readily datable

without other related evidence, but it seems that 18th century stone foundations are about 600mm wide whereas those of the 19th century are about 400-500mm (Dr Antonia Malan, pers. comm.). In this case the walls would fit in the latter category. The only cultural remains found near the structure were the remains of a zinc bath (Figure 13) and a small L-shaped piece of metal which may not be directly related to the ruin. No other remains such as porcelain or glass were observed. The rest of the affected area was also devoid of cultural material except for one small piece of blue glass found near the koppie.

The copy of a 1989 title deed for the farm The Request No 547, on which the proposed extension is located, reveals that the first survey of the farm was done in 1875 (Website of the Chief Surveyor). It is possible that the stone ruin may date to this period.

Figure 7: View towards the north showing the location of the stone ruin close to the DR01264.

The proposed extension of pit 54 is of low Stone Age archaeological significance but I am not able to make an assessment of the significance of the historical remains. It is likely that the stone ruin and walls are older than 60 years and are thus protected by the National Heritage Resources Act of 1999. Quarrying will have a direct impact on the stone ruin in particular.

It is therefore recommended that a suitably qualified specialist be appointed to assess the significance, if any, of these historical remains, their possible significance within a regional architectural context and to make recommendations regarding any mitigation required prior to the proposed extension of the borrow pit. Any structures which have not been assessed should be fenced off and protected during mining operations. A permit for the demolition of such remains will be required from Heritage Western Cape.

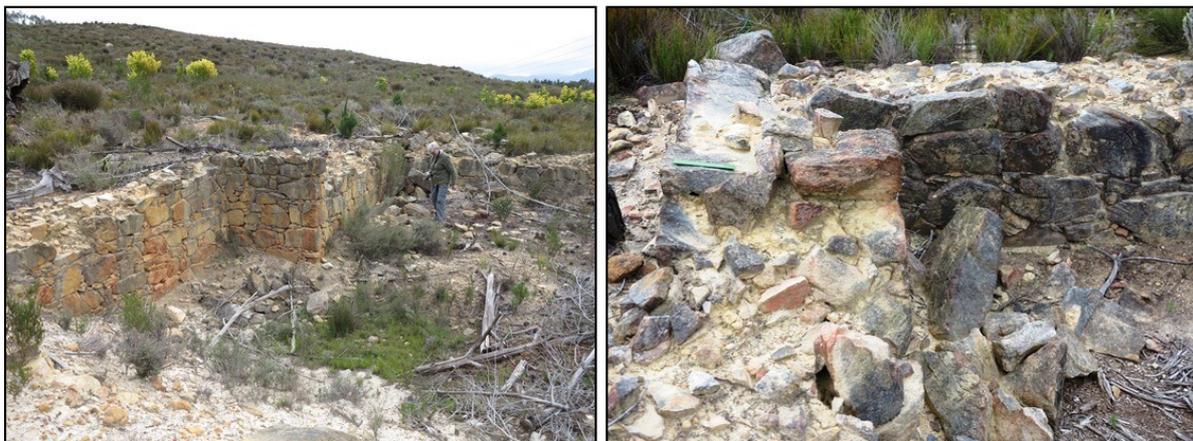
Figures 8 and 9: The stone ruin – view towards the west showing the sub-surface southern wall of the structure; detail of the northwest corner showing the rubble infill between the outer and inner stones. The ruler is about 15cm in length.

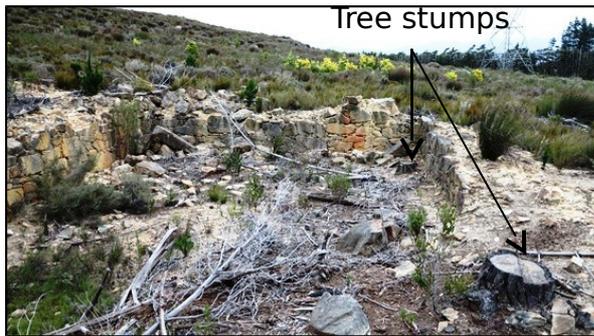
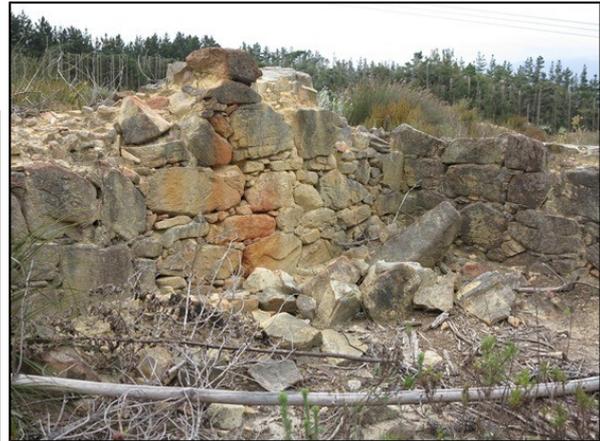
Figures 10 and 11: The stone ruin – view towards the west showing the stumps of pine trees which were planted after the abandonment of the structure; detail of the north-western corner.

the stone ruin, the random rubble stone building method appears to have been used (Figures 15 and 18). These walls are not as substantial as the former so they possibly belong to a later period. In both cases the pine trees must have been planted after the structures were abandoned as the stumps lie very close to, or on top of, the remaining foundations (Figures 10, 12, 15 and 17).

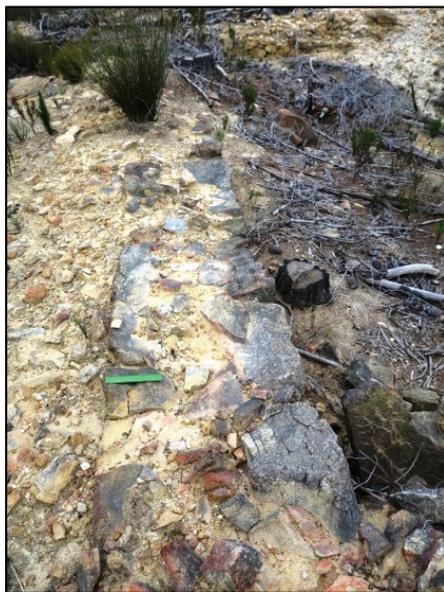
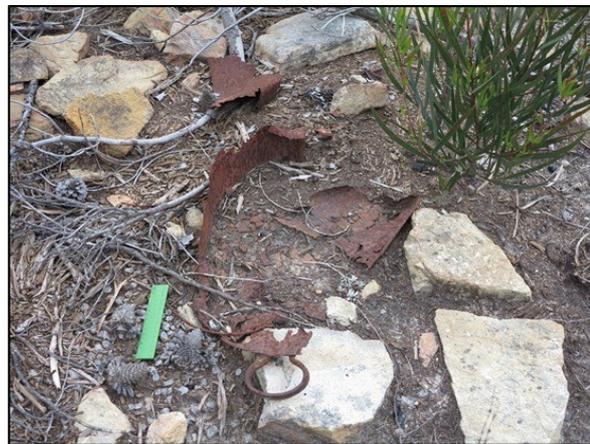
Figures 12 and 13: The stone ruin - view towards the east of the northern wall; the remains of an old zinc tub found within the ruin. The ruler is about 15cm in length.

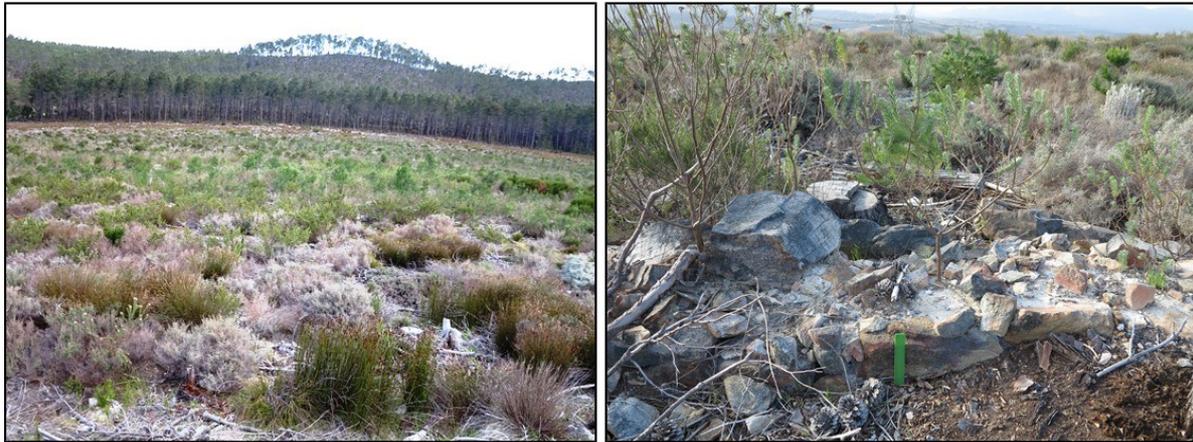
The other possible features noted on the Google Earth image of the southern area (Figure 14) turned out to be the badly-preserved remains of two walls at right angles to each other (Figures 2, 15 to 18). One wall runs east to west, the other north to south. As in the case of

Figures 14 and 15: View towards the south showing the context of the foundation walls observed at the margins of the south-western corner of the proposed pit; detail of one of the best- preserved parts of the east-west running wall.

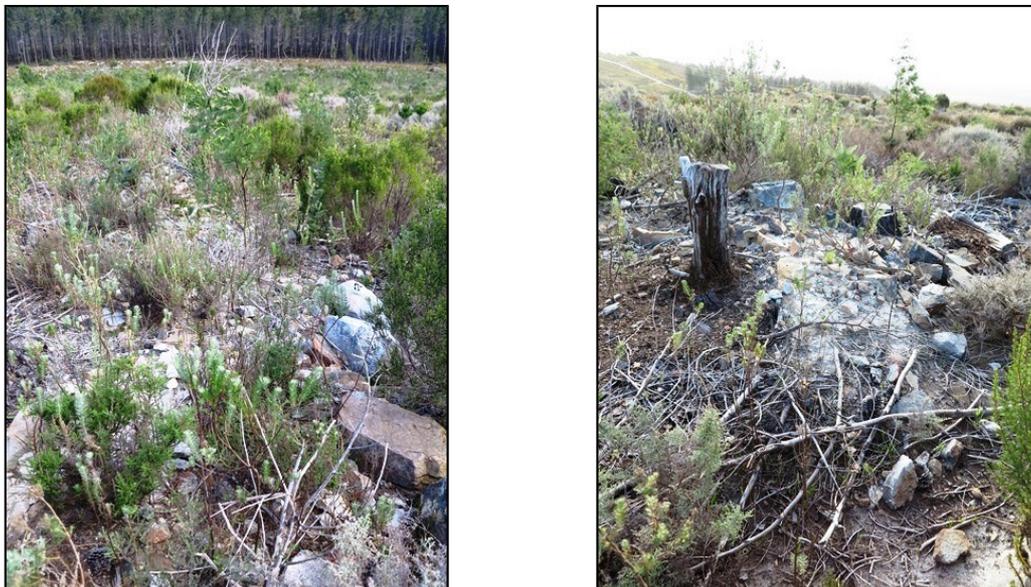
Figures 16 and 17: View towards the east with the remains of part of the east-west running wall (barely) visible in the foreground; view towards the north of the north-south orientated wall.

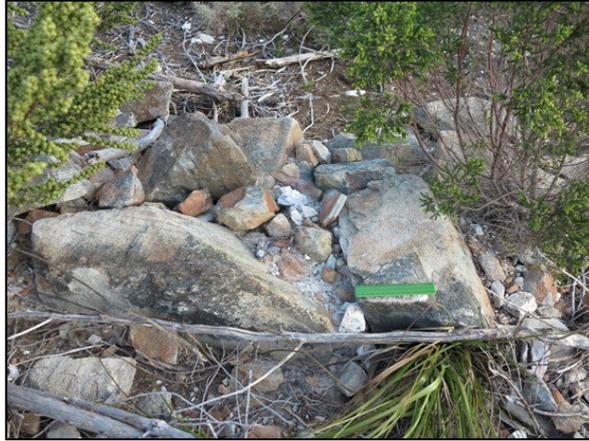
Figure 18: Detail of part of the east-west orientated wall showing the rubble infill. The ruler is about 15cm in length.
